**AEROPLANE AND ARMAMENT
EXPERIMENTAL ESTABLISHMENT**

VENOM FB. 1. WE. 258
(GHOST 3)

4 X 20 MM. MK. 5th HISPANO GUNS
GUNNERY ACCEPTANCE TRIALS

10th Part of Report No. AAE/868

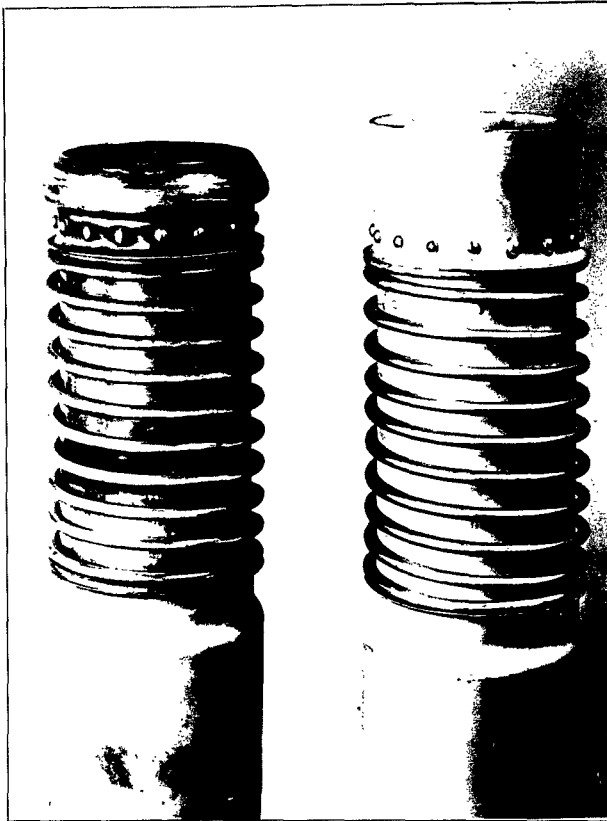
4.6.2. A modified blast tube was evolved by the Martin Baker Aircraft Co. which was found to be satisfactory. Approximately 50 firing sorties were carried out with this type mostly at speeds of 500 knots and over. Fig. 7 shows the original and modified types. The maker's drawing No. of the modified type is MBT60/5350.

FIG. 7 STANDARD AND MODIFIED
BLAST TUBE

6.2. Blast tubes of the modified MBT/60 pattern with the Edge Type Rim to the Martin Baker Aircraft Company's drawing No. MBT/60/M5350 should be fitted as standard. Until this is done blast tubes should be checked for damage after each air firing sortie.

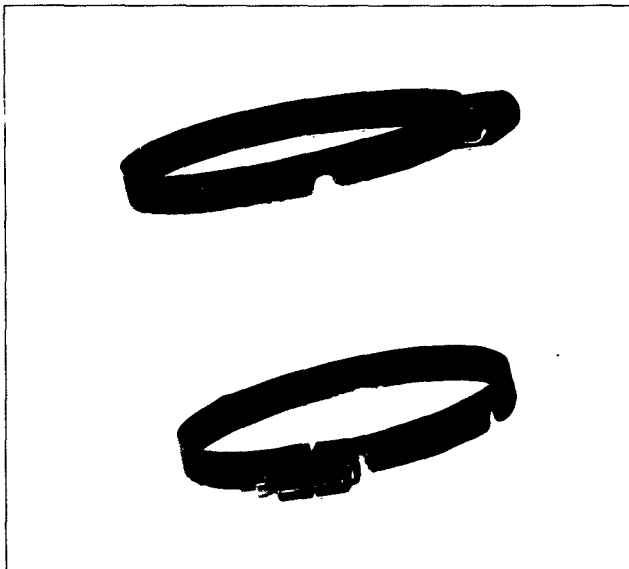
4.6.4. The present method of securing the blast tubes to the front mountings of the guns is not considered strong enough. In two cases the jubilee clips fractured across the out-away portion giving clearance for the outer eccentric lock. It is considered that a clip similar to that shown in fig. 8 should be introduced. This clip is re-inforced at its narrowest part and is secured by a nut and bolt.

FIG. 8 SUGGESTED TYPE OF MODIFIED BLAST
TUBE SECURING CLIP

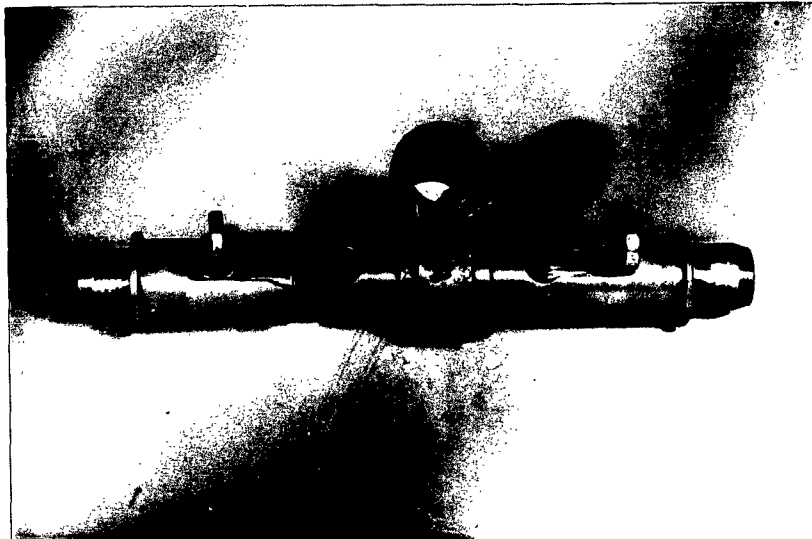
4.4.8. After the 34th sortie it was found that the quick release assembly at the rear mounting (Stores Ref: 26FC/4028) was fractured (Fig. 9). Two other quick release assemblies were changed due to the slide tubes becoming slack in the brackets.

FIG. 9. FRACTURED QUICK RELEASE ASSEMBLY AT REAR MOUNTING.

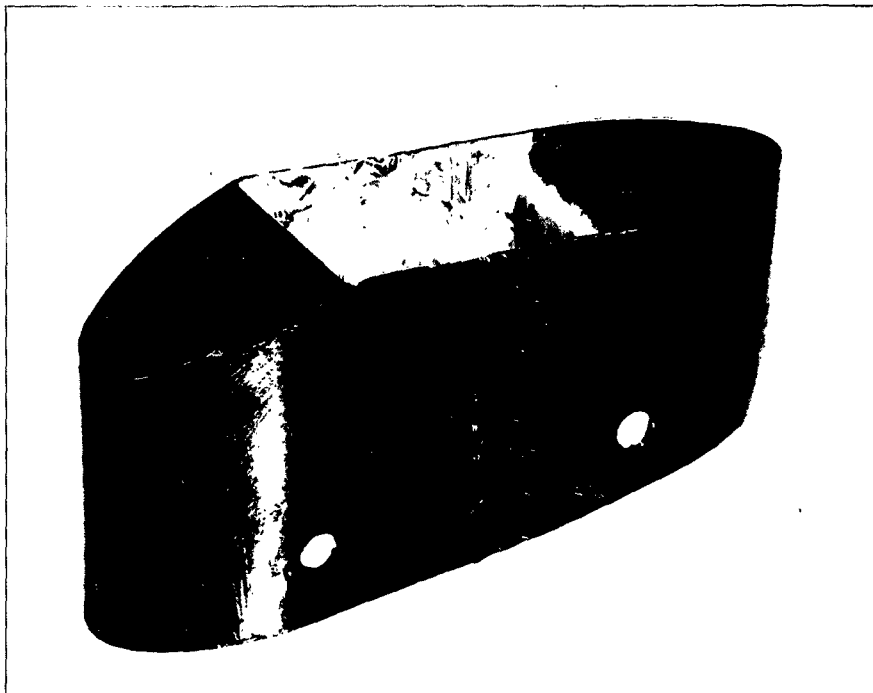
9	Extension link chute as in type No. 8 with 2½" deflector as in type No. 7.	17 & 18				Accepted.

FIG. 17. 2½ FAIRING FOR LINK DEFLECTOR.
NOTE: INTERNAL SURFACES PAINTED
WHITE FOR ILLUSTRATION ONLY.

6.1. Link deflectors of the type shown in the De Havilland Aircraft Company's drawing "D.H.112 Link Chute Extensions" drawing No. 122.2345 but with the 2 $\frac{1}{2}$ " fairings produced by that firm, must be fitted as standard. The underside of the fuselage, the booms and tailplane must be checked for damage after each air firing sortie.
