U S. NAVAL PROVING GROUND  
DAHLGREN, VIRGINIA

REPORT NO. 1118

GUNFIRE TEST OF MODEL FJ-2 AIRPLANE  
OXYGEN CYLINDER MOUNTING BRACKETS

FINAL Report

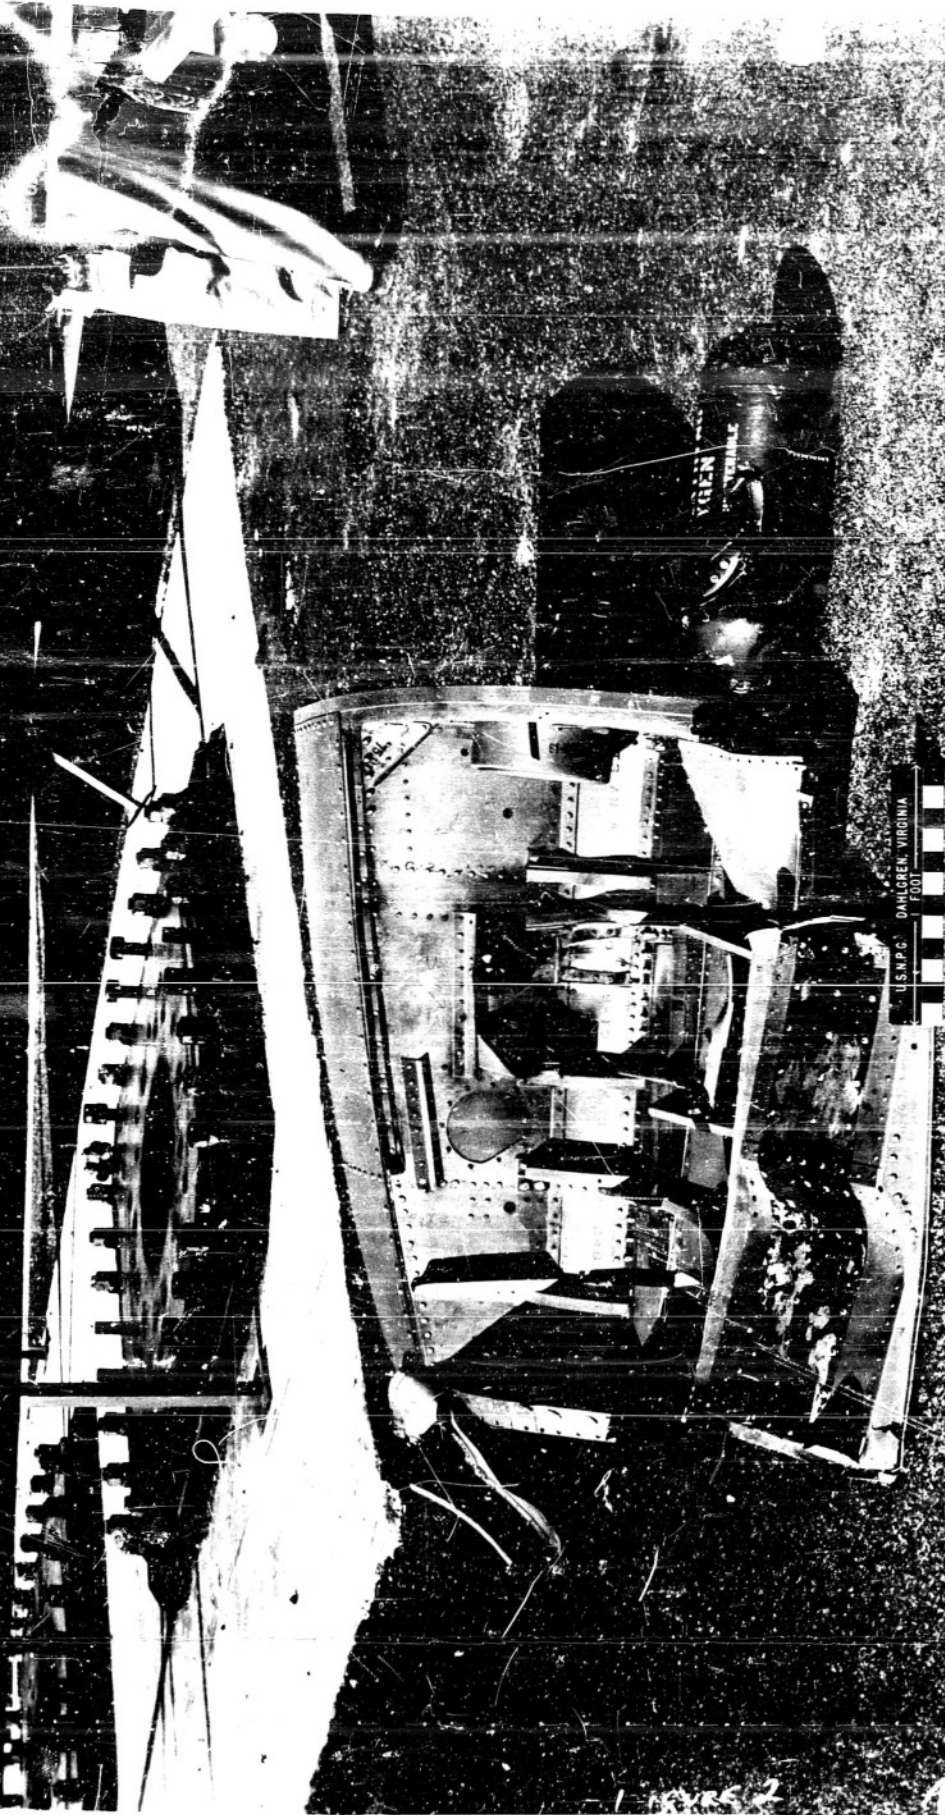
- a. The first bracket assembly tested failed to retain the oxygen cylinder, with damage being inflicted to the bracket and surrounding fuselage structure.

The first bracket assembly tested was mounted in a horizontal position with the longitudinal axis of the cylinder at an angle of 45° to the line of fire and attacked with a .50 caliber armor piercing projectile. The base of the cylinder was closer to the muzzle of the gun than was the neck. The initial impact occurred in the base of the cylinder, the projectile exiting through the aft wall. The effect of the projectile impact and/or the force initiated by the escaping oxygen resulted in the following damage: severed the angle attaching the Marman strap to the fuselage structure allowing the cylinder to fall free of the bracket; the access door was blown free and its hinges severed; the surrounding fuselage structure was torn and some sections were blown free. The damage to the test specimen is shown in Figure 2.

gunfire Test of Model FJ-2 Airplane Oxygen-cylinder Mounting Brackets. View showing damage inflicted to the first test specimen by a .50 caliber AP projectile impact and/or the force of the escaping oxygen. The test specimen was attacked at an angle of 45°. Figure 2

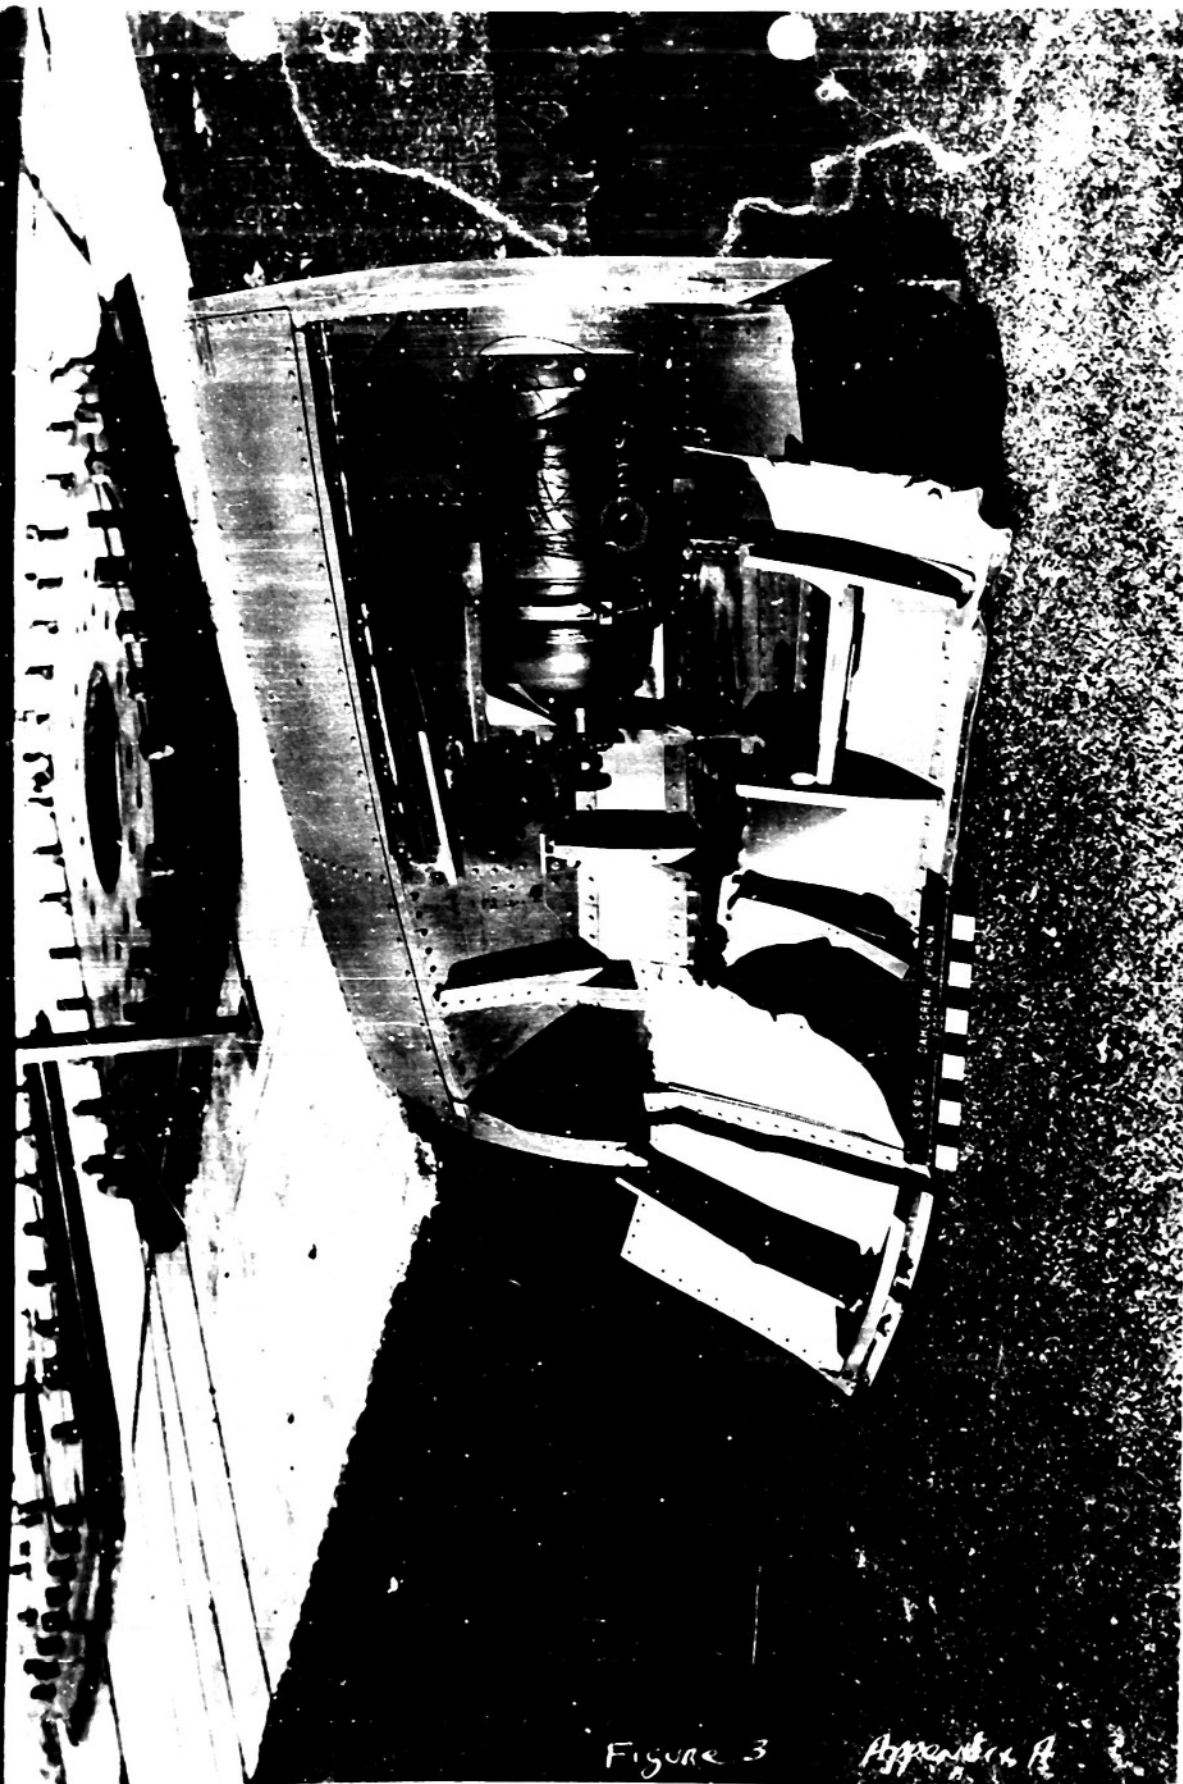
Figure 3

- b. The second bracket assembly tested retained the oxygen cylinder with no apparent damage to the bracket. The surrounding fuselage structure was torn and the access door was blown free.

The second bracket assembly tested was mounted in a horizontal position with the longitudinal axis of the cylinder at an angle of 35° to the line of fire and attacked with a .50 caliber armor piercing projectile. The base of the cylinder was closer to the gun muzzle than was the neck. The initial impact occurred in the forward end of the cylinder approximately 8" below the valve, the projectile exiting through the opposite wall immediately below the neck of the cylinder. The bracket retained the cylinder with no apparent damage, although as a result of the force of the escaping oxygen, the surrounding fuselage structure was torn and some sections were blown free. The damage to the test specimen is shown in Figure 3.

6 February 1953  
Gunfire Test of Model FJ-2 Airplane Oxygen Cylinder Mounting Brackets. View showing damage inflicted to the second test specimen by a .50 caliber AP projectile impact and/or the force of the escaping oxygen. The test specimen was attacked at an angle of 35°.
