REPORT NO. 1143

-----  
COLD WEATHER TESTING OF BOMB,  
EX 14 MOD 0 (FIRE-1000 LBS)

Cold Weather Testing of Bomb, Ex 14 Mod 0 (Fire-1000 lbs)

Date: JUN 29 1953

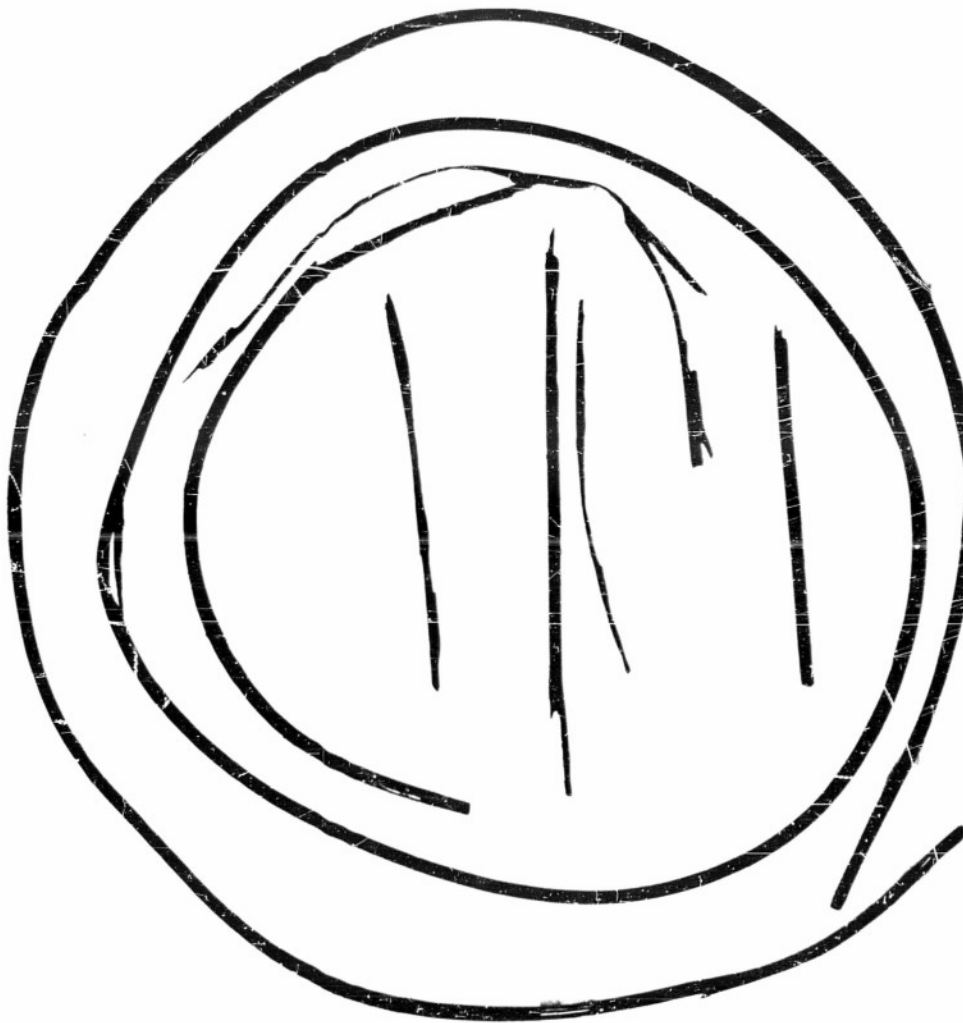
e. At the conclusion of the water tight integrity test, the bomb was cut open and the circumferential "O" ring seals removed and inspected. As shown in Figure 9 the seals suffered considerable damage and would not have held water. It could not be determined what portion of the leakage reported in the preceding paragraph was caused by the damaged "O" ring seals as the pockets and seals are adjacent. Portions of these "O" ring seals were subjected to a simple bend and hammer test at various temperatures. It was found that the seals could withstand bending at -35°F and would fracture at -40°F. In addition, it was found that they would withstand hammer blows at -10°F and would fracture at -15°F. Inasmuch as the "O" ring seals are not hit directly in assembly, it is felt that they would withstand assembly at temperatures down to -20°F.

View shows damaged "on" ring seals.

- a. The present bomb not be assembled at temperatures below -20°F.
- b. The present "O" ring seals and filler cap seals be made of a material that is flexible and will withstand shock at -65°F.
- c. The tape covering the end of the nose and tail sections be left off.
- d. Leak tests be conducted on a bomb assembled at room temperature and stored at -65°F.
