**TWENTY-FIRST**

**PROGRESS REPORT**

**THE FIRESTONE TIRE & RUBBER CO.**

**105 MM BATTALION ANTI-TANK PROJECT**

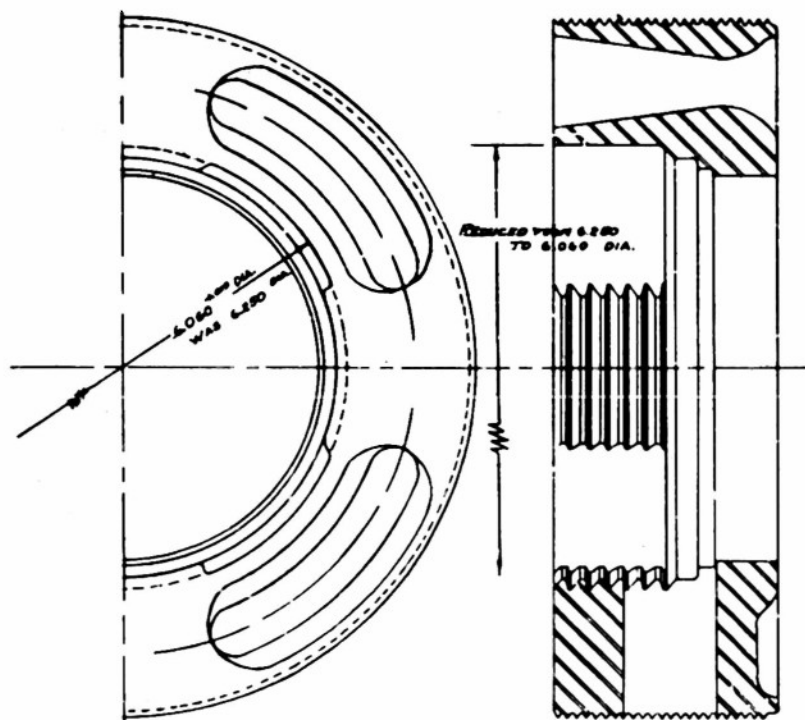
Fig. 1. Revision of Breech Ring.  
Firestone Drawing No. DRD-206-19.

During the course of firing 300 rounds from the T-137 E1 rifle at Aberdeen Proving Ground, evidence appeared that there was excessive stress in the thin web section of the vent ring. Steps have been taken to correct this condition by increasing the thickness of this web. The I.D. of the thin section has been decreased from 6.250 to 6.060 (Figure 1).

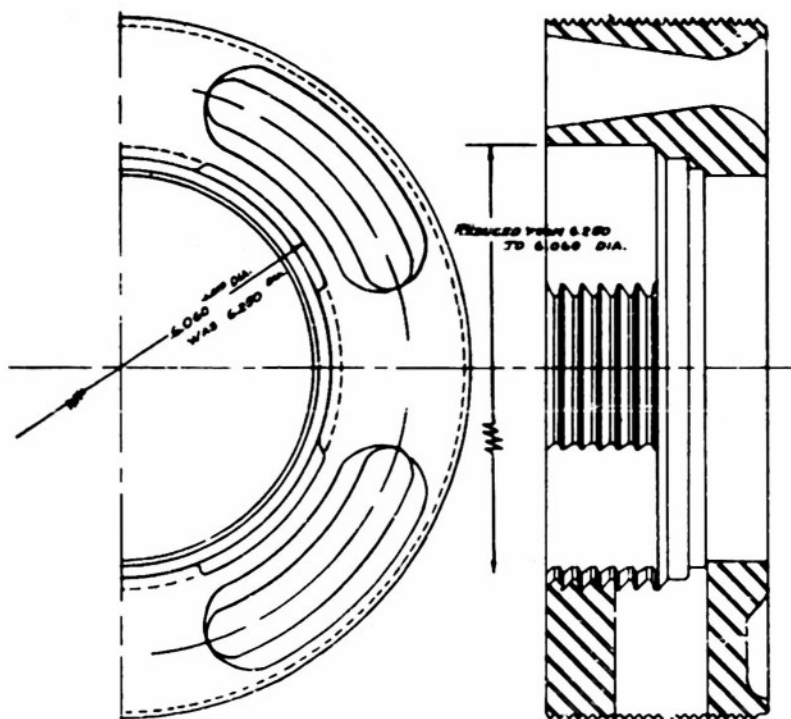
Fig. 1. Revision of Breech Ring.  
Firestone Drawing No. DRD-206-19.

During the course of firing 300 rounds from the T-137 E1 rifle at Aberdeen Proving Ground, evidence appeared that there was excessive stress in the thin web section of the vent ring. Steps have been taken to correct this condition by increasing the thickness of this web. The I.D. of the thin section has been decreased from 6.250 to 6.006 (Figure 1).

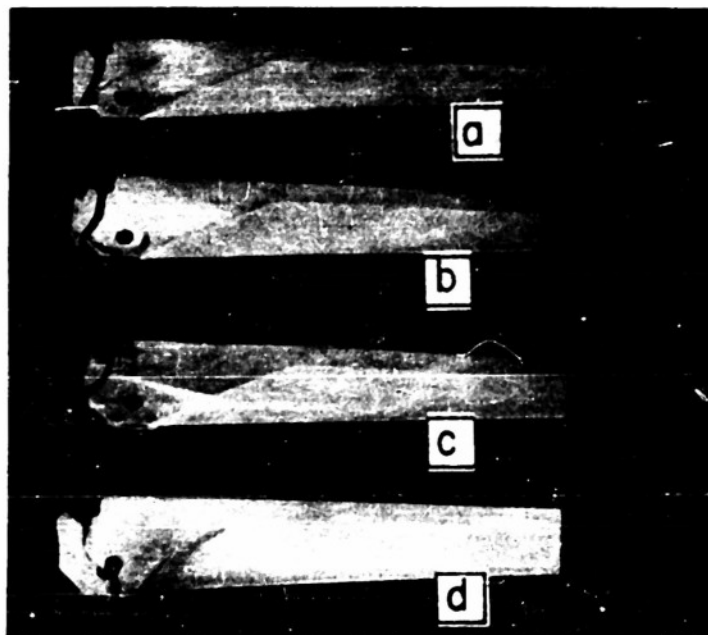
Projectile number 45 was assembled with die cast fins. This projectile was fired through three yaw cards into the recovery box. Recovery of the projectile revealed that each of the fins had broken in a very similar way, at the gear form. One recovered fin is shown as "a" in Figure 3. Inspection of the yaw cards indicated that the fins had broken under the rapid deceleration of the opening action, had over-traveled, and then had returned to their correct positions before entering the recovery box. Since the failure seemed to be caused by impact deceleration, a Riehle pendulum impact tester was modified to accommodate the fin. The complete tester, with pendulum in the raised position, is shown in Figure 4. Figure 5 shows the fin in the test fixture about to be struck by the pendulum. Several fin designs were tested in this machine for impact strength. The data are shown in Table I.

While modifications resulted in a minor improvement over the original casting, the impact strength was still considerably below that of fins milled from 24ST-4 aluminum plate. Consideration is being given to the use of a steel insert in the region of the failure.

Fig. 3. T-119 Projectile Fins.  
Test samples showing typical impact failure. Fins "a," "b," and "c" are A360 aluminum die castings and "d" is a fin milled from 24 ST4 aluminum plate.

1. A larger radius was added at the root of the gear form to reduce stress concentrations.
2. The gear form was die cast and broached to the final tolerance to avoid sharp tool marks.
3. The flat portion of the fin was milled over the region of the hinge pin hole only to preserve as much of the high strength skin as possible.

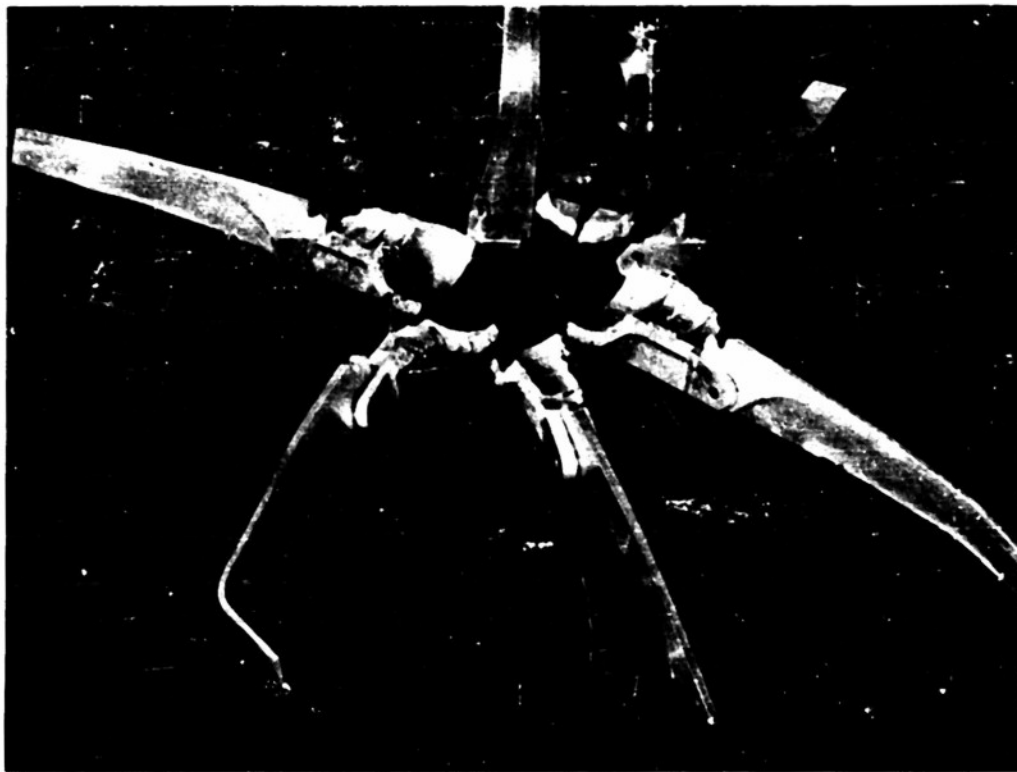
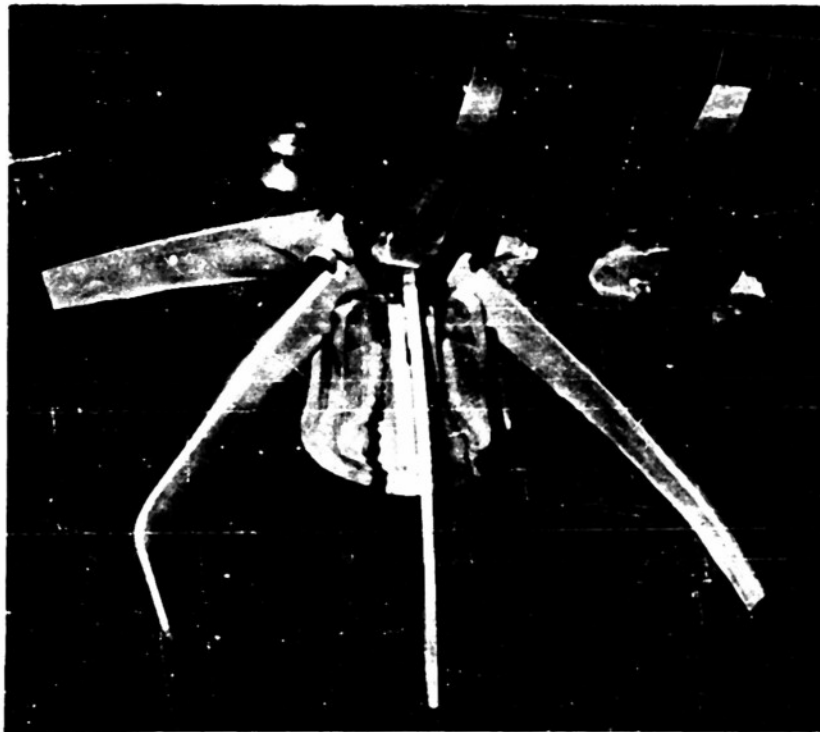
gress Report, Table XIII. The housing failed when the projectile was fired and the recovered fragments are shown in Figures 6 and 7.

The evidence seems to indicate that the failure occurred soon after the projectile left the muzzle and that the failure was caused by the sudden reversal of the pressure differential at the projectile chamber at muzzle exit. This conclusion is supported by the lack of projectile

planned but it does not appear probable that a satisfactory housing can be made by die casting.

Fig. 6. Sand-Cast Housing From T-119 Projectile.

Fig. 7. Sand-Cast Housing From T-119 Projectile.

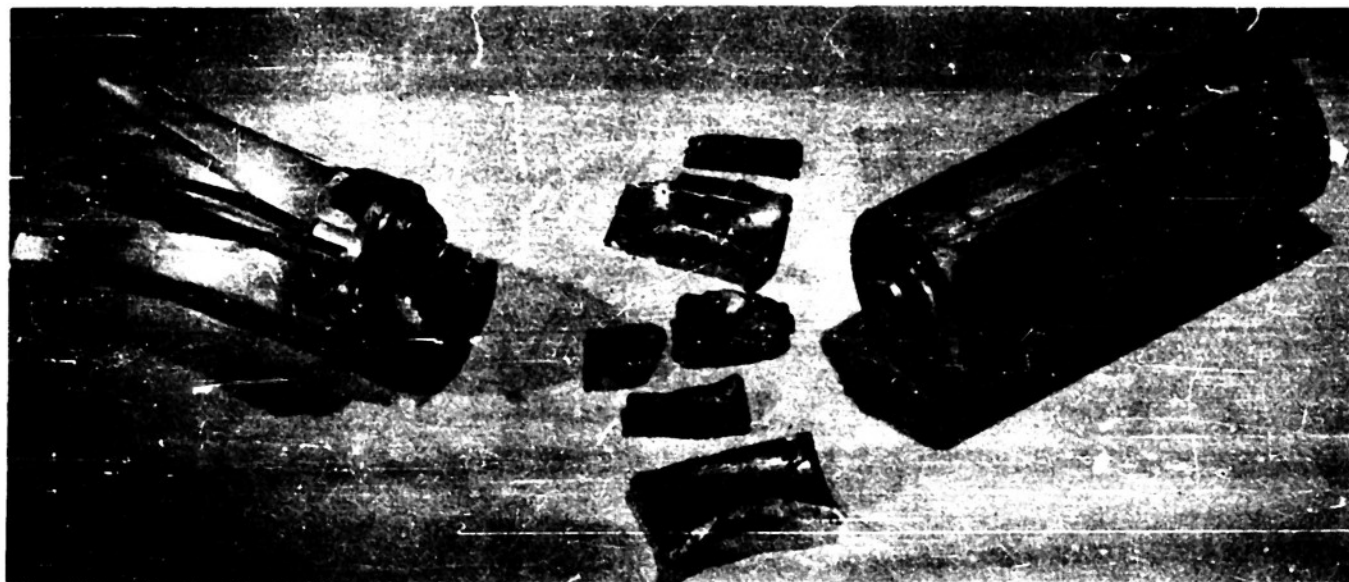
pieces were recovered. An examination of the recovered fragments and of the yaw cards indicated that the projectile gas chamber collapsed in the gun from the pressure of the propellant gases. The recovered fragments are shown in Figure 10 and the first yaw card is shown in Figure 11.

Fig. 10. Recovered Fragments of T-119 Projectile.  
Fired from 105mm. howitzer, M2A1.

Since all components, with the exception of the chamber, appeared to survive the launching in good condition, it is felt that a 105mm T-119 projectile can be made to successfully withstand the higher pressures of a howitzer by simply strengthening the projectile gas chamber.

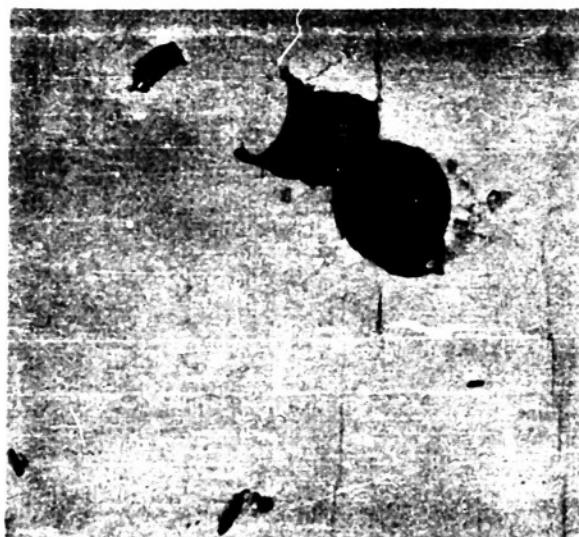
Fig. 11. First Yaw Card for T-119 Projectile.  
Fired from 105mm. howitzer, M2A1.

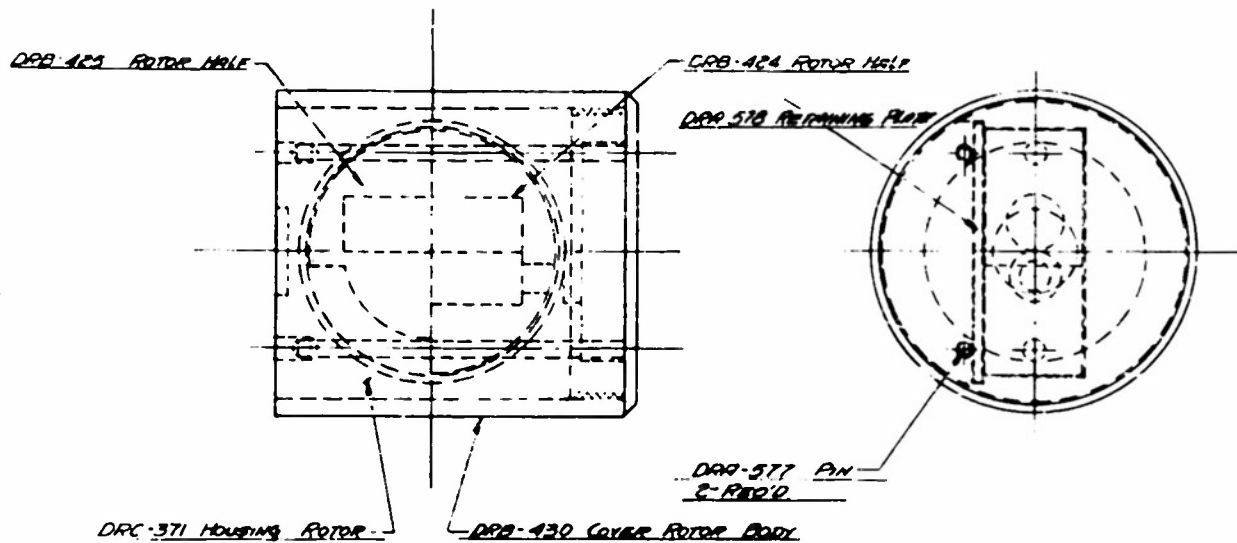
Six of the assemblies had the T-18 detonator and the EX-9 primer-delay arranged with the explosive ends flush (See Figure 16). These six assemblies failed to fire the T-18 detonator when the EX-9 primer-delay was functioned.

Fig. 16. First Arrangement.  
Explosive ends of detonator and primer-delay flush.

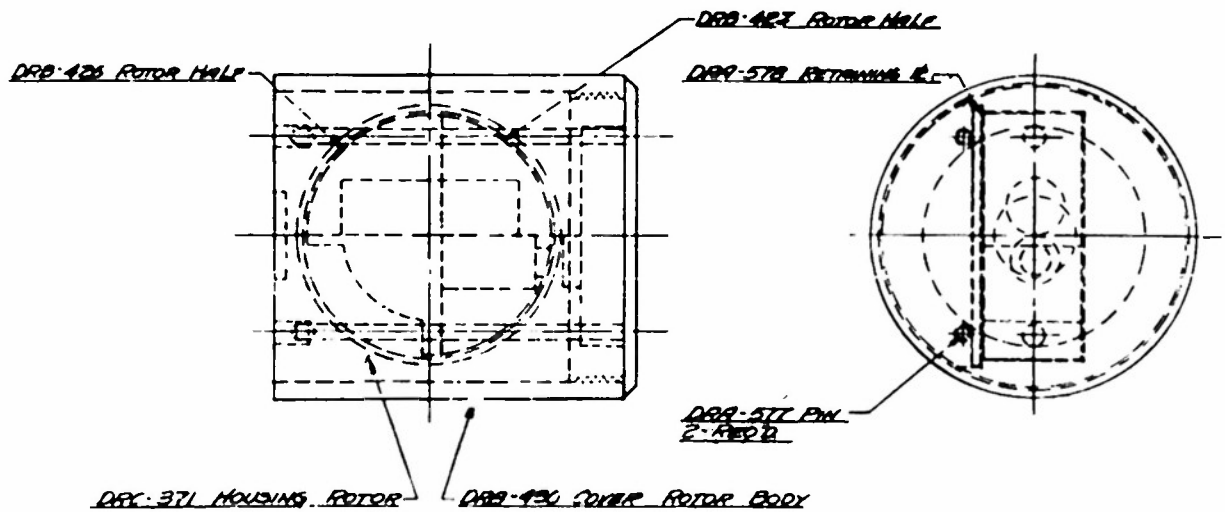
Six assemblies had the T-18 detonator staggered in the rotor with respect to the EX-9 primer delay (See Figure 17). Five of these pyrotechnic trains functioned while one failed to function.

Fig. 17. Second Arrangement.  
Detonator staggered in rotor with respect to primer-delay.
