8th Part of Report No. AAEE/896

# AEROPLANE AND ARMAMENT EXPERIMENTAL ESTABLISHMENT

PEMBROKE C. MK.1 WV.699

RADIO ACCEPTANCE TRIALS

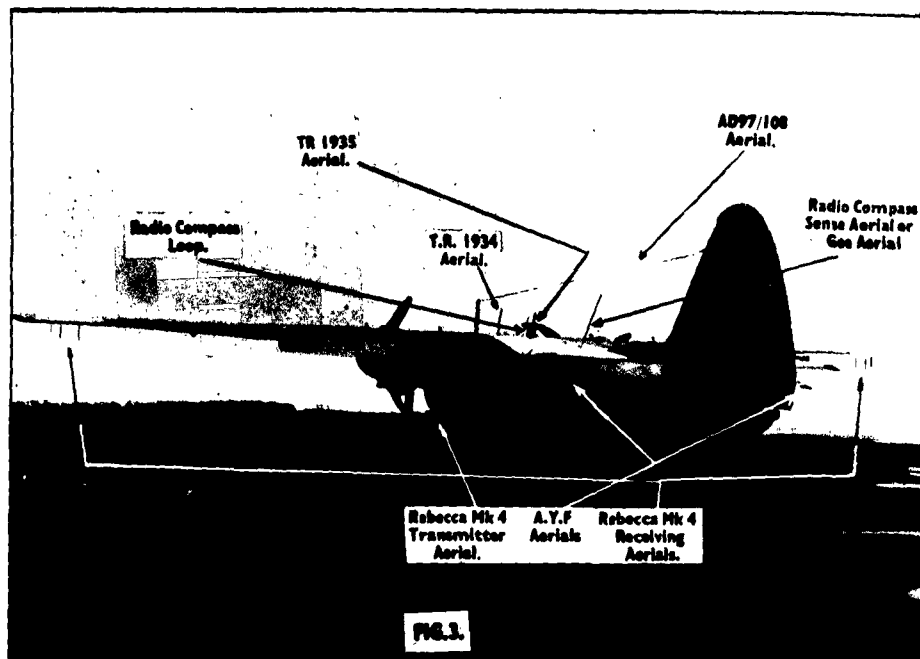
4.1.3. The aerial type 228 was situated on top of the fuselage, offset to port of the centre line of the aircraft (Fig. 3). The aerial Type 229 was situated on the top of the fuselage, offset to starboard of the centre line of the aircraft (Fig. 3), both positions were satisfactory.

5.1.5. The loop aerial was fitted on the centre line of the aircraft (Fig. 3) and was accessible for maintenance.

5.1.6. The sense aerial was mounted on the top of the fuselage, offset to starboard of the centre line (Fig. 3).

6.1.5. The fixed aerial was suspended between a mast behind the cockpit and the tail fin, (Fig. 3). No provision was made for earthing this aerial.

8.1.4. The transmitting aerial was mounted under the fuselage, just aft of the nose wheel (Fig. 3) and gave a satisfactory coverage.

8.1.6. The two receiving aerial assemblies were mounted on the underside of the port and starboard wing tips (Fig. 3) and gave a satisfactory performance.

9.1.3. The standard 3 ft. 7½ ins. whip aerial, which was alternative fit to the Radio Compass sense aerial, was mounted on top of the fuselage (Fig. 3), and was satisfactory for operational coverage.

10.1.4. The transmitting and receiving aeriels were mounted on the underside of both port and starboard tailplanes (Fig. 3), and were considered satisfactory after performance checks.

13.3.3. Provision should be made for earthing the H/F aerial when required. (Para. 6.1.5. refers).
