SEA VENOM MK. 20 WK. 379  
(GHOST 3)

RADIO ACCEPTANCE TRIALS

10th Part of Report No. AAEE/868/1.

A. & A.E.E. Ref.: AAEE/411/77/Radio.  
M. O. S. Ref.: 39th Joint Meeting Ministry of Supply, Admiralty,  
A. & A.E.E., dated 10th October, 1951.  
Period of trials: 20th April, 1953 to 1st September, 1953.

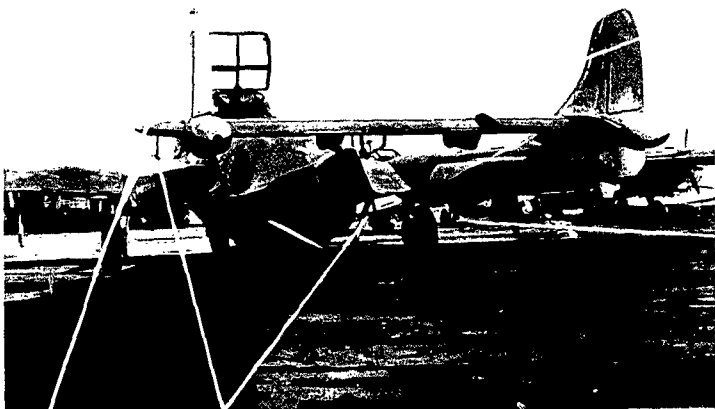
FIG.2.

4.1.5. The I.F.F. Aerial type 90 was mounted centrally on top of the port boom (Fig. 2) and was satisfactory for operational requirements.

5.1.3. The aerials were positioned, one on the port tail plane extension, and the other on the underside of the starboard flap shroud near the fuselage (Fig. 2).

The aerials had been repositioned in accordance with para. 84 Form 555 of the Final Conference. The total length of the feeder is now 61 feet, making it very difficult to adjust some receivers to the necessary Residual Altitude of 48.75 feet. This is also very near the limit of the range of delays available from Test Set Type 16. (i.e. 51 feet absolute maximum).

11.2. A.Y.F. The performance of this installation is satisfactory. It is recommended that the aerial feeders be shortened by 5 feet if possible, so that any receiver can be easily set up to the required residual delay (see para. 5.1.3.)

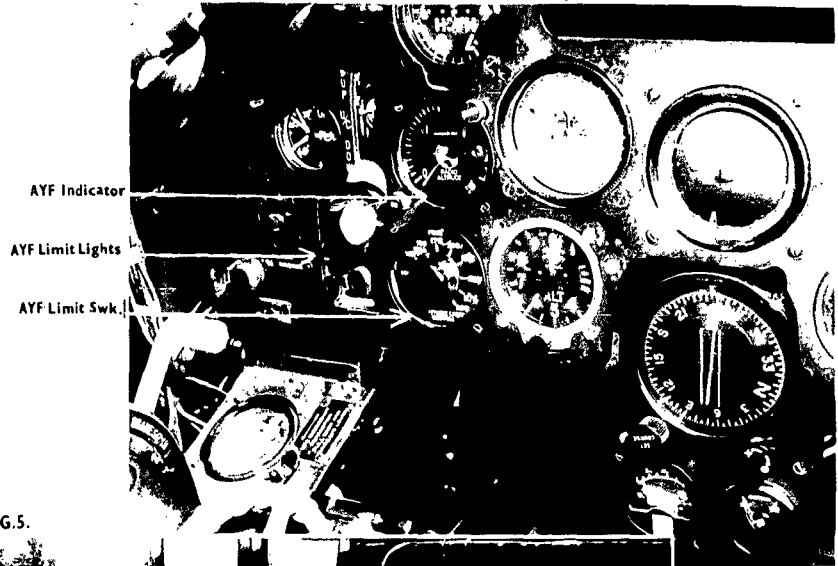
FIG.4.

5.1.2. The Indicator, Limit Switch and Limit Lights were all positioned on the port side of the pilot's instrument panel (Fig. 4) and were satisfactory for operation and viewing.

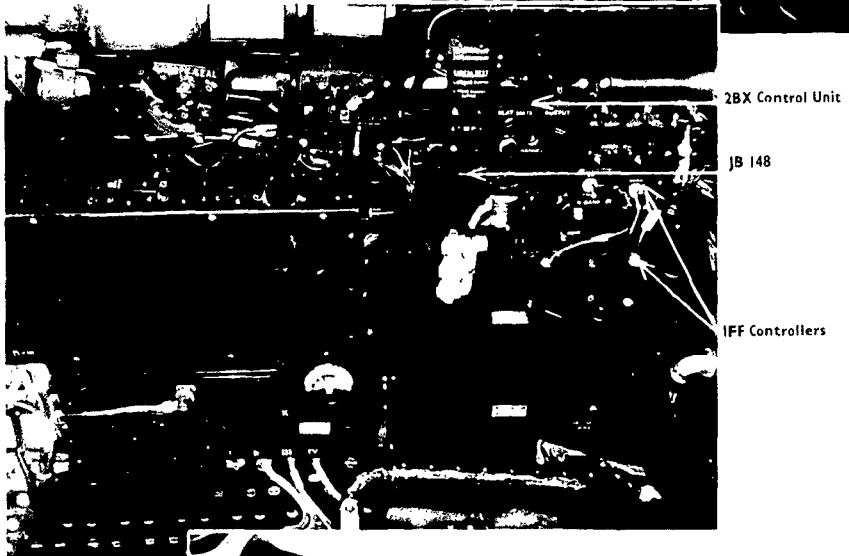
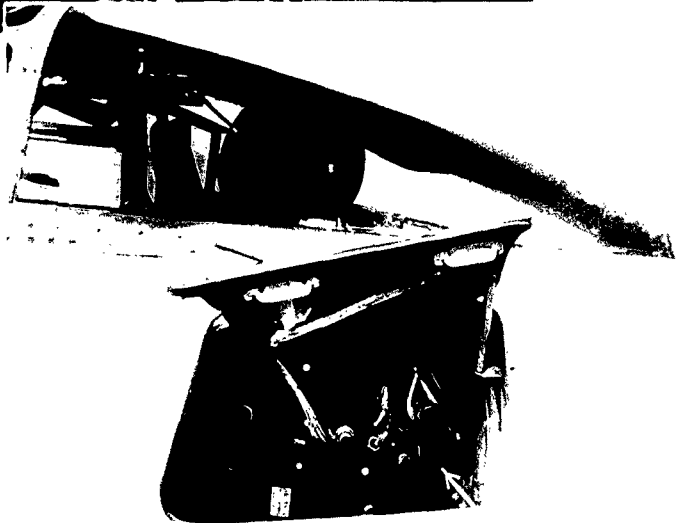
FIG.5.

4.1.3. Controller type C54/APX-1 was mounted on the starboard side of the cockpit (Fig. 5) in a satisfactory position for operation.

4.1.4. Controller type C.53/APX-1 was also mounted on the starboard side of the cockpit (Fig. 5) and was satisfactory for operation.

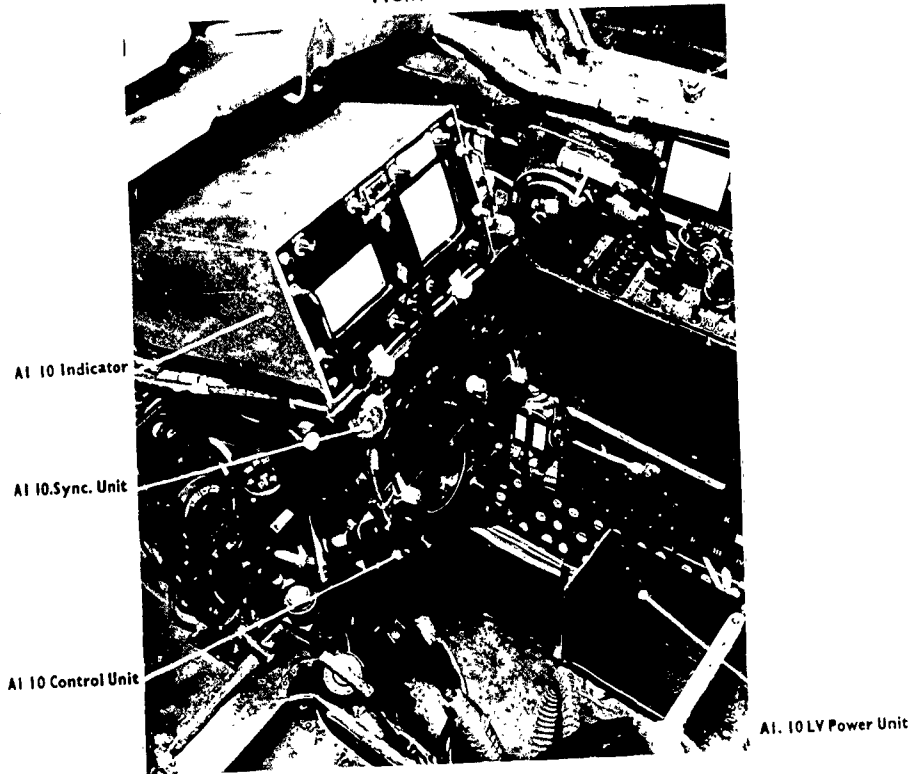
FIG.7.

6.1.1. The Indicator was mounted in the radio cradle in front of the observer's seat (Fig. 7), and was satisfactory for operation and maintenance. When the cradle adjustment control was operated, the hand fouled the pilot's altimeter.

6.1.2. The Synchroniser Unit was also in the radio cradle immediately under the Indicator (Fig. 7), in a satisfactory position for operation and servicing.

6.1.3. The Control Unit type BC.1150C was fitted in the cradle under the Synchroniser Unit (Fig. 7), in a satisfactory position for operation and maintenance.

6.1.9. The Low Voltage Power Unit was positioned under the observer's seat (Fig. 7), and cannot be removed for servicing without first removing the observer's seat.

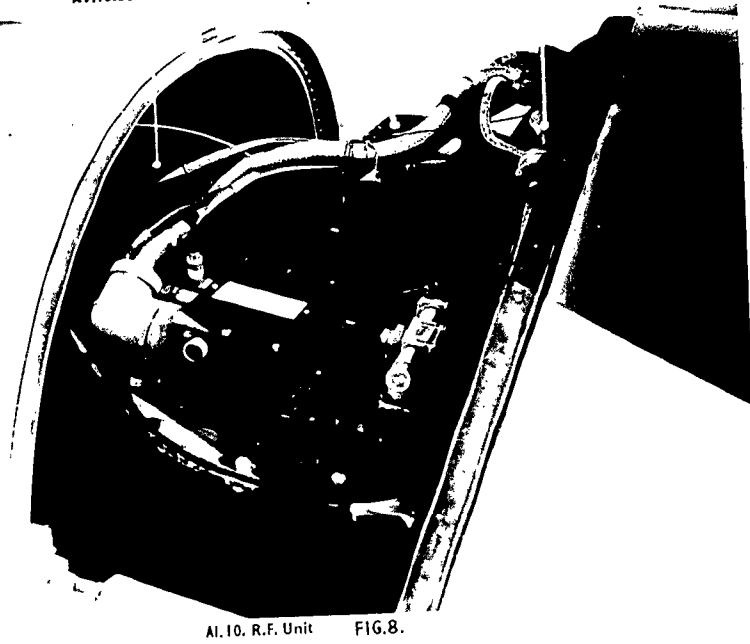
FIG.8.

6.1.4. Junction Box type 253 was fitted on the Bulkhead at the rear of the nose compartment (Fig. 8) in a satisfactory position for maintenance.

6.1.5. The Scanner type RC.94A-A was mounted in the nose of the aircraft (Fig. 8) and was enclosed in a fibre glass radome, neoprene covered. This radome was also fitted with a zinc spray screen to reduce the altitude curtain, and as detailed under para. 6.3.5, prevents the full use of the -20° tilt facility.

6.1.7. The Modulator Unit B.C.1142A and R.F. Unit type B.C.1091A were mounted on runners attached to the bulkhead wall in the nose compartment (Fig. 8), both being satisfactory for servicing. When the modulator is being removed from its mount all connectors should be removed first.

6.1.12. It was found after the trials that a number of connectors were damaged. This was done when removing the scanner or modulator units for servicing, the main area of damage being on the forward face at the base of the bulkhead, starboard side, and it is suggested that a hinged guard be fitted for protection. A guard should also be fitted over cables on the cockpit floor, which were severely damaged by servicing personnel unwittingly standing on them.

- (viii) The zinc spray pattern should be altered to enable the full use of the -20° tilt position of the scanner.
  - (ix) It is recommended that a small notice should be provided adjacent to the connectors which are mounted on the bulkhead above the modulator, to read as follows:- "Disconnect cables from bulkhead before removing modulator".

- (x) A protective guard should be fitted over the cables on the cockpit floor and also over connectors at the base of the forward bulkhead wall on the starboard side to prevent damage when removing units, etc.

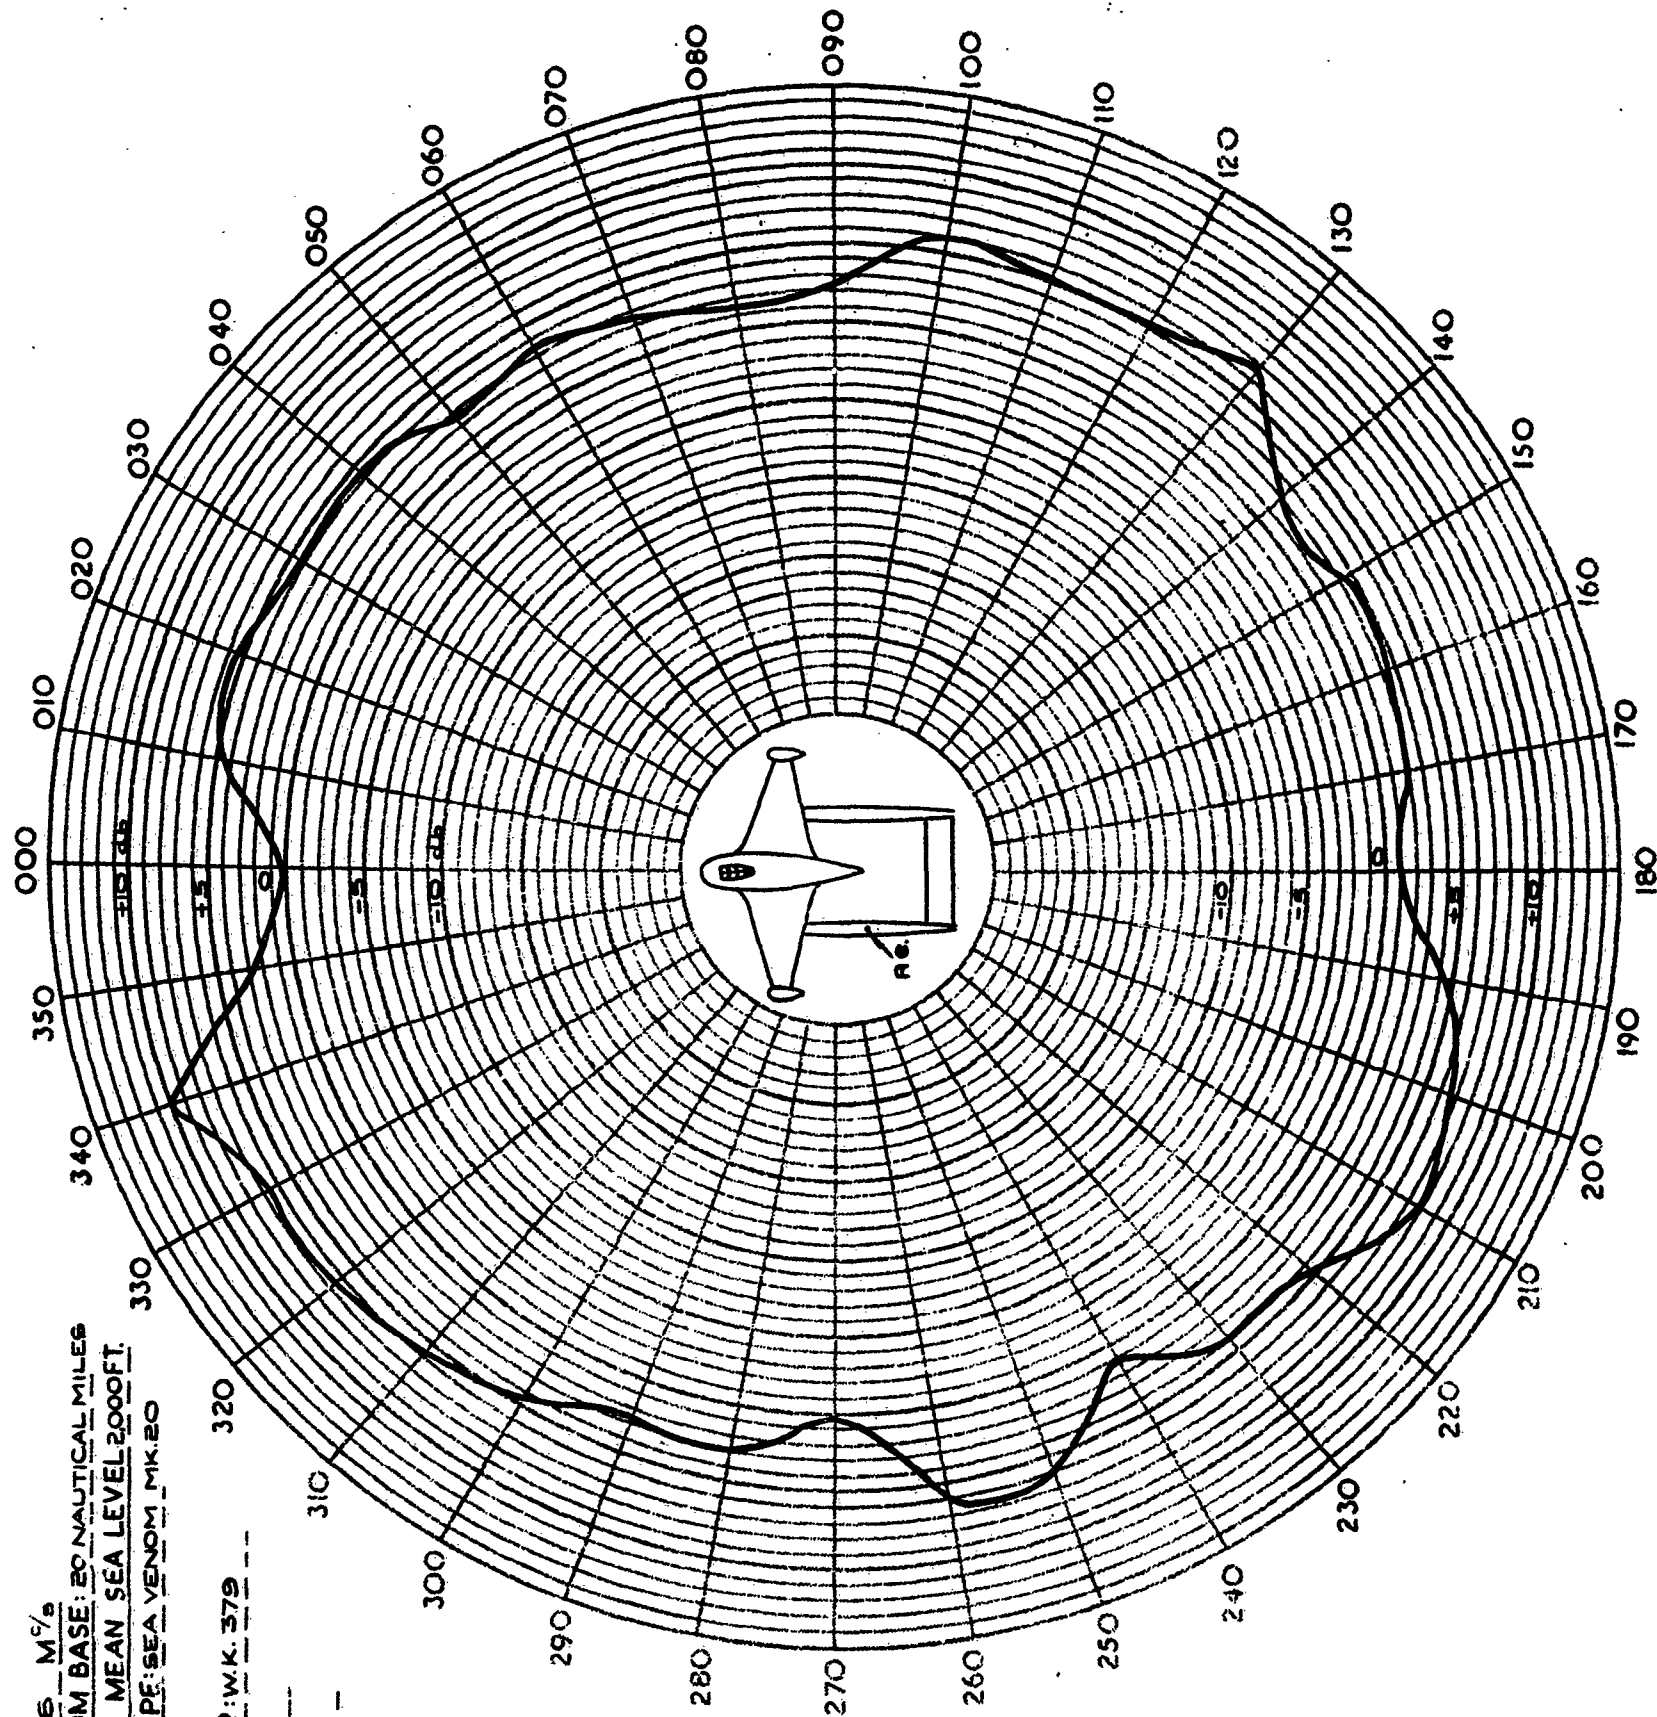
FIG. II

4.3.3. Polar Diagram. The results are shown in Fig. 11 and were considered satisfactory.

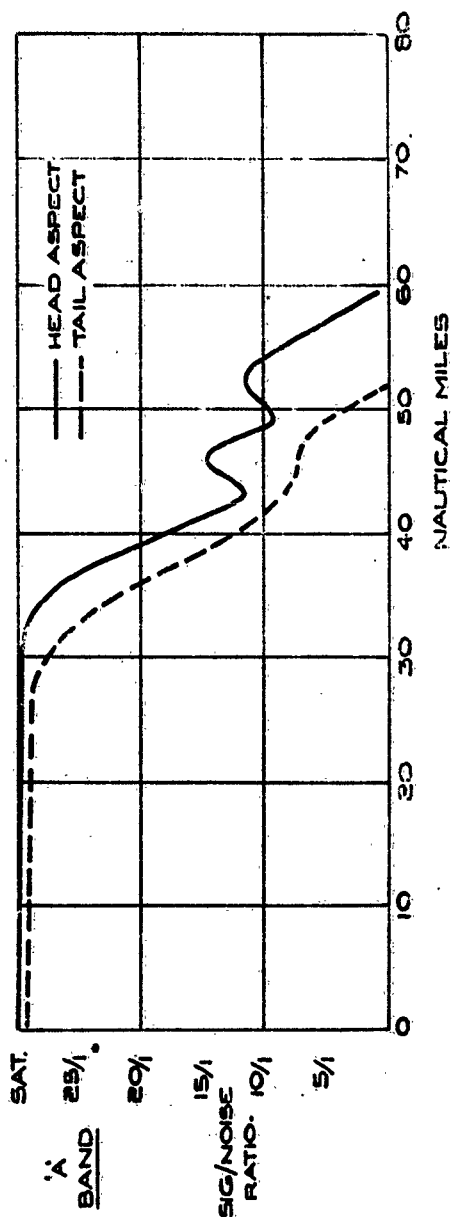
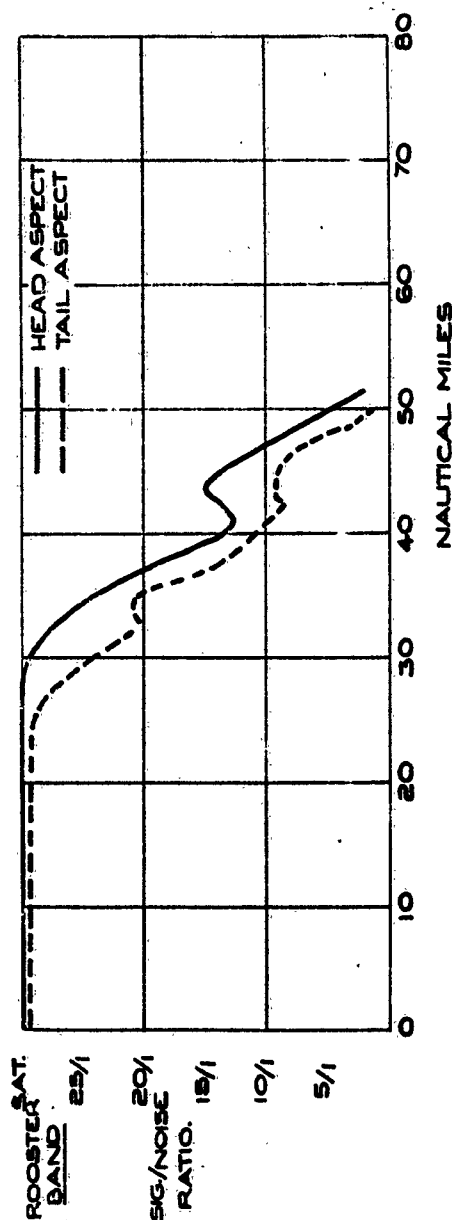
IFF (AN/APX-1) 'A' & 'ROOSTER' BAND RANGE TEST.

4.3.1. 'A' Band Range Test. When interrogated by a standard I.F.F. ground equipment, with the aircraft flying at 4,000 feet, the maximum range on the tail aspect was 52 nautical miles, and on the head aspect 59 nautical miles; signal-to-noise ratio curves are shown in Fig. 12.

4.3.2. "Rooster" Range Test. When using a standard ground interrogator tuned to a frequency of 176 Mc/s., and the aircraft flying at 4,000 feet, the maximum range on the tail aspect was 49 nautical miles, and on the head aspect 52 nautical miles. The results are shown in Fig. 12.

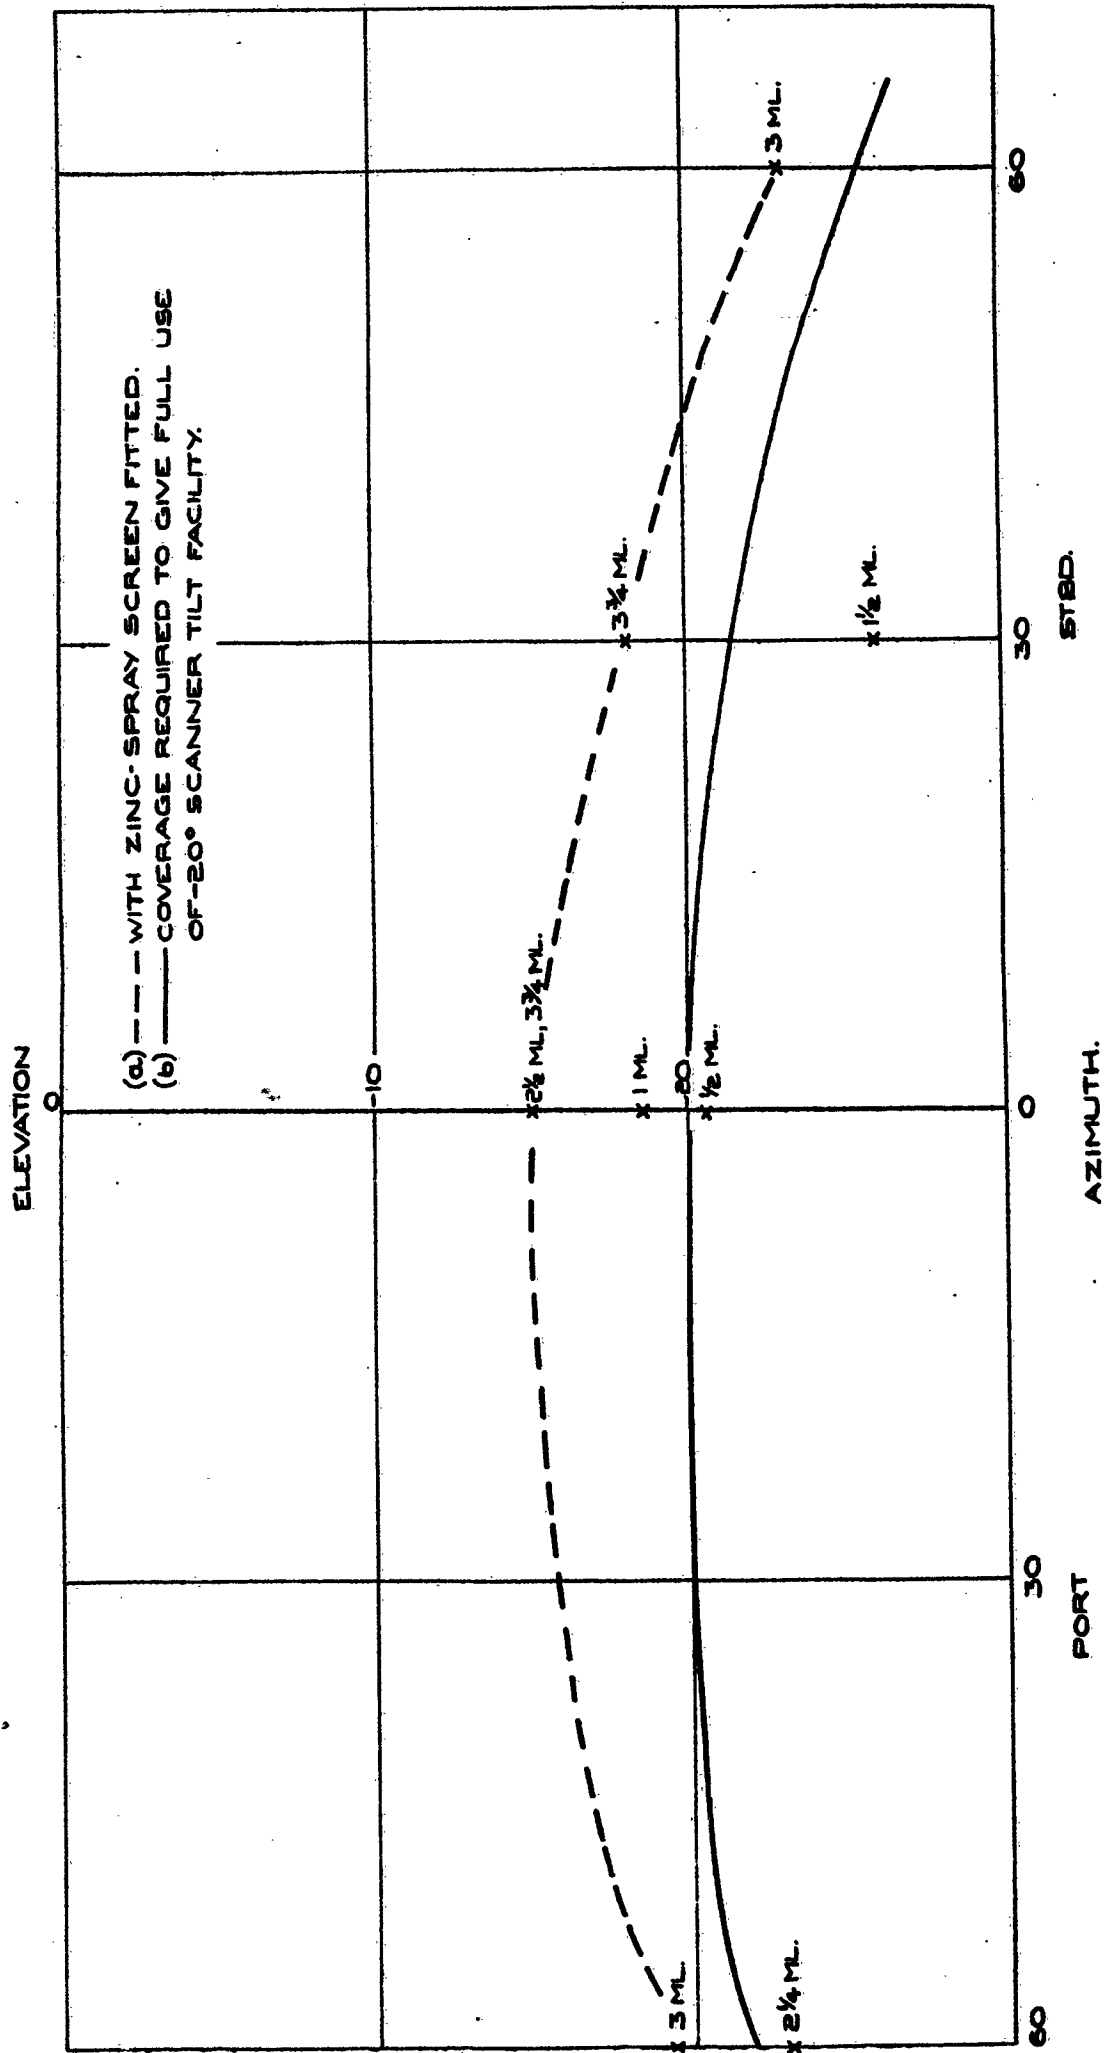
FIG. 13

These figures are shown in graphical form at Fig. 13, and show that the Zinc spray pattern causes a cut-off in radiation at -15°, preventing full use of the -20° scanner tilt facility.
