## CRASH SURVIVAL STUDY:

NATIONAL AIRLINES DC-6 ACCIDENT  
AT ELIZABETH, N. J. ON FEBRUARY 11, 1952

A. HOWARD HASBROOK

Informative Accident Release #15

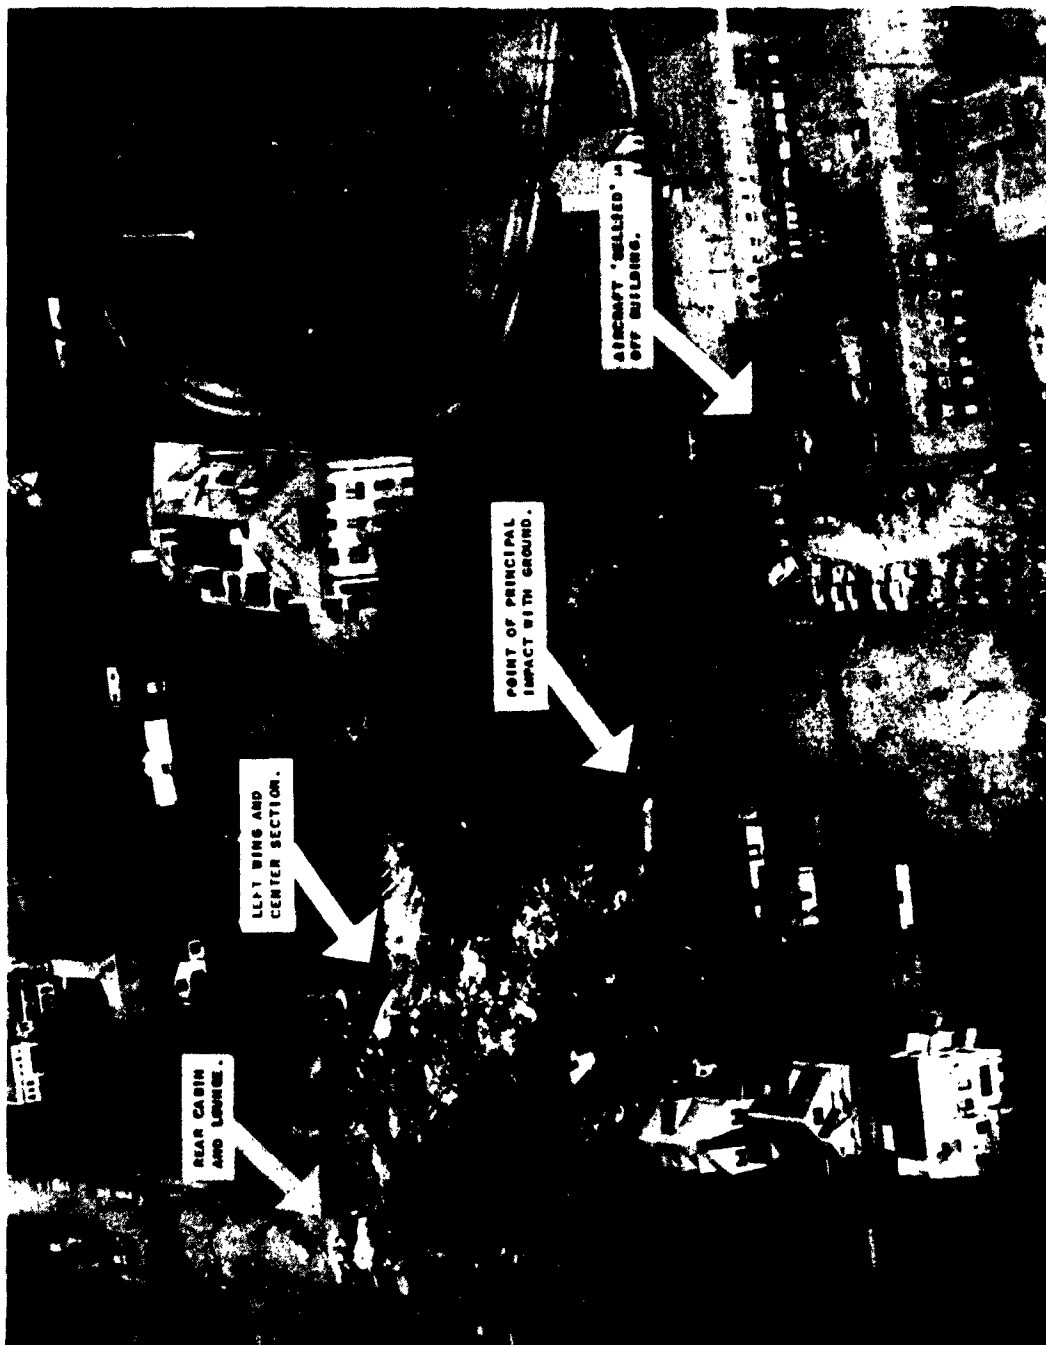
FIG. 1. UNITED PRESS AERIAL PHOTO SHOWING ACCIDENT SCENE.

Unable to climb or even maintain altitude, the pilot attempted to return to the airport but failed; the aircraft struck the roof of a three and one-half story apartment house, while in a partially controlled descent (Fig. 1). Skidding from the roof, the airplane rolled to the right and struck the ground of a school yard at approximately 140 mph, in a nose-down attitude of approximately 10 to 15 degrees.

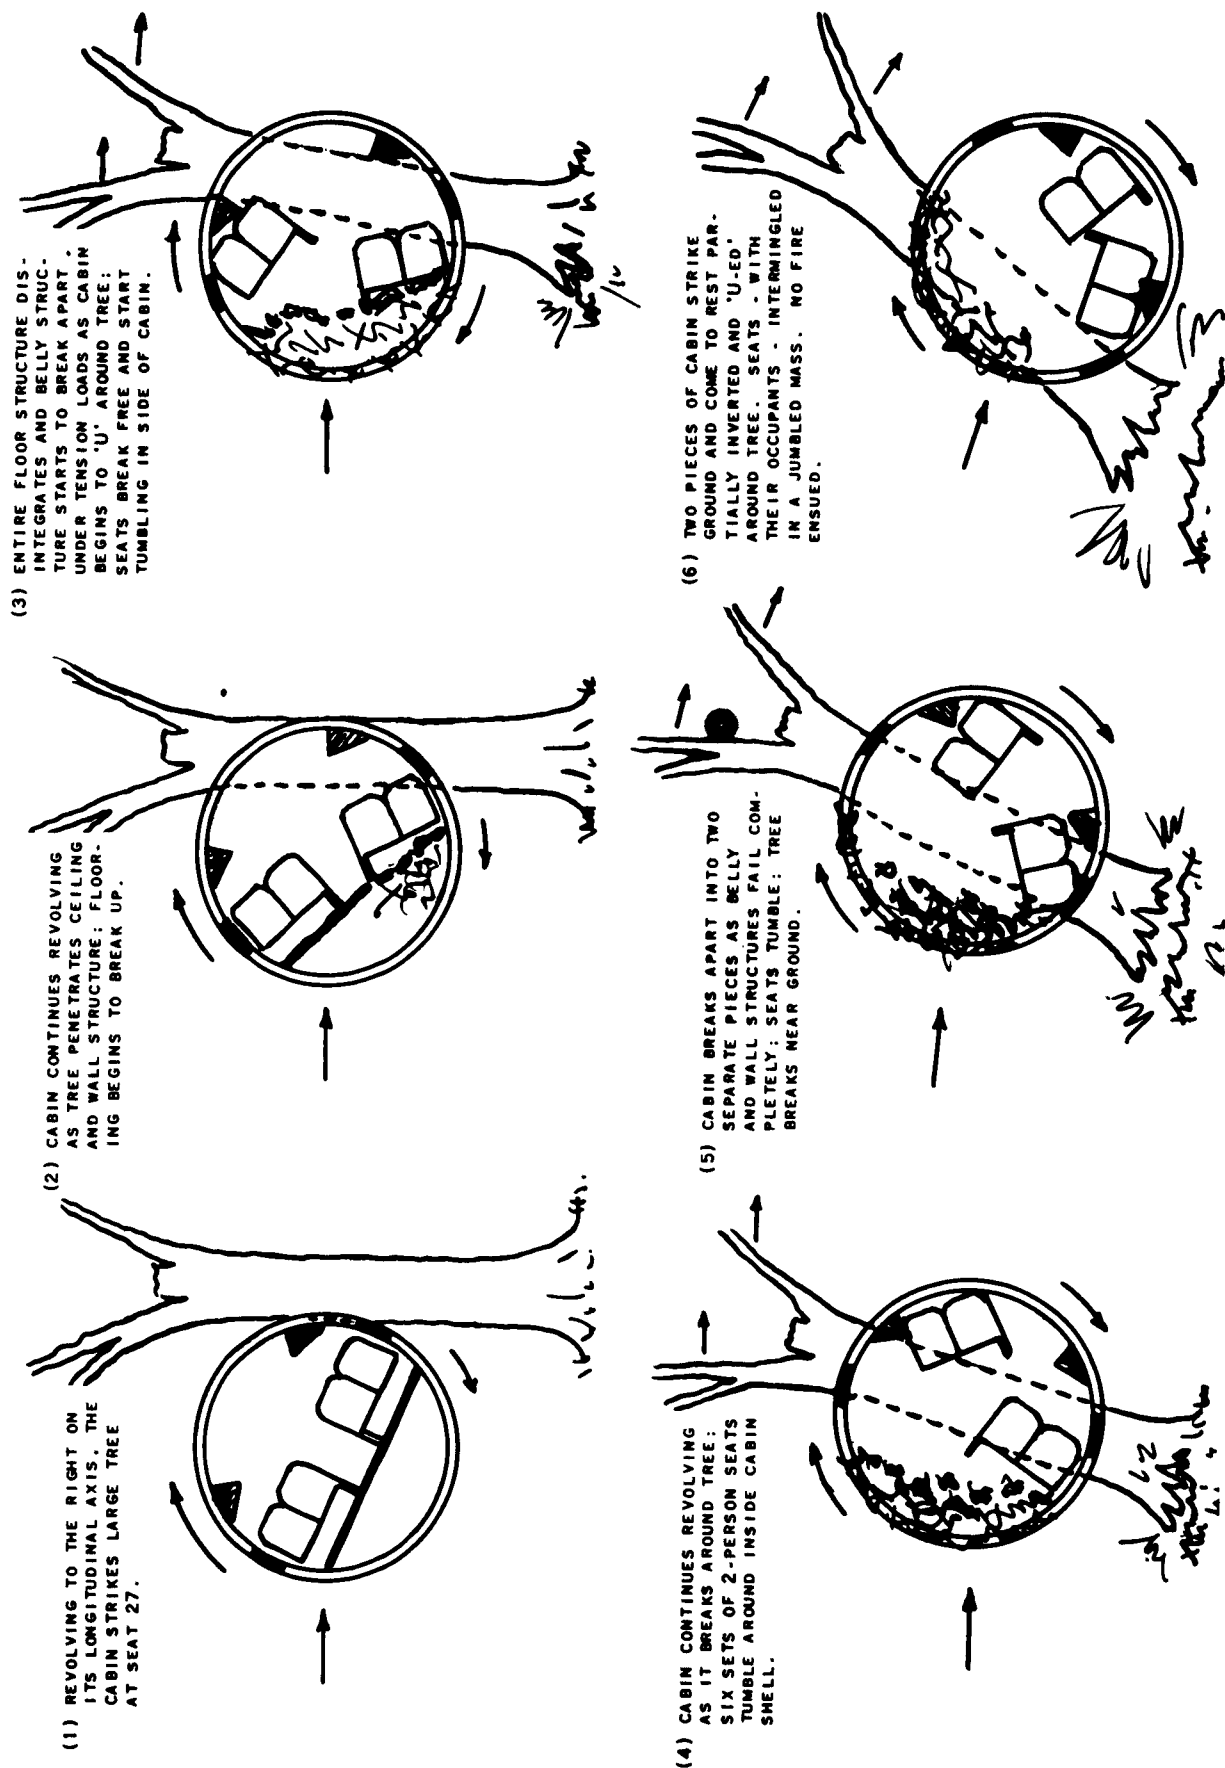
As can be seen from Fig. 7, clockwise rotation of the cabin (around its longitudinal axis) during impact with the tree trunk tended to pull the right hand seats "downward" and away from the tree - prior to failure of the floor structure. This may have had a marked effect in causing the seats - due to inertia - to initially "fall away" from the ceiling and tree as they came free from the disintegrating floor.

FIG. 7. VIEW (THROUGH SECTION A-A OF FIG. 8) LOOKING FORWARD THROUGH REAR CABIN AREA DURING IMPACT WITH TREE.

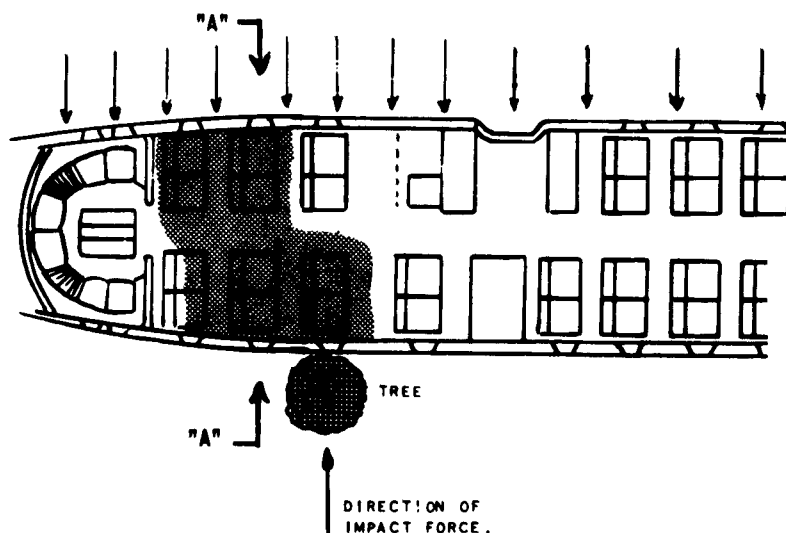
FIG. 8. VIEW SHOWING (1) POINT AND DIRECTION OF CONTACT OF REAR CABIN WITH TREE, AND (2) FLOOR AREA WHICH DISINTEGRATED AS CABIN BROKE IN TWO.

As shown in Fig. 8, the six lounge seats - with low seat-backs - were arranged in a semi-circle. Under the directional conditions of crash force which existed during impact with the tree, the passengers in the left-hand seats (L1, L2) were subjected to "forward facing" conditions and the upper attachments of their seats failed under tension loads, permitting the seats to pull partially away from the side-wall structure; however, the two passengers were uninjured. Those in the center seats (CL, CR) were subjected to "side-facing" loads; the passenger in CL had only minor injuries. The one in CR, however, was thrown heavily sideways against the unyielding armrest and sustained an injury of the lower spine.

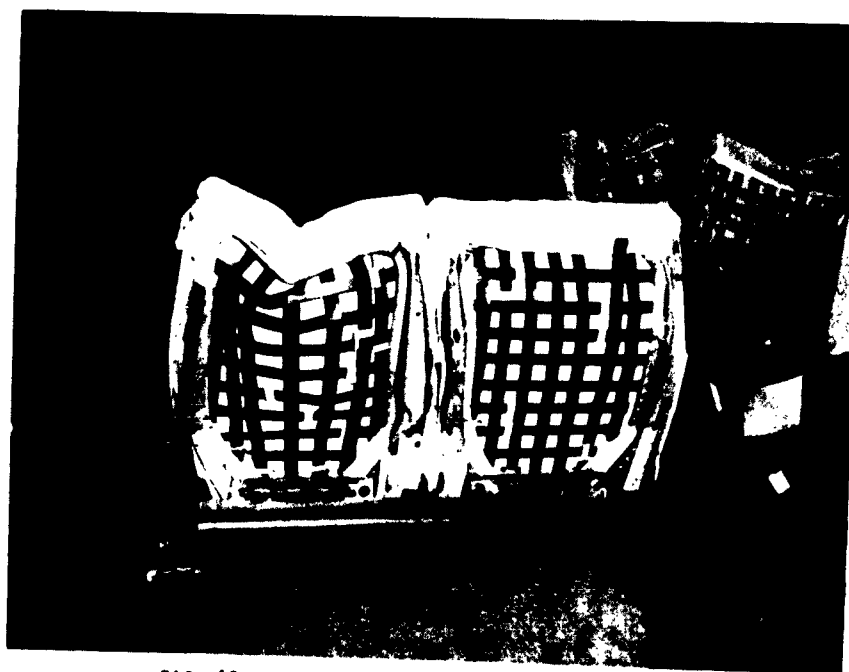
FIG. 12. VERTICAL 'V' DENT IN TOP OF SEAT BACK CAUSED BY HATRACK STRUCTURE.

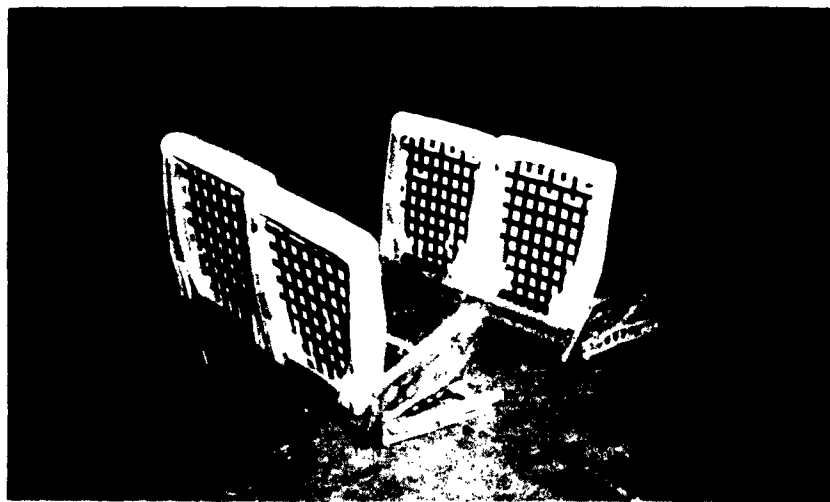
The outboard end of the seat was attached to the wall intercostal by means of two rod-like pins which fitted through slots in the intercostal. However, only one of these pins - the rear one - was threaded and secured to the intercostal by means of a nut. The forward pin was merely inserted in the incostal slot.

FIG. 21. SEATS 19-19A AND 17-17A WITH RELATIVELY INTACT INTERCOSTALS STILL ATTACHED BY REAR PINS. FATALITIES OCCURRED IN SEATS 19 AND 17A.

Thus, in effect, although the seats had four points of attachment, only three of them provided resistance to loads in all directions. Failure of aisle attachments in combination with an aft load on the seat would permit the front pin to pull out of the intercostal. The seat would then be free to rotate around the rear wall attachment (Fig. 21 shows intercostals still attached to seats by rear pins only).

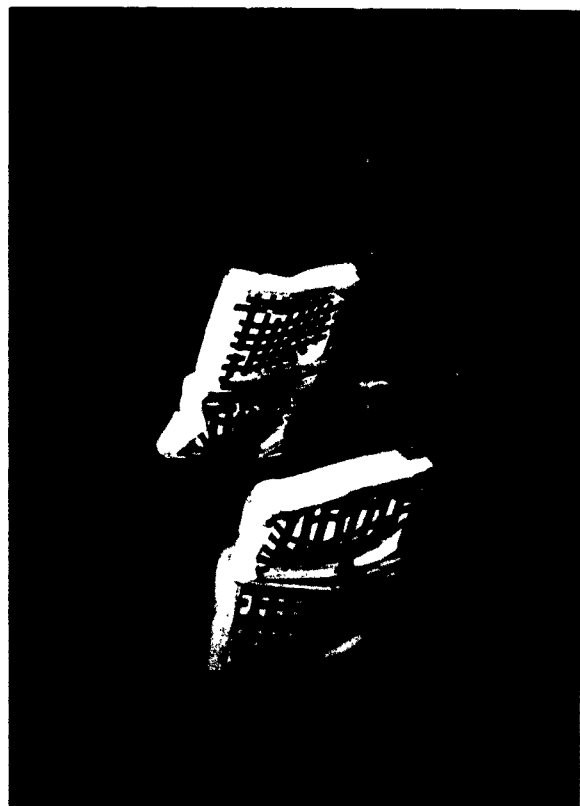
FIG. 47. SEATS 18-18A AND 14-14A (OCCUPANT OF 14A FATALLY INJURED).

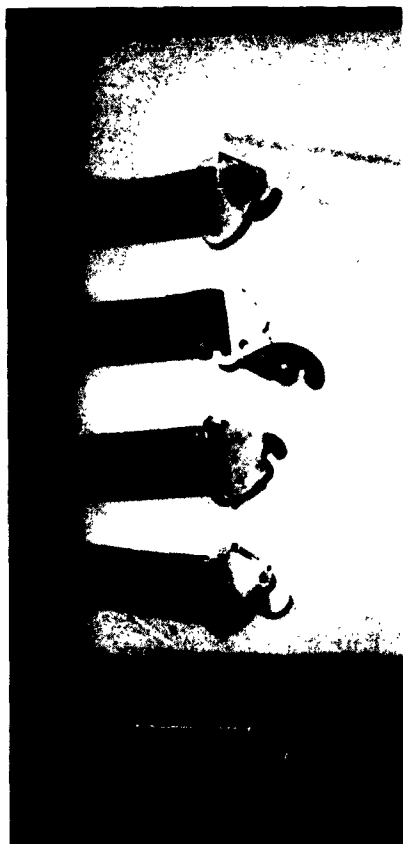
FIG. 49. SAFETY BELT END-ATTACHMENT FAILURE.
