NAVORD REPORT 2830

INVESTIGATION OF PREMATURES EXPERIENCED
IN MAJOR CALIBER PROJECTILES

27 JULY 1953

U. S. NAVAL ORDNANCE LABORATORY
WHITE OAK, MARYLAND

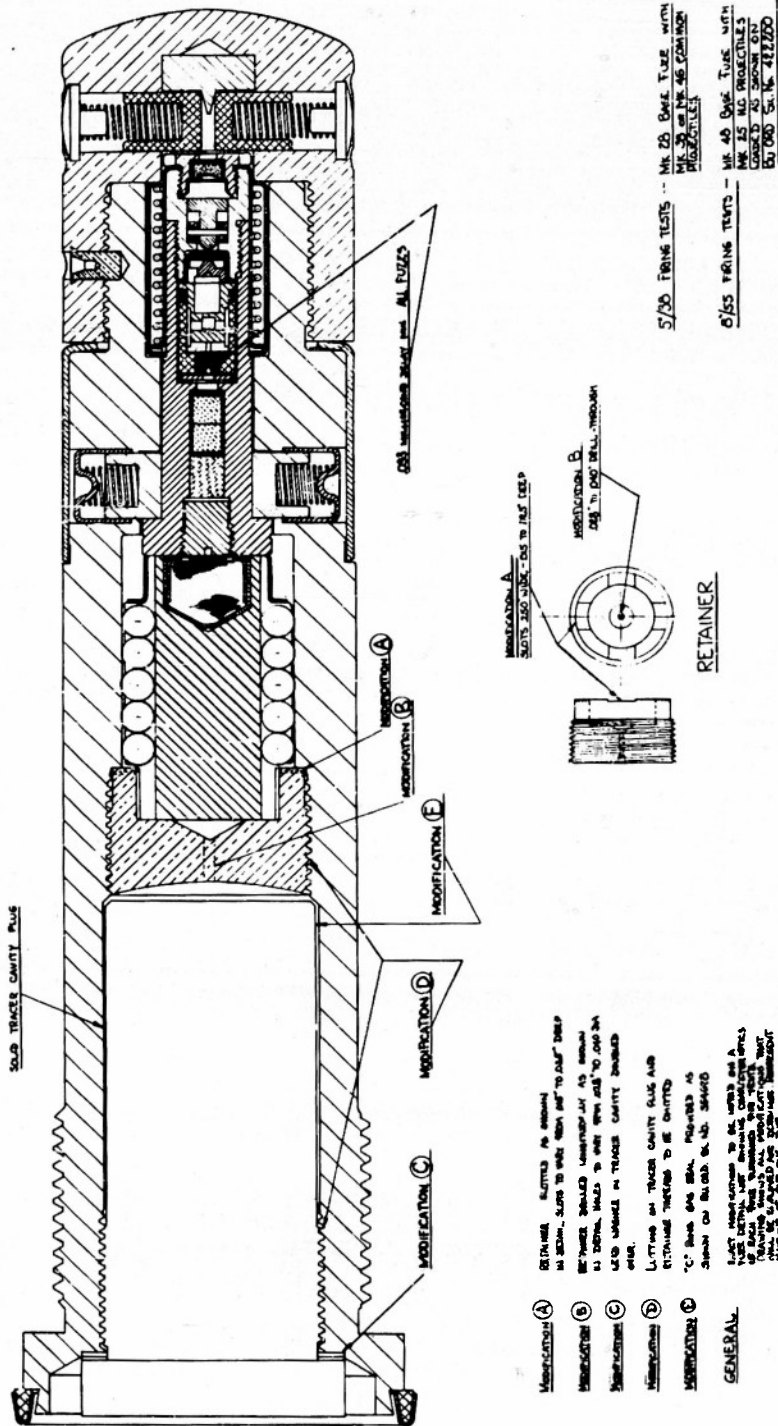
2. The Mk 48 Base Detonating Fuze (Figure 1) consists of a fuze body and nose cap. The body contains a detonator plunger assembly, an auxiliary plunger, a retaining plug, anti-creep spring assembly, detents, and side wall boosters. The nose cap houses the sensitive firing pin and detents. Arming occurs when the centrifugal forces on the detents exceed the side frictional forces due to setback. As the round leaves the muzzle, the setback force ceases and the centrifugal force on the detents snaps the detents outward. The detonator plunger

FIG. 1 GENERAL ARRANGEMENT OF MK 48 BASE FUZE
SHOWING MODIFICATIONS TO INDUCE PREMATURES

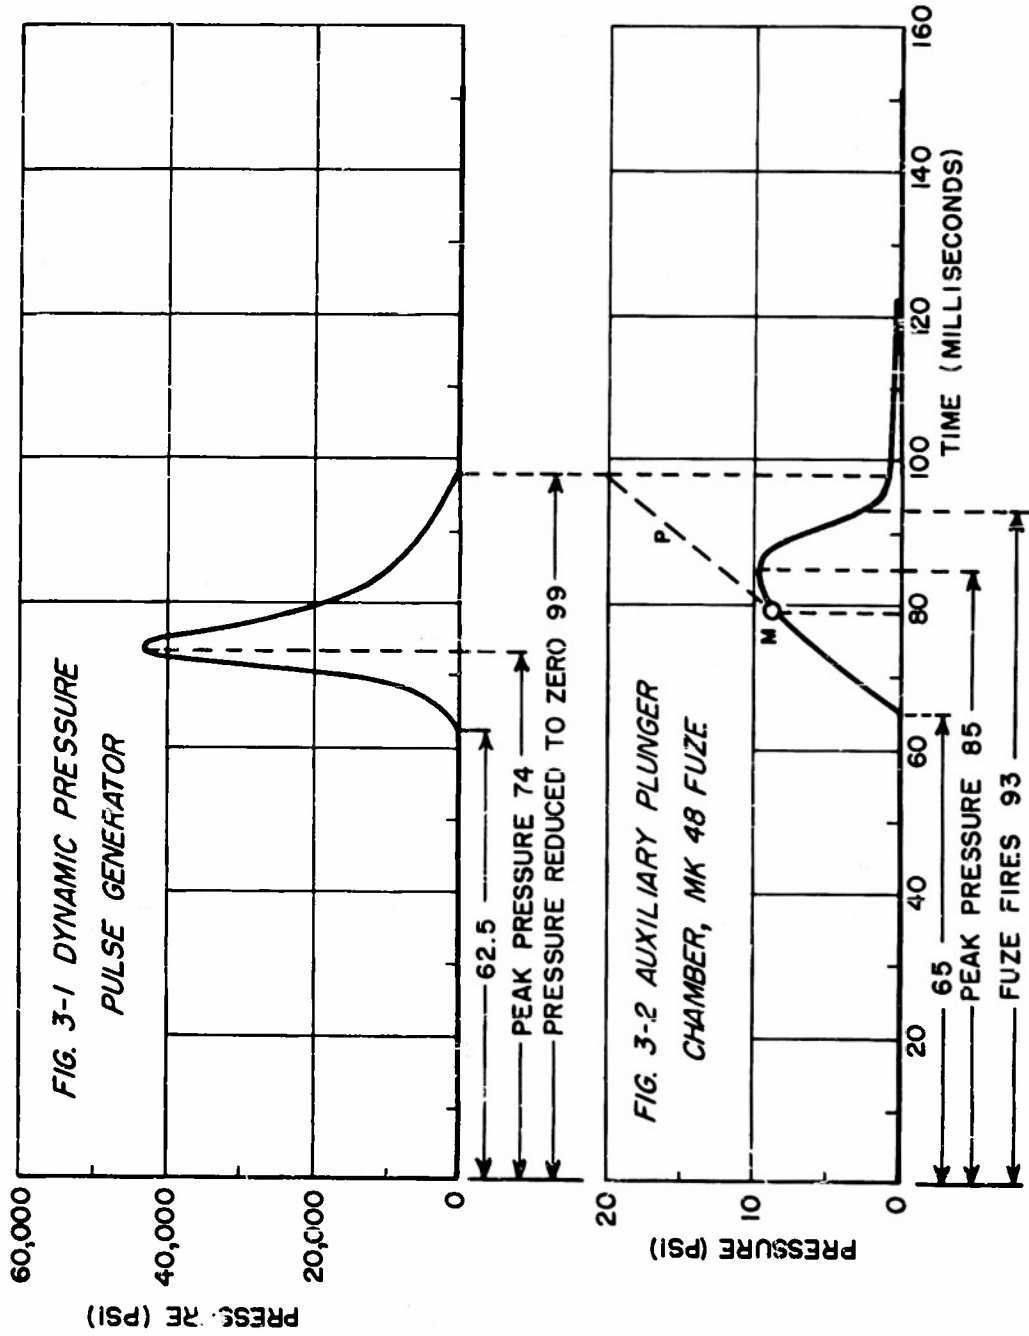
19. In test No. 15, the fuze fired with a 10 p.s.i. pressure peak in the auxiliary plunger chamber. The pressure-time characteristics of the leakage pulse are shown graphically in Figure 3-2. The firing time noted in the graph was measured by starting a Potter time when the firing circuit was closed and stopping it by shorting the timer on plunger impact with the sensitive firing pin. The fuze fired in this test before the Thundermug pulse (plotted in Figure 3-1 for comparison) had reduced to zero. In action firing the detents would prevent plunger movement until the projectile left the bore, thereby causing a continued leakage into the fuze similar to the dotted line P in Figure 3-2. This would result in a peak pressure of approximately 20 p.s.i. As seen in the graph, the pressure build-up is linear to point M and then flattens and diminishes. Because relatively high Thundermug pressures still exist, one can assume that the decreasing rate of build-up is due to an increasing volume as the plunger moves and that the plunger begins accelerating at point M or 79 milliseconds after closing the firing circuit. Since the sensitive primer fired 93 milliseconds after starting the test and there is a 10 millisecond explosive delay in the Mk 48 Fuze, this shot represents a premature occurring 24 milliseconds after the projectile leaves the bore or at a distance of 52.8 feet if an 8"/55 reduced charge was used. Actually, the peak pressures in the tracer cavity plug voids are higher than those in the auxiliary plunger chambers and gases will continue to flow into the plunger region for a short period after the projectile leaves the bore. This could cause prematures to occur at distances greater than 52.8 feet. Tests Nos. 19-26 were conducted to determine the pressures that any gas seal would have to withstand if the

FIG. 3
PRESSURE PULSE CHARACTERISTICS

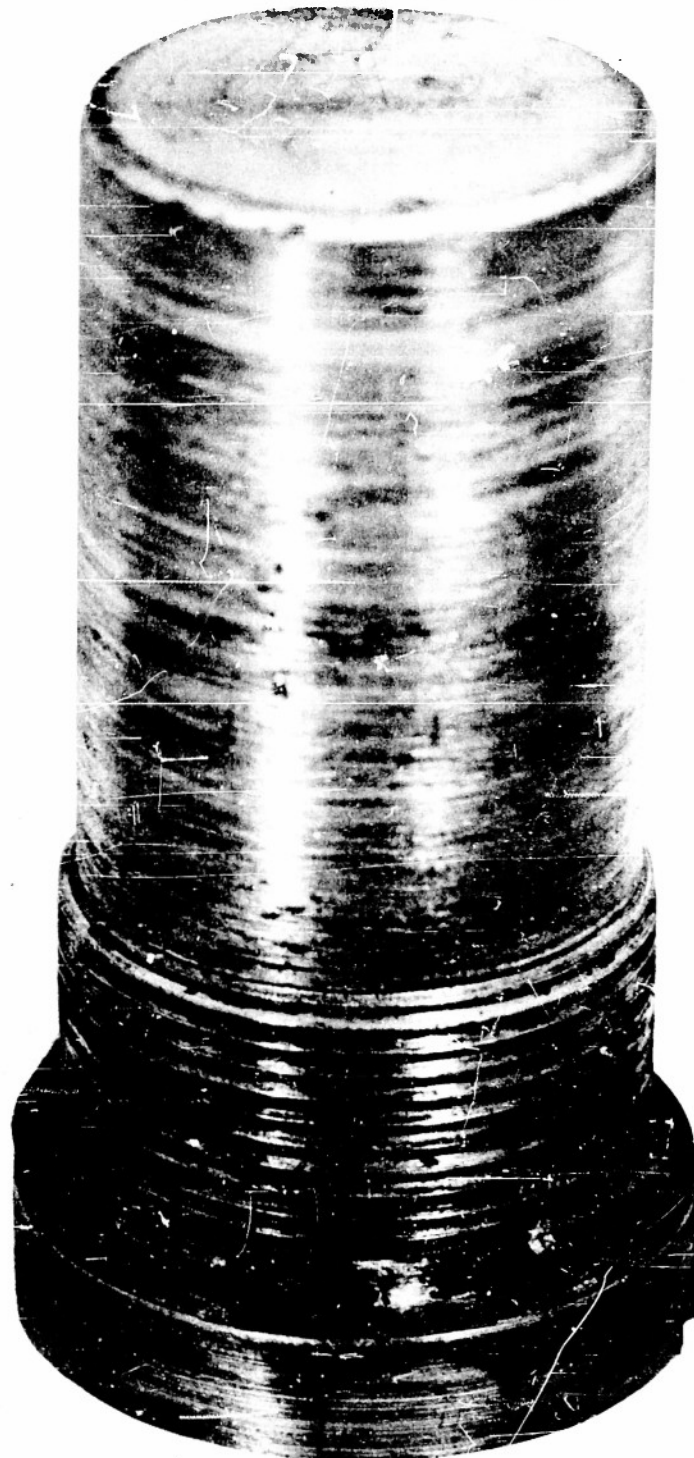
In test Nos. 6, 7, and 11 (Table 2) carbon deposits were found on the tracer cavity plug threads even though the fuzes did not premature. Gas leakage occurred past a normal lead washer seated properly in Test No. 11. This shows that gas leakage does not necessarily result in a premature and also that the sealing qualities of the lead washer alone are not satisfactory. A comparison of shots Nos. 11 and 12 indicates that the difference in friction, weights, and relative positions of fuze components due to tolerances also affect the malfunctioning of any one leaker. In test No. 3 the portion of the lead sealing washer exposed to a 3/5 diameter wrench hole in the base of the fuze melted and formed an enlarged hole (Figure 4). The erosion effect of the high temperature gases leaking into the fuze is clearly defined. The wrench hole in the fuze body is outlined by carbon residue on the tracer cavity plug. With extreme tolerances the conical tips of the wrench holes are .021 from the face on the fuze body on which the .025 lead sealing washer is seated. The .025 thick washer must be compressed .00+ to .021 to avoid direct exposure to gases.

FIG. 4 EFFECTS OF GAS EROSION ON
A NORMAL LEAD WASHER ASSEMBLED
IN A MK 48 BASE FUZE
CONFIDENTIAL

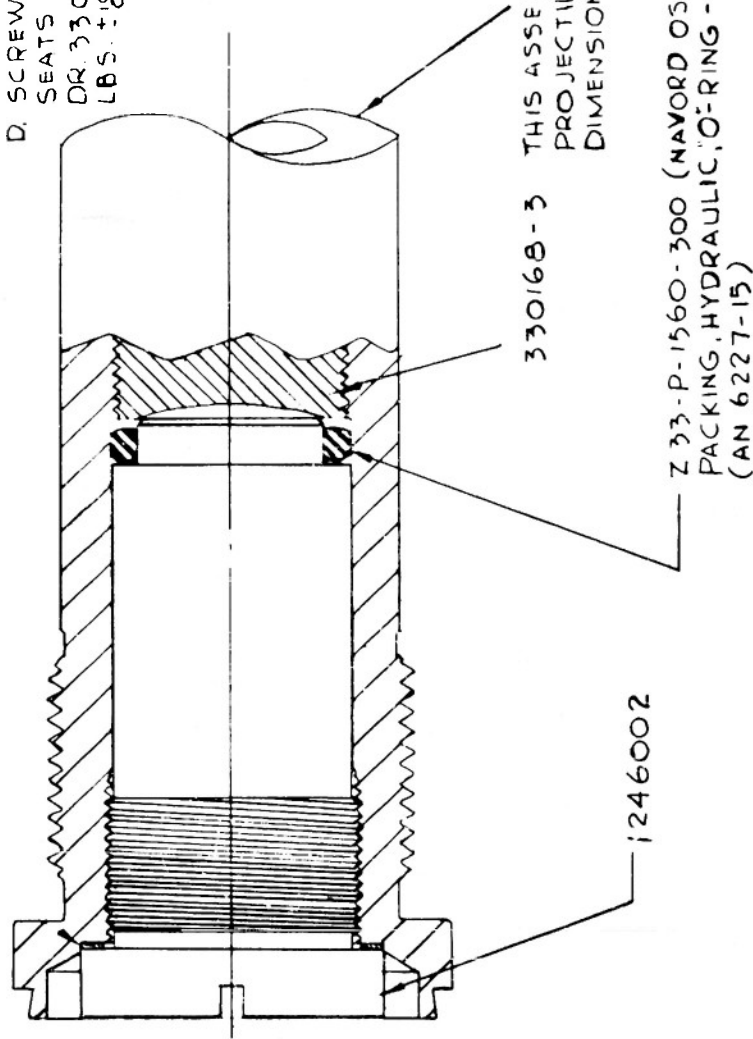
23. The "O"-ring seal, assembled in accordance with BuOrd Drawing No. 124-6001, Figure 6, was then test fired in the Dynamic Pressure Pulse Generator. Test Shot No. 23 shown in Table 3, subjected the "O"-ring seal to the extreme leakage limit discussed previously in which bore gases passed directly to the "O"-ring through a .040 hole in the side wall of the tracer body. No carbon deposits were visible in the fuze past the "O"-ring. Tests Nos. 25 and 26 substantiate the effectiveness of the "O"-ring. Leakage did not occur past the "O"-ring in Test No. 25. Shot No. 26 was similar to No. 23 except the auxiliary plunger chamber pressure was recorded. A leakage of 3 psi was noted; however, the slope of pressure build-up was approximately three times less than that shown of a premature in Figure 3-2. Examination of the fuze disclosed a slight bulge in the body at the "O"-ring seal. The 3 psi leak was attributed to a decrease in compression of the "O"-ring caused by the bulge. This test shows that the "O"-ring alone can prevent gas leakage up to pressures that actually can cause deformation of the fuze body.

FIG. 6 TRACER CAVITY & PLUG ASSEMBLY DETAIL

46. The Laboratory recommends that the "O"-ring gas seal, Figures 6 and 7, BuOrd Dwg. Nos. 1246001 and 1246002 respectively, be utilized as the best way to effectively eliminate gas leakage in the present designs of the Mk 28 and Mk 48 Base Fuzes.

C. COAT ALL THREADS OF PLUG WITH FUZE THREAD LUTING (UNDILUTED) MADE IN ACCORDANCE WITH NAVY DEPT SPEC. MS 603.

D. SCREW PLUG INTO TRACER CAVITY UNTIL IT SEATS AGAINST PLUNGER RETAINER PLUG, DR. 330168-3, USING A TORQUE OF 40 FT. LBS. \pm 8 FT. LBS.

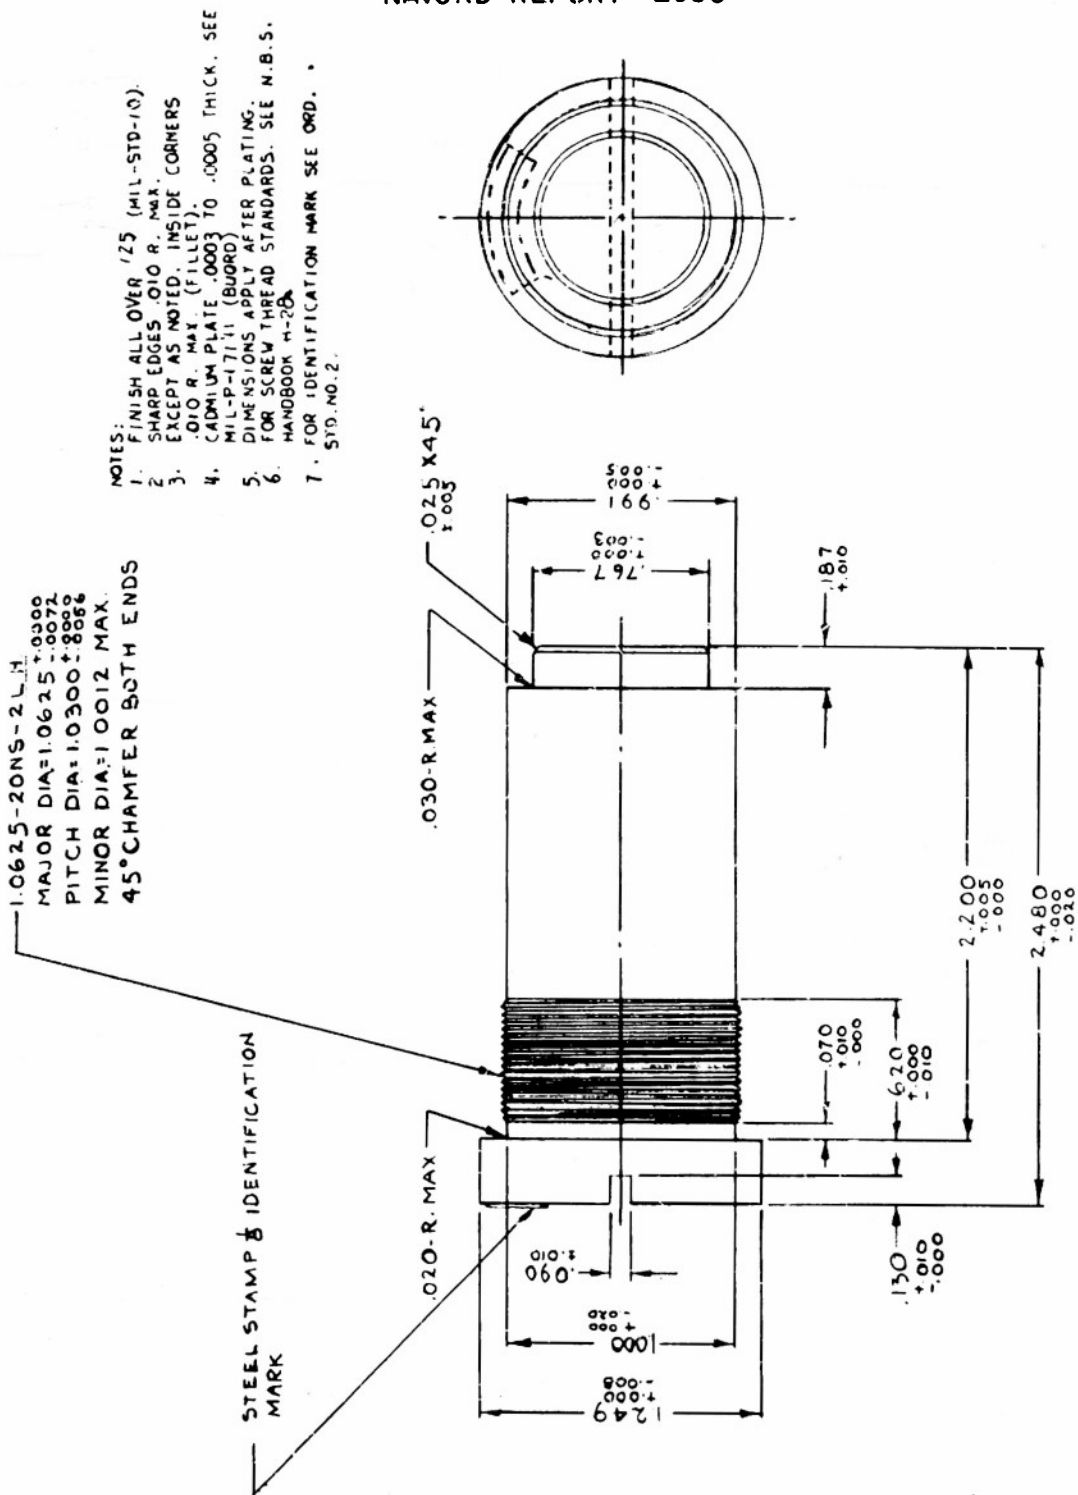
32. Two fuzes with #098 holes in the retainer plugs and two fuzes with #125 holes with fuze characteristics the same as noted above were then fired with the "O"-ring modification, Figures 6 and 7, in further substantiation of the effectiveness of the seal. No prematures occurred in these rounds.

FIG. 7 TRACER CAVITY PLUG
 FROM BUORD DRAWING NO. 1246002

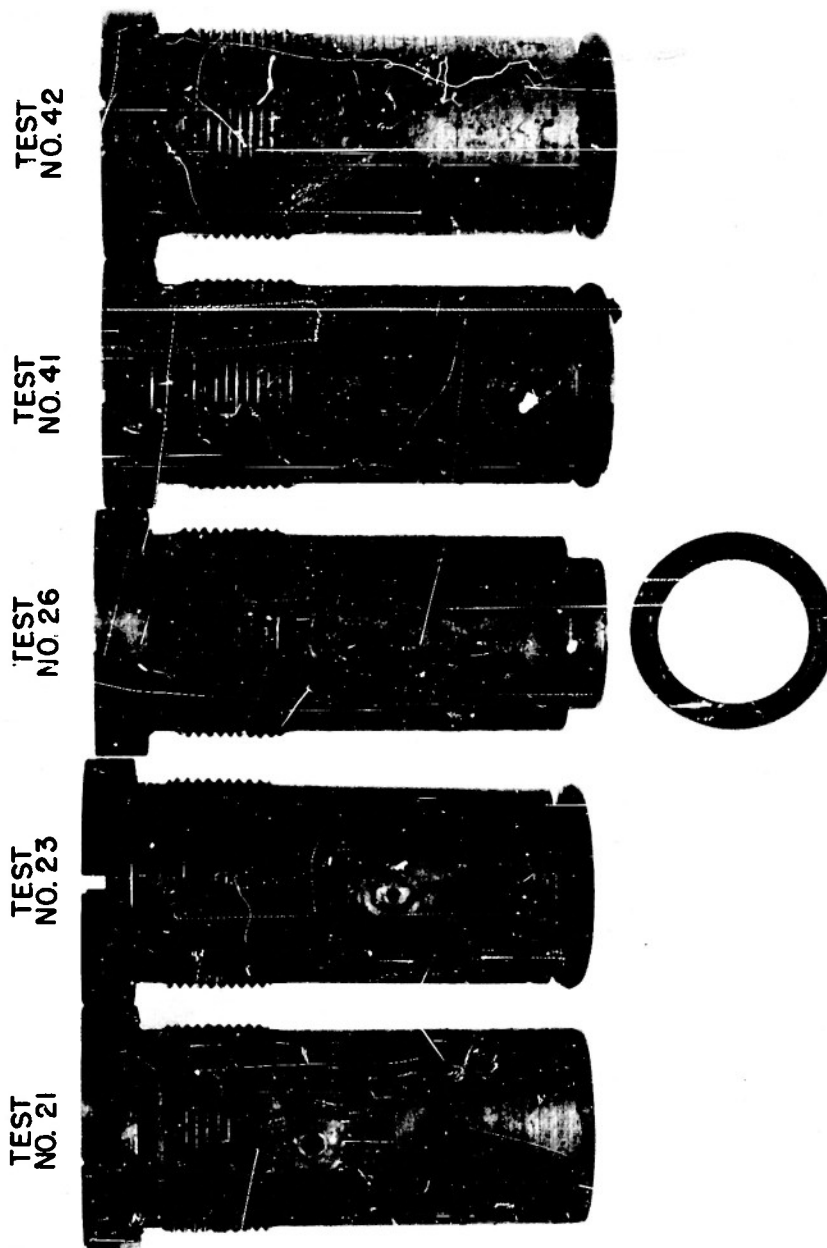
FIG.8 EFFECTS OF GAS EROSION OF A 0.040 HOLE IN MK 5
TRACER WITH AND WITHOUT AN "O" --RING SEAL
