NAVORD REPORT 3670

A STUDY OF THE EFFECTS OF STATIC ELECTRICITY ON LOW INPUT ENERGY
ELECTRIC INITIATORS OF THE CARBON BRIDGE TYPE

5 AUGUST 1954

U. S. NAVAL ORDNANCE LABORATORY
WHITE OAK, MARYLAND

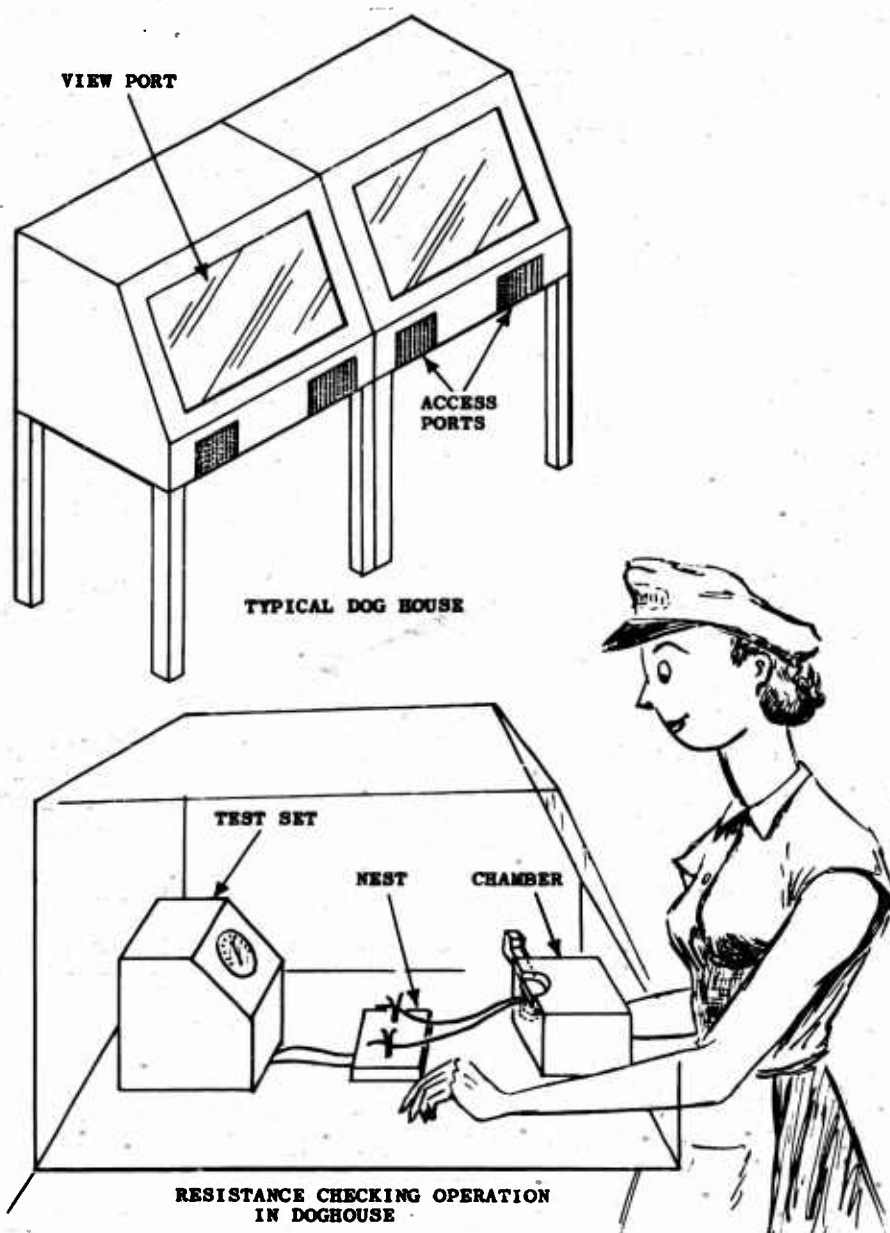
FIG.1 OPERATION ENVIRONMENT DURING 1 OCT AND 8 OCT ACCIDENTS

9. The entire operation is carried out in an enclosure of the type shown in Figure 1. This enclosure, known as a "doghouse," has a steel floor and framework. The operator is grounded by a coil spring type wrist bracelet of the type shown in Figure 2. Dangling grounding chains of the bathtub stopper chain type were spaced about every quarter of an inch across the ports into which the operator inserted her hands. It was found by measurement with an electrostatic voltmeter that these grounding chains were in some instances ineffective against static potentials generated by an operator. At the time of the accident it is probable that the doghouses were not connected to the driven ground provided for the purpose. The doghouses did provide a mechanical support for the fluorescent fixtures which are, in turn, referenced to ground via the electrical conduit system. It is not likely that the resistance of the ground return of the doghouses could have exceeded 10 ohms.

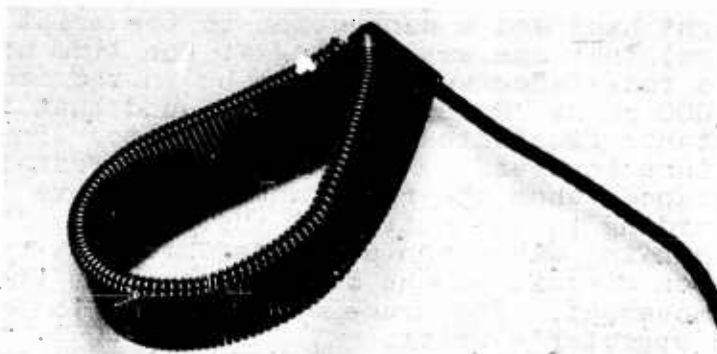
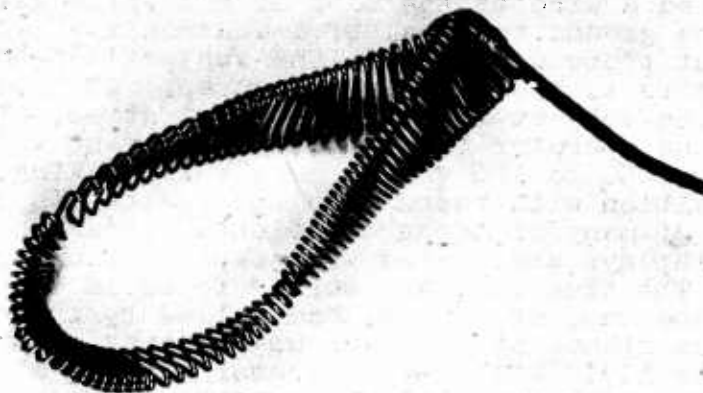
FIG. 2 WRISTLETS WORN DURING 1 OCT AND 8 OCT ACCIDENTS

WRISTLET WORN BY OPERATOR DURING 1 OCT ACCIDENT

WRISTLET WORN BY OPERATOR DURING 8 OCT. ACCIDENT.

11. The operator's body resistance was measured with a battery powered volt-ohm-milliammeter between a test lead held in her right hand and a connection to the wrist band (on her left arm) that she was wearing at the time of the accident. This resistance was found to be in the order of 50,000 to 100,000 ohms. However, it was found that this value of resistance fluctuated when the operator simulated the normal motions involved in checking primer resistance. There were instances when the resistance went above 5 or 10 megohms according to the motion of the needle. It is likely that grounding was momentarily defeated but not indicated as open circuit on the meter because of the inertia of the needle movement. The bracelet was found to fit rather loosely on the operator's wrist.

16. Much less detailed information is available concerning the circumstances of the 8 October accident. The operator was in the habit of wearing her grounding band on her upper arm. That the grounding band was stretched (probably for comfort) is known. How well it maintained contact is not known. Since the accident occurred while the primer was in the safety chamber, it is possible that the test circuitry may have in some way contributed to the firing. The fact that the operator's finger was in the blast area indicates that the hand may have been in some way involved with the primer leads.

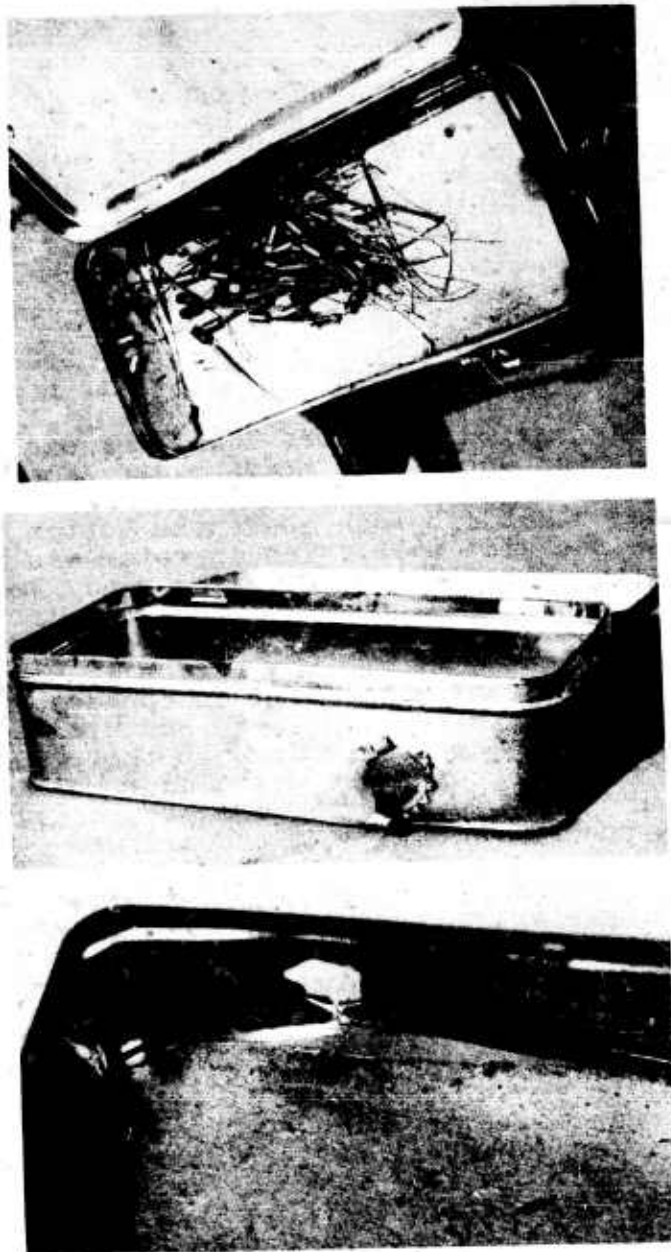
FIG. 3 PHOTOGRAPHS OF THE READY BOX
INVOLVED IN THE 1 OCT ACCIDENT

10. The ready box in which the 1 October explosion occurred was resting on a steel well which was set into and electrically in contact with the floor of the doghouse. The resistance from a similar ready box, placed in about the same position to the point of attachment of the grounding wire to the wrist bracelet was less than 5 ohms. It was noticed that the resistance between two diametrically opposed points on the bracelet was about 10 ohms. This is due to the resistivity of the stainless steel used in making the watch band. However a 15 ohm ground return resistance can be considered a short circuit in comparison with ordinary body skin contact resistance.

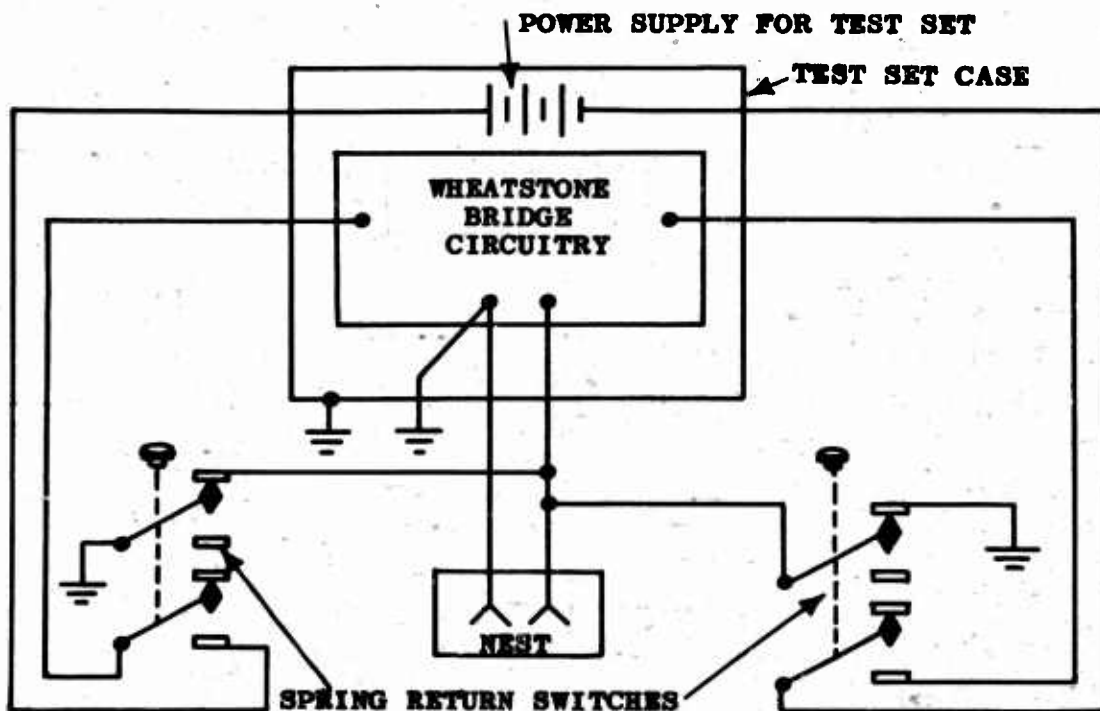
FIG. 4 SUGGESTED ARRANGEMENT OF TEST SET MK 162 MOD 1 CIRCUIT

17. Inspection of the test circuitry revealed some interesting facts. The circuit had been constructed in agreement with the specifications for Test Set Mk 162 Mod 1. The wiring in the instrument box, the leads to the "nest", and the nest contacts were well insulated from ground. This means that the entire circuit would have a definite capacitance to ground. The magnitude of this capacitance was not measured but was estimated to exceed 50 micro-microfarads and could perhaps be an order of magnitude greater. Another aspect of this design was noted; the power was on continuously in the test circuit. Thus the meter needle began to move to its final reading as soon as the primer connection to the nest was completed. This was done to speed up testing and to give economy of motion. The insertion of one or two hand operated "read-out" switches would slow up the operation somewhat but should not make much difference in the total cycle time simply because of the inherent sluggishness of other parts of the cycle.

18. The lack of grounding of the circuit of the test set is inherently a dangerous condition. As was pointed out in reference a., this particular arrangement could store enough energy on the insulated circuit to fire a primer. The energy thus stored can be derived at some time previous to a primer handling cycle and is thus a latent source of trouble. Since there are a number of quite different ways in which this arrangement can act adversely, it is possible to conjecture a number of different circumstances attributable to the isolated circuit, whereby the 8 October accident could have happened. In order to eliminate the isolated circuits, it was decided to ground the instrument circuits and cabinets of all the test sets on the line. This led to a new effect. Because of the peculiarities of the circuit, an operator touching the steel floor of the work enclosure and the ungrounded spring brass terminal of the nest, could cause the meter needle to deflect from zero, even with the test set power turned off. This was due to the galvanic action between the steel and brass using skin moisture as the electrolyte and the microammeter as the return path. However, the current that resulted from the galvanic potential was quite small, less than that which could flow through the primer from the test set. In any case, the maximum e.m.f. derivable from a single cell is well below the presently known lowest voltage at which a primer of this type has been fired.

19. It is not good practice to have an electrical test circuit energized at the time an electro-explosive unit is connected to it. True, the basis of the design of the

test circuit is that the maximum current put-through is still safe by a large margin. However, it is normally possible to devise some method, by mechanical interlock or by operational requirement, whereby the power to the primer is applied only after the operator is completely protected. In the present instance, it seems that a good modification of the circuit, as in Figure 4, might be to install two push button, double throw switches, one for each hand, at points that would move the operator's hands well away from the safety chamber and from the primer containers. By this switching arrangement it would insure not only that the

power to the test circuit would not be turned on till both hands are out of harm's way, but also that both leads would be shorted to ground. This would eliminate the galvanic effect mentioned in the previous paragraph, in addition to giving electrical grounding of the connected primer except during actual testing.

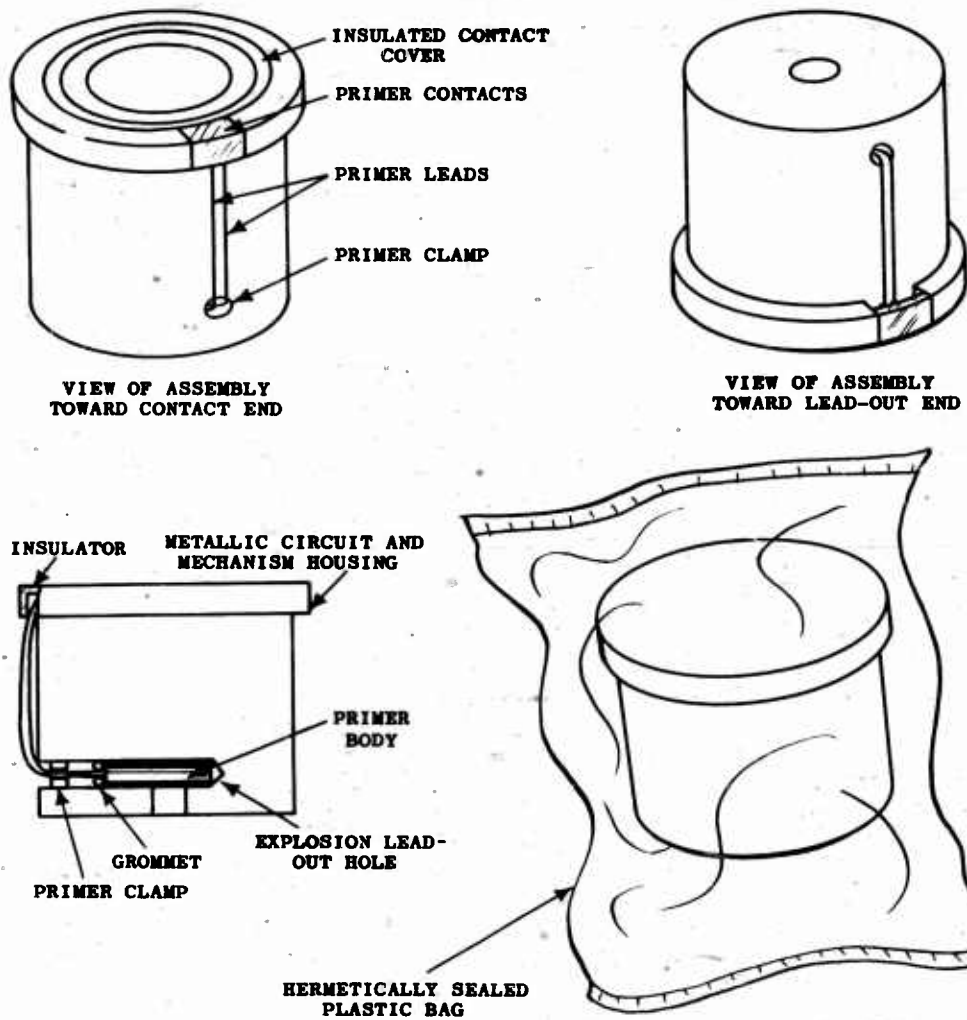
FIG. 5 VIEWS OF THE ASSEMBLY AND POLYTHENE BAG OF THE TYPE THAT FIGURED IN THE 20 NOV AND 2 DEC ACCIDENTS

Among other things, the circuitry provides an electrical short across the primer leads. The grounding is to the metal frame of the assembly. Figure 5 shows an artist's conception of various views of this assembly demonstrating the salient features pertaining to this and the following accident.

28. An inspection of the shorting circuit mechanism was made. Certain contact members which are normally held firmly in place were found to slide. Personnel of Plant B had found that by shaking the assembly it was possible to obtain occasional readings on a volt-ohm-milliammeter of 10 ohms. It is probable that the momentary maximum values of resistance could have been much greater than 10 ohms. Whether this condition of the shorting circuit was brought about by the primer blast or whether it existed before is not known. Subsequently other assemblies of the same lot were tested at the Naval Ordnance Laboratory. A primer was connected by extra leads to the two terminal points to which would be connected the primer installed in the assembly. These two points are normally electrically connected by the internal shorting mechanism. An external battery and resistor were connected in series with the terminal pair. With this arrangement, any momentary opening of the short circuit, even as short a time as a few microseconds, should cause the primer to fire. In one of the assemblies tested, a tap with a light hammer defeated the short. In another instance, the short was defeated by the slight disturbance created by picking up the assembly.

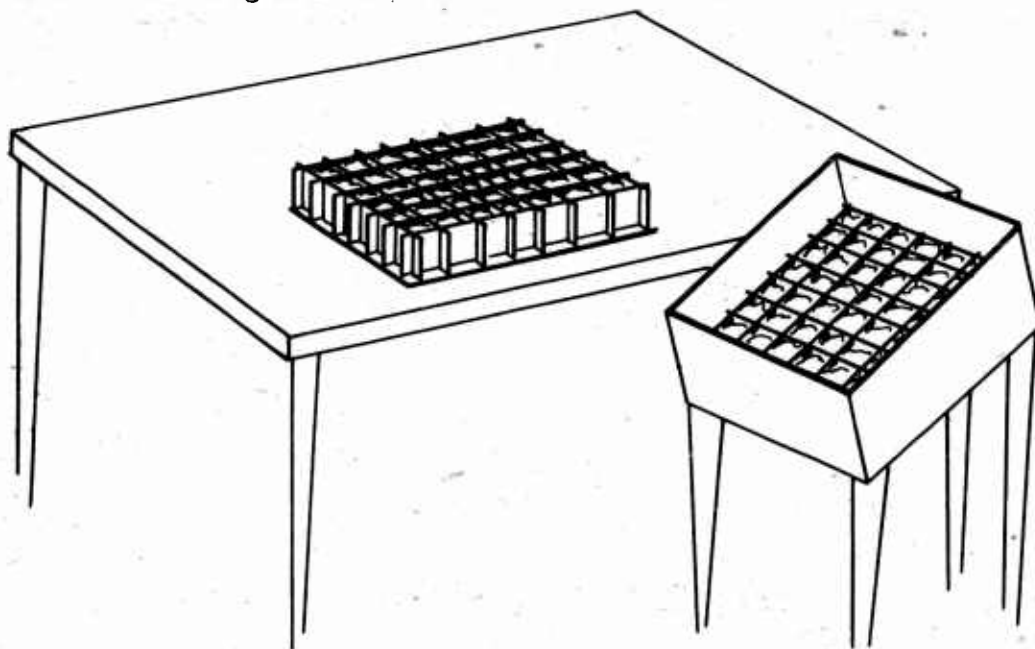
FIG. 6 TABLE ARRANGEMENT PRIOR TO FIRST ACCIDENT AT PLANT B

23. As well as the operator can remember, she was involved in the "spilling" process when the primer fired. She received numerous cuts and burns and particle embedment on various portions of the face, embedment just below the left collar bone and some minor cuts and burns on one hand. The sound wave brought about a temporary deafness. Miraculously, she escaped optical injury or cutting of major blood vessels in the neck or forehead.

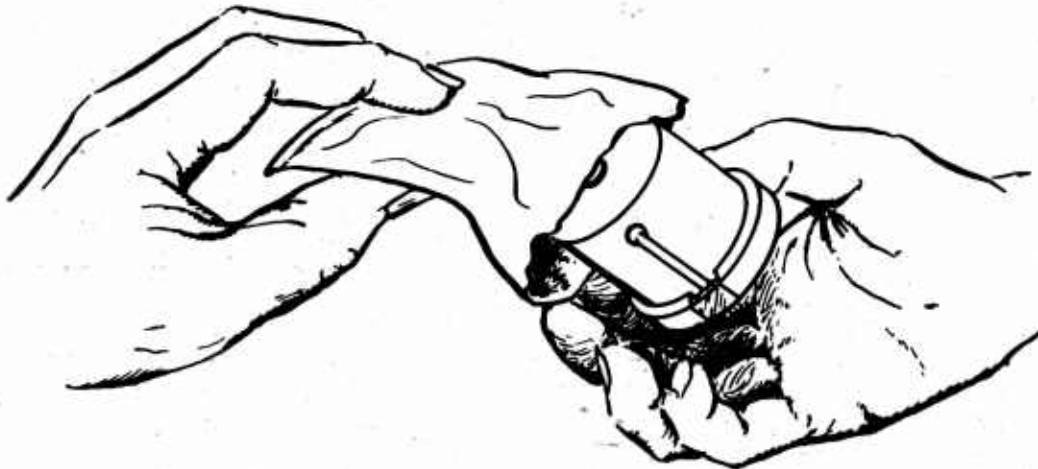
FIG. 7 REMOVING ASSEMBLY FROM PLASTIC BAG

When these assemblies are completed by Plant A, they are put in heat sealed polythene bags to keep out foreign material and moisture, and then are put into cardboard "egg-crate" type shipping containers, each assembly isolated from the next by a complete surround of cardboard. The first operation in Plant B prior to 20 November in handling these assemblies was to take out a tray of 42 and place it on a felt covered steel bench, as in Figure 6. The next step was to cut open the tops of all the bags and then to remove each assembly from its bag by spilling it out as in Figure 7.

27. From the nature of the injuries, resulting from the 20 November accident, it would seem that the lead out hole of the assembly was pointed directly at the operator's face, and the side hole and therefore the primer lead wires toward the operator's hand. Tests were made at Plant B on 4 December to determine if a detectable charge could form on an assembly when spilled from the plastic bag. An assembly was allowed to slide out of its bag on to an insulator and into contact with the input of an electrostatic voltmeter. Potentials to ground of 250 to 300 volts were frequently observed. The input capacity of the electrostatic voltmeter was about

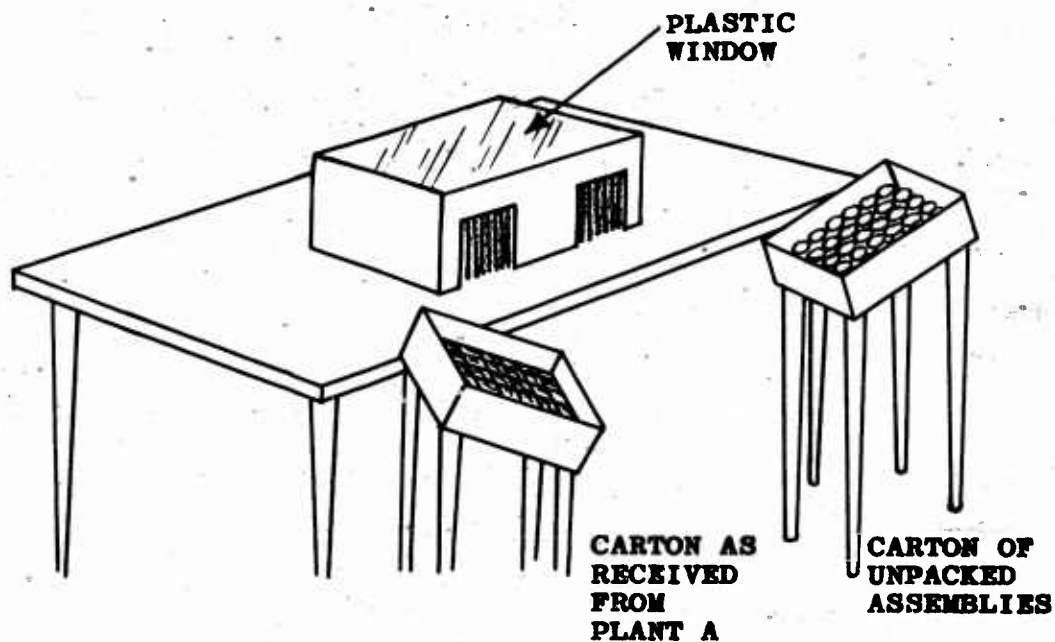
FIG. 8 UNPACKING STATION AT PLANT B ON 2 DEC 1953.

The packaged assemblies were removed singly from the shipping container at the left and set down on the steel table inside the shield. The bag was cut open, the assembly spilled out and then placed with the right hand in the box of unpacked assemblies. The unpacked assemblies are placed touching each other in layers on a cardboard sheet which separates the layers. The box is also cardboard.

Either as the operator was setting the three assemblies down, or as she was moving her hand away, one of the primers fired before the bag had been cut open. Her involuntary sudden motions away from the explosion area caused her to scrape the back of her right hand on the enclosure. The location of the assembly at the instant of the explosion can be deduced from the denting of the steel work table surface. The assembly must have been standing with its axis of symmetry vertical and with the lead out hole downwards. The assembly must have been standing very nearly as close to the rear wall of the enclosure as its plastic bag would allow it and no more than a quarter of an inch above the surface of the table. The orientation of the side hole cannot be deduced from the available evidence.

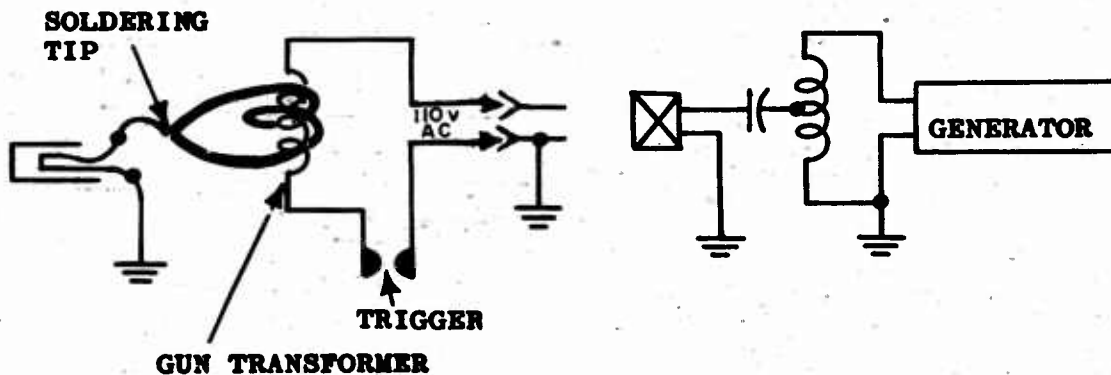
FIG. 10 SYMBOLIC REPRESENTATION AND CIRCUIT ANALYSIS OF THE ACTION OF THE WELLER GUN ON MK 121 PRIMER

and had then released the soldering gun trigger while the gun tip was in contact with the post to which the primer lead was still fastened. The primer fired. Since the operator was holding the assembly between his left thumb and forefinger with the thumb over the side port leading to the primer, he suffered loss of the nail and a portion of the first joint of the thumb.

33. Tests subsequently performed at the Naval Ordnance Laboratory indicated that peak potentials could be generated across a primer bridge of 80 to 100 volts if one unshorted lead of the primer is in contact with the gun tip and the other lead grounded. Figure 10 shows the electrical physical arrangement and the circuit analog. It is not as likely that the voltage pulse was derived from magnetic coupling as that it resulted from the capacitance existing between the windings. The association of the pulse with trigger action turning the gun either on or off can be explained on the basis of inductive "kick". Due to the induction of the primary winding, the opening or closing of power to the winding usually causes a momentary peak voltage to appear across the winding. This voltage peak may be considerably greater than the normal supply voltage. As part of the test at the laboratory, six Mk 121 primers were fired

in the arrangement shown in Figure 10. It was not possible to fire the Mk 121 primer when the leads were twisted together nor was it possible to fire a Mk 114 primer

34. In reviewing this accident, it is possible to see that two fundamental rules had not been followed. First, the explosive operation had not been carried out in an adequately shielded area. Second, an improper soldering iron had been used. In working with electro-explosive devices, it is imperative that a heating element type soldering iron with grounded tip and element insulated from the tip should be used. Even better would be a grounded iron which does not have any heating element but is kept at the proper temperature by resting in a separate heater. In the case of an iron with a heating element, it should be designed to keep to a minimum the capacitive and magnetic coupled fields due to the wiring contained within the iron. An iron having a thermostat might be dangerous due to switching surges during operation of the thermostat.

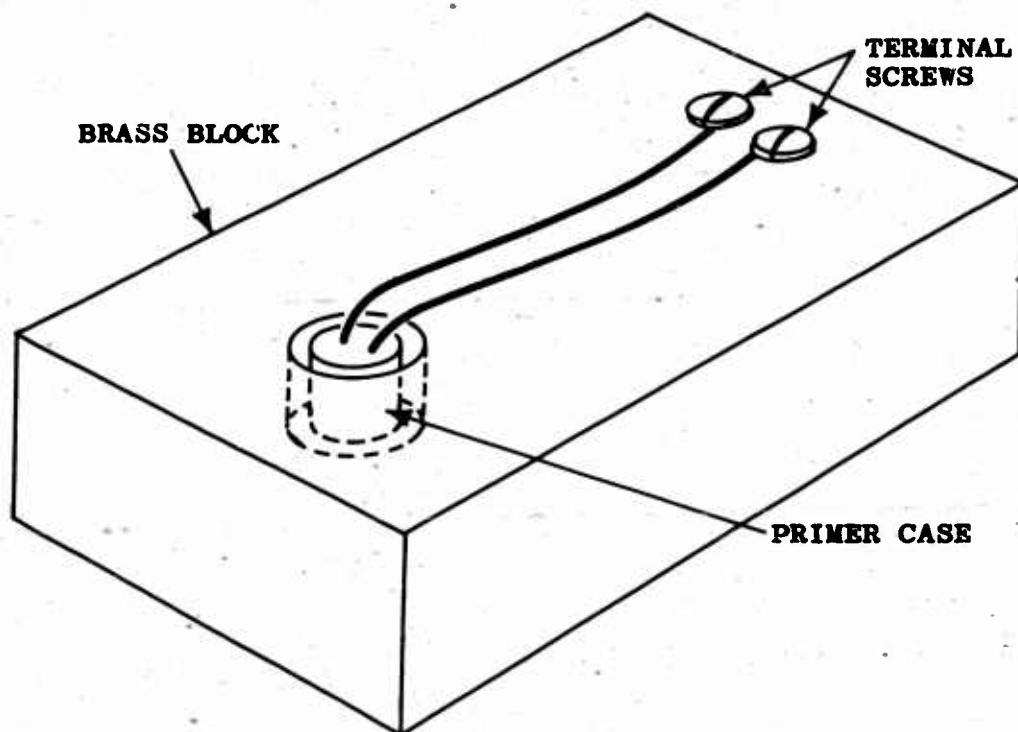
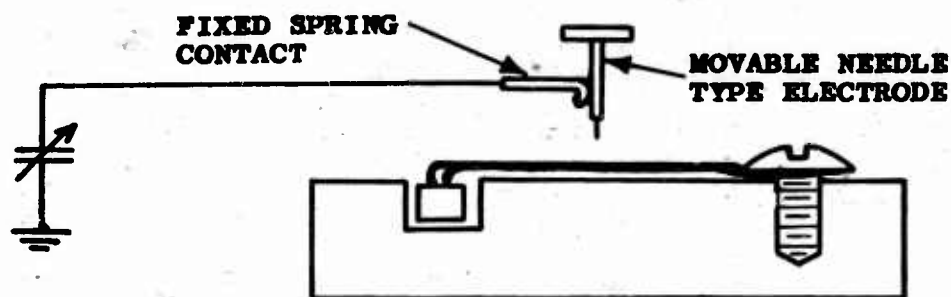
FIG. 12 SETUP TO DEMONSTRATE SENSITIVITY OF INITIATOR WITH GROUNDED CASE AND LEADS TO ENERGY PULSES

a shorting system. Figure 12 shows the method of mounting the primers for this test. In this case the insulated length of lead was about 4 inches. The bare lead ends were clamped to the brass blocks by two roundhead brass screws. The explosive unit case was set in the drilled hole below

the surface of the block. The block was set on a grounded support, as in Figure 13 and a 50 $\mu\mu\text{fd}$ capacitor charged to 10,000 volts was discharged to the center portion of the insulated lead wires through an electrode system. Of 25 primers tested in this setup, one fired. This behavior can be attributed to the fact that under pulse or transient conditions a large potential gradient can be established momentarily on a conductor, the gradient propagating along the conductor in the manner of a micro-wave transmission line. Under this condition the primer initiation might be a normal bridge firing or a lead-to-case breakdown.
