WADC TECHNICAL REPORT 55-107

## **"PROJECT BIG EVA"**

**Accelerated Service Test  
of Radio Sets AN/ARC-21**

**COMMUNICATION AND NAVIGATION LABORATORY**

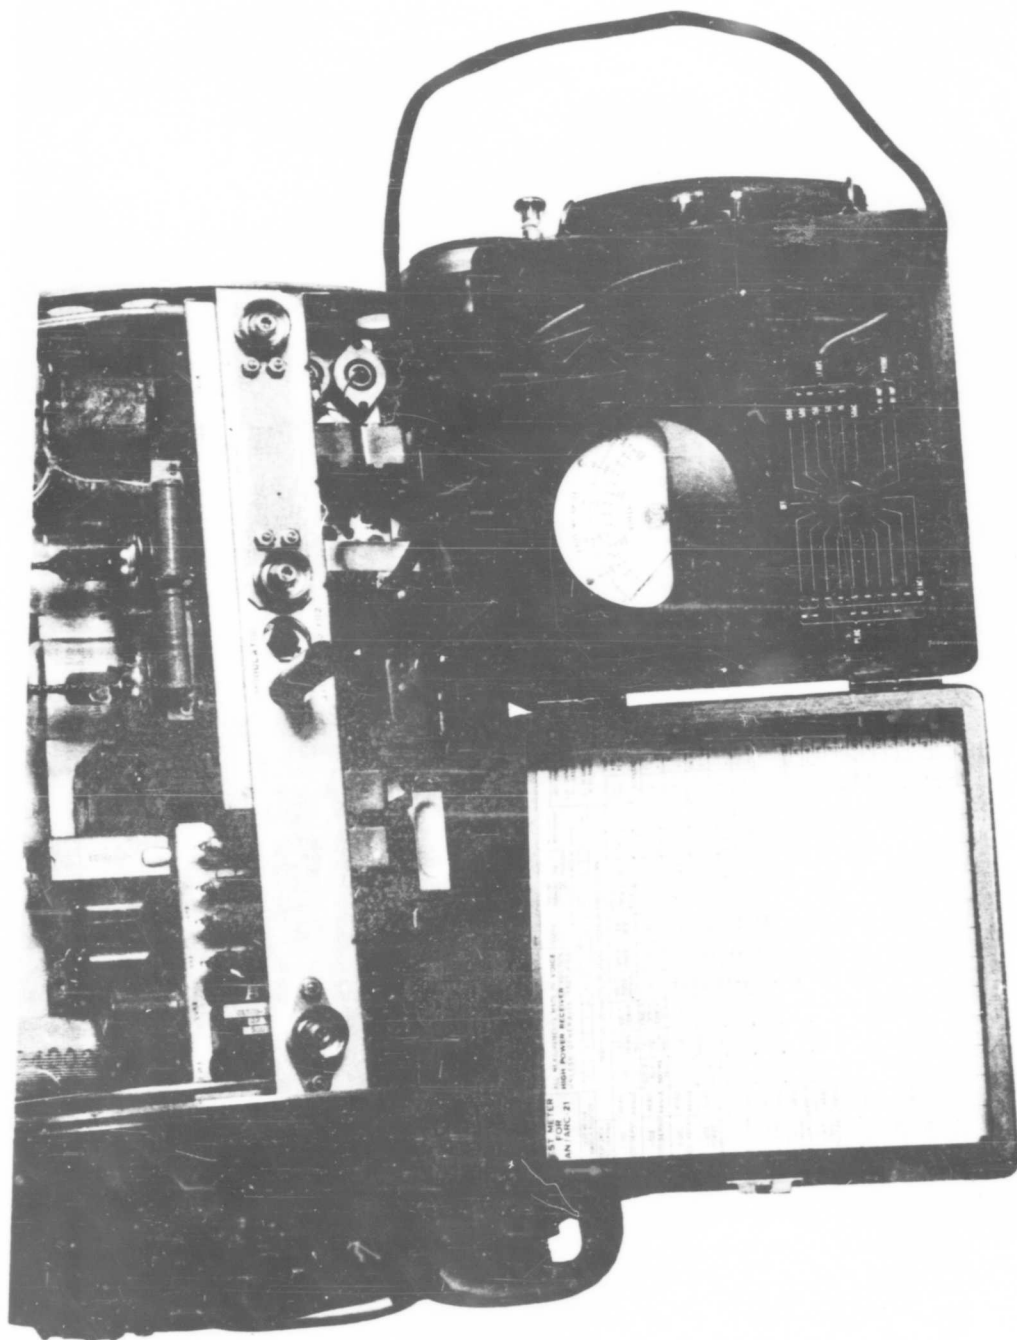
Multimeter ME-75/ARC-21. Use of the "go, no-go" meter at Scott AFB in training operations resulted in the discovery of a potential personnel shock hazard. Wearing of insulation within the instrument could connect the metallic case to the potential of the high-voltage lead (1000 v) from the radio set. The contractor determined a fix which prevented such an occurrence. The fix was accomplished by grounding the case of the instrument to the frame of the R-T Unit through a separate lead, after which the instrument case cannot be above ground potential.

FIGURE 13  
MULTIMETER ME-75 (XA) / ARC-21 PLUGGED INTO TEST SOCKET

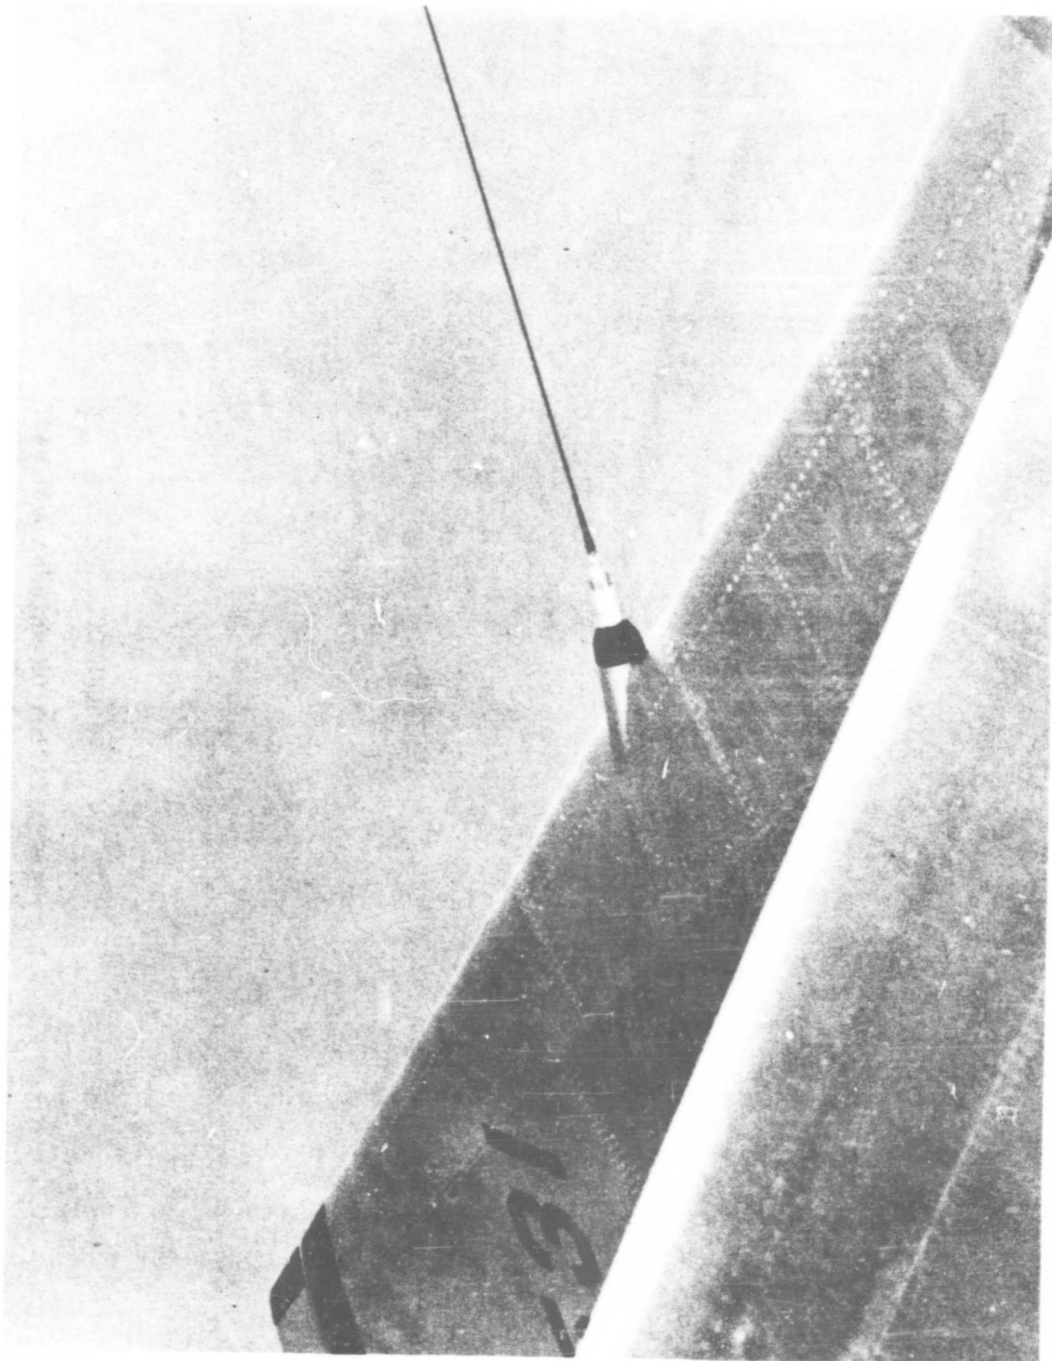
Relay RE-132/ARC. Some difficulty was experienced at MacDill AFB due to transients caused by operation of the antenna shorting relay affecting the proper operation of the ERA Coupler. The fix consisted of an addition of a filter in the Coupler.

FIGURE 27  
B-47 INSTALLATION OF ANTENNA SHORTING RELAY
