Project Whirlwind  
Servomechanisms Laboratory  
Massachusetts Institute of Technology  
Cambridge, Massachusetts

SUBJECT: ELECTROLYTIC CORROSION AS A POSSIBLE FUTURE SOURCE OF TROUBLE  
AFFECTING WWI RELIABILITY

Date: June 25, 1951

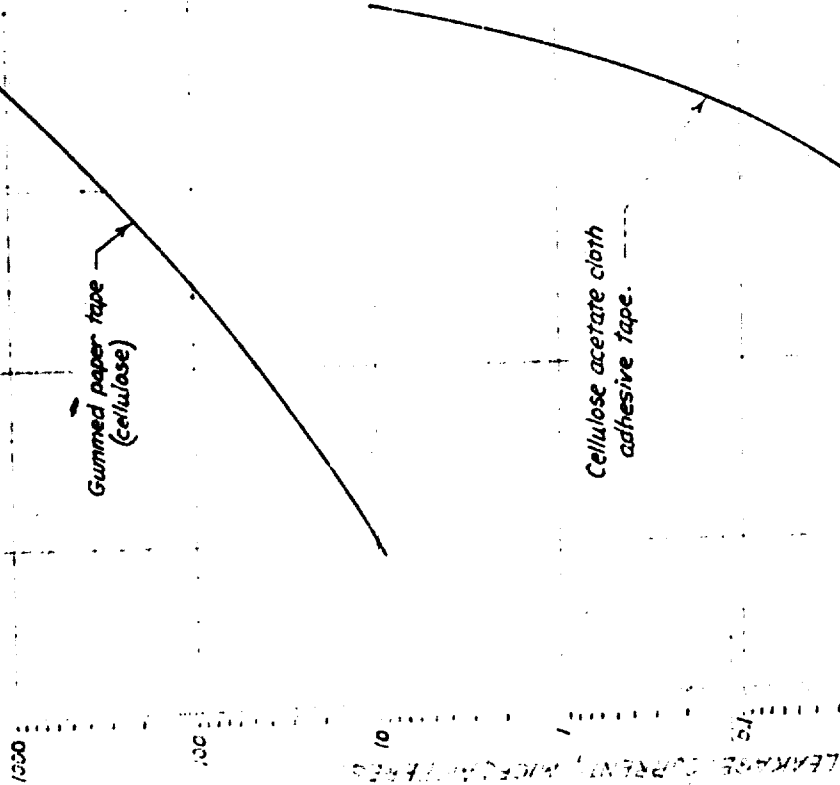
In Figure 6, a comparison of the relative leakage currents of two common insulating materials, gummed paper tape and cellulose acetate cloth adhesive tape, shows the effect of varying combinations of the aforementioned hydrolysis, leakage resistance, and moisture absorption properties. Since the individual effect of each of these properties is difficult to determine, leakage resistance is not a dependable measure of insulation quality where favorable conditions for corrosion exist.

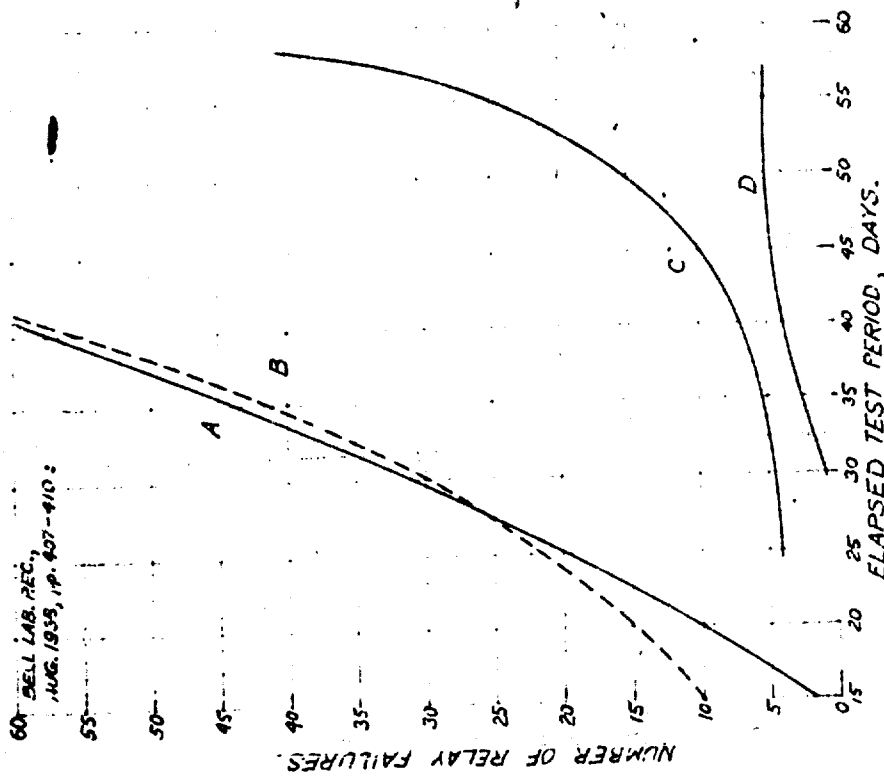
- A- Mixed paper core cover, interwinding insulation, and outer cotton yarn sewing.
- B- Same, but impregnated.
- C- Cellulose acetate yarn core and cotton covers, stored paper interwinding insulation.
- D- All coil insulation of cellulose acetate sheet.

FIG. 7. EFFECT OF HUMIDITY ON LIFE EXPECTANCY OF RELAY.

Obviously, if all cellulose-based insulating materials and adhesives containing glue or other hydrolyzing substances are eliminated from relay coils of fine wire energized for long periods of time at positive d-c potentials, relay life expectancy is without limit where corrosion elimination is concerned, as shown in Figure 7, page 9.
