M.A.E.E. Report No. F/187  
(Saunders-Roe Report No. FT/15/0/24, Part 3)

June 1955

SAUNDERS-ROE PRINCESS FLYING BOAT G-ALUN

ENGINEERING APPRAISAL

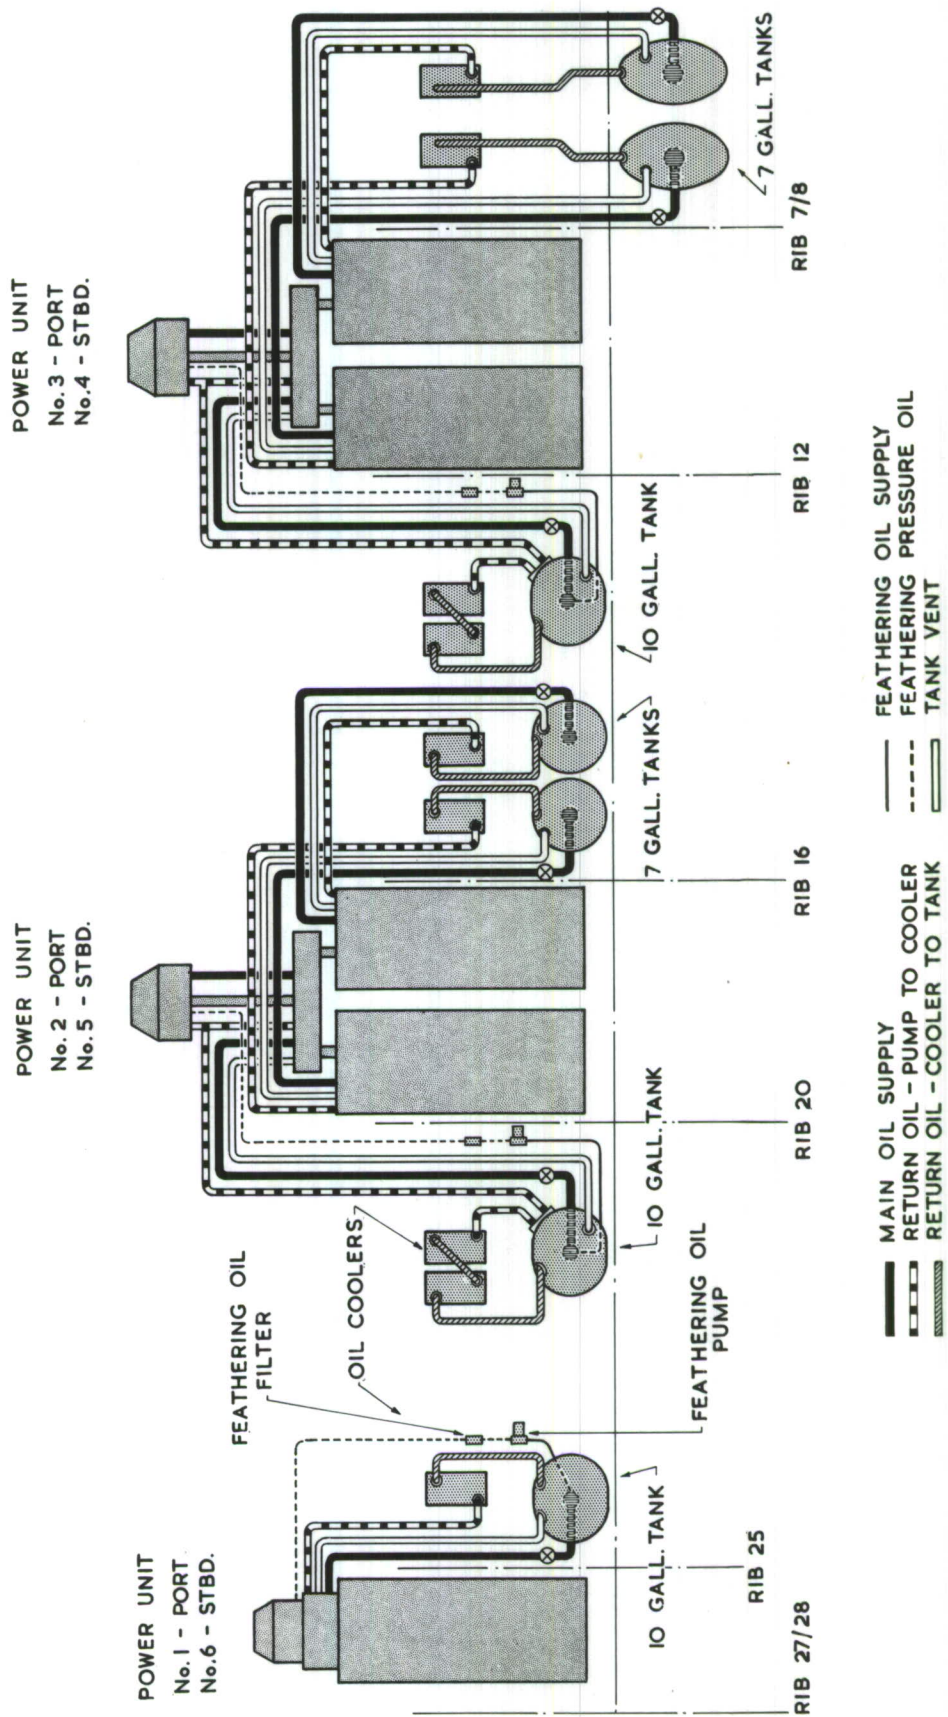
DIAGRAM OF OIL SYSTEM

Each coupled power unit had its own oil system and also a separate transmission oil system. A single unit installation had one common system for both engine and transmission. The layout of the oil systems for two coupled and one single engine is shown schematically in Figure 5 and a full description may be found in Section 4, Chapter 3 of Reference 4.

The four coupled engine transmission systems and the combined single engine systems were satisfactory. The oil systems for the coupled units were not satisfactory. Even under temperate summer conditions it was not possible to warm the oil up to a desirable operating temperature, or to maintain it at a figure above the minimum limit in flight. This over-cooling was mainly due to the low oil circulating rate through the engine, and was aggravated to some extent by air leaks around the cooler shutters. Temporary sealing was fitted to the shutters, and part of the cooler matrix blanked off; this enable flying to continue, but was only a temporary arrangement.

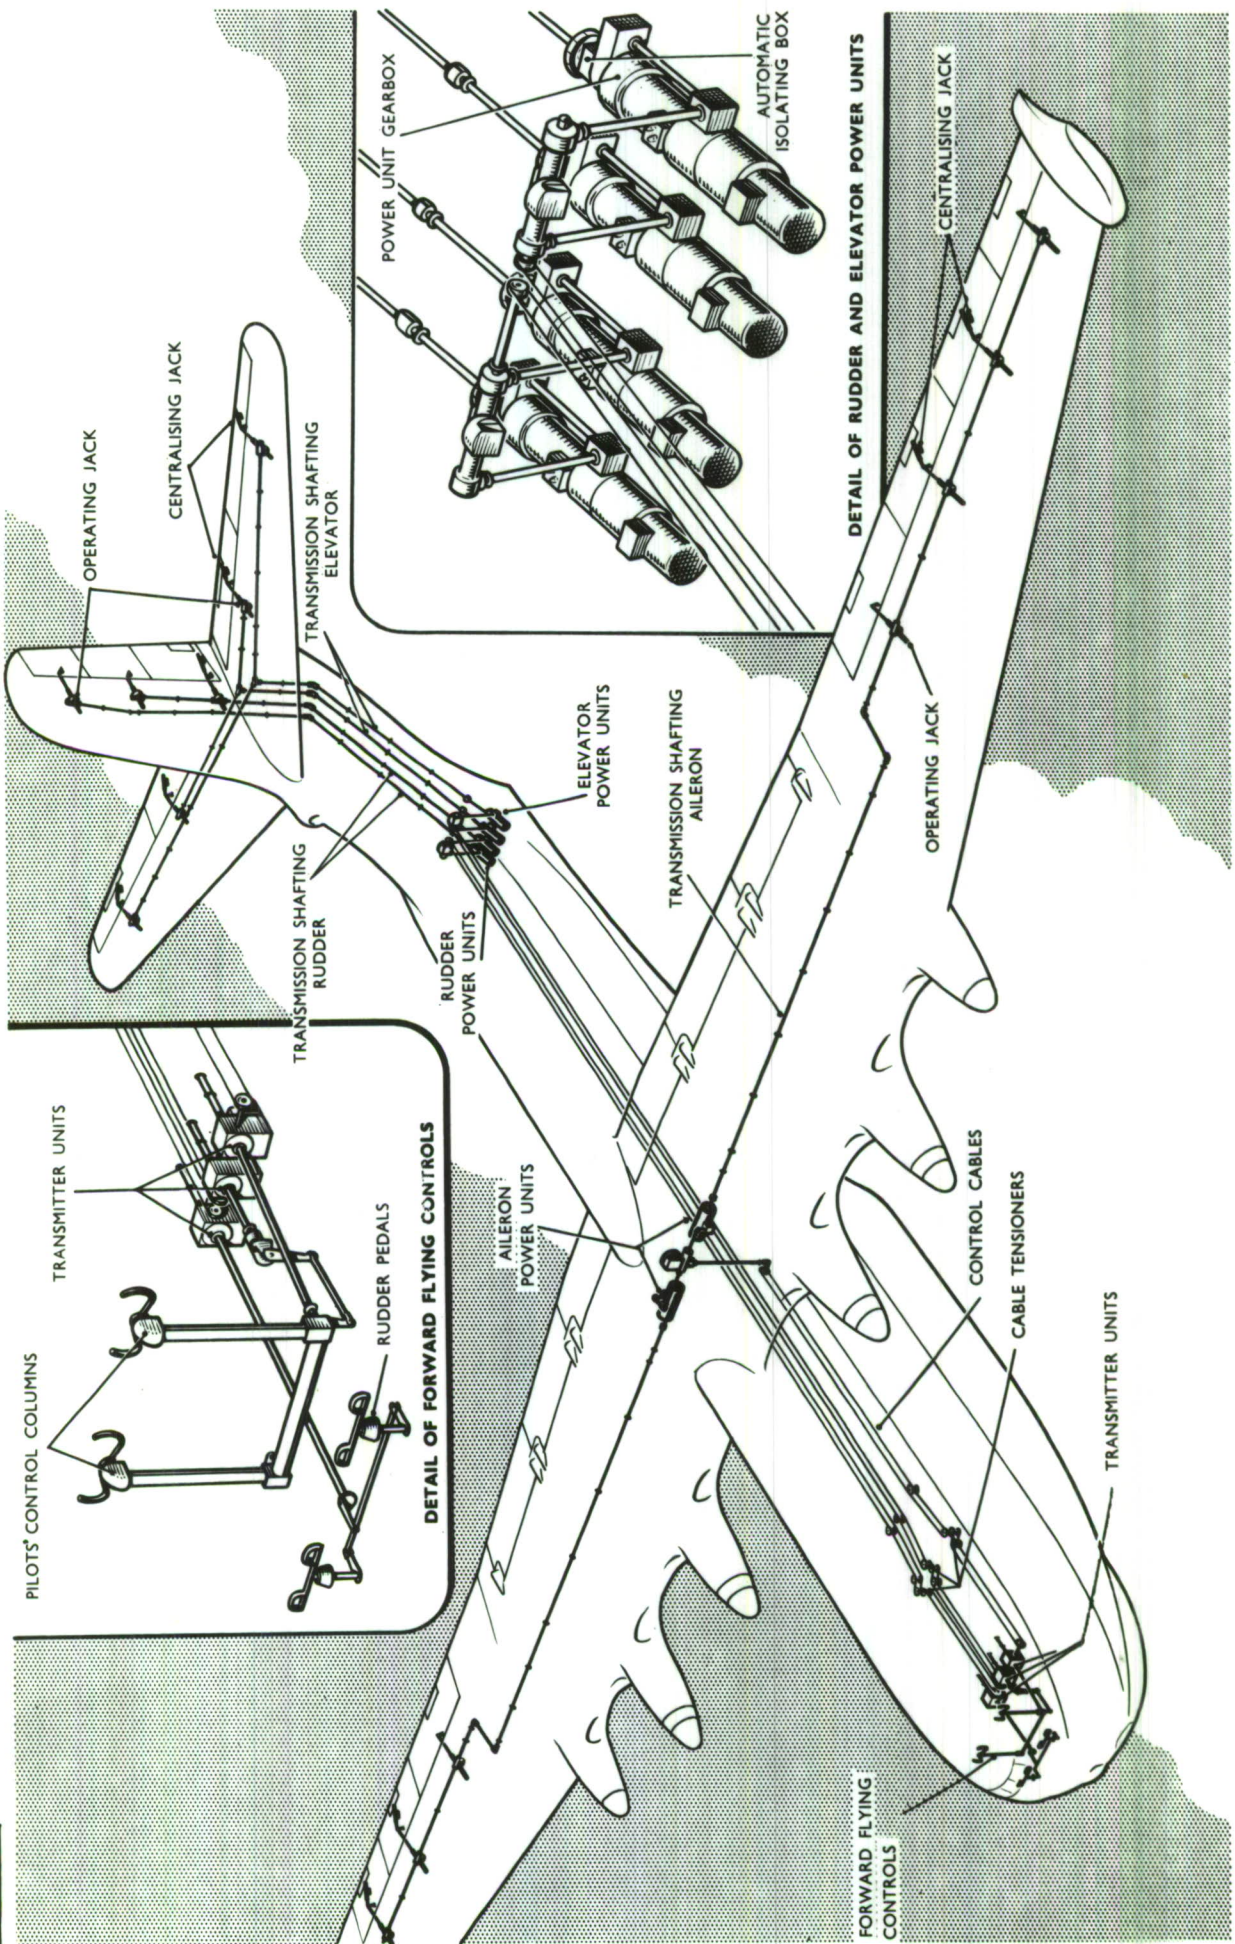
DIAGRAMMATIC LAYOUT  
OF POWERED FLYING CONTROLS

A diagrammatic arrangement of the powered flying controls is shown in Figure 7. From this it will be seen that control column and rudder bar movements were taken by cables, via a transmitter unit, to a pair of electrical/hydraulic power units for each of the three flying controls. The power units in turn operated the control surfaces by means of torque shafts and screw jacks. By splitting the surfaces into sections it was so arranged that one power unit of each pair operated half of the particular control surface. This ensured that a power unit failure would leave half of any control system operative. A means of centralising the surfaces, in the event of such a failure, was also provided by fitting separate actuators in the surface operating lever, aft of the main screw jack. A full description of the installation is given in Section 3, Chapter 4 of Reference 4.

Secondly, the motor generator sets which provided A.C. current for the centralising actuator motors were not satisfactory. These sets, Type B.T.H. D2A1, were running under stand-by conditions (no load) during all flights, current only being required from them in the event of a flying control power unit failure. The functioning of these generator sets is discussed in Paragraph 4.

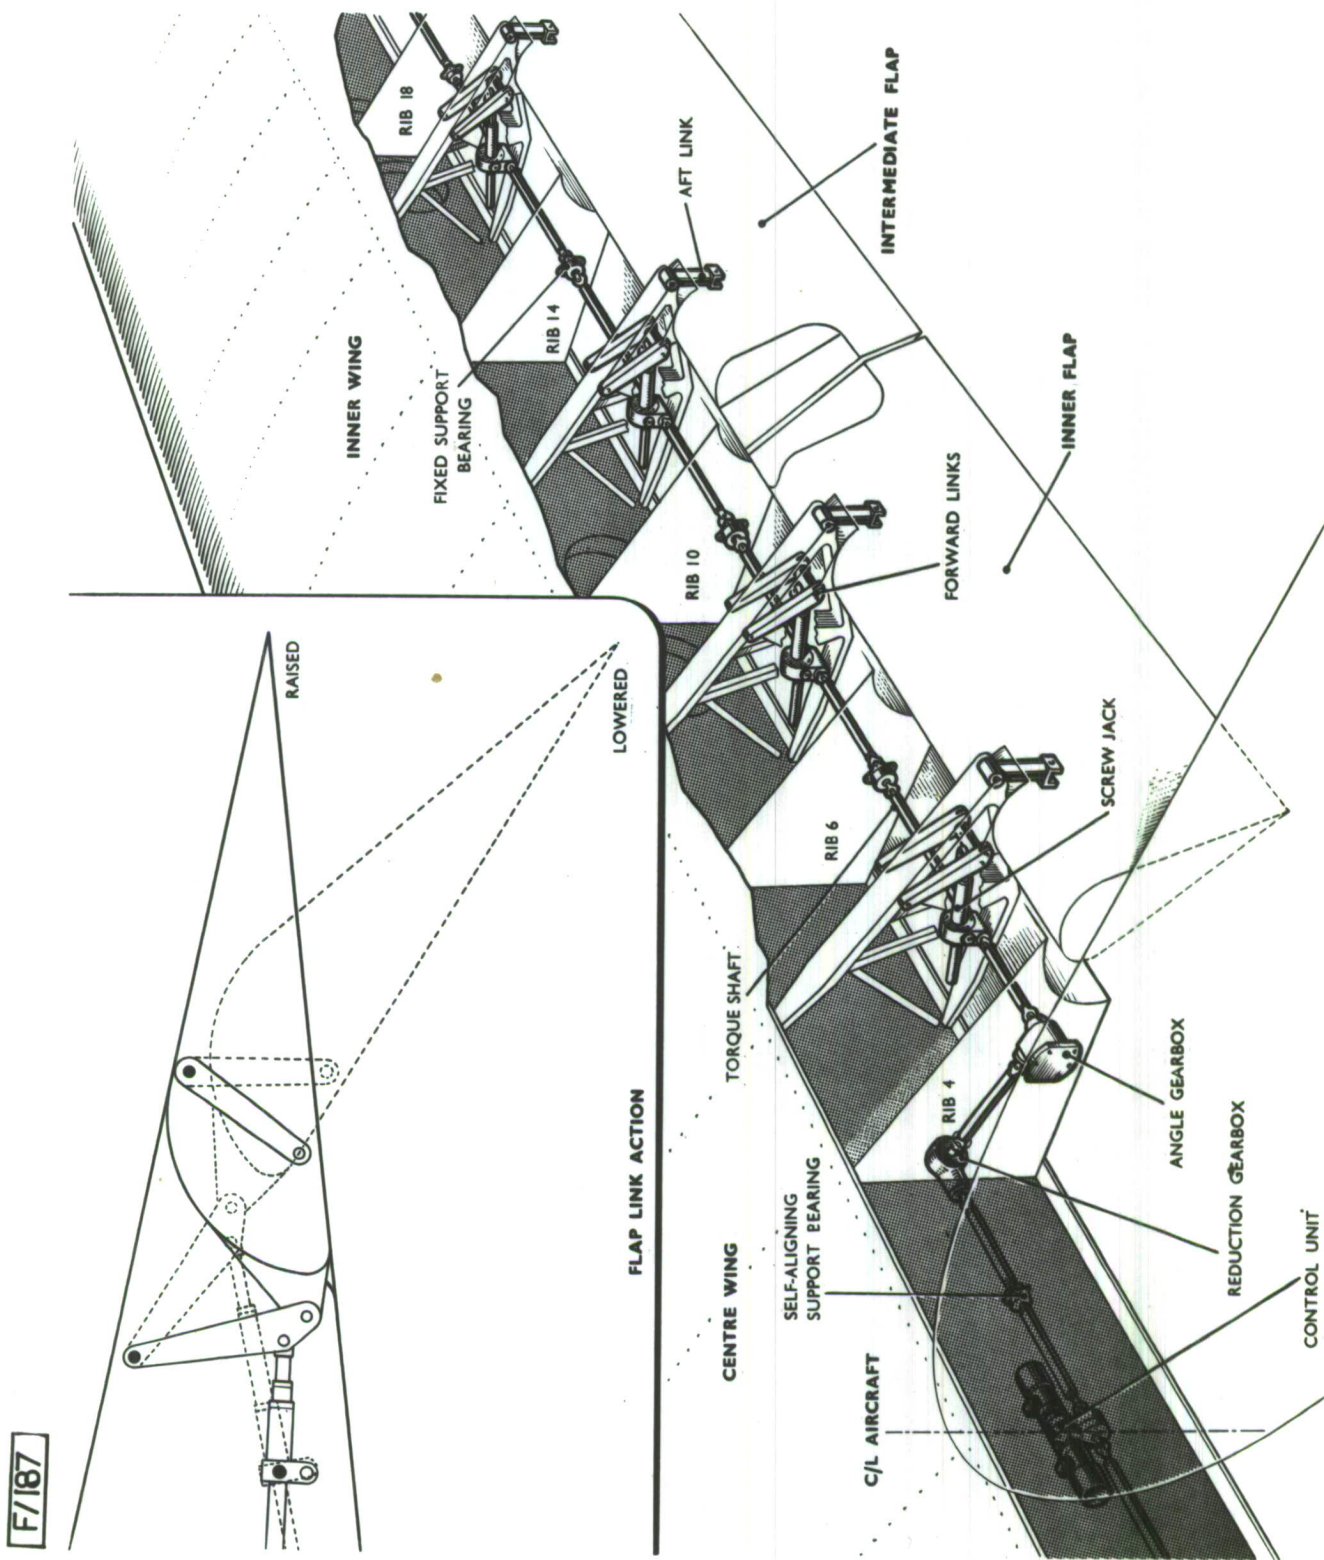
GENERAL ARRANGEMENT  
OF FLAP CONTROL SYSTEM

As can be seen from Figure 8, two electric motors driving through a differential gear box operated screw jacks, two on each unit. In the event of one motor failing, an automatic electrical brake came into operation, allowing the other motor to drive the system at half speed; flap movement at half speed was satisfactory.

A full description of the construction and operation of the system is given in Section 3, Chapter 17 of Reference 4. Short-rated motors were installed and these imposed a limitation on the number of operations permissible in a fixed period of not more than two-and-a-half complete retraction and extension cycles without a subsequent cooling period of at least forty-five minutes; under these conditions flap operation was satisfactory. This limitation, whilst probably being quite acceptable for normal operation, was exceeded during test flying (measured take-offs and landings) with the result that two motors were burnt out. The installation of up-rated motors should be considered to give a higher operating frequency for specific testing or training programmes.
