ARMAMENT RESEARCH AND DEVELOPMENT
ESTABLISHMENT

A.R.D.E. REPORT (S) 26/55

Investigation of Accidental Explosion of 1000 lb.
Bomb at R.A.F. Station Marham

D.E. Jarrett (S.2)

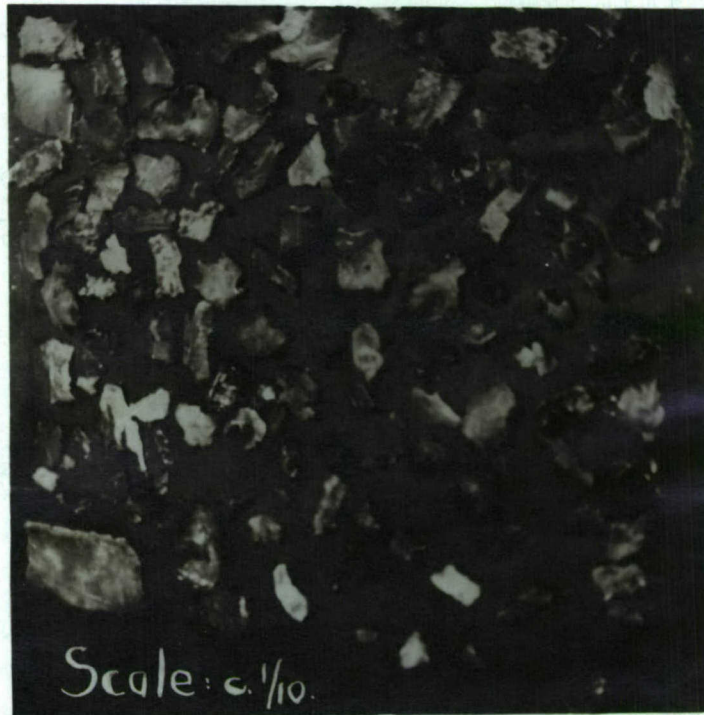
The fragments of the bombs (photographs 1 and 2) varied in size from 1 ft. in length and 6 in. in width to very small pieces. Many bore evidence of detonation, (photograph 3C) and among these were some which had originated from the nose and base of a bomb. Fragments from nose and base were found which had either been driven violently into concrete or were produced when

1. Fragments of bomb recovered after the explosion at
Marham

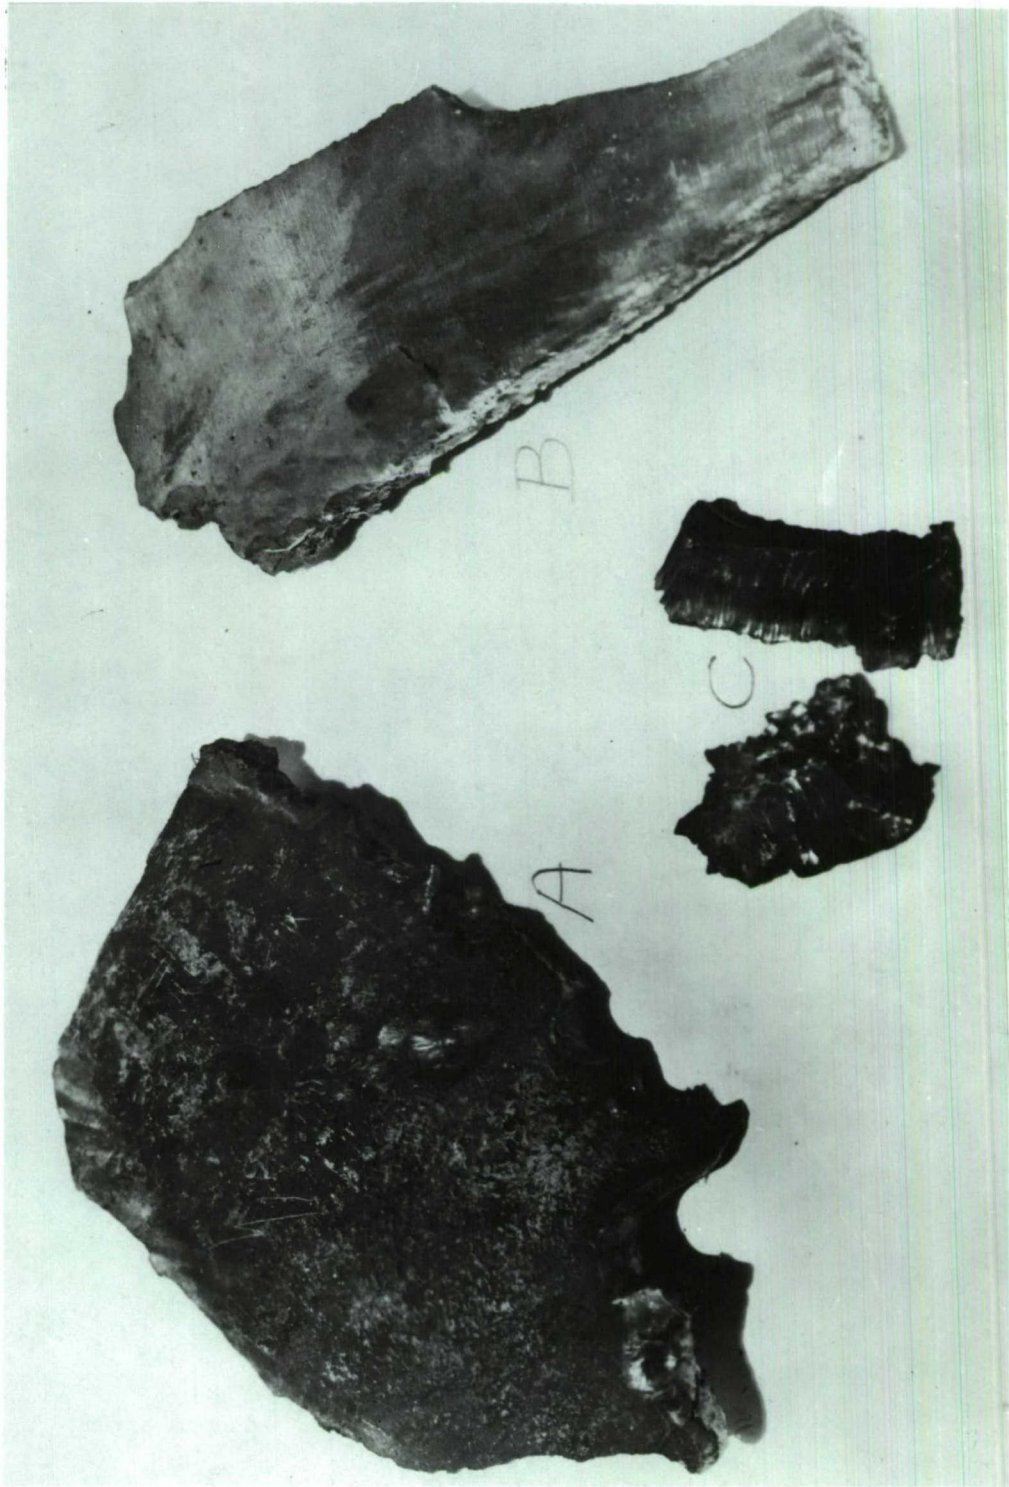
3. Fragments of bomb recovered after the explosion at Marham

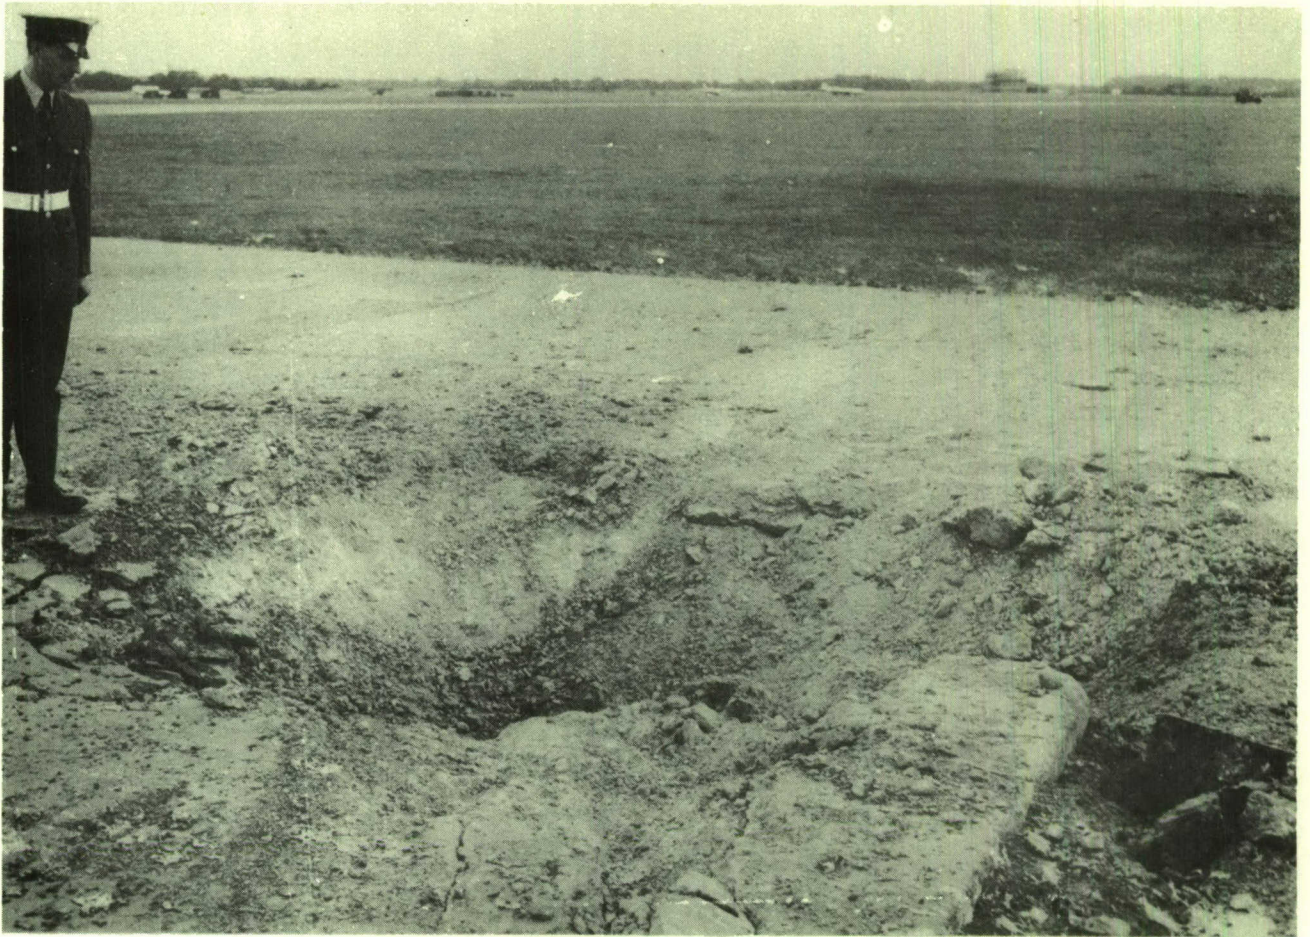
The general inference was that an ignition occurred somewhere along a bomb body - actually from descriptions of the crater (photographs 4 and 5) the port bomb - which built up to detonation in the direction of nose and base. This would account for the presence of large fragments with marks of ignition on the inside surface (photograph 3B). The presence of other large fragments on which the exterior paint was still intact and which showed signs of fragment attack (photograph 3A) suggested that the second bomb was initiated by the explosion of the first.

4. The crater from the explosion at Marham

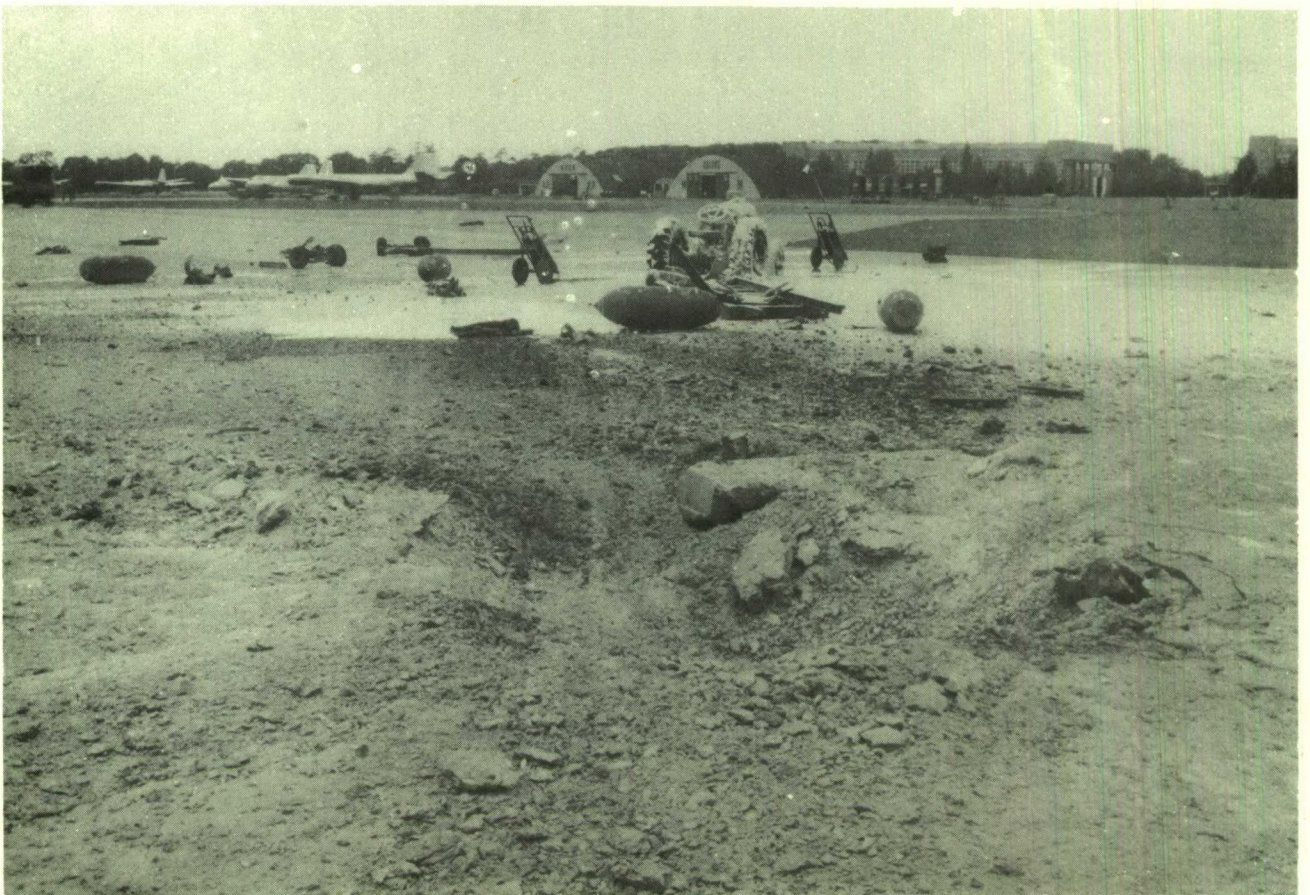
5. The crater from the explosion at Marham showing damaged bombs

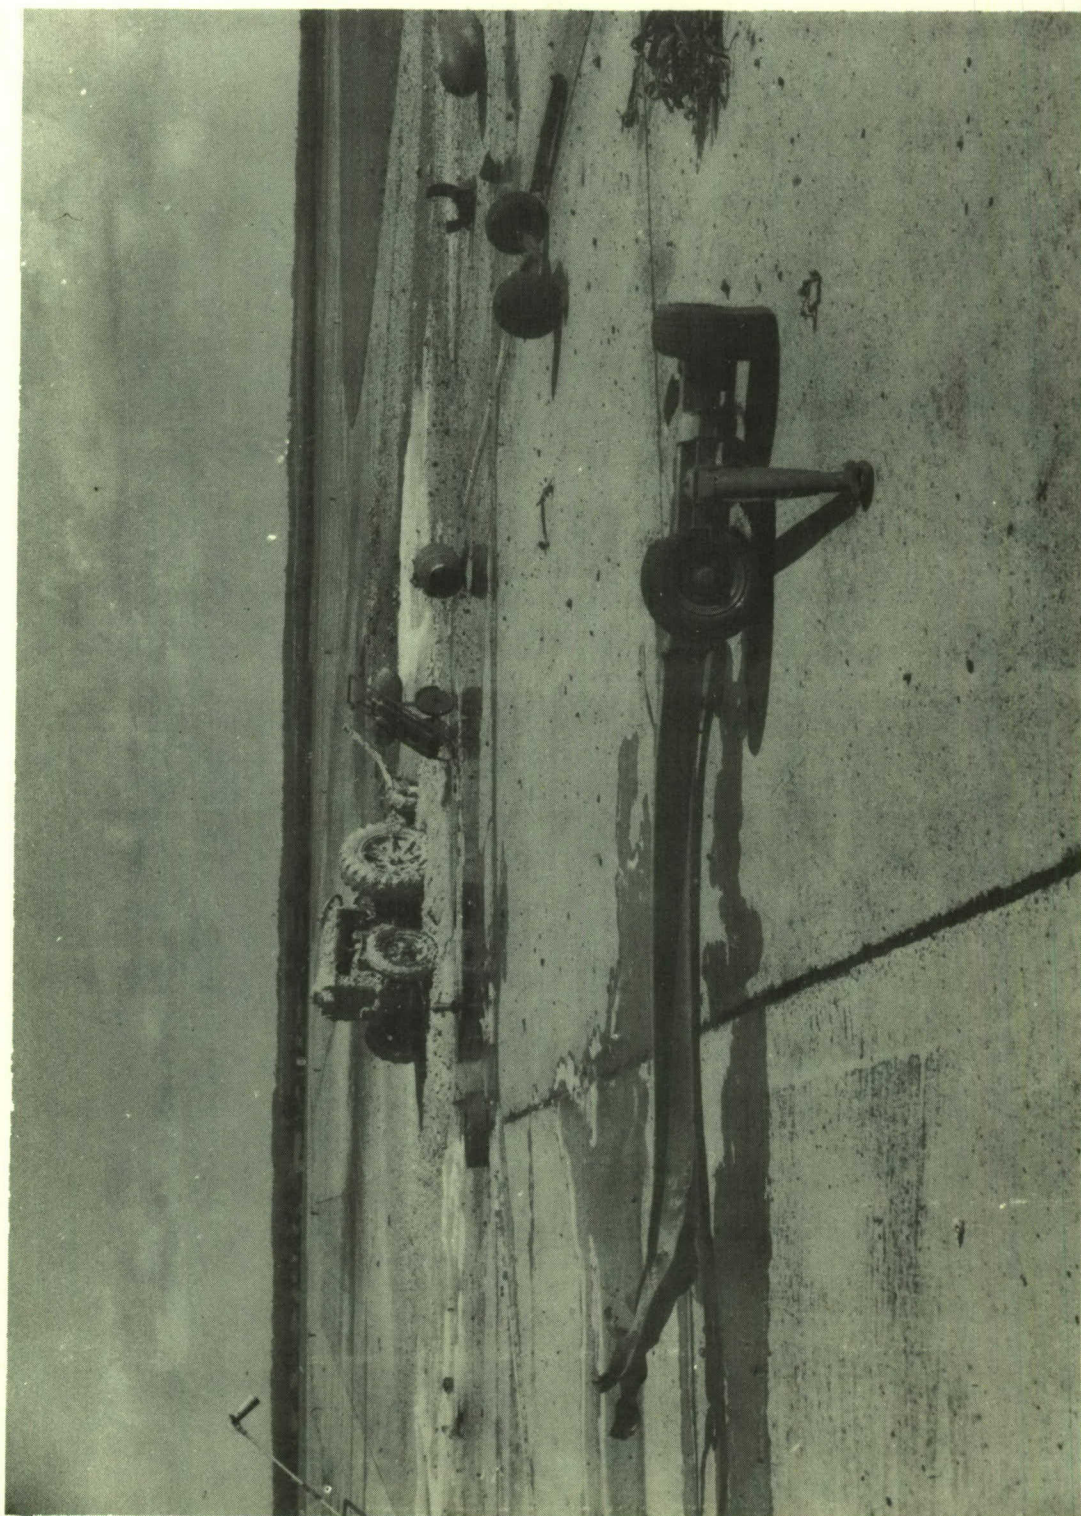
The remains of the bomb trolley were examined. The force of the explosion was directed mostly forwards, the trolley rails and main frame members being twisted outwards and slightly downwards. These rails and main frame were intact up to a point which would be beneath the centre of the bombs when resting normally (photograph 6), but the rear portions could not be identified. The right hand side of the rear axle was recovered from the crater showing signs of an explosion above it. The left hand side was not recovered. The damage is consistent with the explosion of a bomb displaced from the cradle and resting above the rear axle rather than with the explosion of a bomb in its correct position. The two positions are shown in photographs 9 and 11.

6. The rear bomb trolley after the explosion at Marham

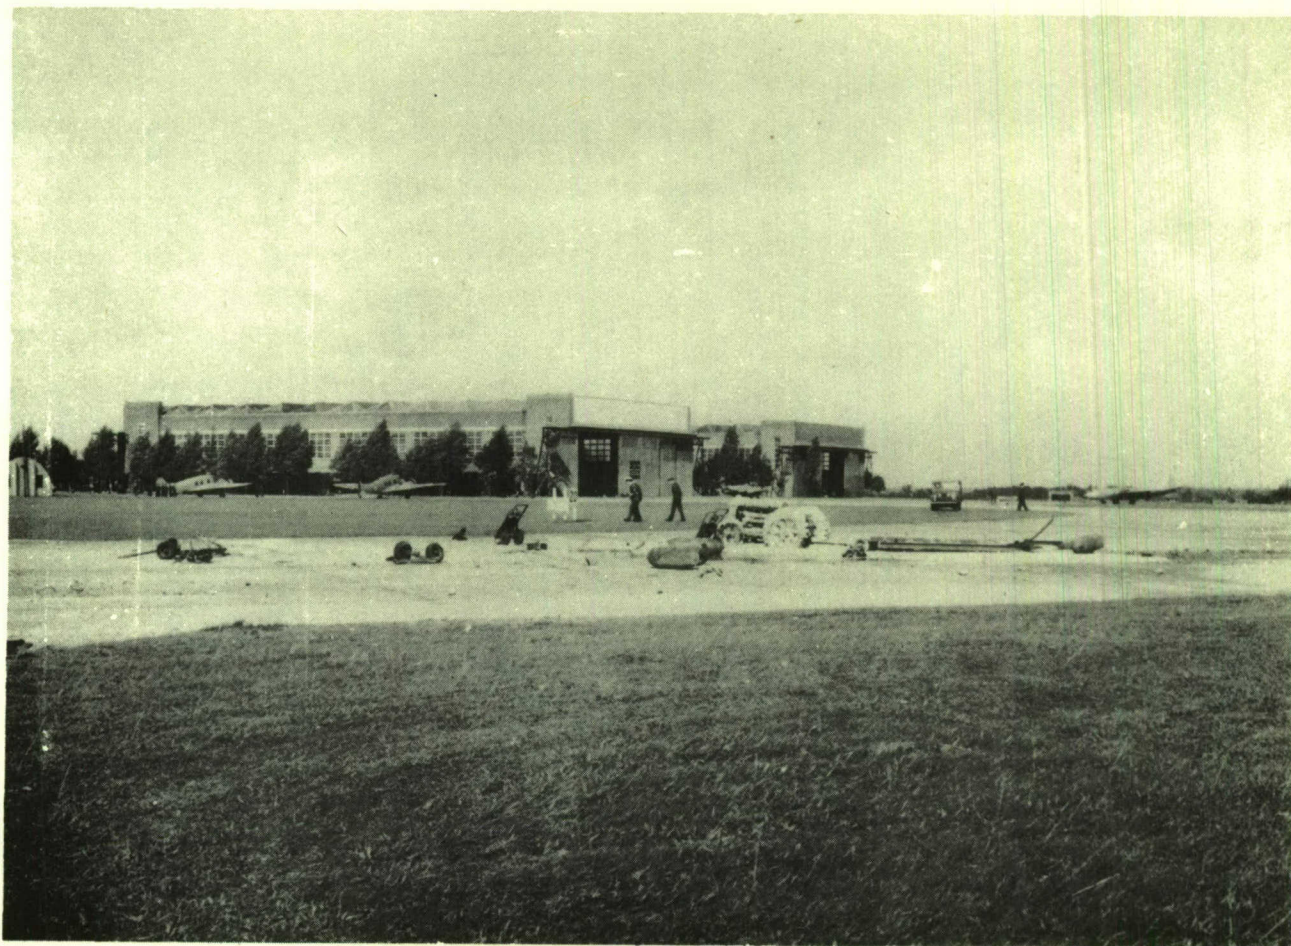
"At 12.00 hours on 20.9.54 a tractor towing two loaded bomb trolleys was being driven from the explosive area towards No.115 squadron dispersal area. The route of the tractor is shown in Fig.1. There were four bombs on the forward trolley and two in the rear position on the rear trolley. About three quarters of the way across runway 24 the tractor stopped for about 30 seconds and then carried on. About 50 yds. beyond runway 24 the driver took the bomb train on the grass for an unknown period, then returned to the perimeter track. The rear bombs were noted at this point by the Station Commander as having moved slightly but not to a dangerous position. The driver continued on the perimeter track until entering runway 20 where he stopped and got down to examine the bombs on the trolleys. He then drove very slowly across runway 20 and stopped again on the other side. At this point the bombs were observed on the rear trolley, by an aircrew member, to be off the trolley cradles. The driver started slowly toward 115 squadron dispersal when an aircraft had passed and had reached a position about one third of the distance across the perimeter track when there was an explosion (12.08 hours). Four unexploded bombs were found in the area." (photographs 7 and 8).

7. General view after the explosion at Marham

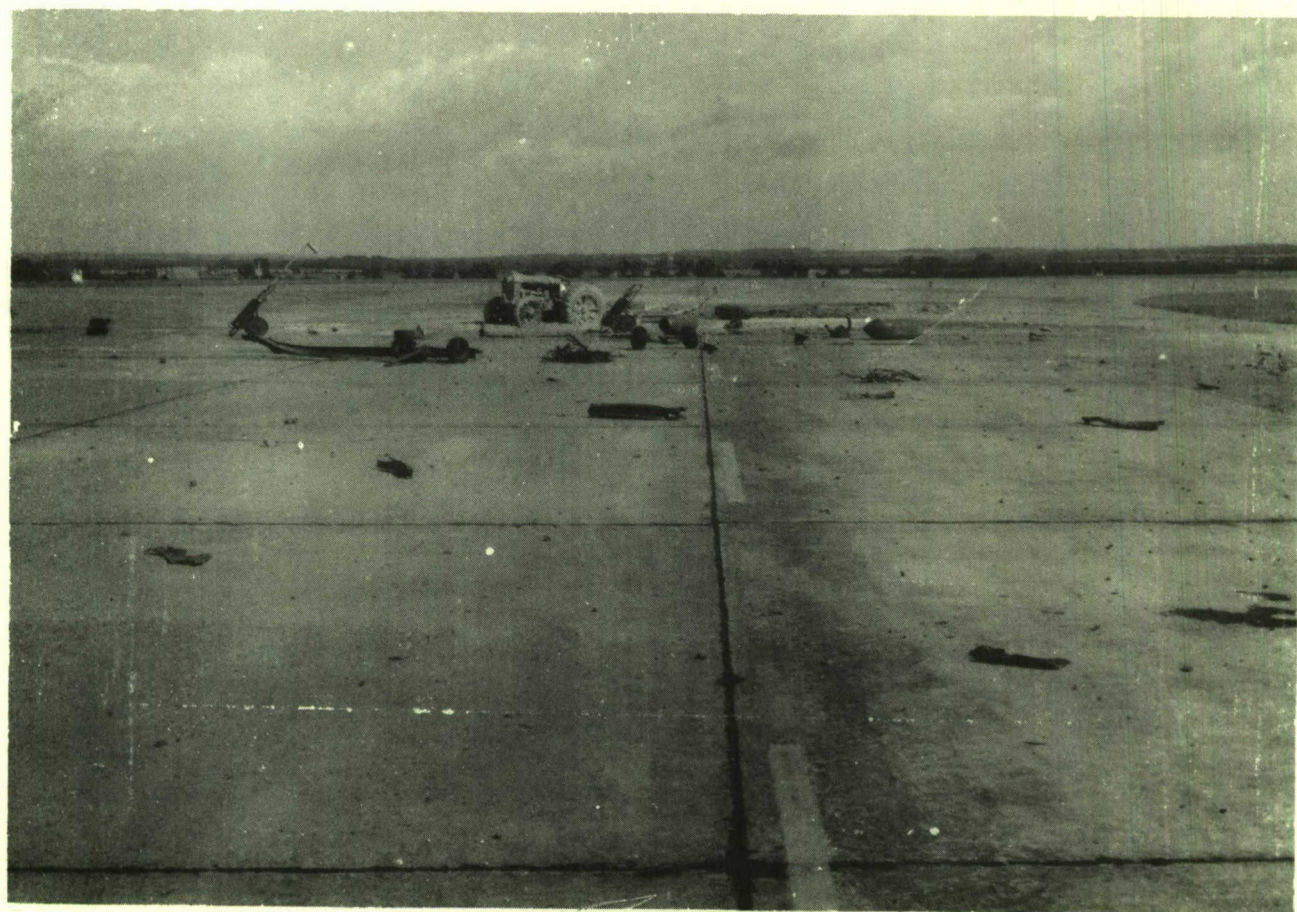
8. General view after the explosion at Marham

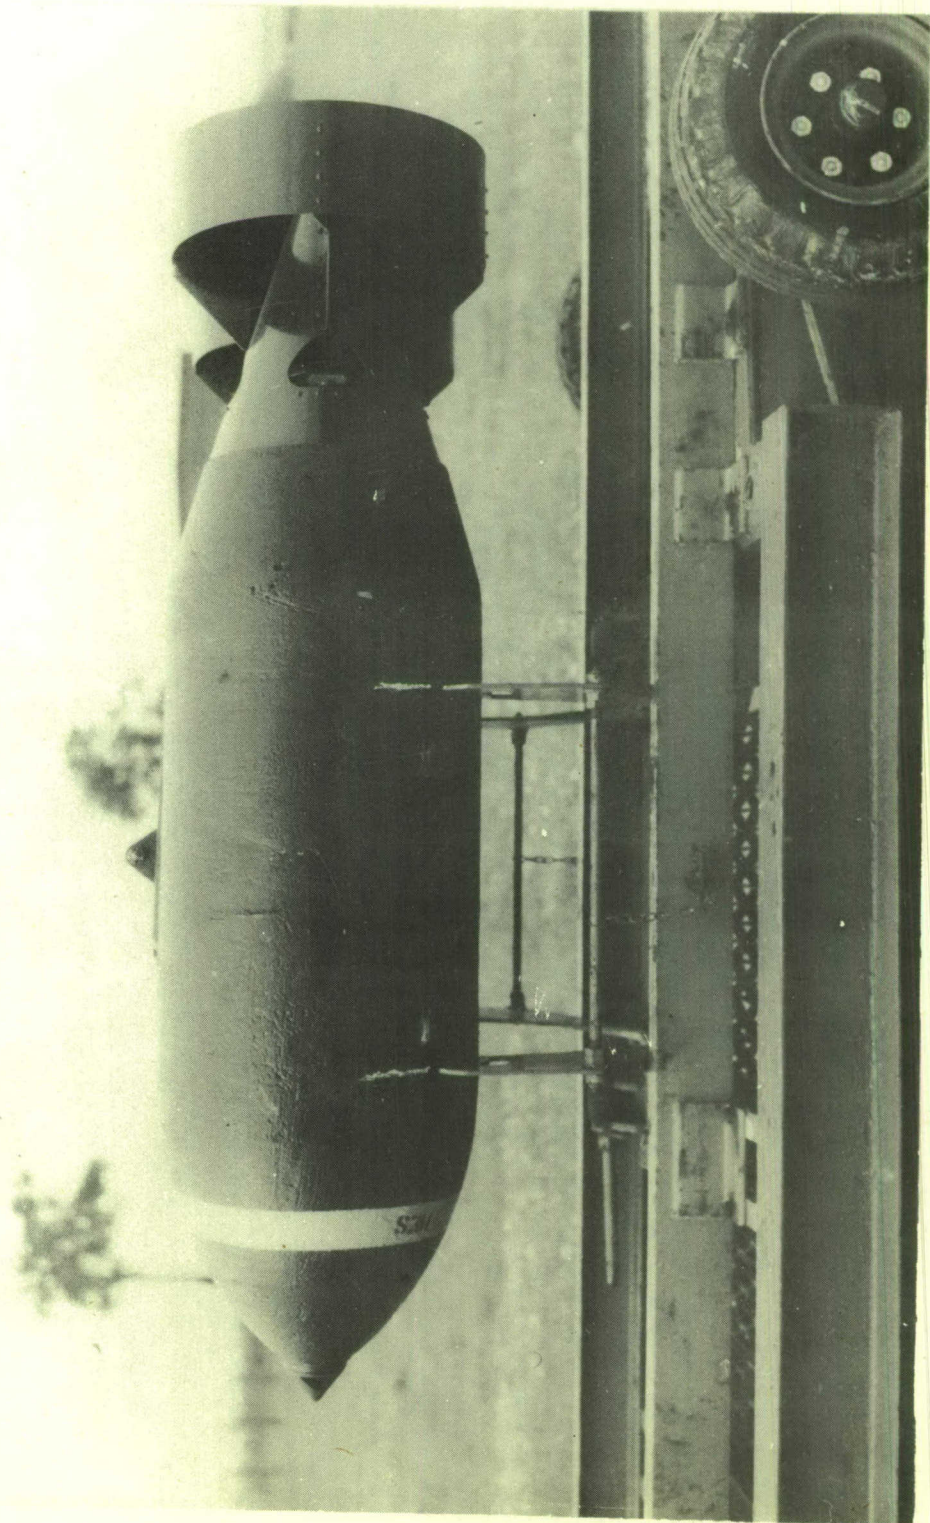
9. Bombs in normal position on cradle of trolley

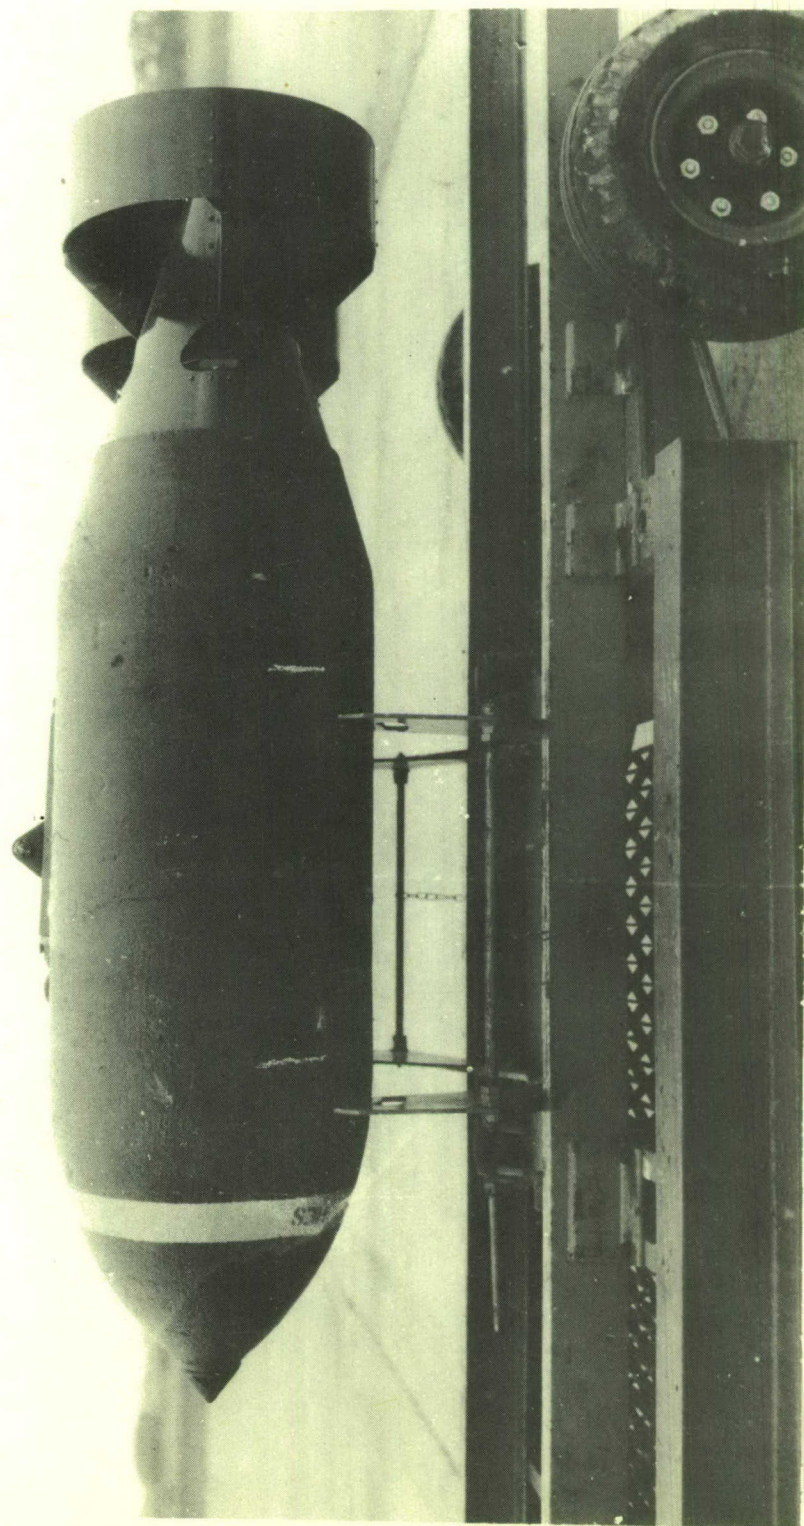
That such a displacement of bombs on a trolley is easily possible was demonstrated at Marham. With only two bombs on the cradle of the trolley slight jerking started the bombs moving backwards. (photographs 9 and 10). As the centre of gravity of the bombs moved back this tendency increased until the bombs slipped from the cradle and came to rest on the framework of the trolley (photograph 11). The bombs came to rest in one of two ways. In both cases one bomb was resting with the base on the towing hook, the nose on the back upright of the cradle, and most of the weight being taken by the frame. The other bomb would fall either outside the rear wheel (photograph 12) or on the tyre of the rear wheel (photograph 13). If it fell outside the rear wheel, the tail of the inside bomb dragged on the ground, the wheel pushed the outside bomb forward and the force exerted could break the carrier (photograph 14). If it fell on top of the rear wheel a stable condition was set up, the tyre rubbing on the bomb (photograph 15). In this position towing could proceed without noticeably affecting the ease of movement. In the trials at Marham it was found that the Mark 7 bombs normally fell in the latter manner. Converted Mark 2 bombs, owing to the remains of the welded lugs present, were more difficult to shake off and usually fell in the first manner.

10. Bombs on cradle of trolley showing beginning of backward movement

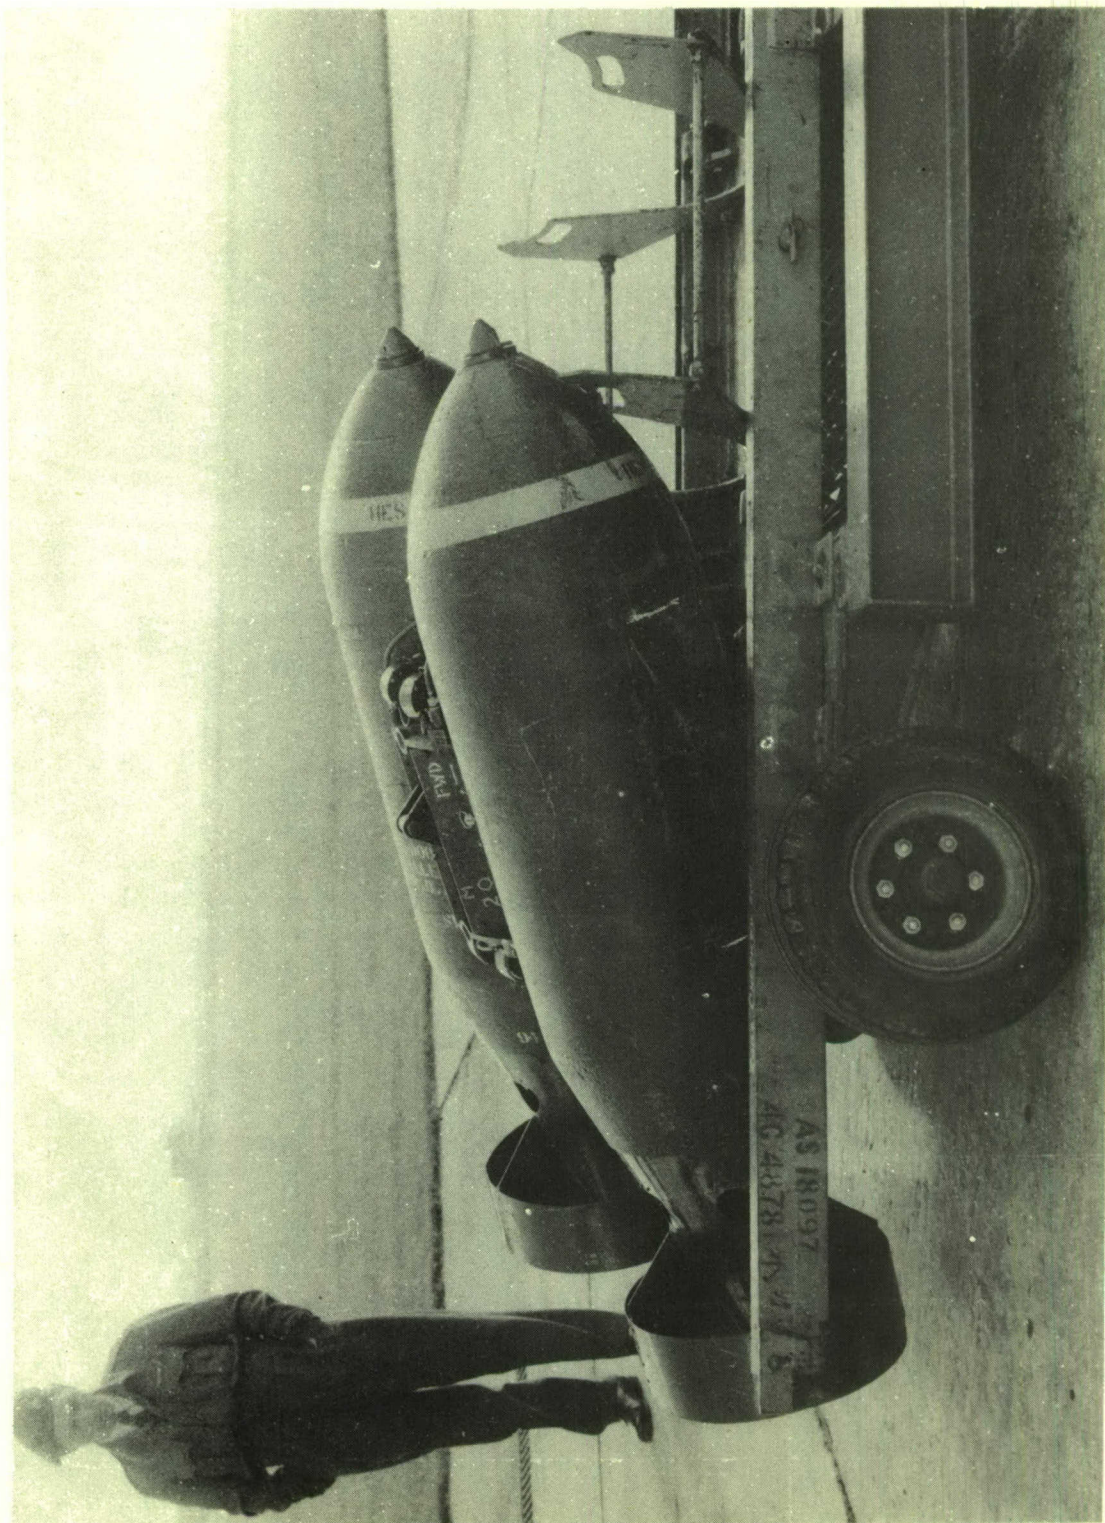
11. Bombs after falling off cradle of trolley

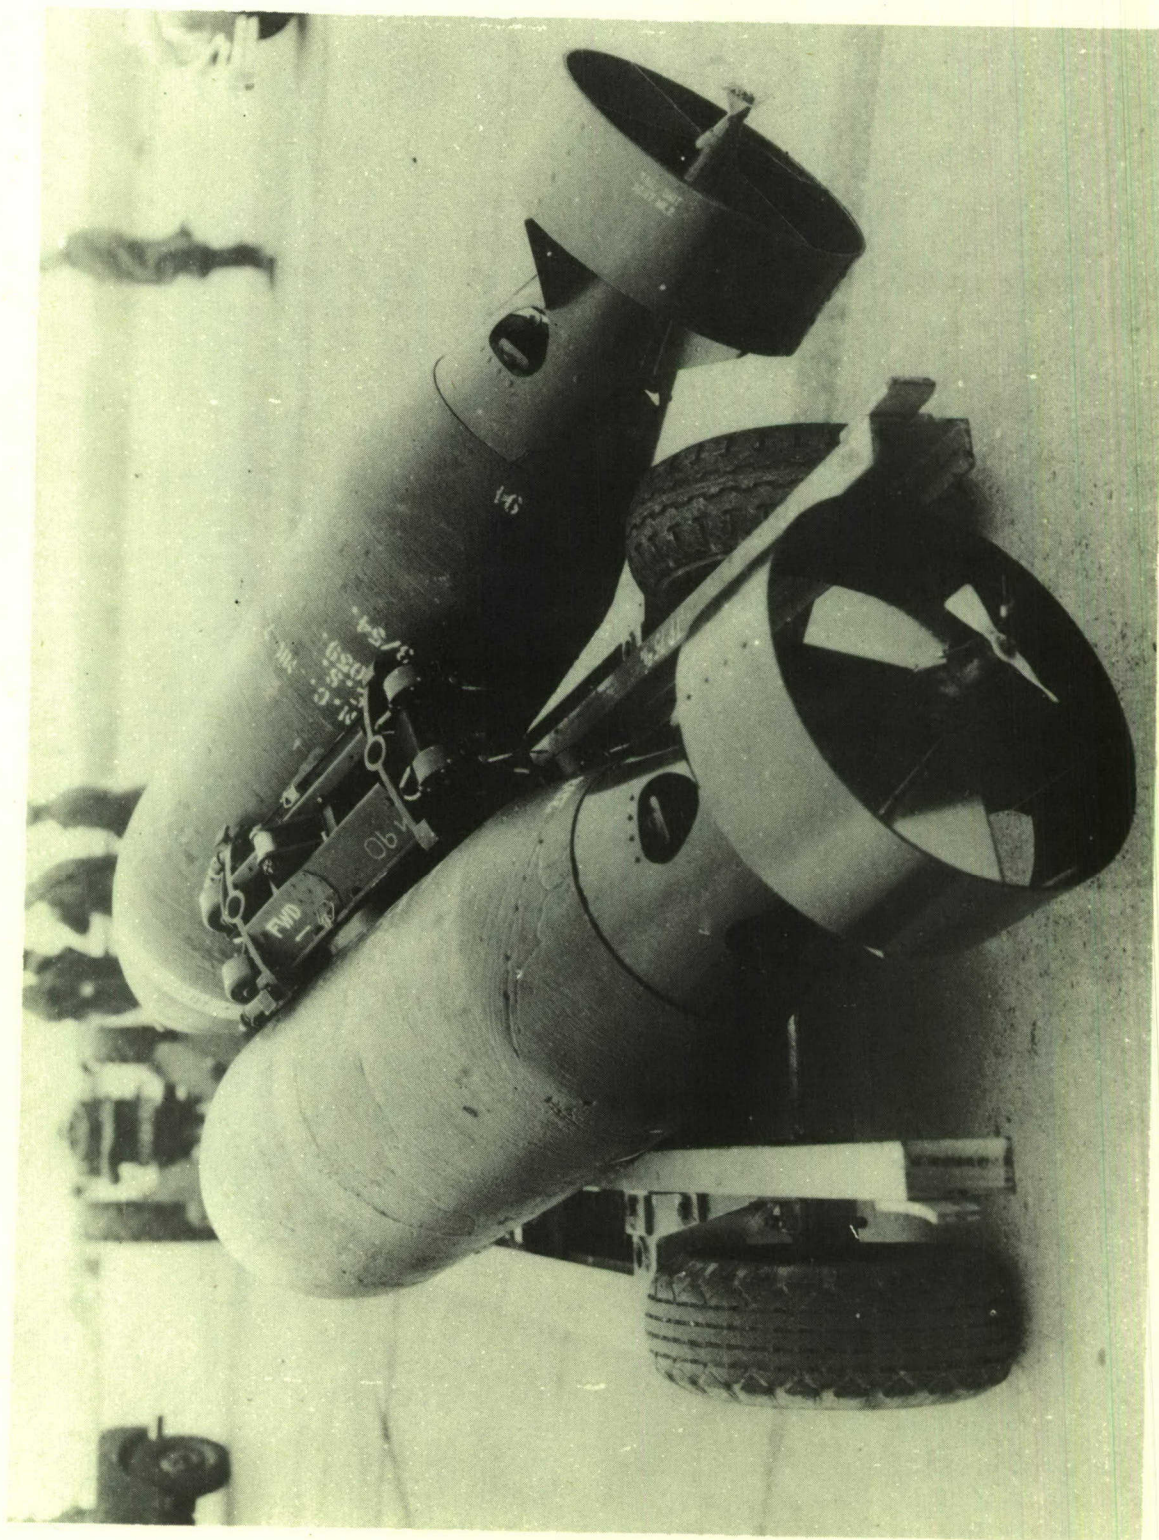
12. Bombs displaced into an unstable position

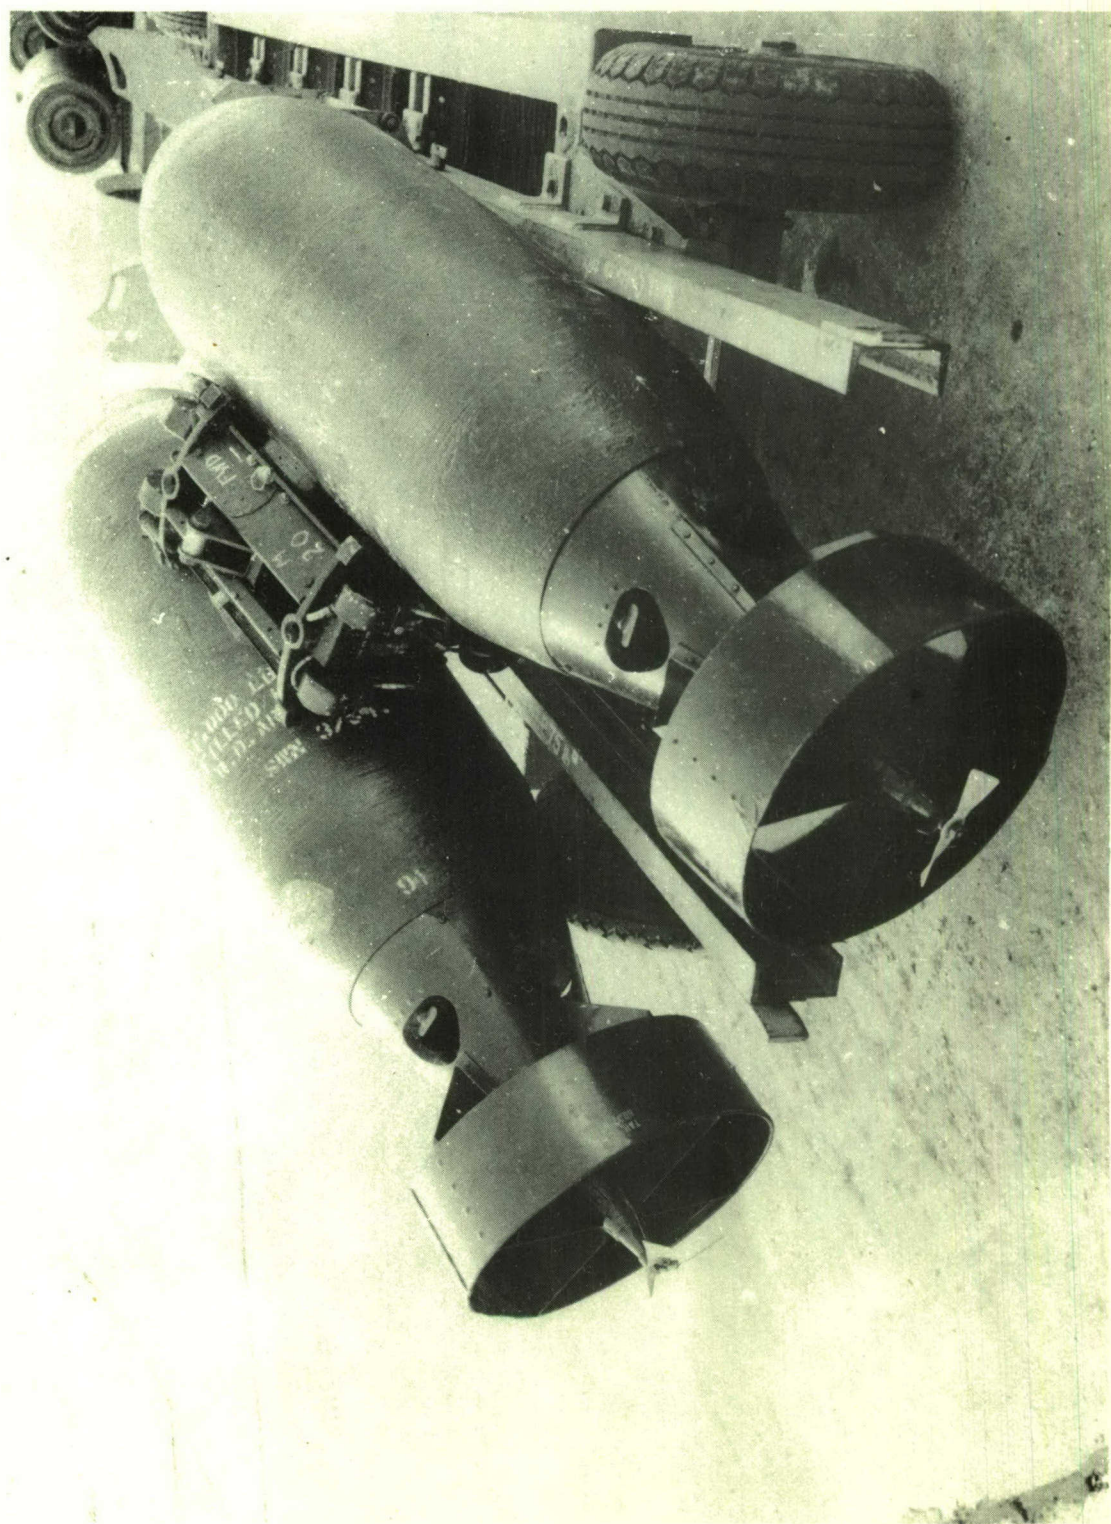
13. Bombs displaced into stable position. Port trolley
tyre rubbing on bomb

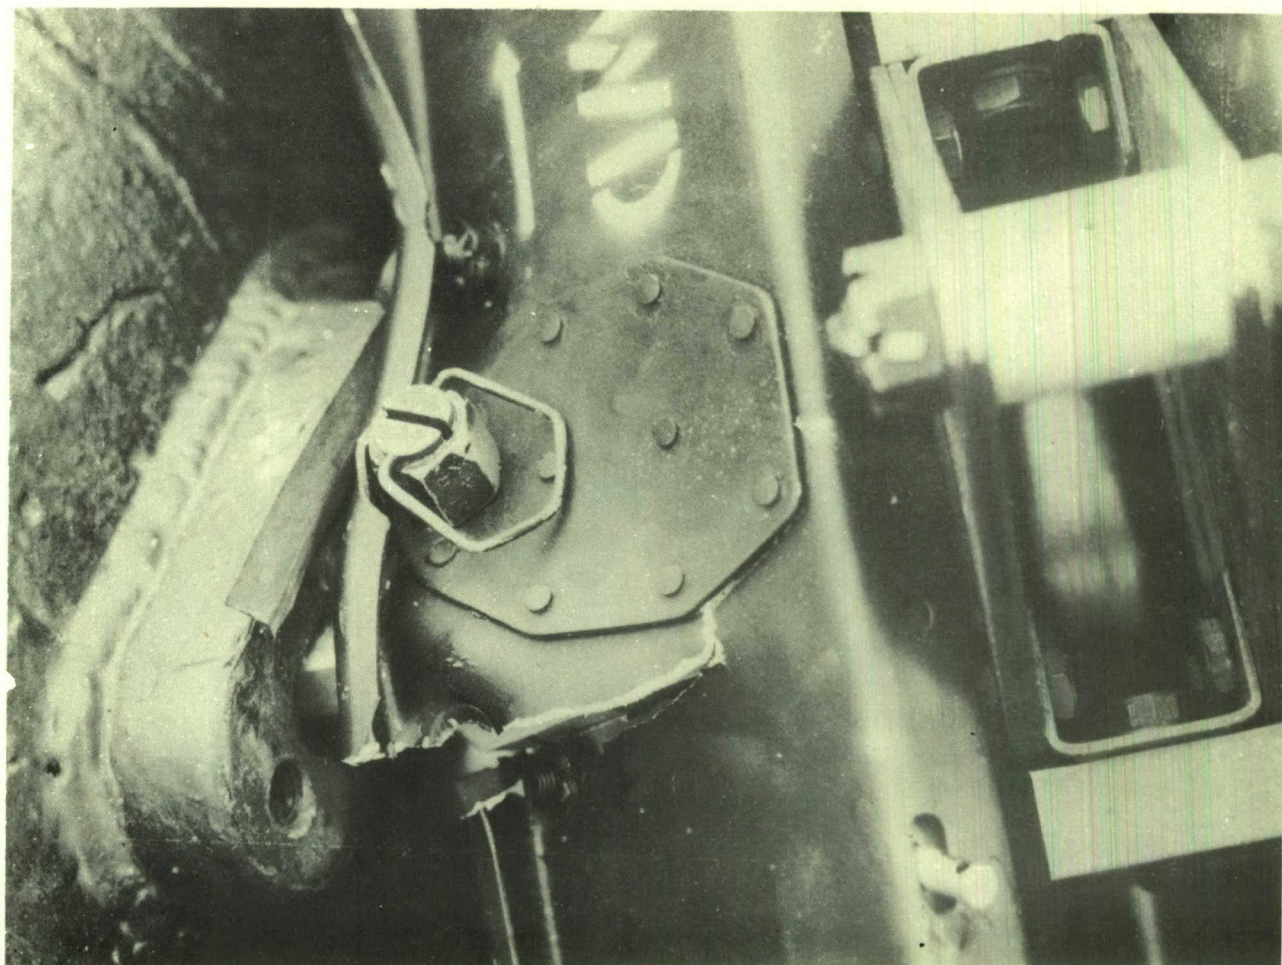
14. Broken carrier

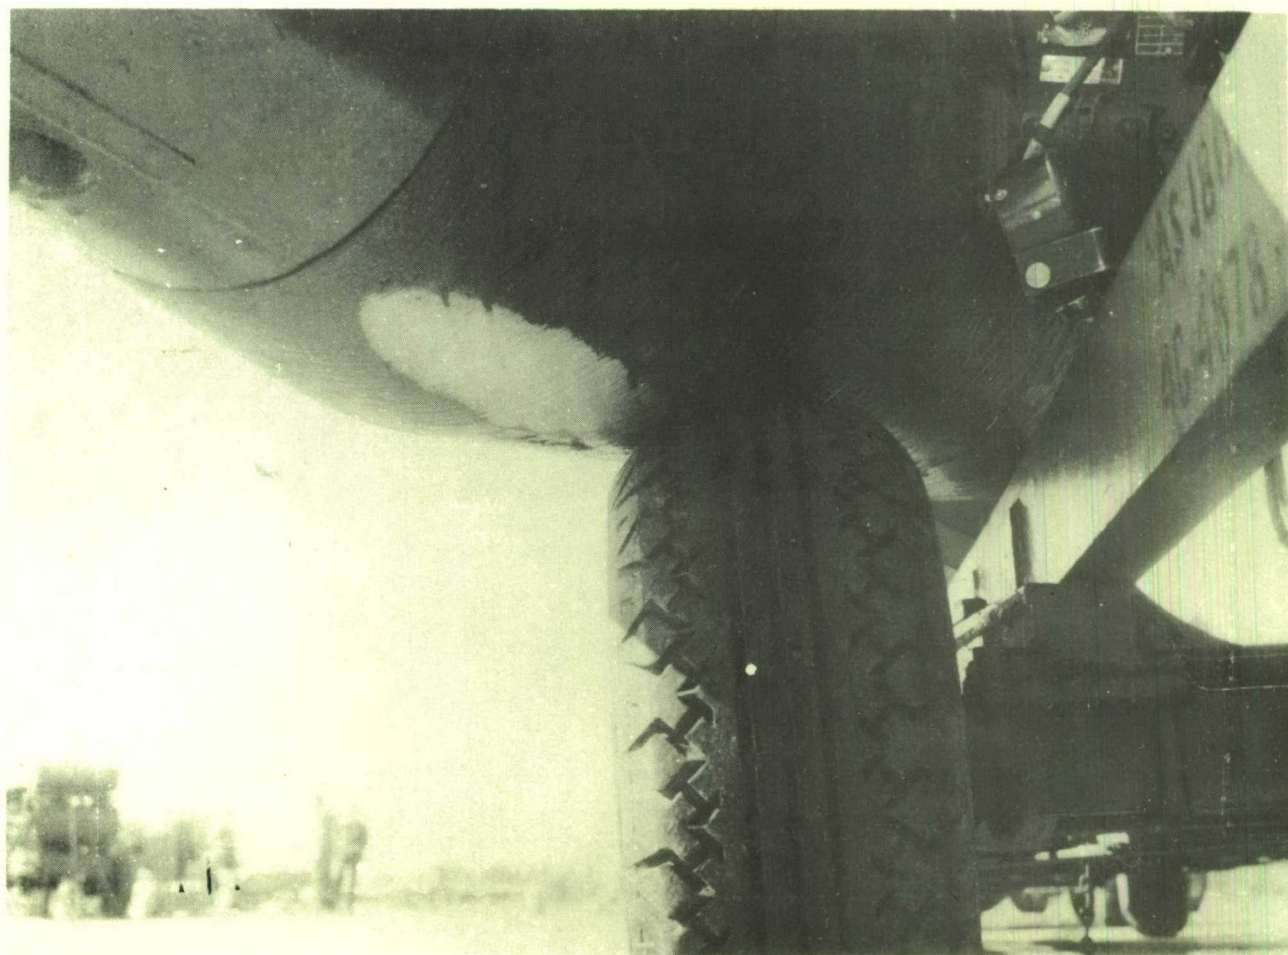
15. View after short run showing paint worn off bomb
by tyre

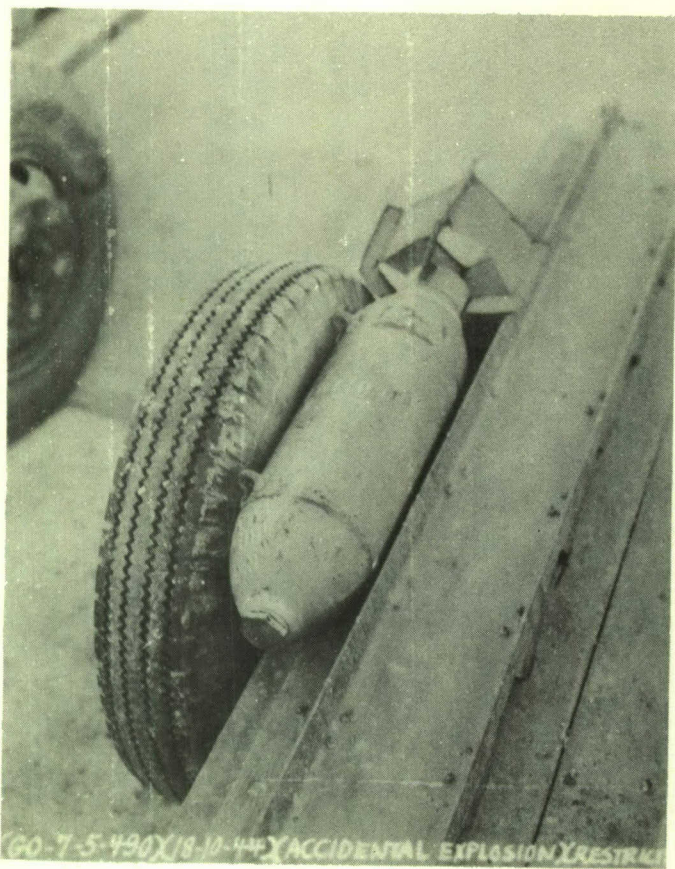
It was known from exploratory trials of a previous incident carried out at No.3 M.U. Milton, that appreciable local heating could be produced by the friction of a tyre on a bomb, and it was thought possible that this might be the cause of the explosion. The same suggestion had previously been made by the American Office of Ordnance and Armament to explain an explosion of a 100 lb. G.P. bomb filled T.N.T. at the U.S. 8th Air Force station (Eye) on 16th October 1945. There, a trailer was loaded with thirty-four 100 lb. G.P. bombs, unfuzed, and towed about 850 yards until, on entering the runway, one bomb exploded. It was thought that in going out of the bomb revetment the right rear wheel of the trailer hit a bump, causing the bomb nearest to it to shift and rest against the tyre. The explosion was of a very low order, no damage being done to the trailer bed, and no other bombs on the trailer being moved. The tyre was destroyed and the rear wheel of the trailer bent. The tail exploder container assembly from the bomb was blown 100 feet across the perimeter track, and the bomb itself split open but remained in one piece. The damage is shown in photographs 16 -21.

16. Reconstruction of explosion with American bomb

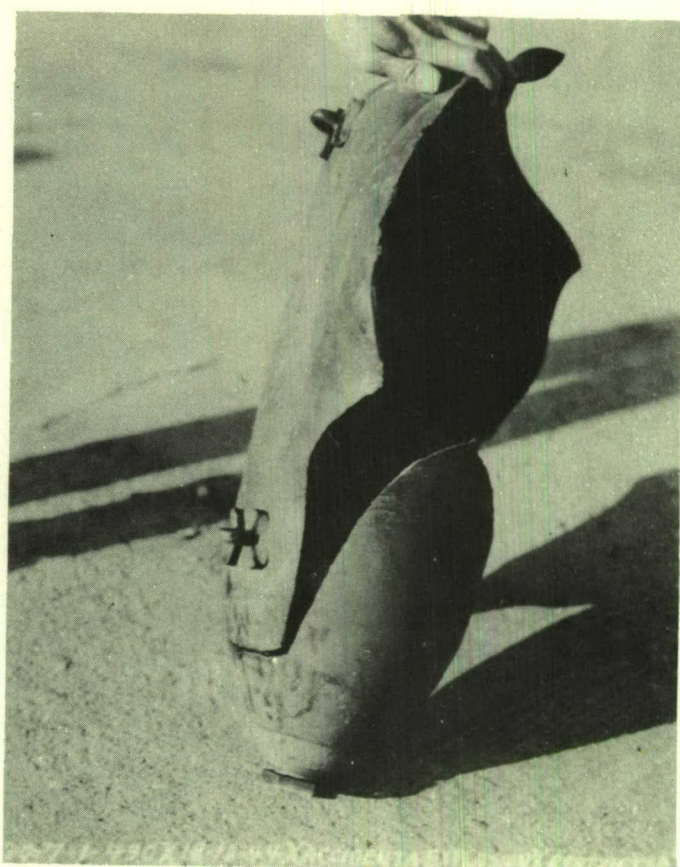
17. Result of explosion with American bomb

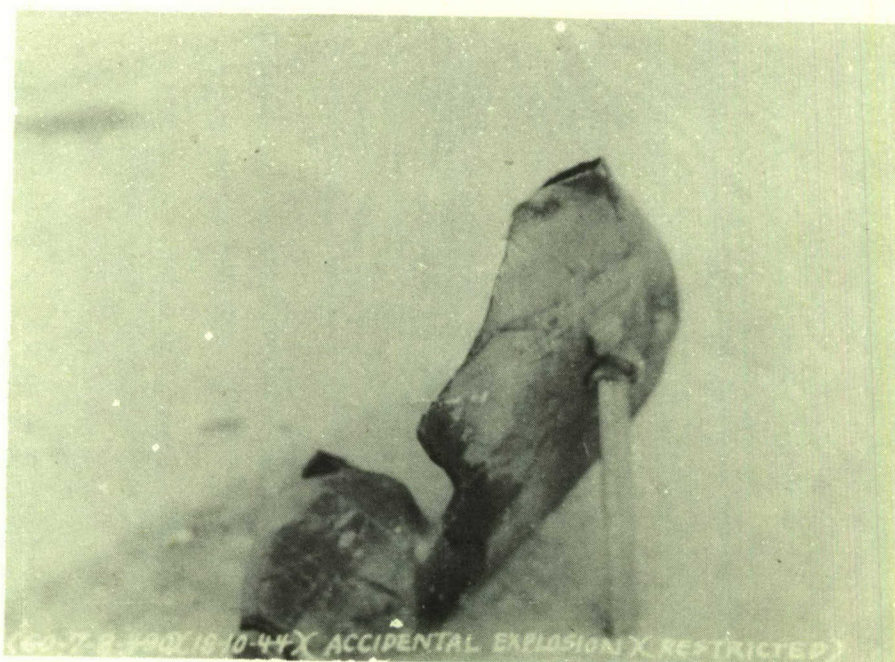
18. Result of explosion with American bomb
