ARMAMENT RESEARCH AND DEVELOPMENT
ESTABLISHMENT

A.R.D.E. REPORT (S) 26/55

Investigation of Accidental Explosion of 1000 lb.
Bomb at R.A.F. Station Marham

D.E. Jarrett (S.2)

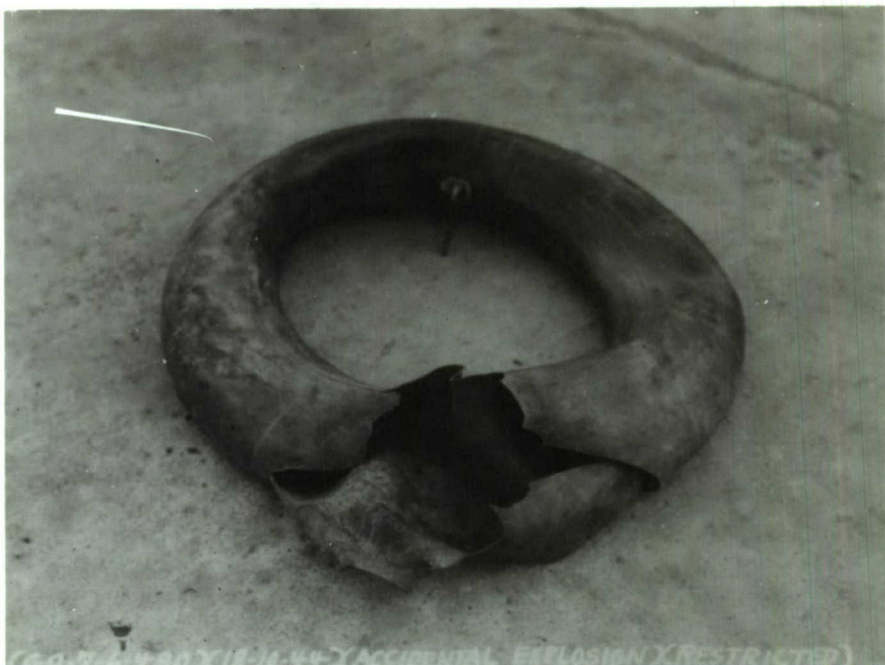
It was known from exploratory trials of a previous incident carried out at No.3 M.U. Milton, that appreciable local heating could be produced by the friction of a tyre on a bomb, and it was thought possible that this might be the cause of the explosion. The same suggestion had previously been made by the American Office of Ordnance and Armament to explain an explosion of a 100 lb. G.P. bomb filled T.N.T. at the U.S. 8th Air Force station (Eye) on 16th October 1945. There, a trailer was loaded with thirty-four 100 lb. G.P. bombs, unfuzed, and towed about 850 yards until, on entering the runway, one bomb exploded. It was thought that in going out of the bomb revetment the right rear wheel of the trailer hit a bump, causing the bomb nearest to it to shift and rest against the tyre. The explosion was of a very low order, no damage being done to the trailer bed, and no other bombs on the trailer being moved. The tyre was destroyed and the rear wheel of the trailer bent. The tail exploder container assembly from the bomb was blown 100 feet across the perimeter track, and the bomb itself split open but remained in one piece. The damage is shown in photographs 16 -21.

19. Inner tube of trailer tyre after explosion with American bomb

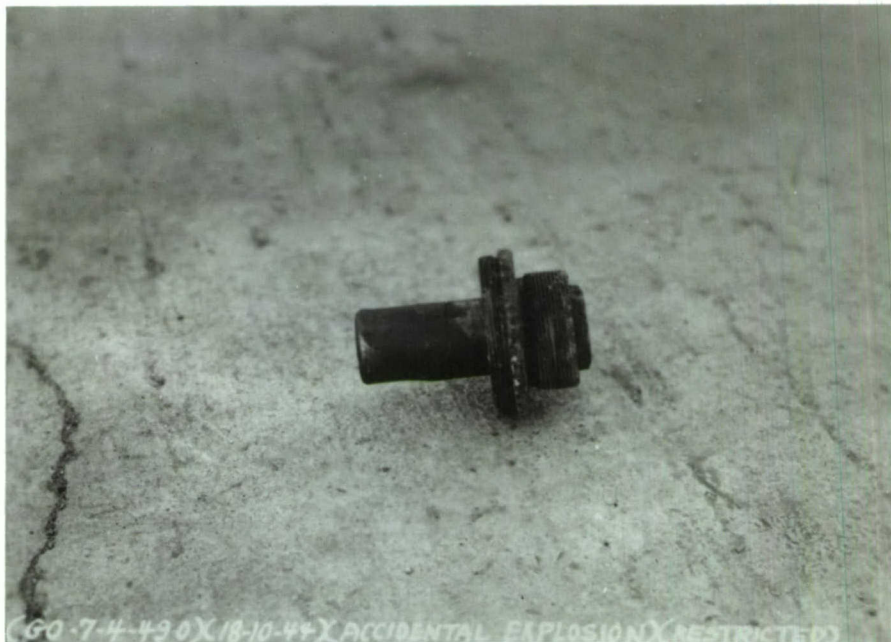
20. Exploder assembly after explosion of American bomb

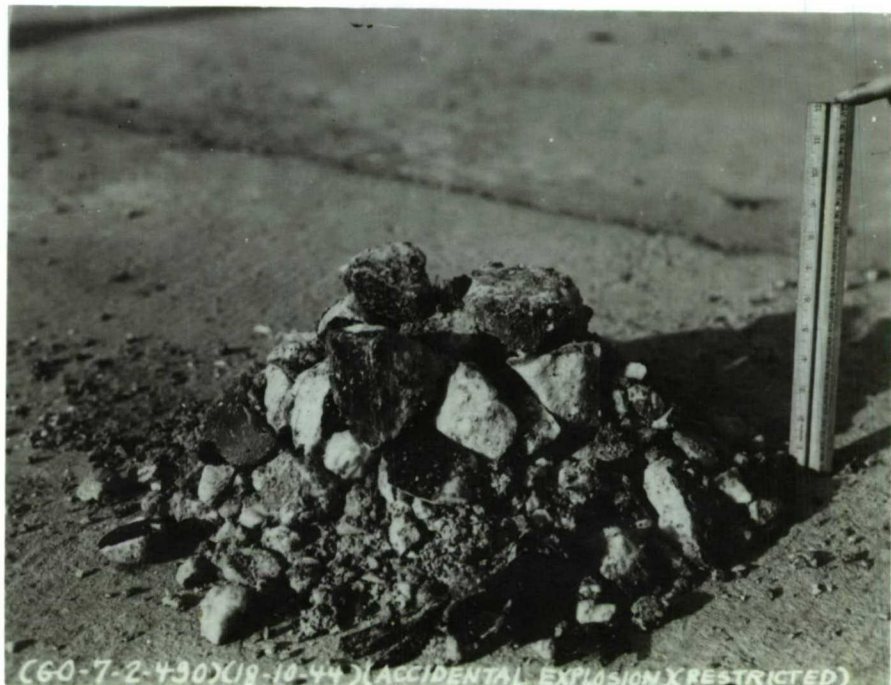
21. Filling from exploded American bomb
