# ROHM & HAAS COMPANY

REDSTONE ARSENAL RESEARCH DIVISION

Report of Fatal Explosion - March 28, 1958

CONTRACT NO. DA 01-021-ORD5135

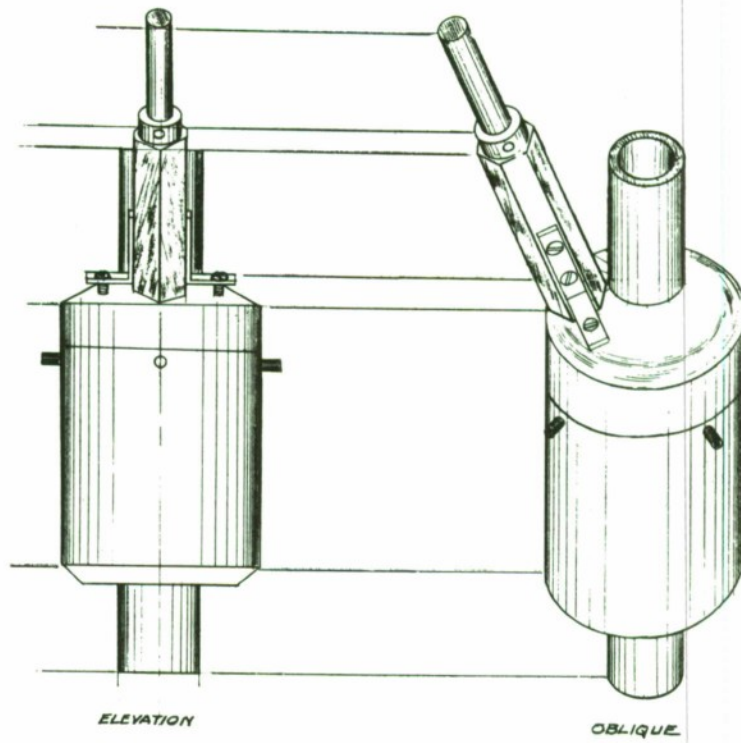
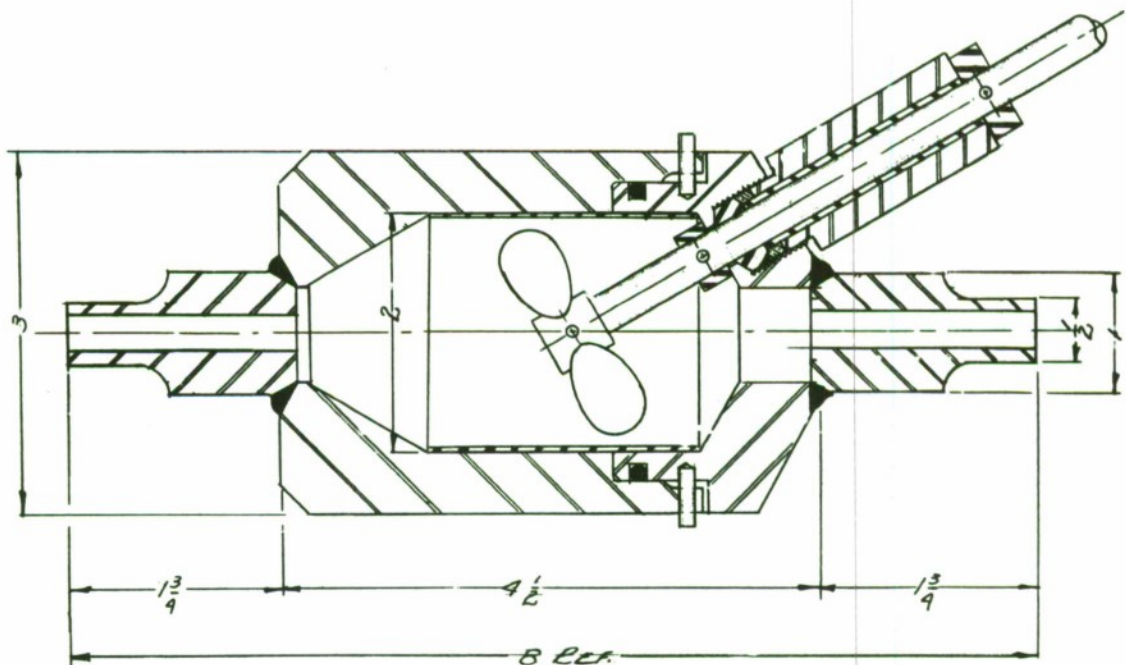
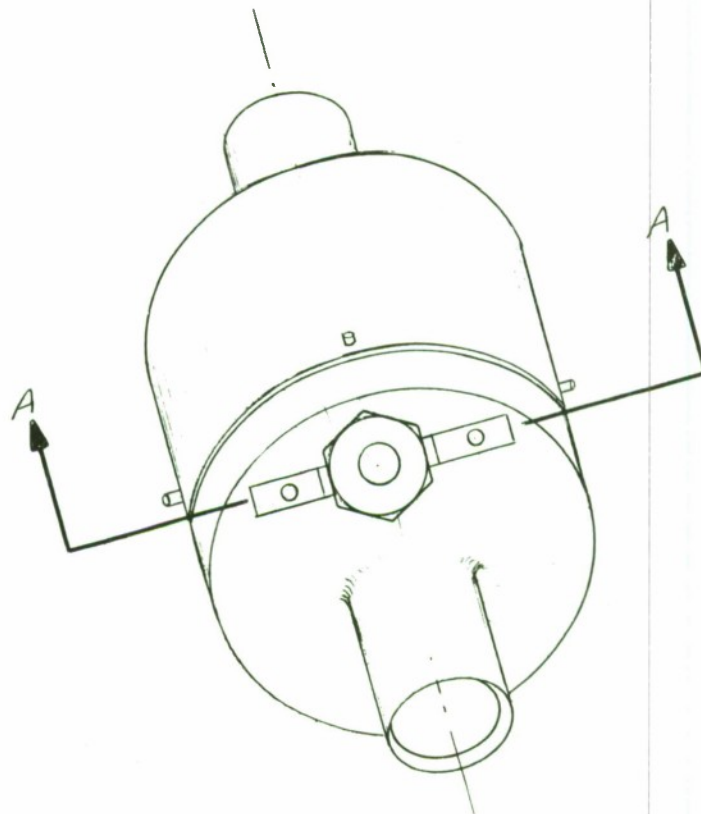
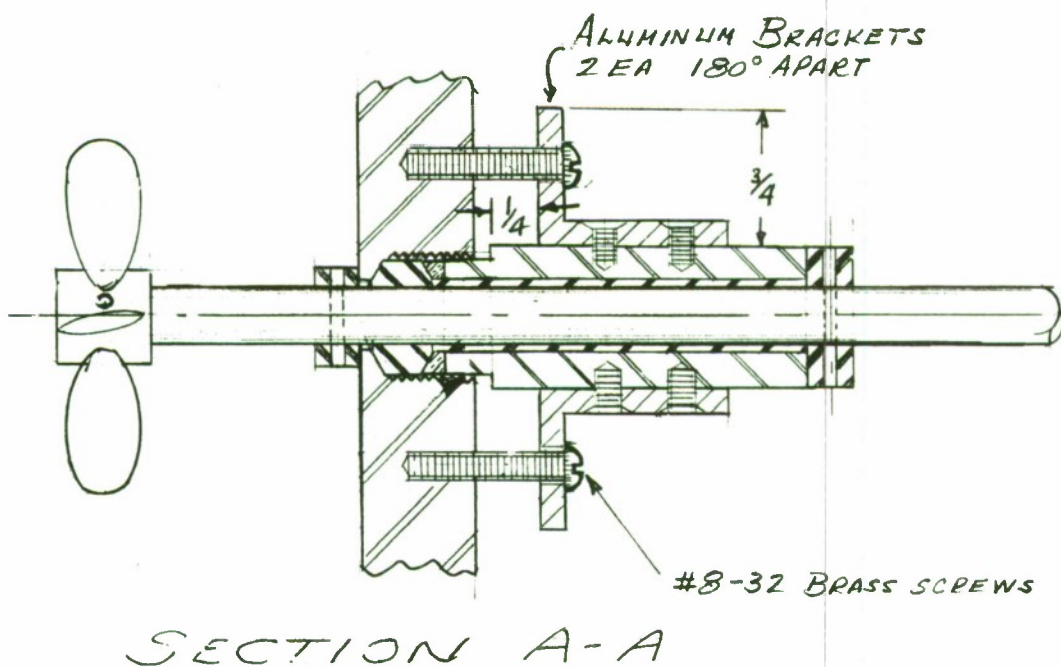
2. The explosion appears to have been caused by inadequate design of the propeller shaft packing system of the in-line mixer which permitted metal-to-metal contact or pinching of propellant between the shaft and the mixer head.

The in-line mixer (Figs. 4 - 7) was a cylindrical metal vessel having an inside diameter of 2 inches, length of approximately 4 inches, and a volume of approximately 10 cubic inches. The mixer was closed with an end cap held in position by two shear pins, and nipples were welded to each end to allow attachment of the hose. An impeller shaft was set into the head-end at approximately a 30° angle, and Teflon packings were used to prevent metal-to-metal contact. The impeller and shaft were made of stainless steel, and the interior of the mixer was lined with a Teflon sleeve to prevent metal-to-metal contact between the mixer and the impeller if the impeller shaft should become malaligned. In the original design of the in-line mixer the packing around the impeller shaft was tightened by screwing the gland into threads in the mixer head. However, an overheating had been noted at one time and there was also the possibility that propellant could enter the threads. Therefore, for safety, the male threads were cut off and two brackets attached by small screws to opposite sides of the hexagonal outer surface of the gland. One brass screw was inserted in the protruding part of each bracket and the gland tightened by screwing into blind threaded holes in the mixer head.

Fig. 4 External views of modified in-line mixer.

Fig. 5 Cross-section of modified in-line mixer.

Fig. 6 Oblique view of modified in-line mixer.

Fig. 7 Shaft cross-section of modified in-line mixer.

1. Redesign of processing equipment to eliminate all possibilities for frictional or metal-to-metal contact in the direct presence of propellant.

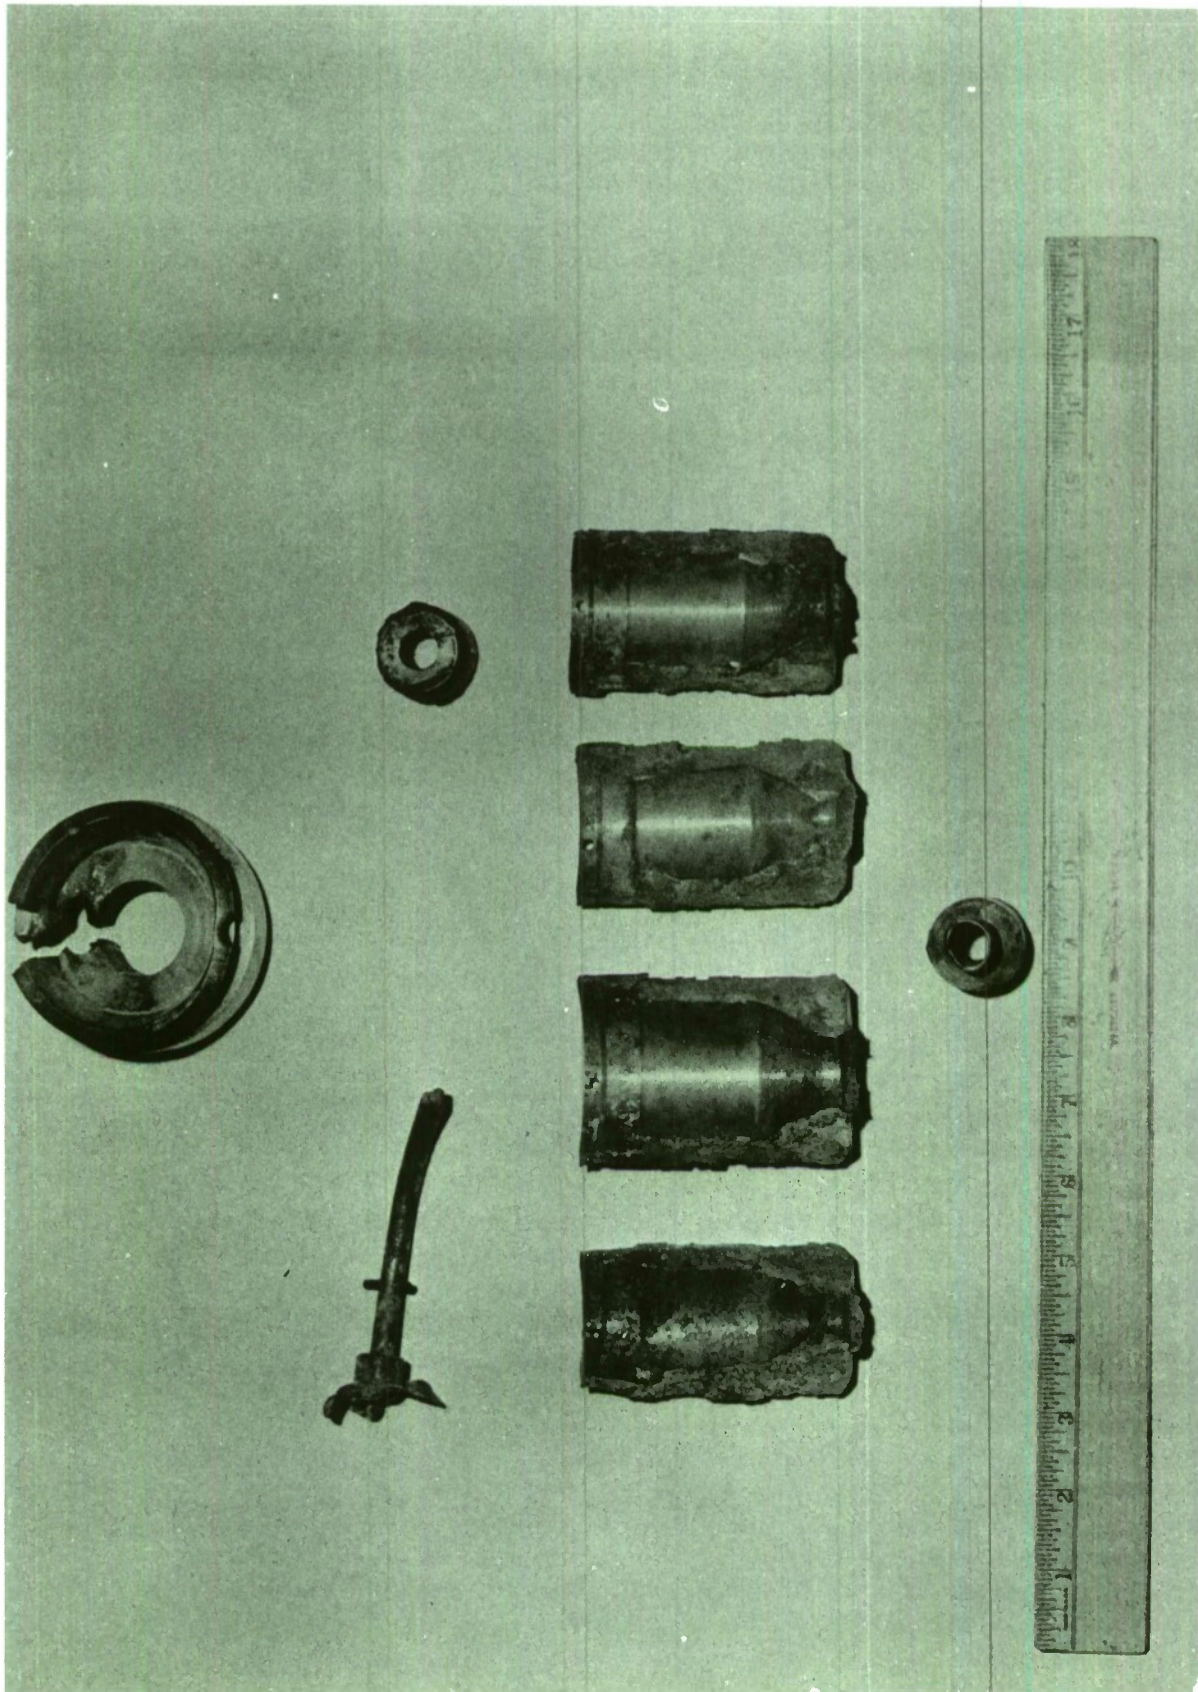
The explosion apparently started in the in-line mixer and blew this into five large pieces (Figs. 8 & 9), one of them consisting of the upstream mixer head and the other four almost symmetrical longitudinal fragments of the downstream mixer body. A loud report and bright flash with a spray of burning propellant occurred almost simultaneously. Flying fragments of this mixer and neighboring parts (Fig. 10), such as a hose clamp apparently from one end of the mixer, caused fatal wounds to Corder, while Meinert was cut by a fragment but suffered mainly from flash burns from the spraying propellant.

Fig. 9 Pieces of in-line mixer body recovered after the explosion.

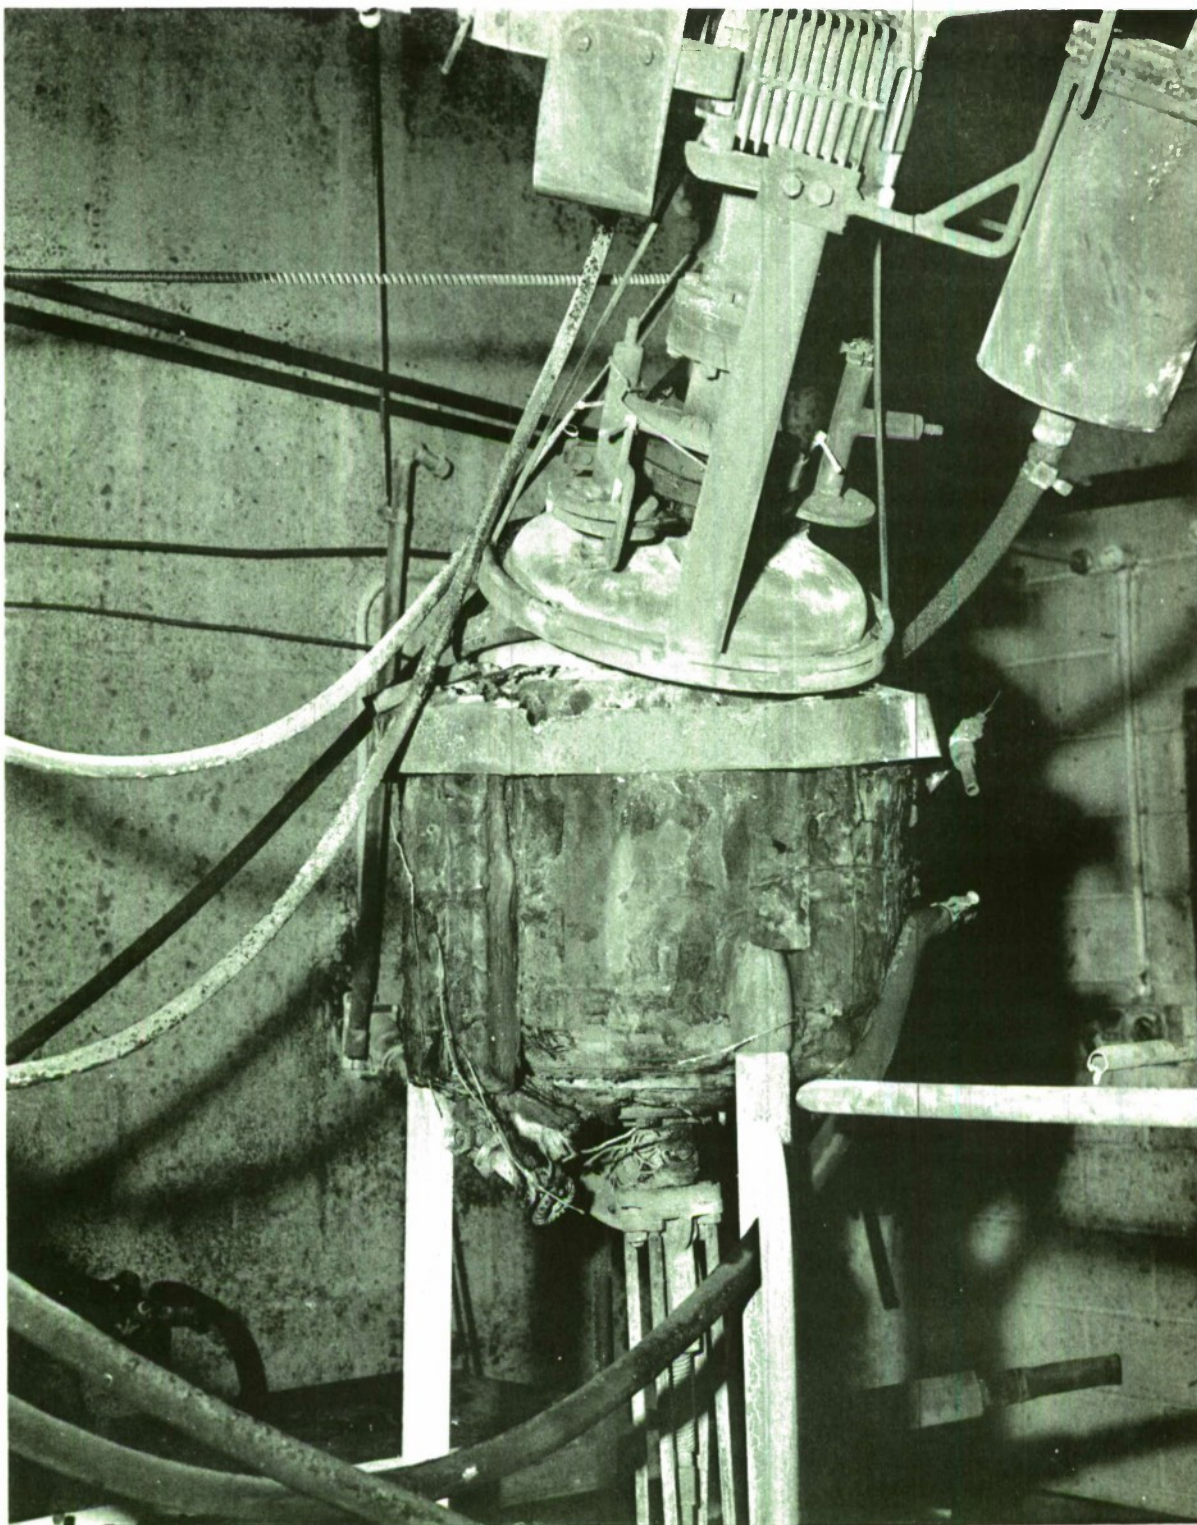
sharp boom was heard, most likely from the release of the top of the 10-gallon kettle into which the flame probably propagated from the bottom outlet. This vessel, though lidded, was vented; the pressure buildup caused the lid to break its few fastenings and rise but the lid with its agitator and drive stayed on top of the kettle (Fig. 11) while the room filled with flame and smoke from this kettle and from propellant sprayed out the top of it.

Fig. II Mixer kettle after explosion.

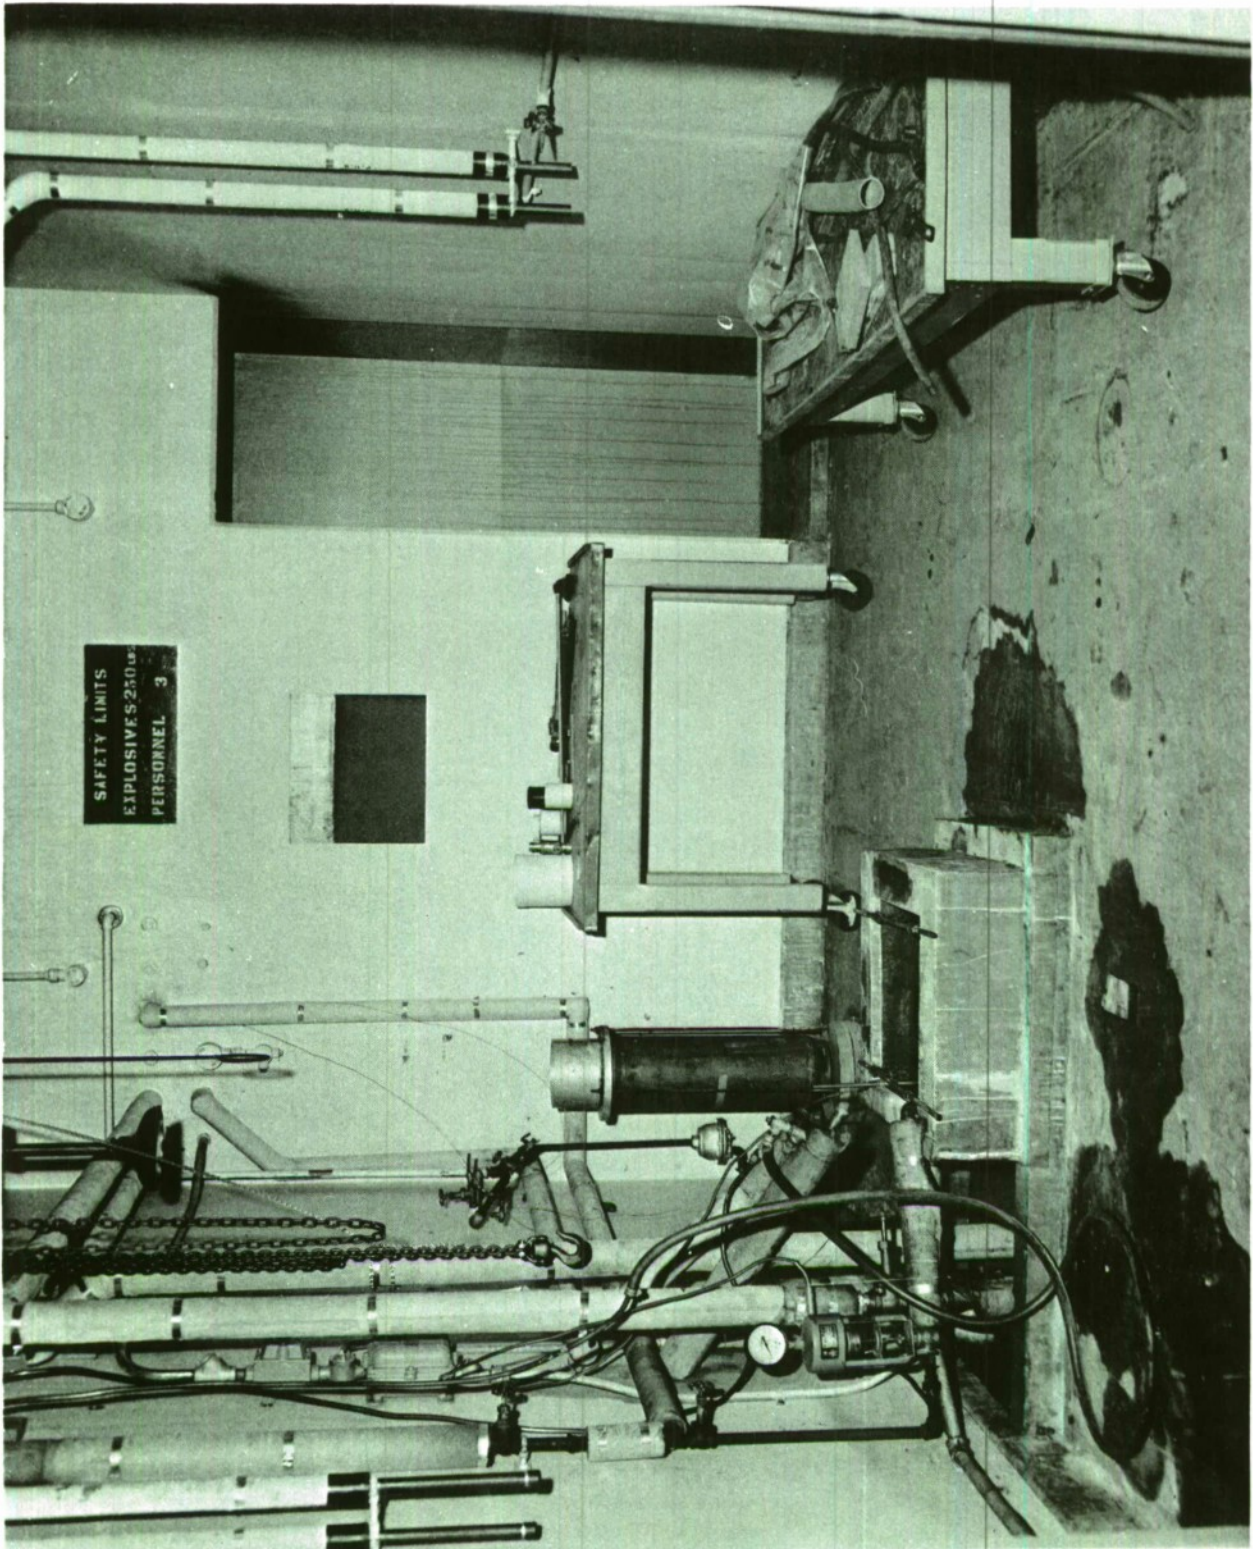
One or more lighter blows were heard later by some observers, perhaps from the vacuum trap on the kettle or other sources. The hoses on either side of the pump burned, but neither the hose through the wall nor the section in the pump ignited. The pump happened to be in a condition where the fingers had both ends of the hose in it sealed off. No part of the blast or fire propagated to the casting pit (motor) bay (Fig. 13) or to the control area in the west corridor (Fig. 14).

Fig. 13 Casting pit bay following explosion in adjacent bay.

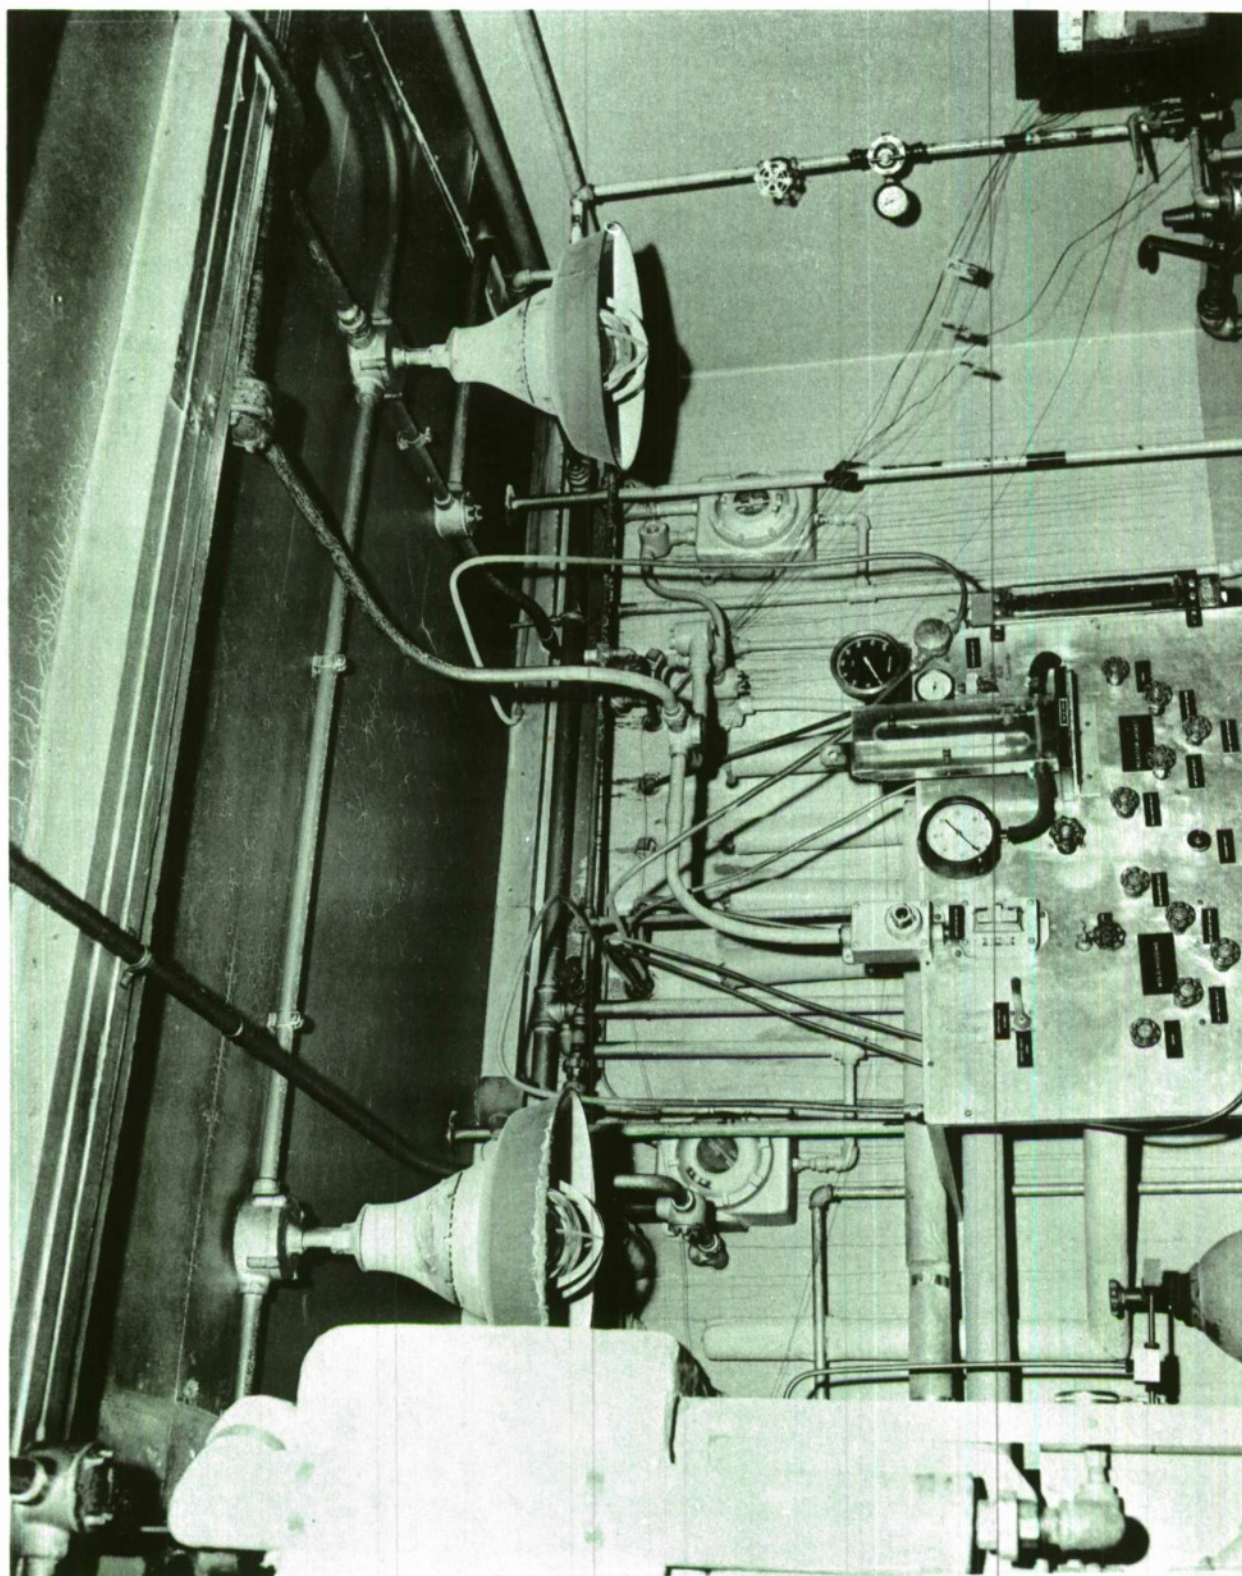
Fig. 14 Control area in west corridor following the explosion. Blackened area near ceiling was caused by smoke.
