WATERTOWN ARSENAL LABORATORY

NO. WAL 710-583-1

Metallurgical Examination of 2 1/2" Rolled Homogeneous Armor Plate
Manufactured by H. Disston and Sons, Inc.
Which Backspalled under the PTP Test

DATE 18 April 1944

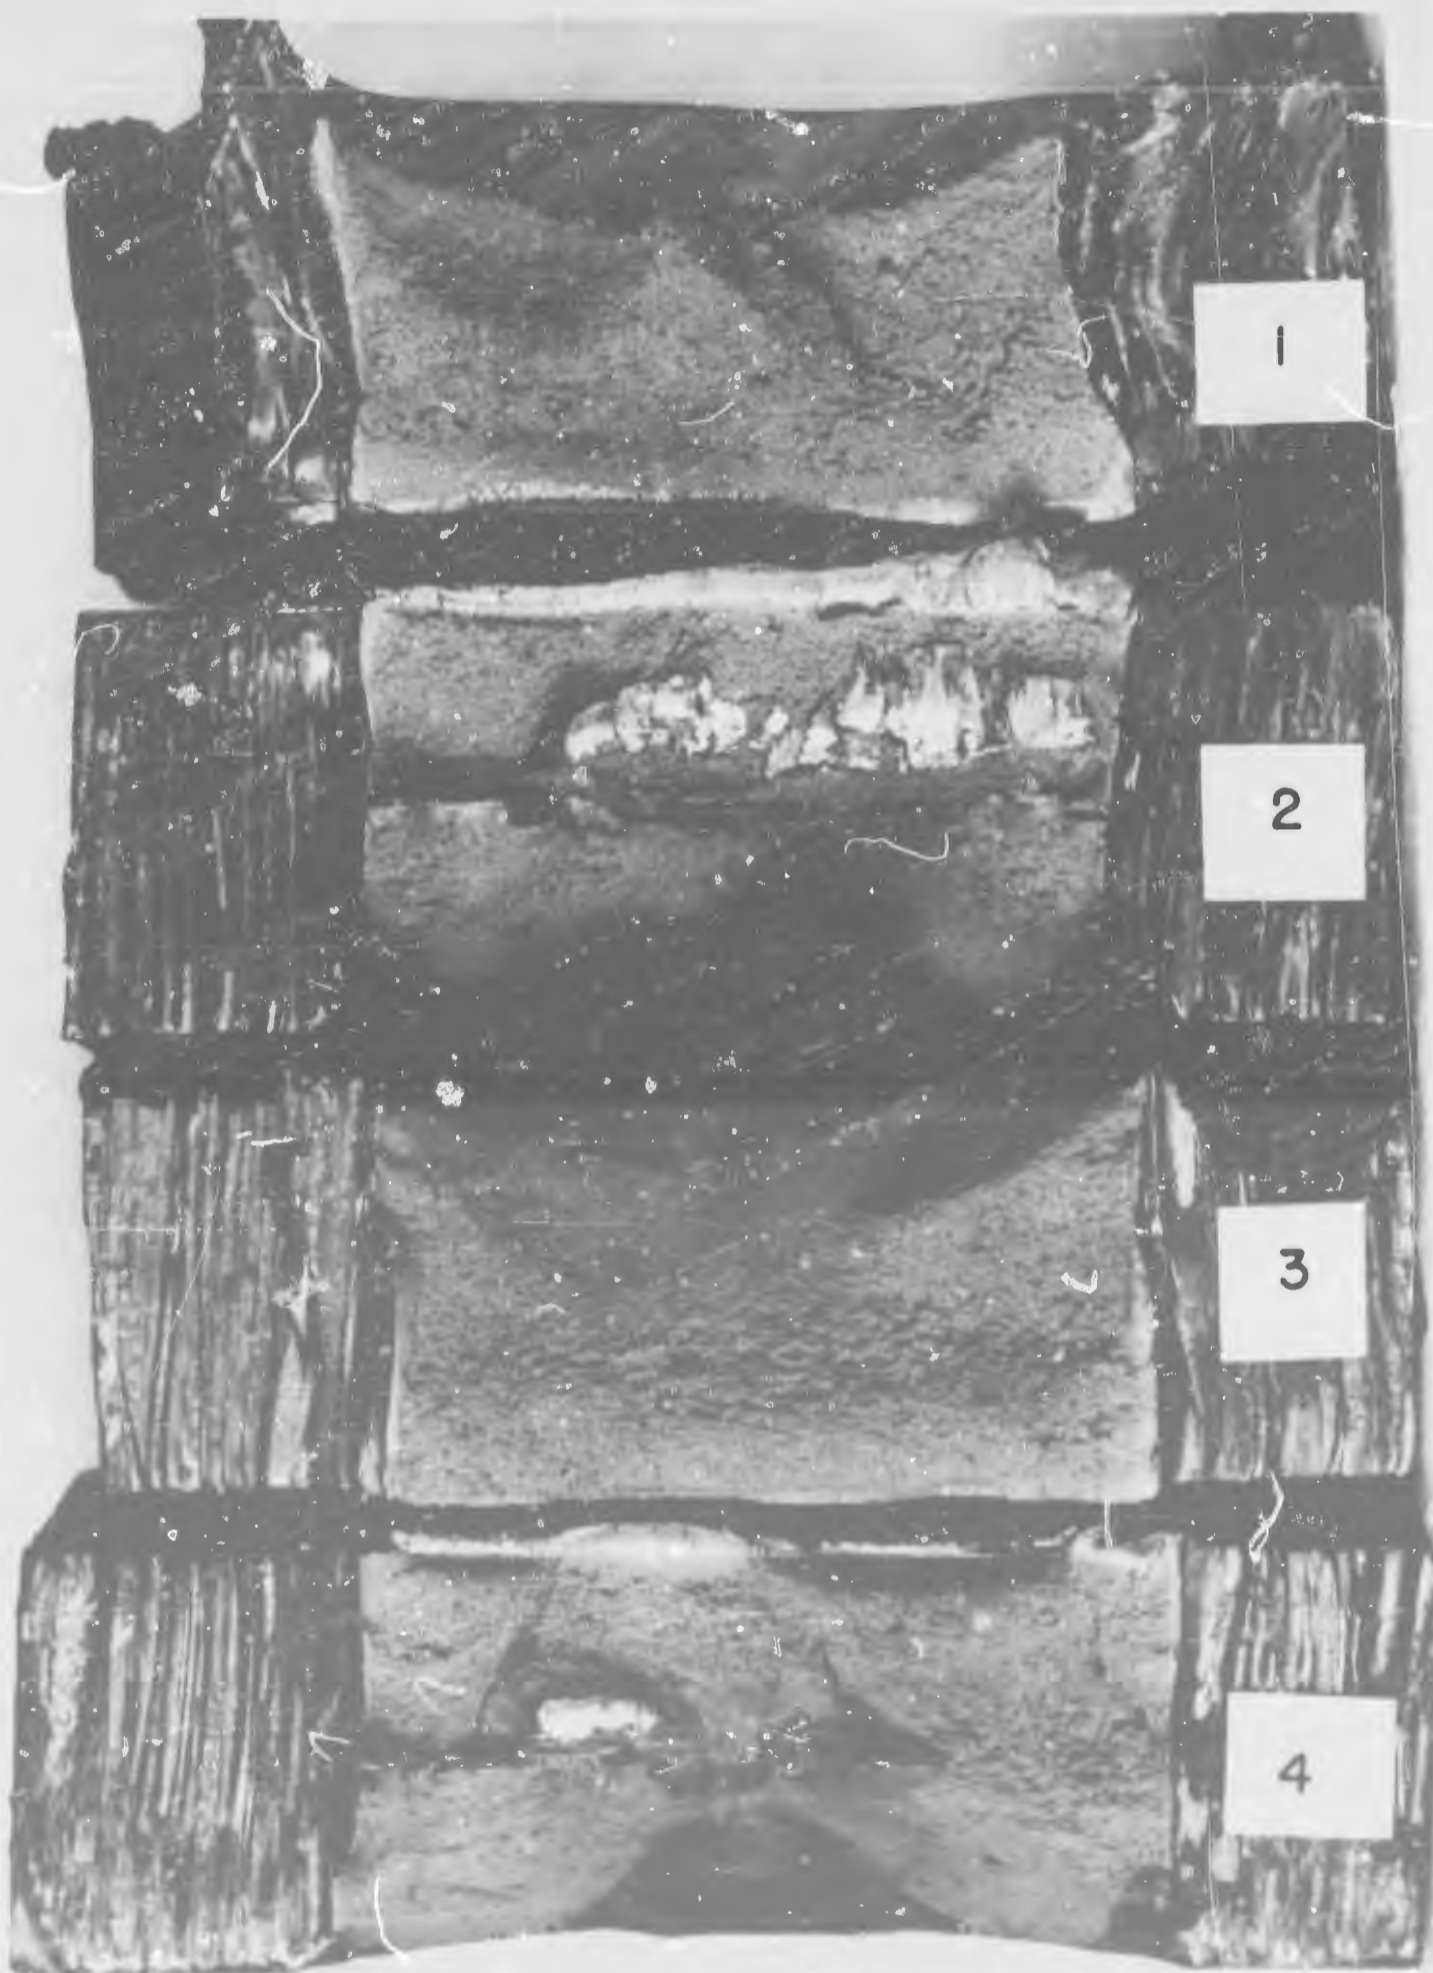
FIGURE 2

Blocks #1 and #3 have B quality fractures which resemble that of the originally submitted corner section. Blocks #2 and #4 have D quality fractures, #2 containing one long discontinuous lamination over the entire length of the fracture and #4 showing a similar lamination over 75% of its length. The smear shown on fracture #2, Figure 2, resulted from the contact of this projecting shelf with the lower projecting shelf of the opposing face during fracture. In both fractures #2 and #4, one half of the fractured surface projected approximately one inch above the other half, with the lamination occurring at the boundary. Examination of the backspalled regions on the plate show that the spalls coincide with the laminations revealed on the fractures.

In view of the fact that a D quality fracture which consists of one lamination extending over a major portion or the entire length of the fractured surface can be responsible for excessive backspalling leading to ballistic failure, it is believed that such fractures should be considered rejectable in gages from 1-1/4" to 4" in thickness. According to the present specification requirements, at least three such laminations must exist before the plate is considered rejectable, even though but one plane of weakness is sufficient to cause backspalling.

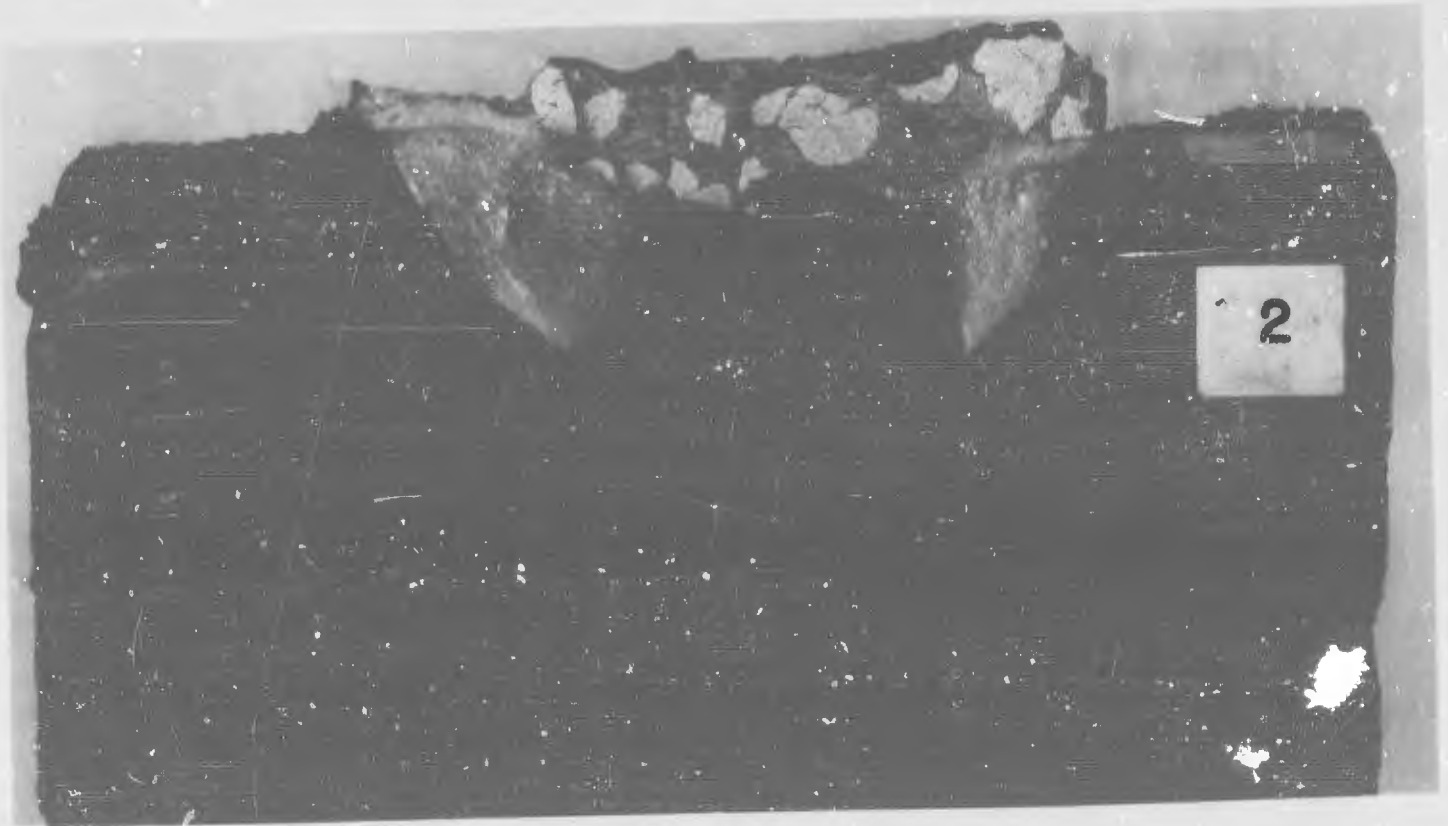
"FISH - EYES" ON PLANE OF LAMINATION

f. The "fish-eye" condition observed in the backspalled region of round #2 is also evident on the fracture test for steel quality and is believed to represent discontinuous films of oxides present in the piped region.

When fracture #2 is turned up 90 degrees, so that one looks down upon the flat plateau between the projecting and depressed portions of the fractured surface, the same "fish-eye" condition is observed that was noted on the backspalled surface of round #2, compare the upper photograph of Figure 3 to the lower one of Figure 1. Thus a definite correlation between the backspall and the lamination is established. The nature of the "fish-eyes" will be considered later.

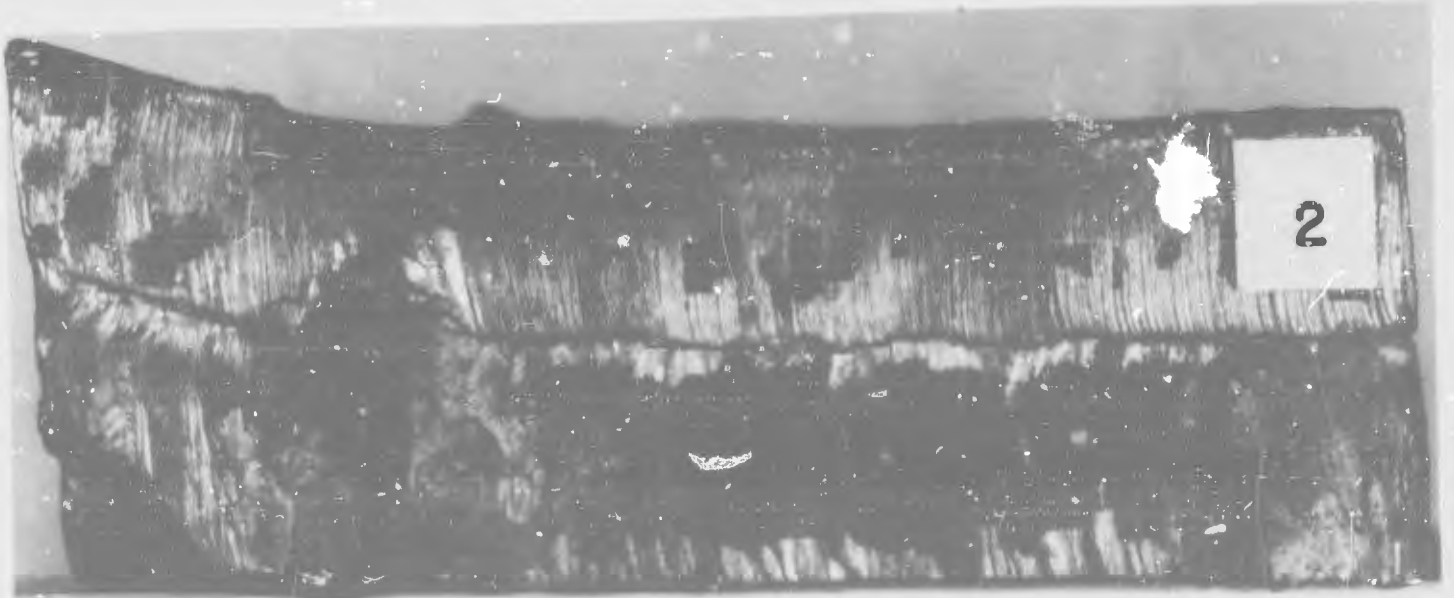
LAMINATION REVEALED ON FLAME CUT EDGE - DISSTON 4529-1

The lamination is also revealed on the flame-cut edges of some of the fracture blocks, note the lower photograph of Figure 3.

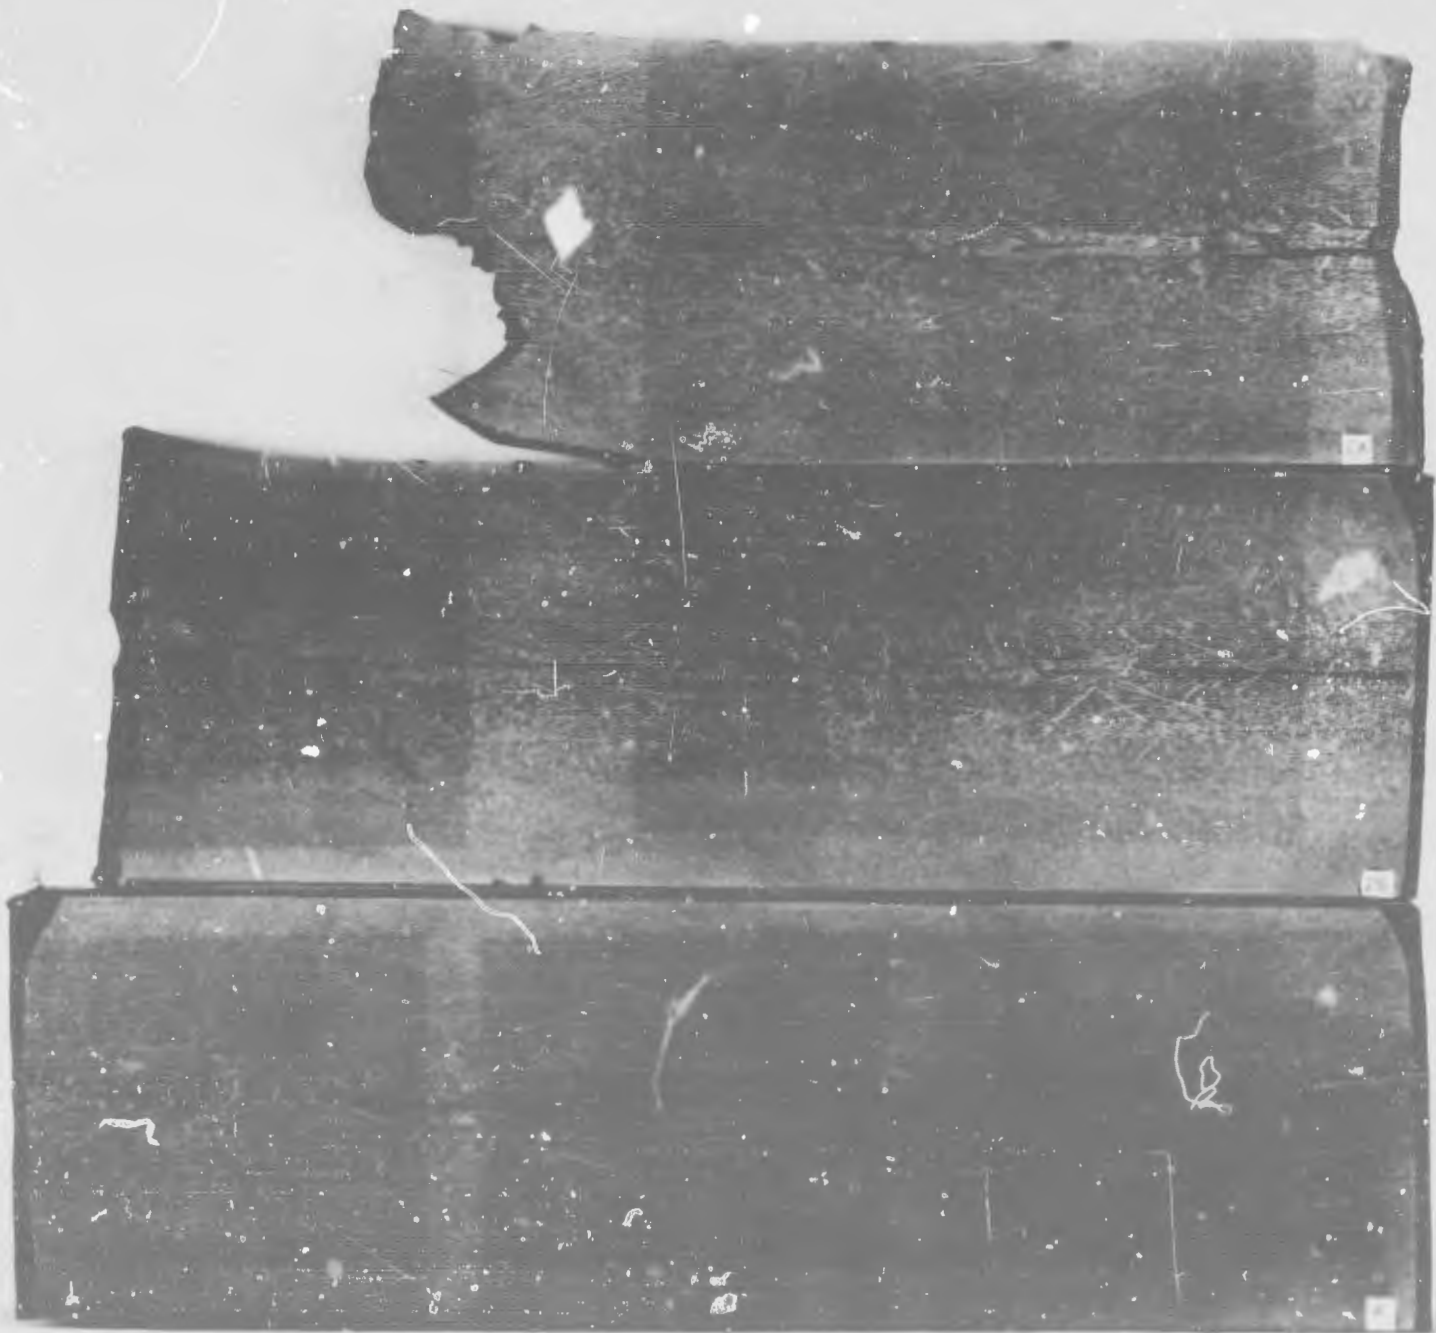
FIGURE 4

The sections were etched in a hot 50% hydrochloric acid solution. Photographs of the etched surfaces are shown in Figure 4. The lamination is revealed as discontinuous cracks confined to a 1/4" wide zone at the middle of the plate. The upper photograph of Figure 4 contains a profile of the fractured surface, illustrating the projecting of one portion of the fracture above the other with a sharp break at the plane of the lamination. The left hand portion of macroetched section #4 coincides with the left hand portion of the fracture shown in Figure 2 and represents the transition from the laminated portion to the region free of laminations.

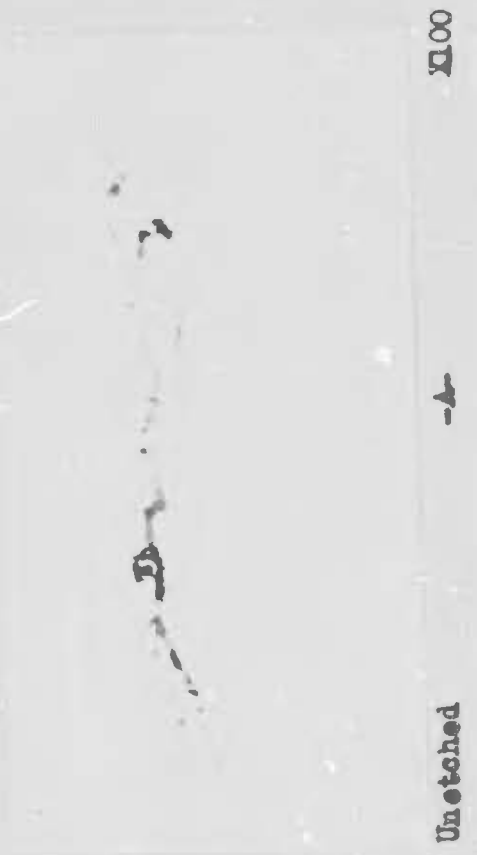
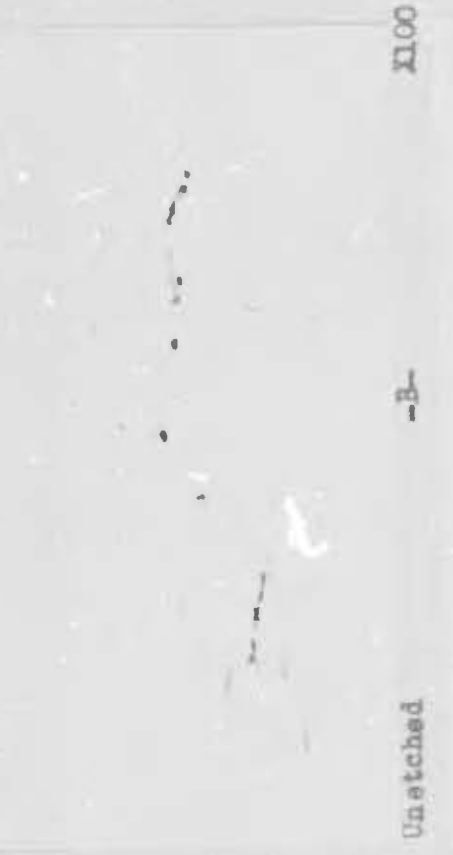
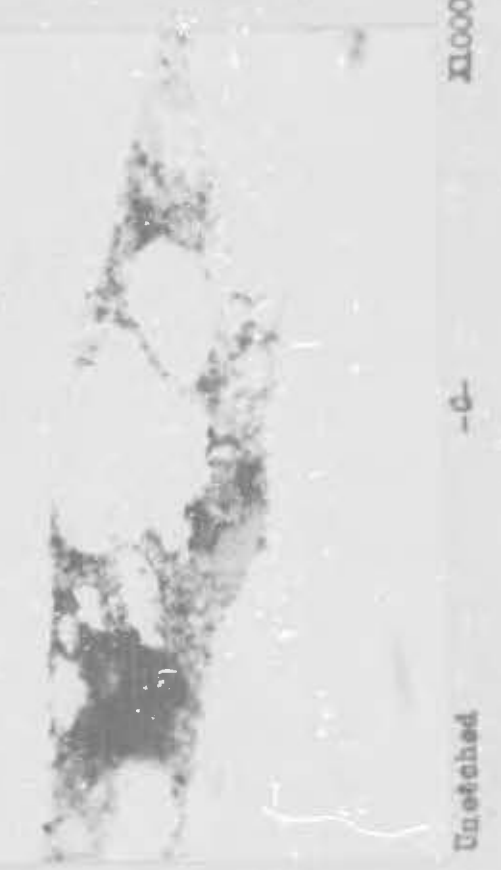
FIGURE 5

Disconnected stringers of nonmetallic inclusions were found in the midsection of the plate, see Figure 5A. This type of nonmetallic was identified as iron oxide using the etching procedure outlined on page 748 of the 1939 edition of Metals Handbook. A second type of inclusion was also observed in the midsection of the plate, occurring as high concentrations of short, oval inclusions, Figure 5B. These were identified as iron-manganese sulfides. A typical iron oxide type inclusion is shown in Figure 5C at a higher magnification.

The etched structure in the vicinity of the lamination is shown in Figures 5D and E. Figure 5D shows a region which has been highly oxidized and decarburized. Small globular oxides are visible in the decarburized zone. The arrow points to some iron-manganese sulfide inclusions found in the same region. The "fish-eyes" observed on the plane of the lamination were found to coincide with these highly oxidized and decarburized areas. Figure 5E shows a region at the plane of the lamination which contains segregations higher in alloy and carbon content than the base metal.

It is concluded from the microscopic examination that the lamination represents a piped condition in the ingot which was retained in the subject plate.
