WADC TECHNICAL REPORT 53-192

## MECHANISM OF RAIN EROSION

Part XIII. Mechanism Studies on Neoprene Coatings

*Olive G. Engel*

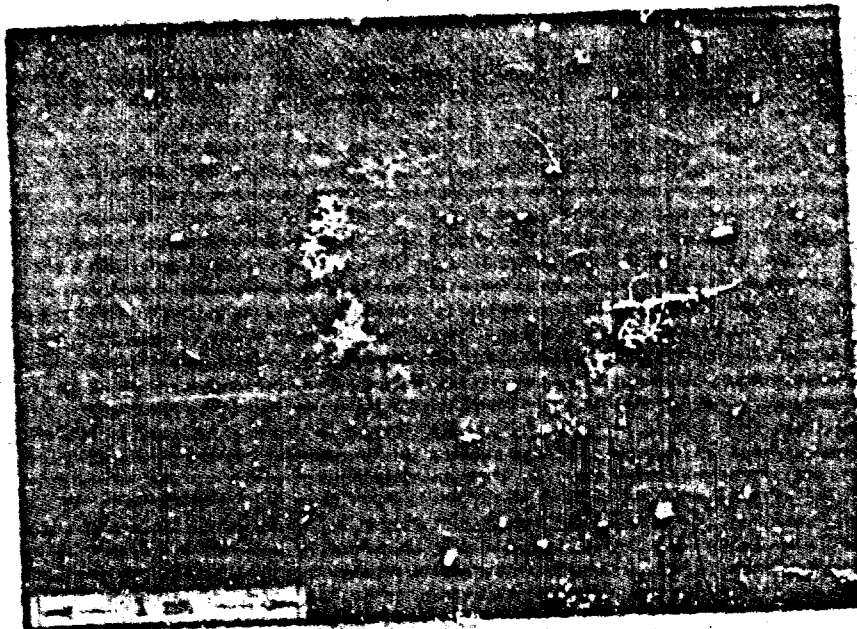
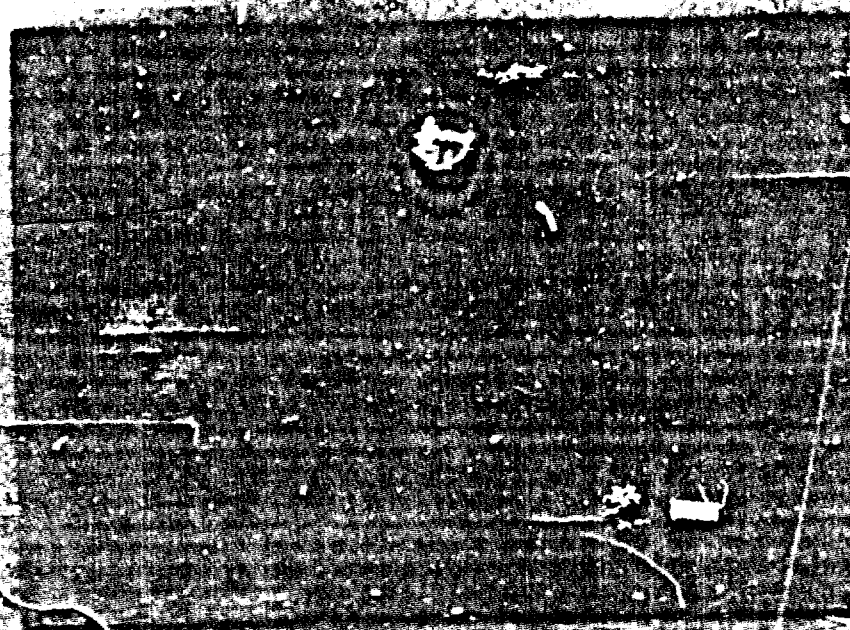
FIGURE 5 STRUCTURE OF WATERDROP IMPINGEMENT ADHESION  
OF NITR BC-539 NEOPRENE

It is possible that these circles of abrasion may be caused by the radial flow of individual waterdrops after the neoprene surface has become weakened by other waterdrop blows that were not themselves able to cause visible damage. The circles are not caused by every waterdrop that impinges against the specimen because, if this were the case, there would be so many circles of abrasion after 1.5 min of test at a velocity of 600 mi/hr in 1-in./hr rain that they would overlap. If these circles are caused by the radial flow of water from single drops, the wrinkles or trenches of which they are composed should be perpendicular to radii of the flow. This may be true of the circle of abrasion in picture 1 of Figure 5, but in the circle of abrasion shown in picture 2 of Figure 5 the trenches seem all to be oriented in the same direction.

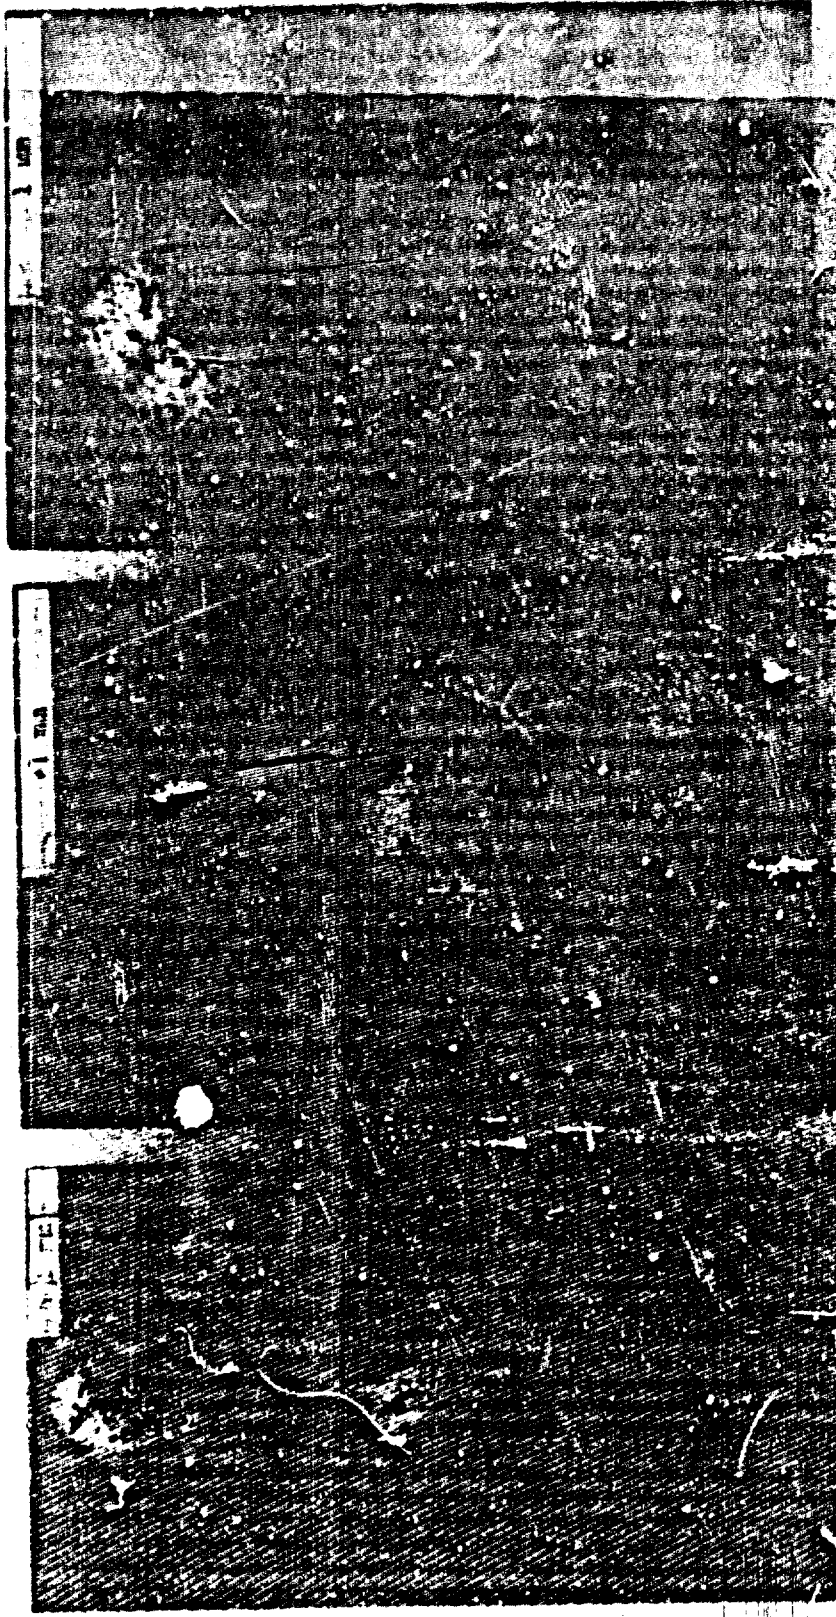
FIGURE 6. STRUCTURE OF A SINGLE DAMAGE MARK PRODUCED ON MM PC-539 IN REVERSE BY  
IMPLACEMENT OF WATERDROPS AT A VELOCITY OF 980 FT/SEC

1. AT LOW MAGNIFICATION
2. WITH CAMERA FOCUSED AT LEFT EDGE OF THE MARK
3. WITH CAMERA FOCUSED AT RIGHT EDGE OF THE MARK

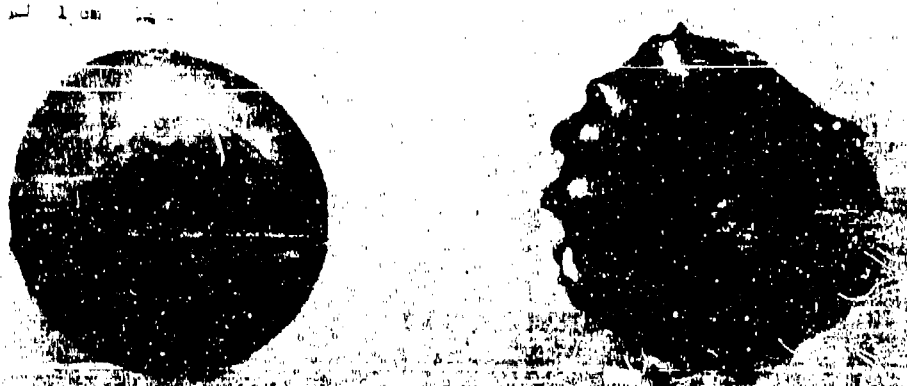
At a velocity of 530 ft/sec the raised collar or bubble of coating in the Gaco N-79 neoprene was of about the same diameter as that produced in it at a velocity of 490 ft/sec but the cut in the coating was a complete circle. The raised section of coating in the Goodyear 23-56 neoprene was nearly twice as large as that produced in Gaco N-79 neoprene at this velocity. This may indicate that the adhesion bonds between the metal and primer and/or between the primer and topcoat of the Goodyear-23-56-Bostik-1007 system are weaker than those of the Gaco-N-79-Gaco-N-15 system. The adhesion failure of the Goodyear coating system appeared to be between the primer and the metal. The raised section of coating in the Gates KV-9433 white neoprene was more than four times larger than that which formed in Gaco N-79 neoprene at this velocity. There was no tearing of the white neoprene topcoat at the periphery of the coating bubble but this did occur in the case of Goodyear 23-56 neoprene. This may indicate either that the adhesion bonds of the white neoprene system are weaker than those of the Goodyear-23-56-Bostik-1007 system and permit the growth of a large bubble without undue stress to the topcoat or that the white neoprene topcoat has higher strength properties than the Goodyear 23-56 neoprene topcoat permitting the growth of a large bubble in spite of strong adhesion bonds.

At a velocity of 640 ft/sec there is no tearing of the Gaco N-79 neoprene at the periphery of the coating bubble but such tearing did occur both in the Goodyear 23-56 neoprene and in the Gates KV-9433 white neoprene. There is some abrasion of the neoprene surface around the circular cut in the coating in the case of the white neoprene and rather extensive abrasion in the

IMPINGEMENT VELOCITY 530 FT/SEC      IMPINGEMENT VELOCITY 640 FT/SEC

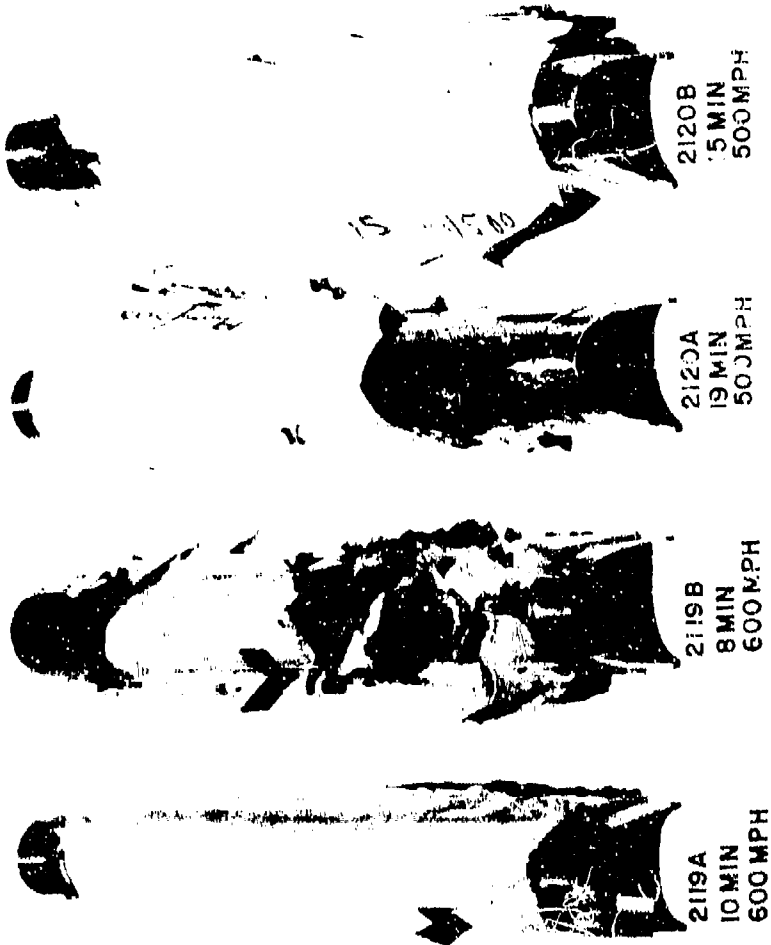
The specimens that were coated with white neoprene were numbered 2119 A and B and 2120 A and B. A picture of the four eroded specimens is shown in Figure 16. Only one specimen was tested at a velocity, in a rain density, and for a time interval comparable with that used for the other neoprene coating

systems. This was specimen 2119 A which was tested at a velocity of 600 mi/hr in 1-in/hr rain for 10 min. The coating on this specimen failed drastically in adhesion between the primer and the metal specimen-base. The coating loosened to form a large bubble that covered about three-fourths of the leading edge. Inspection of the eroded coating on this specimen with a stereoscopic microscope at a magnification of X20 revealed an indistinct chevron pattern in the neoprene at the low-speed end of the specimen and some abrasion of the coating surface on the leading edge. There were also randomly spaced gouges in the coating along the leading edge from about the center of the specimen to the high-speed end. The damage done to this specimen was obvious to the unaided eye whereas the specimens coated with the Gaco N-79-Gaco-N-15 and with the Goodyear-23-56-Bostik-1007 systems that were tested under the same conditions appeared to be undamaged to this degree of inspection.
