NAMC-AEL-1625 14 DEC 1959

CALIBRATION AND QUALIFICATION TESTS  
OF McCULLOCH YO-100-4 ENGINE  
FOR ROTORCYCLE USE

FINAL REPORT ON  
BUAER PROJECT TED NAM-PP-2648.1  
BY  
C. W. SHEARER

Final Report NAMC-AEL-1625  
on  
BUAER Project TED NAM-PP-2648.1

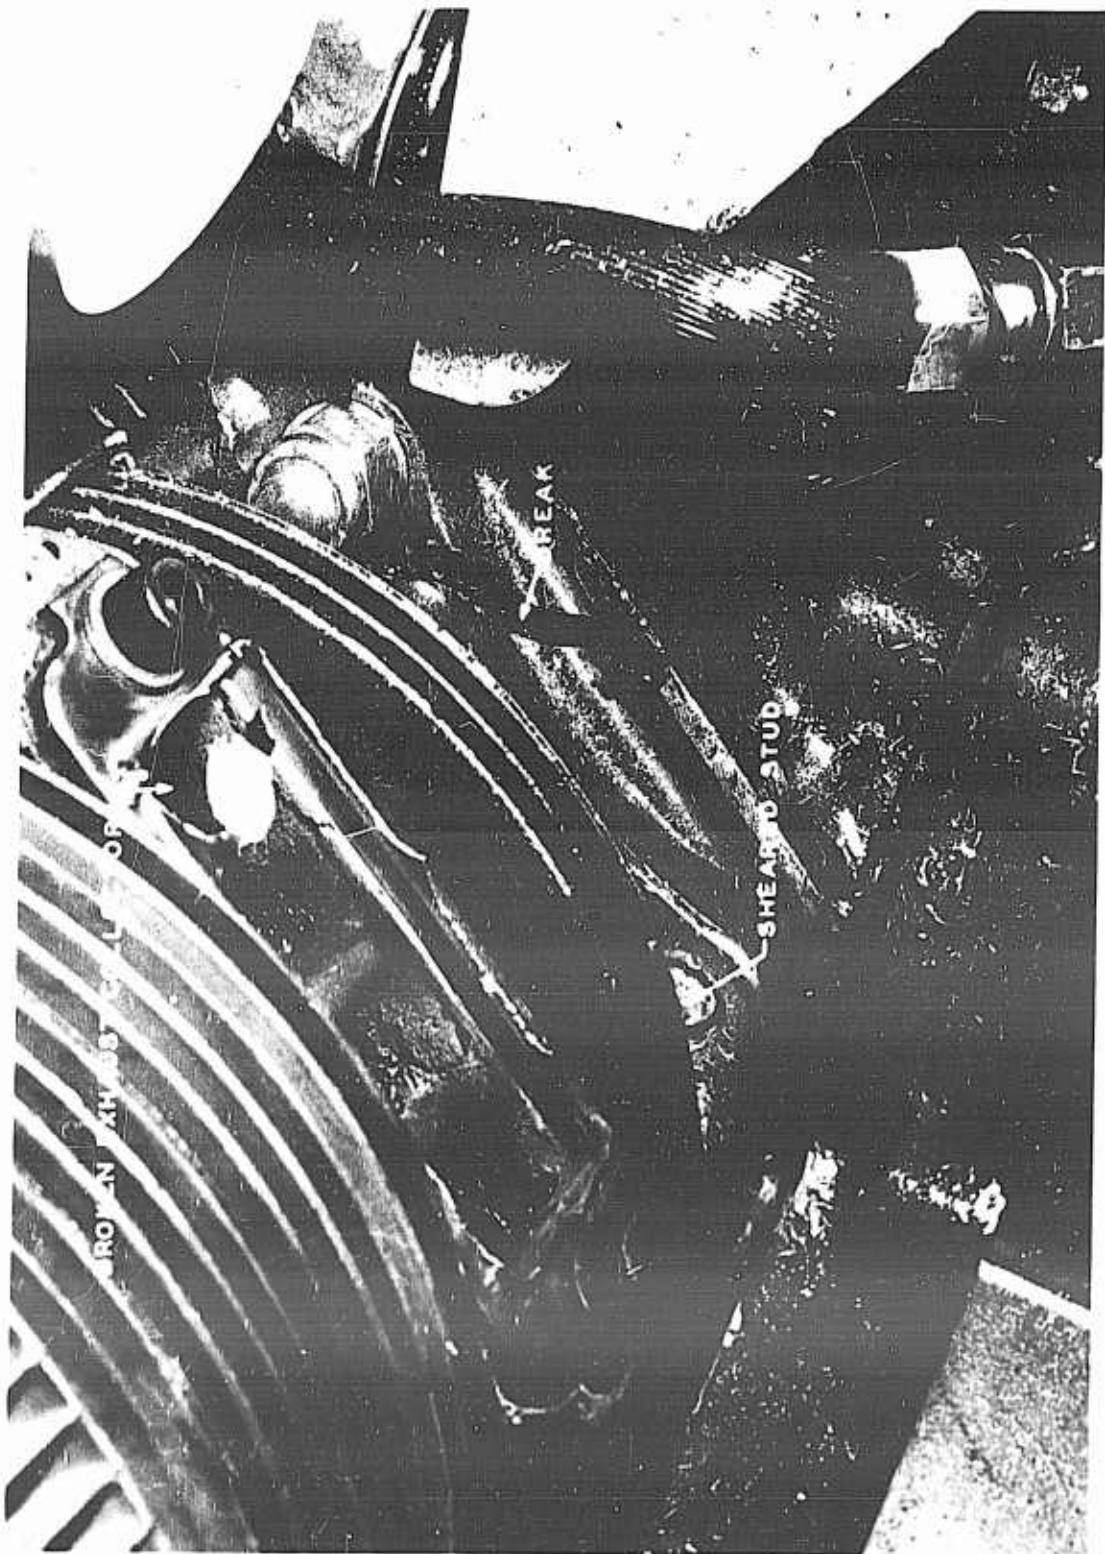
PLATE 8

(b) The second of these failures occurred on engine Serial No. 431-C-3 (rebuilt) (this engine was built-up at AEL of parts from the two engines, Serial Nos. 431-C-1 and 431-C-3, received for the test), after 28.3 hours total operating time (21.5 hours endurance time). In addition to a sheared stud, two fiber lock nuts were found loose on other studs, and the No. 4 cylinder was cracked at the base (see plates 8 and 9). A more positive locking device, possibly castellated nuts with safety wire or cotter pins, would be more effective than the fiber nuts. A secondary failure, the right hand cooling fan (see plate 10), also occurred at this time and it is believed directly attributable to the severe vibration induced by the cylinder failure. The sheared stud was replaced; another cylinder, rod, piston, and cooling fan were installed and tests were resumed.

SECOND FAILURE OF NO. 4 CYLINDER RETENTION

ENGINE S/N 431-C-3 (REBUILT)

(3) Because of the three failures of No. 4 cylinder retention system, corrective action is mandatory. The stiffening of the aluminum crankcase, as recommended by the manufacturer, is endorsed providing that the over-stresses of the studs are the result of crankcase deformations. In addition, it is believed that positive locking of the cylinder holddown nuts should be incorporated and stud installation methods improved to prevent stud loosening. One method of improving stud installation would be to incorporate helicoil or other steel inserts in the crankcase. These latter recommendations would not appreciably increase the cost or weight of the engine.

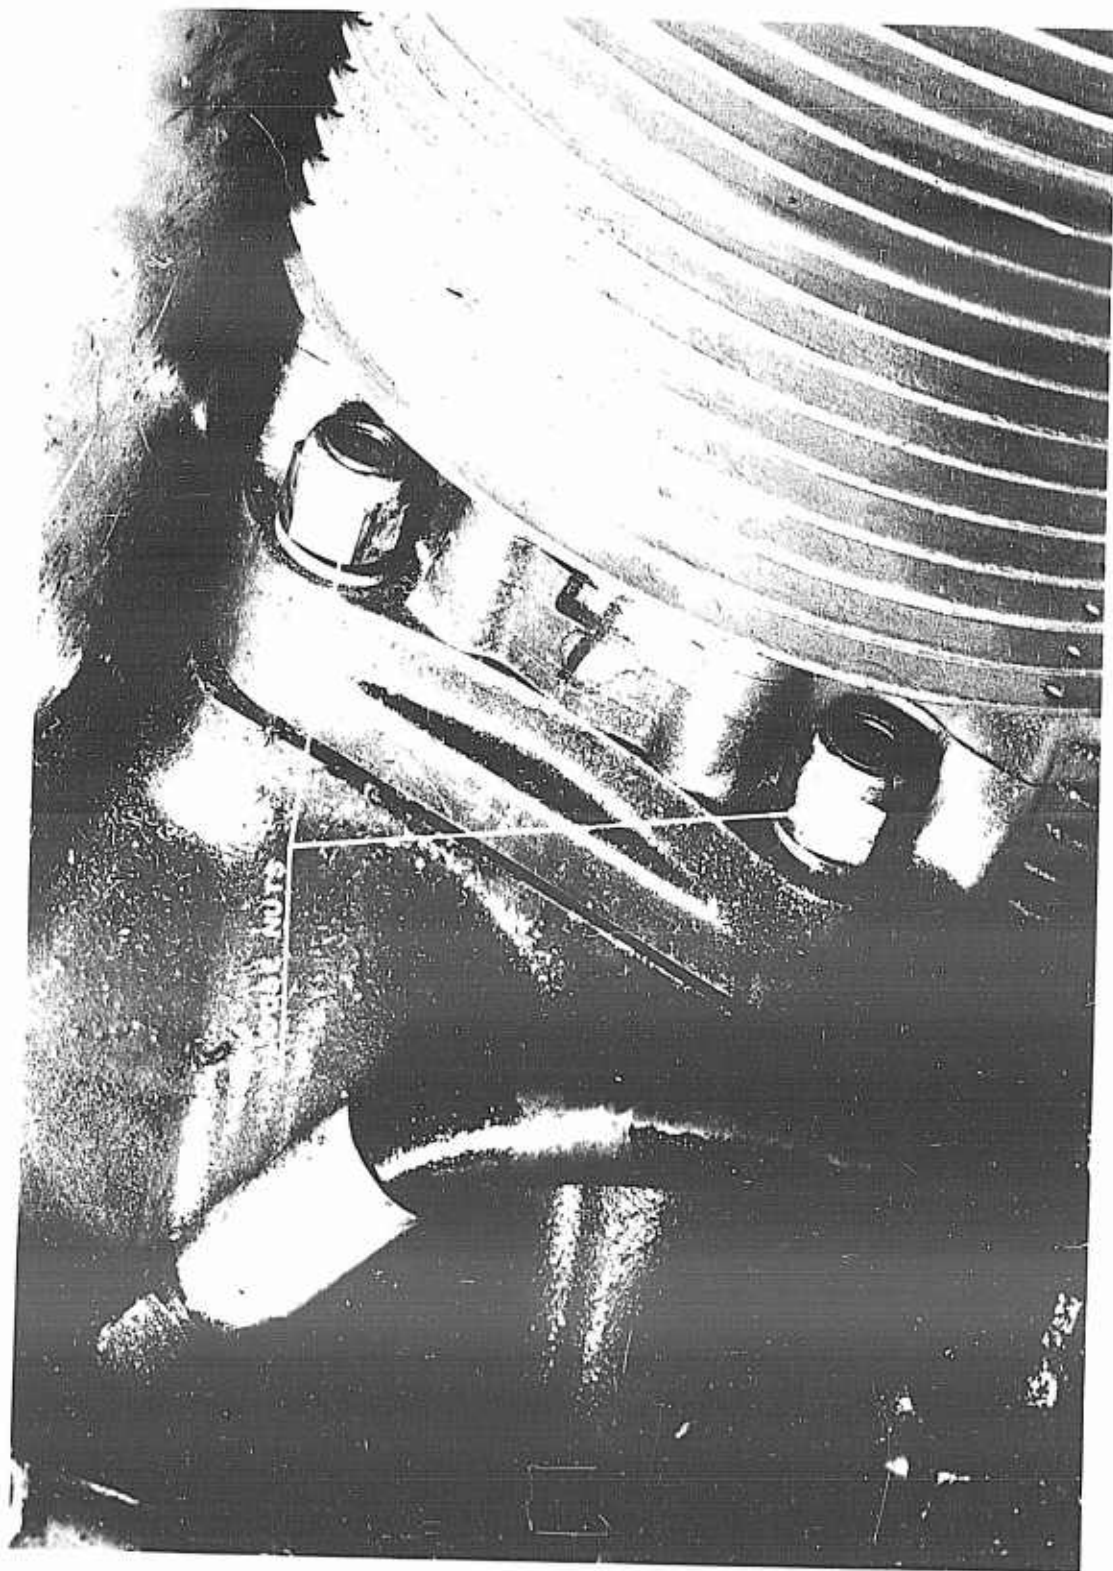
PLATE 9

SECOND FAILURE OF NO. 4 CYLINDER RETENTION

21.5 HOURS ENDURANCE (28.3 HRS. TOTAL) - ENGINE S/N 431-C-3 (REBUILT)

LOOSE CYL. HOLD DOWN NUTS

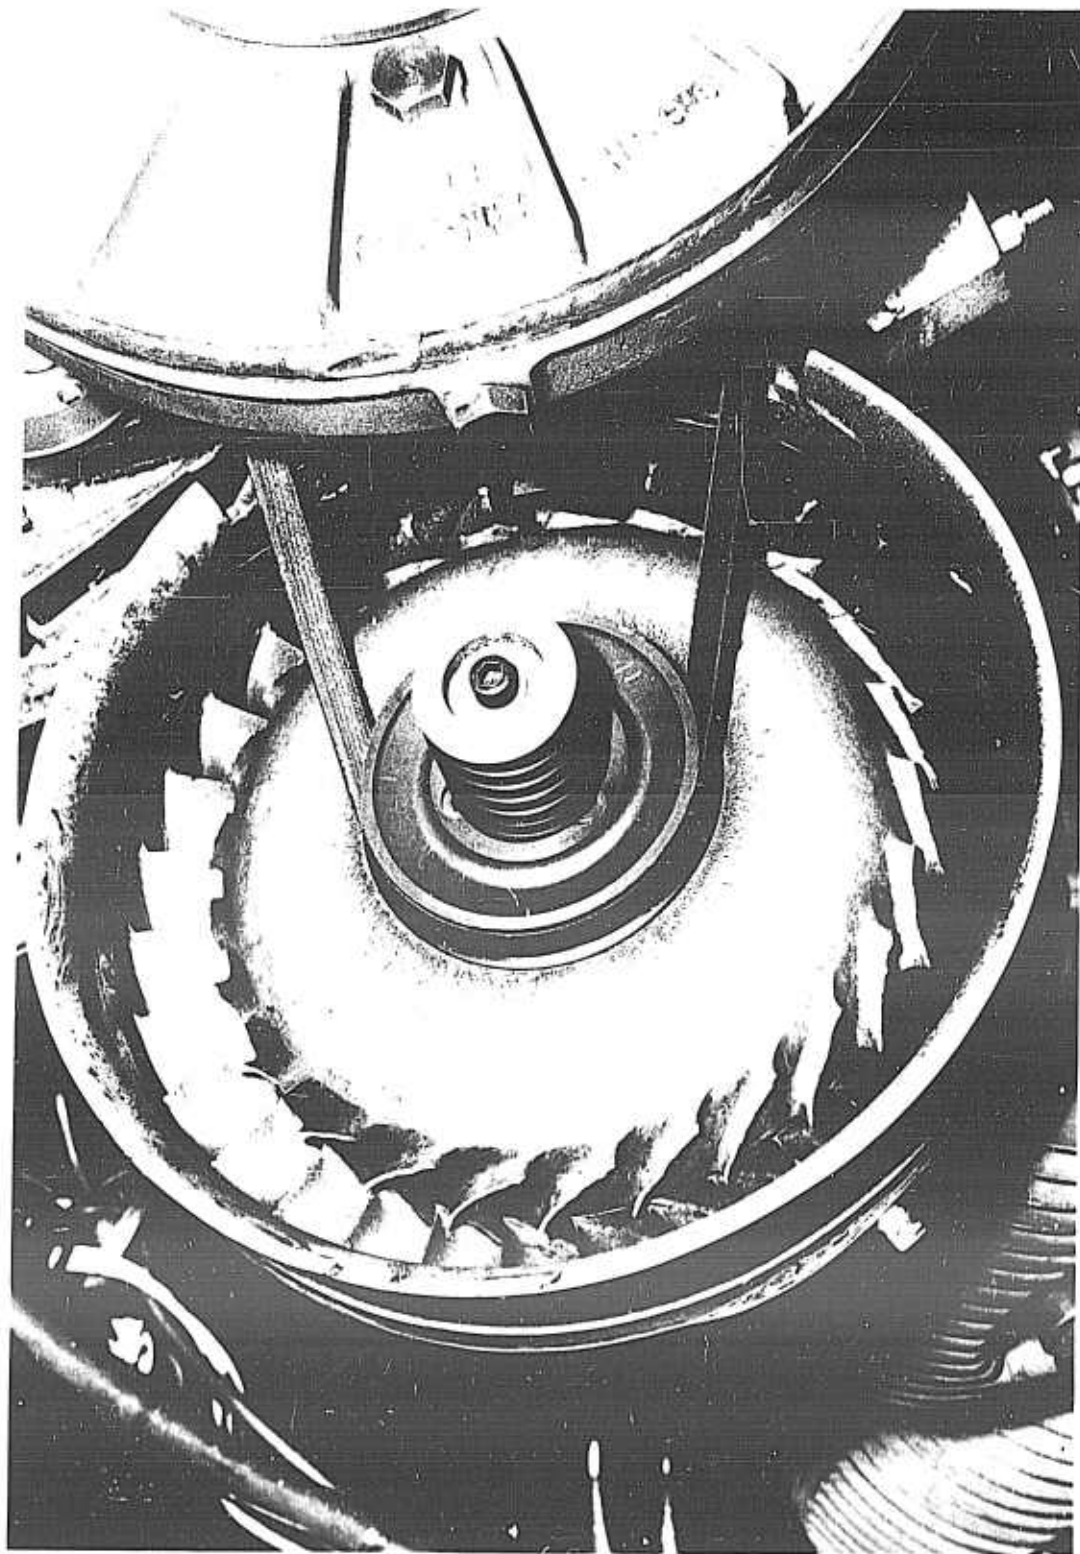
PLATE 10

FAILURE OF R.H. COOLING FAN

21.5 HOURS ENDURANCE (28.3 HRS. TOTAL) - ENGINE S/N 431-C-3 (REBUILT)  
(Secondary to Cylinder Failure)

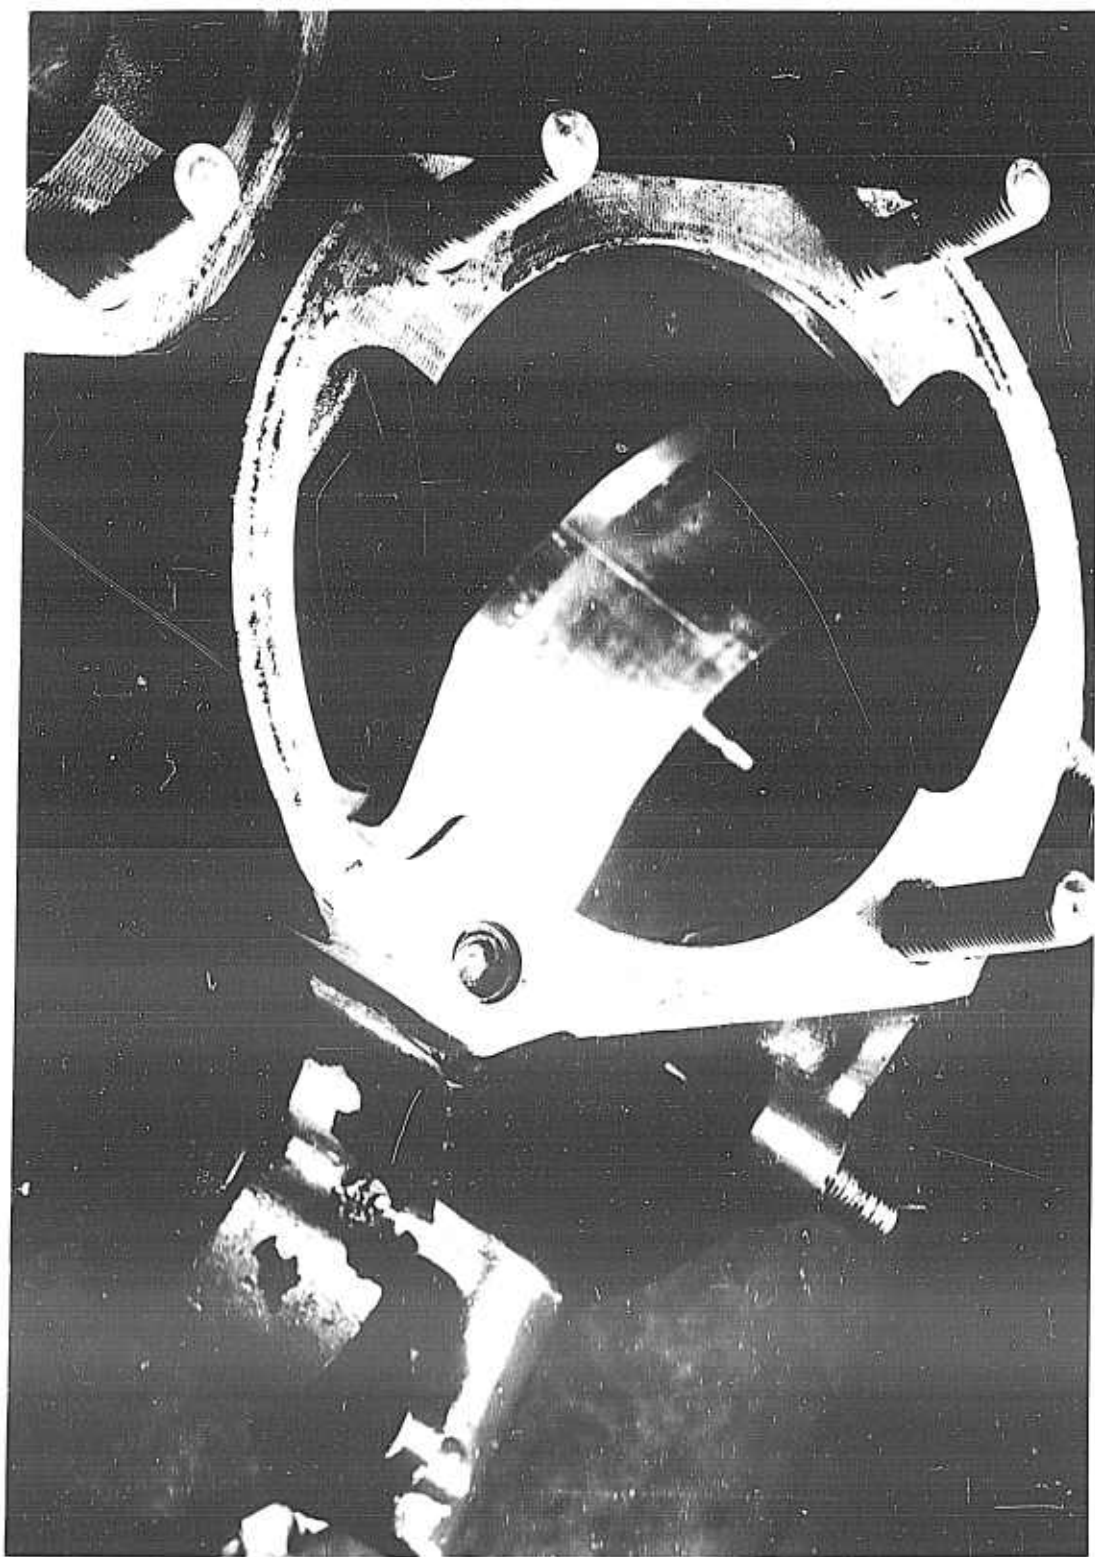
PLATE 11

(c) The third failure consisted of a single broken stud of No. 4 cylinder occurring after 25.5 additional hours of endurance time on the rebuilt, Serial No. 431-C-3, engine after the second failure. This stud failure was found during a periodic inspection, between runs of the engine, before damage progressed beyond the stud. The stud had sheared in the crankcase threads about two threads beneath the mating surface (see plate 11). It was observed upon removal of several studs from the crankcase that two studs backed out at approximately 30 inch-pounds torque. These studs should have been installed to at least 175 inch-pounds torque. Other stud breakaway torques measured approximately 200 inch-pounds. Obviously loose studs are highly unsatisfactory as they often cause deflections and oscillatory loads which greatly increase the stresses in the companion studs.

THIRD FAILURE OF NO. 4 CYLINDER RETENTION

25.5 HOURS ADDITIONAL ENDURANCE TIME - ENGINE S/N 431-C-3 (REBUILT)

(d) Structural experts of the Aeronautical Structures Laboratory were consulted for information of strength and materials of studs to seek recommendations for better material and stud design. Tests were conducted to determine the ultimate and shearing stresses of three studs removed from the crankcase. Spectrographic analysis of the studs by the Aeronautical Material Laboratory indicated the material is SAE 4140 steel; however, hardness tests indicate a tensile strength of only 120,000 psi, and static tensile stress tests were approximately of the same stress values. The stud threads appear to be rolled, a desirable feature which work-hardens the threaded areas and reduces notch effects. As all stud failures were of fatigue nature, the important feature is to increase the fatigue life of the stud. Handbook values of SAE 4140 steel, for this small diameter, indicate it can be easily heat-treated to 160,000 psi by tempering at 1000°F and quenching at 1525°F. From the standpoint of good fatigue life with good impact resistance, a value of approximately 150,000 psi is recommended. A smooth neck-down section, replacing the constant area between the threads, reduces the thread stresses and increases the fatigue life. Use of the neck-down section is common practice on high strength studs and cap screws. Increased radii at the thread roots also increase fatigue life of the studs.

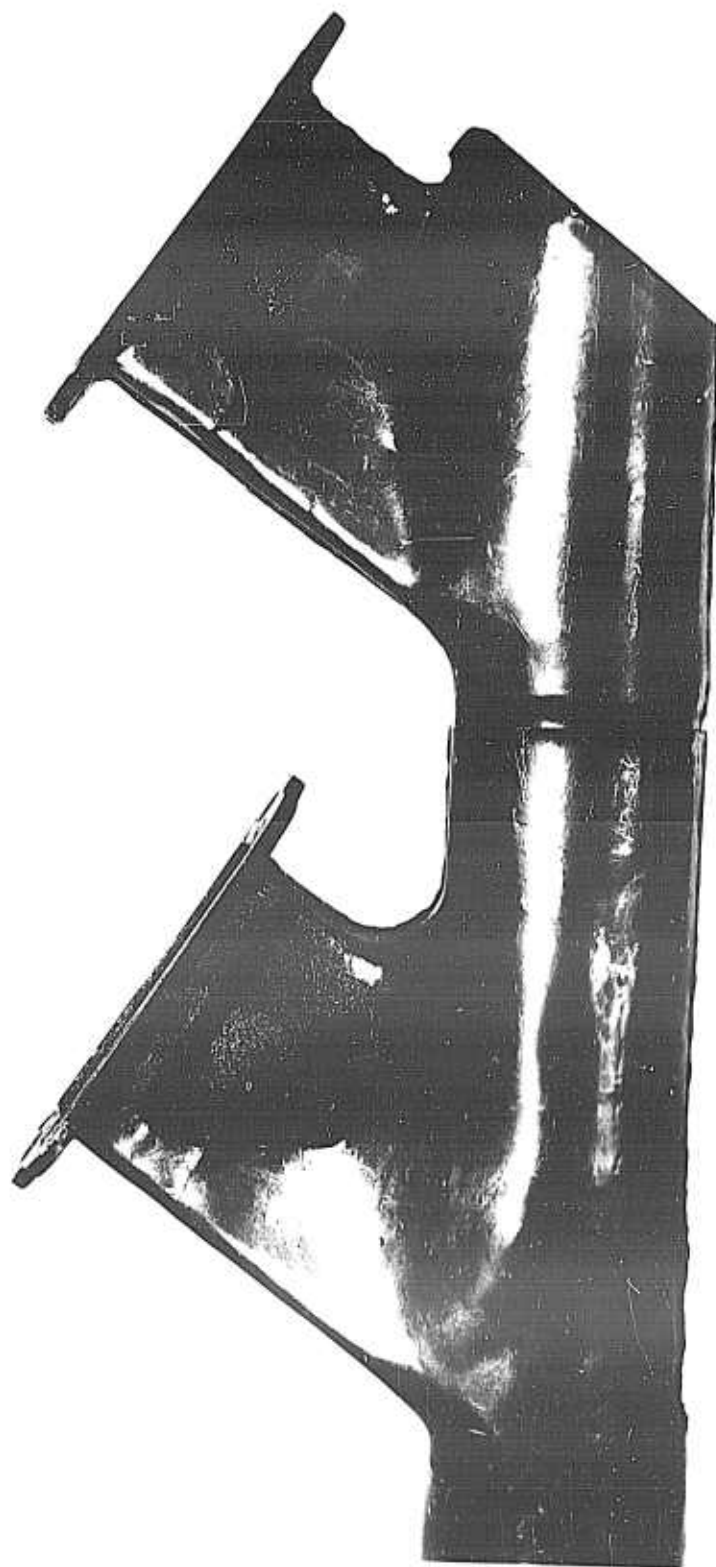
PLATE 12

(a) The exhaust manifolds cracked or ruptured several times. A typical failure is shown on plate 12.

TYPICAL FAILURE OF EXHAUST COLLECTOR MANIFOLD

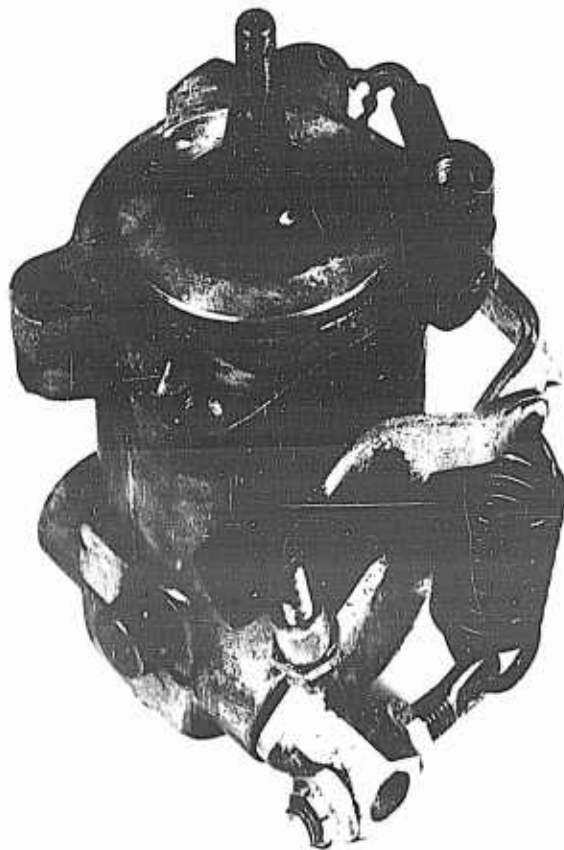
PLATE 13

(d) Two overspeed governor control failures were attributable to insufficient bearing lubrication. The overspeed governor control was designed for a horizontal mounting position of its shaft. Oil in the case up to the sight level permits adequate lubrication to a bearing facing forward, but with the engine in the near vertical position the oil in the control is at the opposite end of the case, away from the shaft bearing, and therefore, the bearing is inadequately lubricated. Filling the entire case with oil did not correct the situation because the added oil was forced out of the case by the rotating flyweights. The overspeed control simply limits the engine speeds higher than the setting of a spring tension adjustment by restricting the throttle opening and does not regulate the engine speed. Plate 13 is a photograph of the overspeed governor control.

VIEW OF OVERSPEED GOVERNOR CONTROL

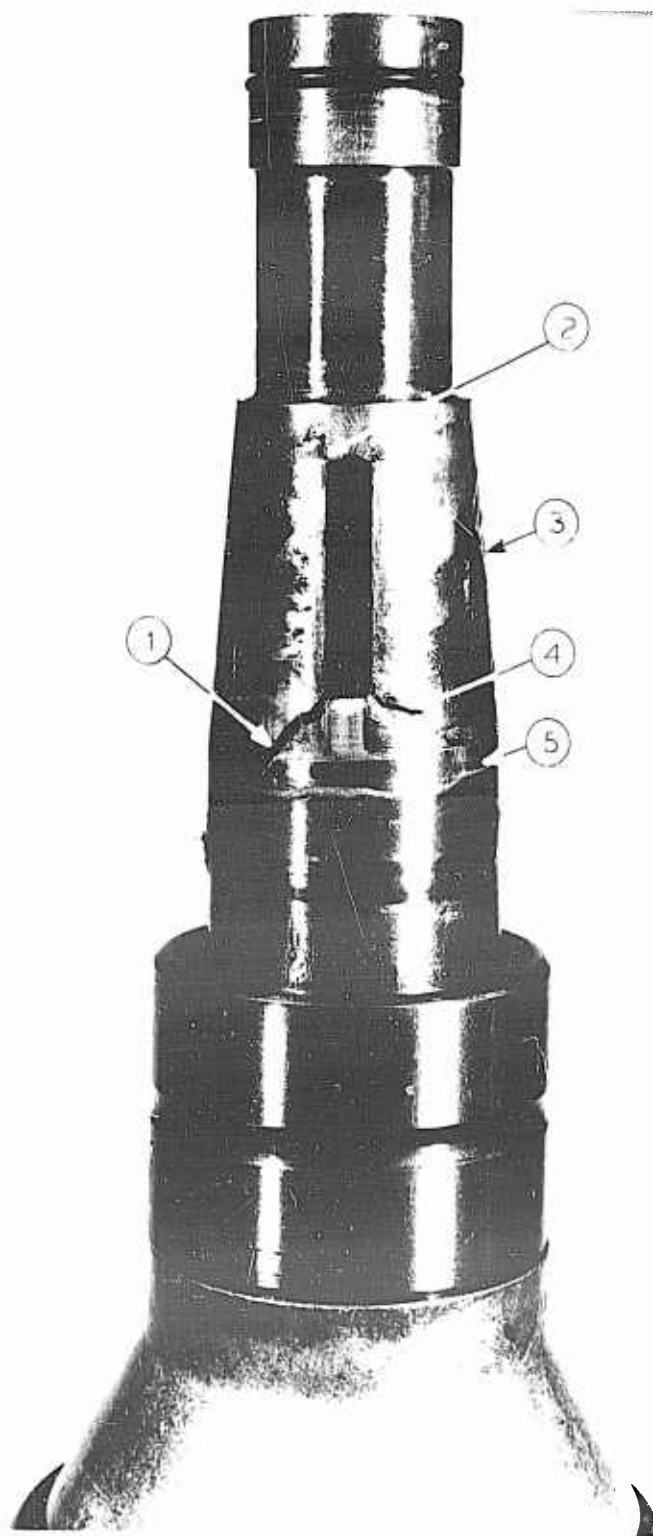
ENCLOSURE (2)

2. Visual examination of the cross-section of the crankshaft in the failed area revealed that the main fracture followed a path indicative of torsional shear. The incipient cracks at the corners of the Woodruff Key way opposite to the corner of the main fracture confirmed this observation as did the path of the failure about the circumferential cross-section of the crankshaft. Enclosure (1) shows the locale of the failure in reference to the crankshaft assembly. Enclosures (2), (3), (4) and (5) show a close up view of the path of fracture. Enclosures (4) and (5) reveal the galling which occurred at the crankshaft - fluid coupling assembly interface. On opening the fracture, the typical "oyster shell" markings indicative of the action of a fatigue mechanism were revealed. These marks indicated that the failure originated at the sharp corner between the lateral side and curve base of the Woodruff Keyway located approximately between the crankshaft surface and the base of the keyway. The lack of concentricity of the lightening hole in this portion of the crankshaft made the material cross-sectional thickness at the base of the keyway quite thin. Numerous tool marks were observed on the surface of the lightening hole.

4. From the foregoing examination, it is concluded that the failure occurred by the fatigue mechanism. This was initiated by the cyclic stresses concentrated in the sharp corner in the Woodruff keyway (described in Section 2 above and shown in enclosure (6)). The galled surfaces shown in enclosures (4) and (5) are indicative of poor bearing contact between the crankshaft and hydraulic coupling. In view of the detailed instructions found in the manufacturer's drawing #263253 with regard to the elimination of tool marks in the lightening hole and the emphasized details concerning the tolerance limits for fillet radii exclusive of the keyway, the sharp edges and contours found in the Woodruff keyway would seem to indicate a design oversight or possible poor fabrication practice. Whether or not design, fabrication, or assembly was deficient with regard to this engine is beyond the purview of this report. There is insufficient data available for determining the origin of the cyclic torsional stresses which produced the fatigue failure. However, since the metallurgical examination gave no evidence that the failure was due to a material deficiency, it is suggested that the vibrational effects of crankshaft rotation, as evidenced by the galling and the working stresses imposed by the operative stresses, added to the notch effect of the Woodruff keyway, triggered the failure.

| 1. Main path of failure | 2. Incipient cracks | 4. Secondary failure |
| torsion effects | | of failure |

FAILED AREA OF CRANKSHAFT SHOWING WOODRUFF KEY

5. It is, therefore, recommended that the design, fabrication, and assembly of the engine and its components be reviewed with regard to the elimination of notch effects, proper bearing contacts, and misalignment.

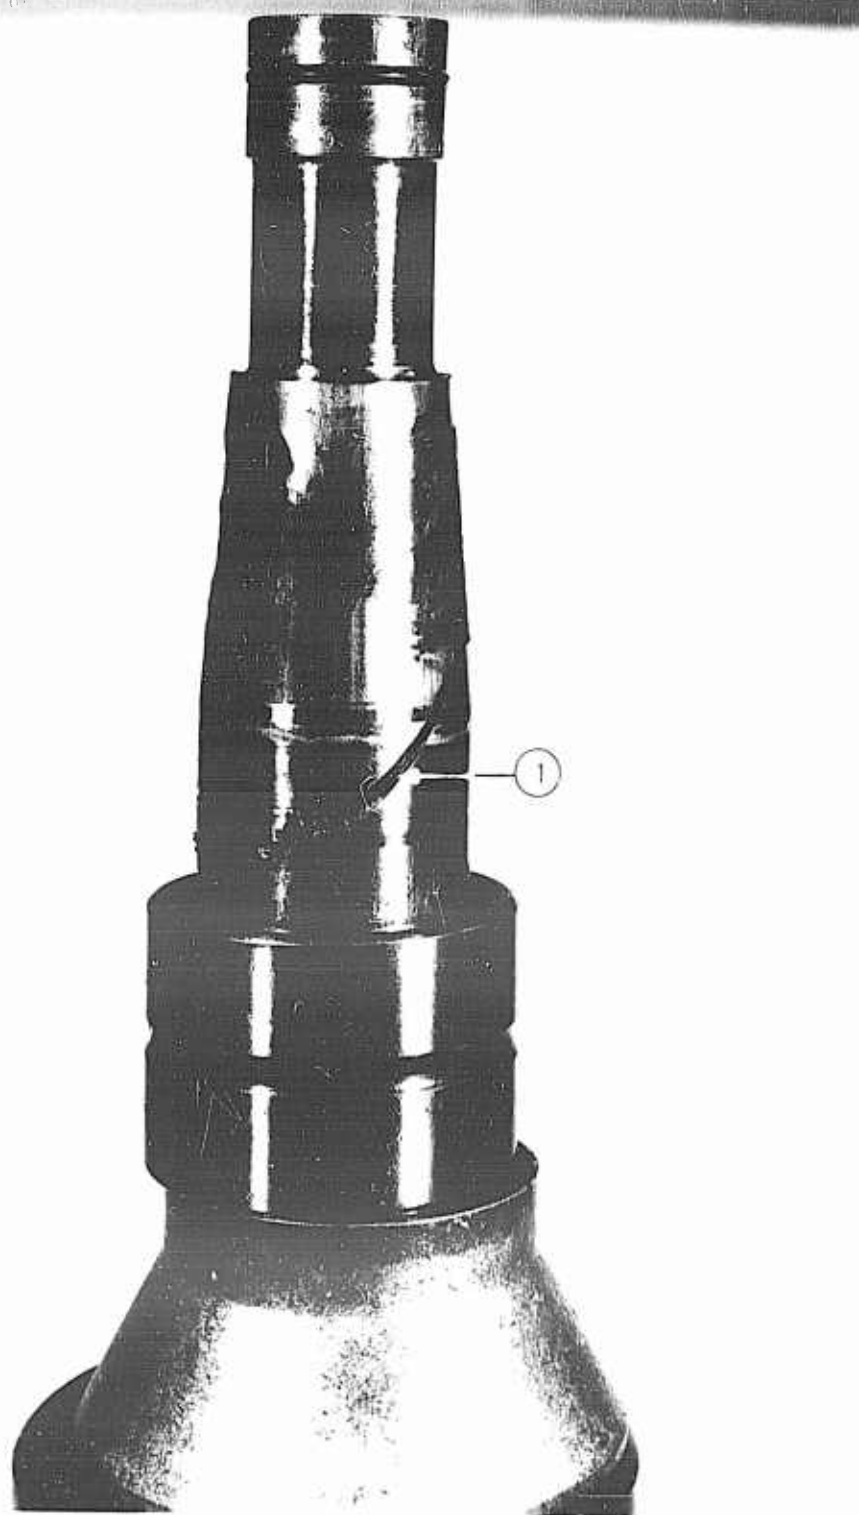
ENCLOSURE (3)

1. Main path of failure - angle of path indicates torsional effects

FAILED AREA OF CRANKSHAFT, ROTATED 90° TO RIGHT OF VIEW GIVEN IN ENCLOSURE (2)

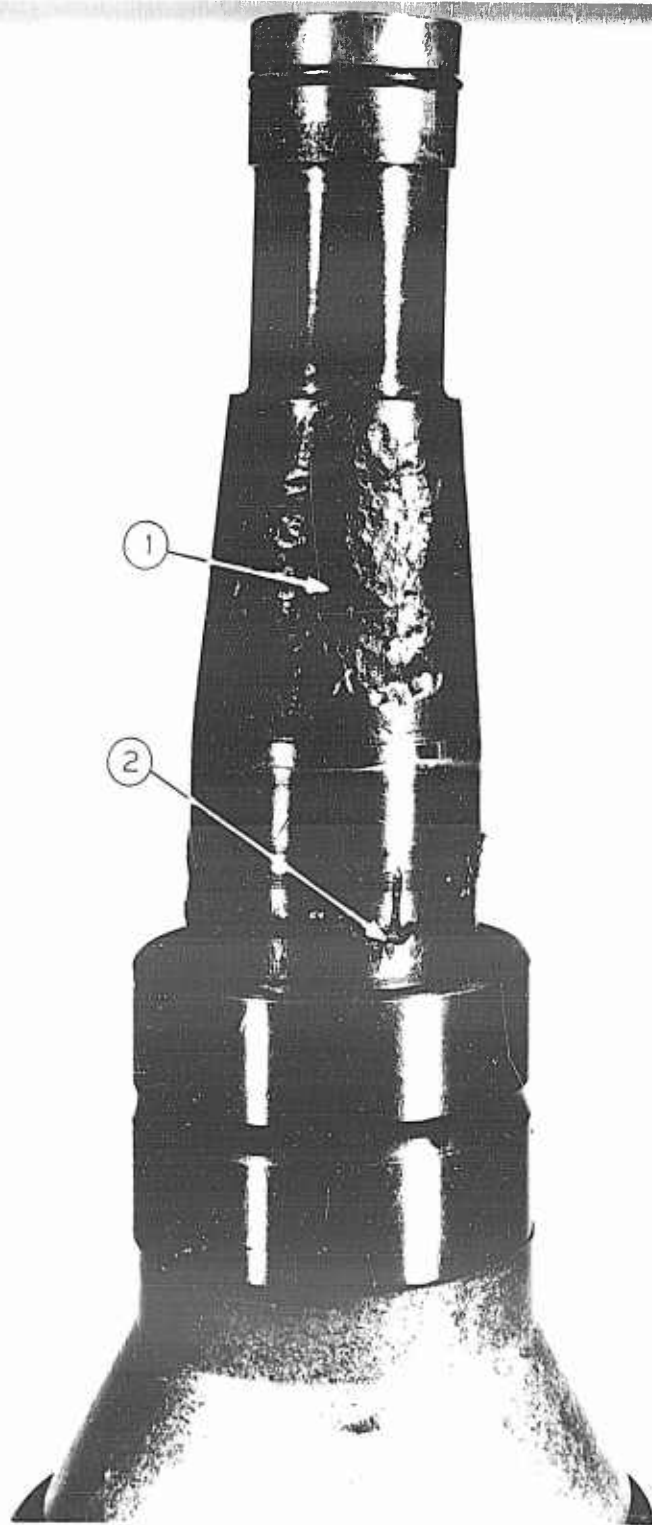
ENCLOSURE (4)

1. Galled Area

2. Path of Failure

FAILED AREA OF CRANKSHAFT, ROTATED 180° TO THE VIEW GIVEN IN ENCLOSURE (2)

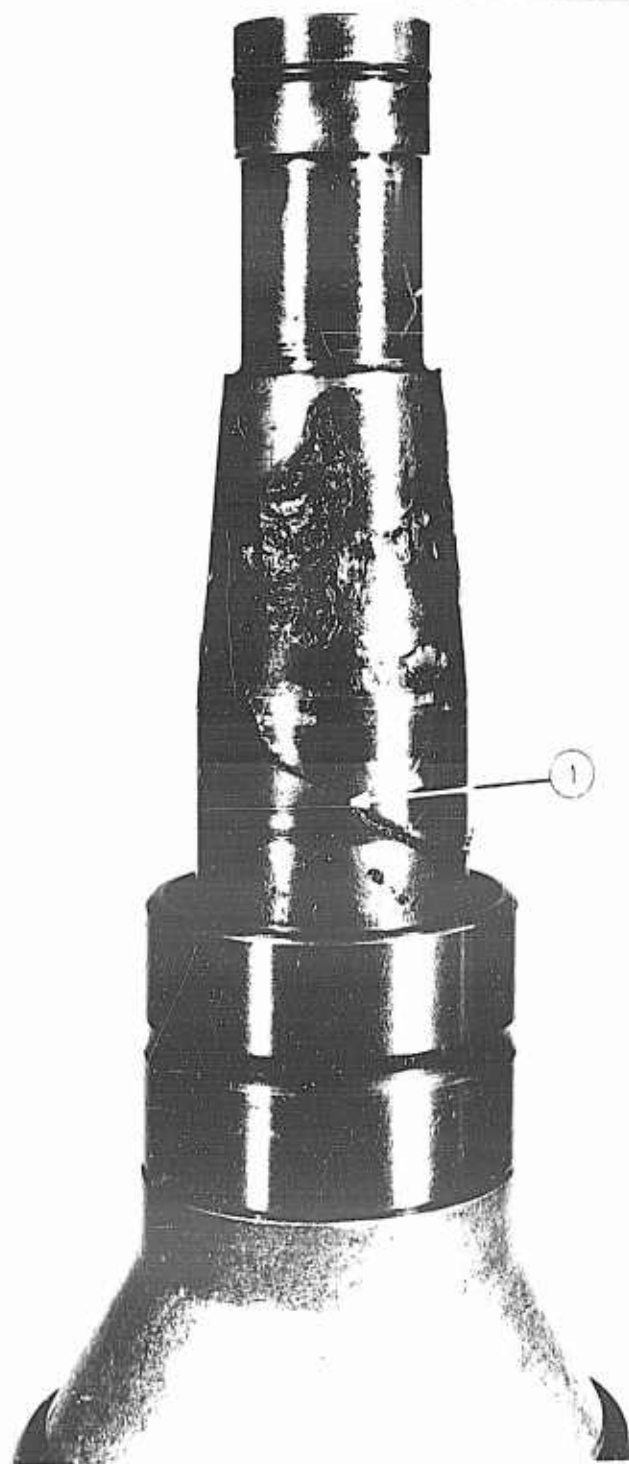
ENCLOSURE (5)

1. Path of failure

FAILED AREA OF CRANKSHAFT, ROTATED  $270^{\circ}$   
TO RIGHT OF VIEW GIVEN IN ENCLOSURE (2)

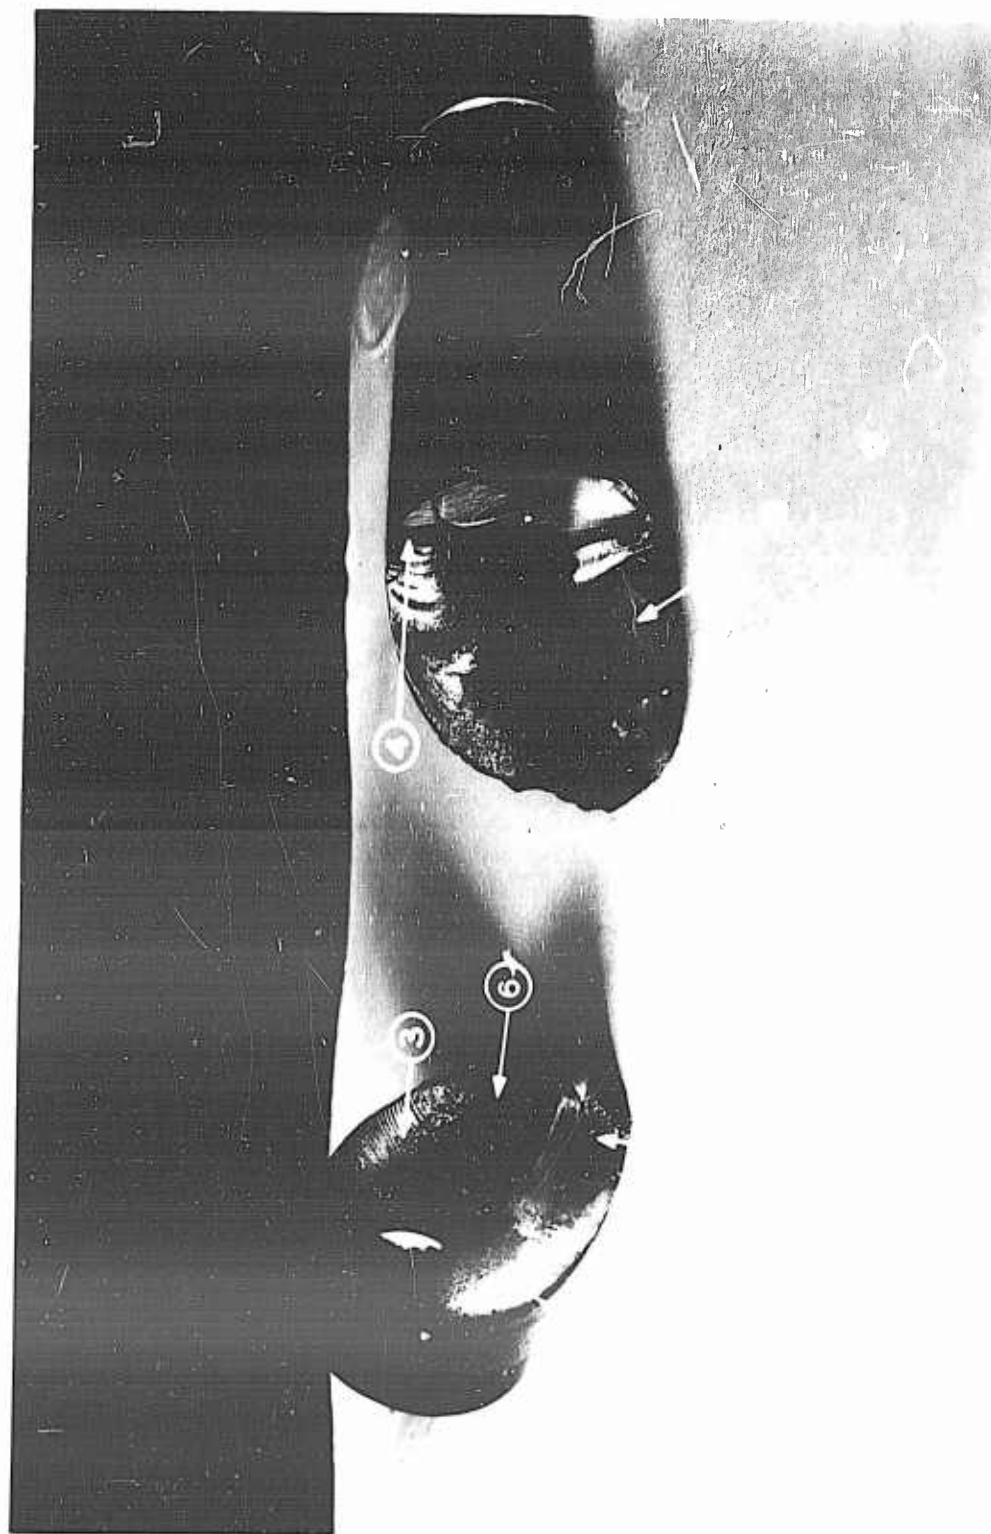
ENCLOSURE (6)

| 1. Rubbed surface | 4. Origin of failure |
| 3. Final fatigue | 6. Broken through when opening fracture faces |

FRACTURE FACES: A rotated 180° may be mated to B.

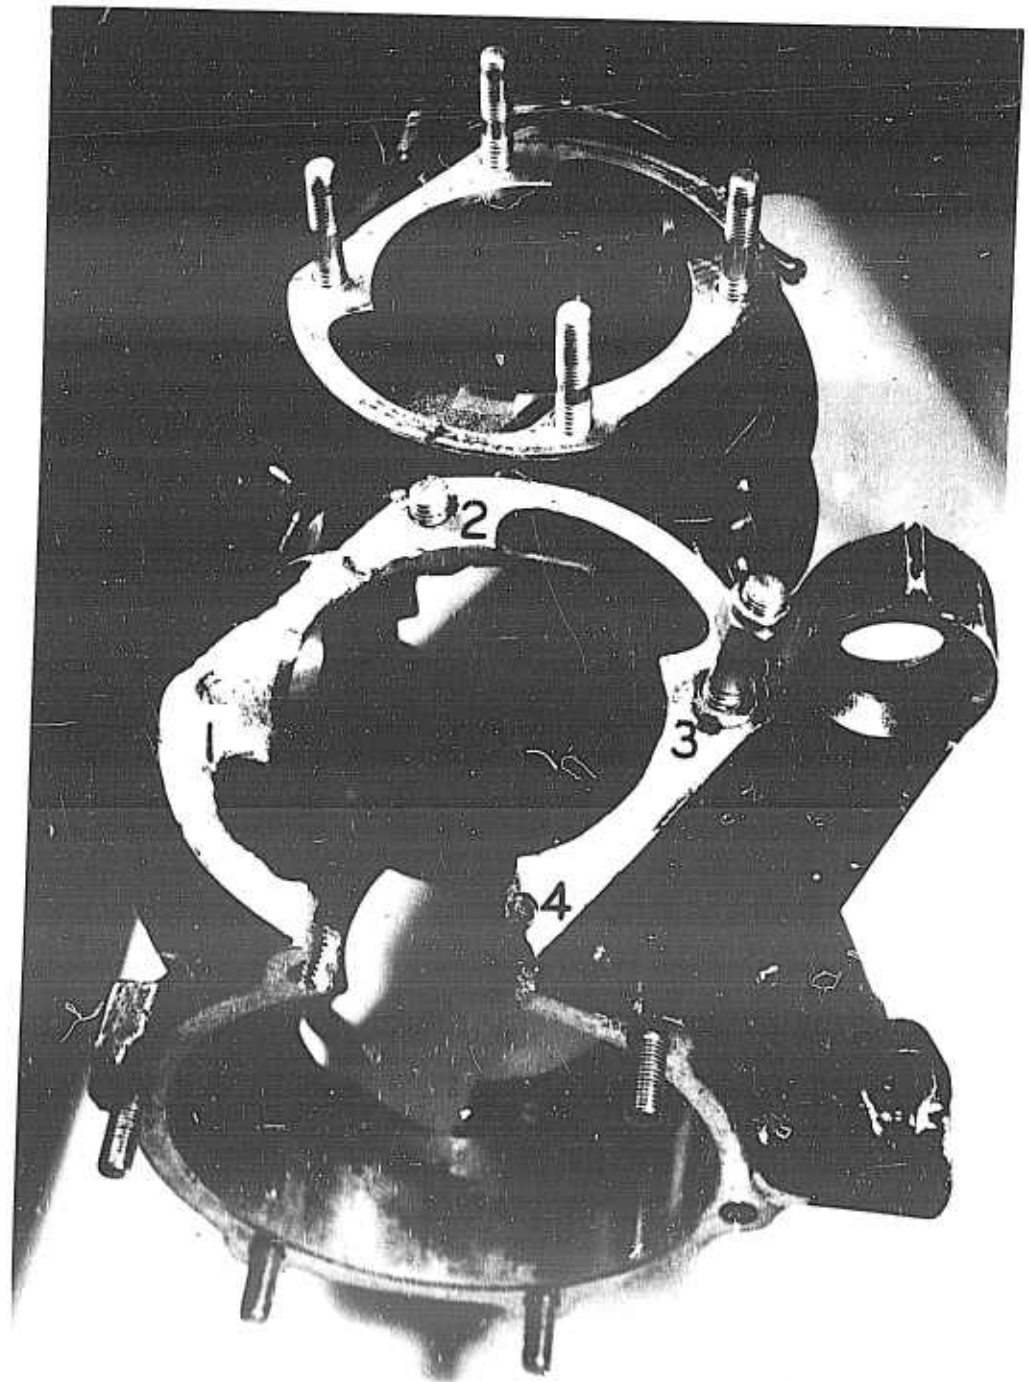
ENCLOSURE (1)

2. Visual examination revealed that failure occurred in the No. 4 cylinder. Further examination disclosed that the stud labeled No. 1 (enclosure (1)) had failed just below the top portion of the flange and had been partially covered by deformed material from the casing. Stud No. 2 (enclosure (1)) failed through the root of a thread. Stud No. 3 which was in contact with the broken out portion of the cylinder (enclosure (2)) did not break, but was bent along the plane of the diagonal between studs nos. 1 and 3. No damage other than a slight evidence of wear was apparent on stud no. 4, although chips of aluminum were found embedded in the threads.

6. While the case casting exhibited porosity, it is believed that the break-out in the flange area was a secondary failure. The primary failure is believed to be due to a fatigue failure in stud no. 1 (see enclosure (1)). Evidence for this may be seen in the cracks at the thread roots and fracture face of stud no. 1. In view of the fact that all the studs were found to be free from microstructural defects and were otherwise metallurgically sound, it is suggested that the fatigue failure of stud no. 1 was precipitated by the cyclic loads of engine operation. Following the failure of stud no. 1, and with the continuing operation of the engine, stud no. 2 and the case flange failed almost simultaneously. This is evidenced by the fact that stud no. 4 was not damaged but did have particles of aluminum embedded in the threads. The motion of the moving piston then imparted a bending moment to stud no. 3, which by this time was the only stud holding the cylinder head. As may be seen by reference to enclosure (2), this stud bent backwards and to the right away from studs nos. 2 and 4. When the bending moments became too great, the cylinder casting failed.

GENERAL VIEW OF FRACTURED ENGINE CASE

Note Wear on Left Side of Cylinder Mounting Flange

7. While it is extremely difficult to predict whether a part will fail in fatigue, it must be assumed that cyclic stressing makes it susceptible to failures of this type. Considering that operational stresses are not completely predictable from design criteria, it is recommended that the performance of the engine be investigated with this in view. Additionally, because of the fatigue failure observed in stud no. 1, it is suggested that attention be given to the proper tightening of the cylinder studs in the assembly of the engine. A loose stud results in a larger range of cyclic stress which leads to premature failure by reducing the fatigue limit of the stud.

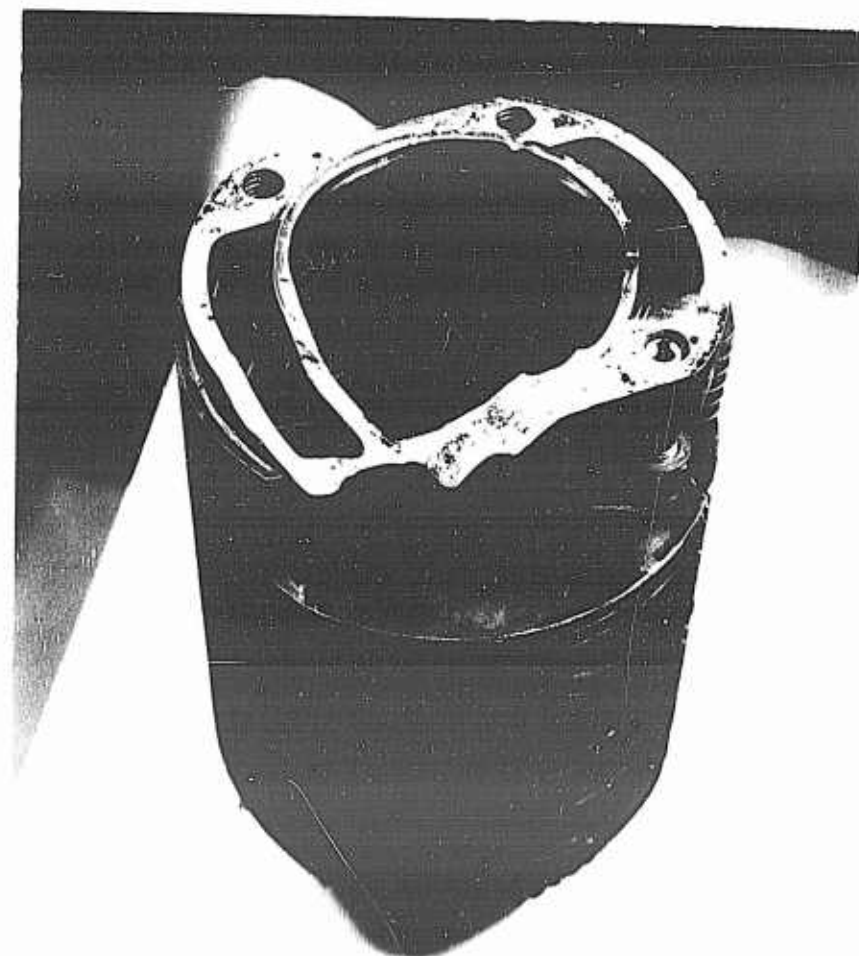
ENCLOSURE (2)

GENERAL VIEW OF FRACTURED CYLINDER

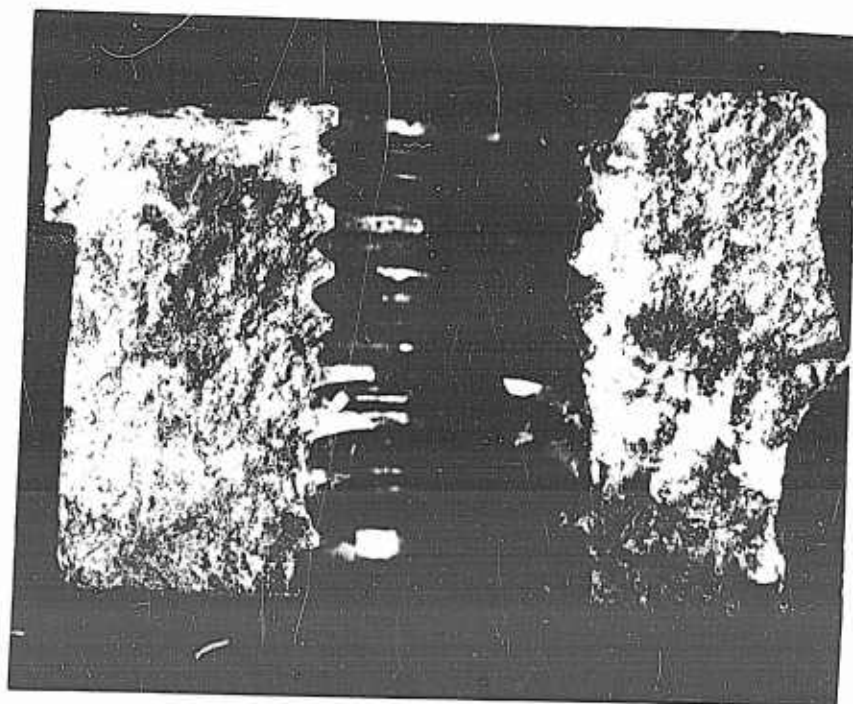
ENCLOSURE (3)

3. Enclosures (3) and (4) are illustrations of the fracture faces of the section of the case casting that broke out. Wear is evident in that section which was forced past the flange stud (enclosure (4)). The fracture face appears granular with no evidence of a gradual propagation of failure, indicating an abrupt failure. Porosity was observed in these sections. Enclosure (5) illustrates the degree and distribution of the porosity observed in the longitudinal and transverse sections adjacent to the fracture. The smaller section is that taken just below the surface parallel to the fracture face.

FRACTURE FACE AT CYLINDER STUD HOLE

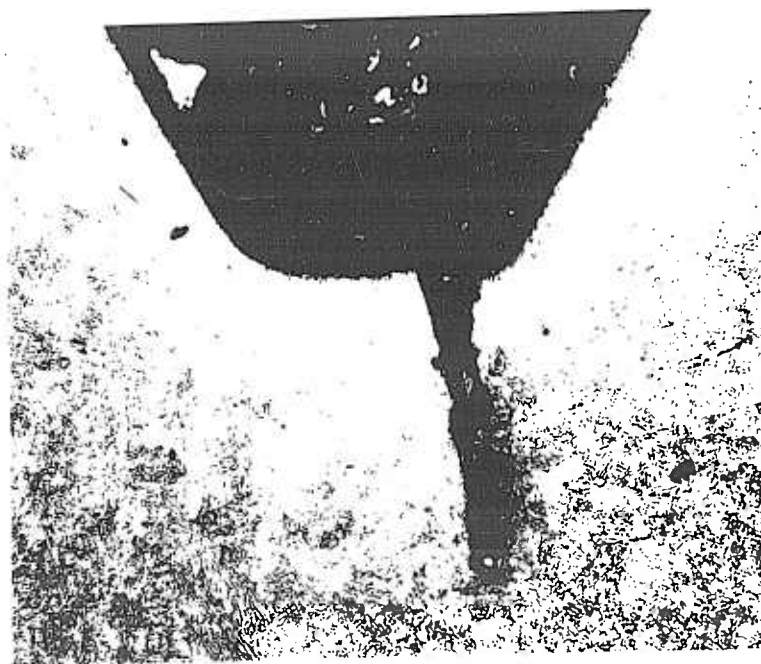
ENCLOSURE (7)

Plastic deformation may be seen on the extreme left side of the fracture face. The remainder of this face shows the characteristic oyster shell markings associated with fatigue failure. Microscopic examination of a longitudinal section of stud no. 1 revealed the presence of small cracks at the roots of several threads. This condition was not observed in a similar examination of the other studs. Enclosure no. 7 shows a crack located in the thread root adjacent to the thread through which failure occurred.

CRACK IN STUD THREAD ROOT

Note inclusion at base of crack

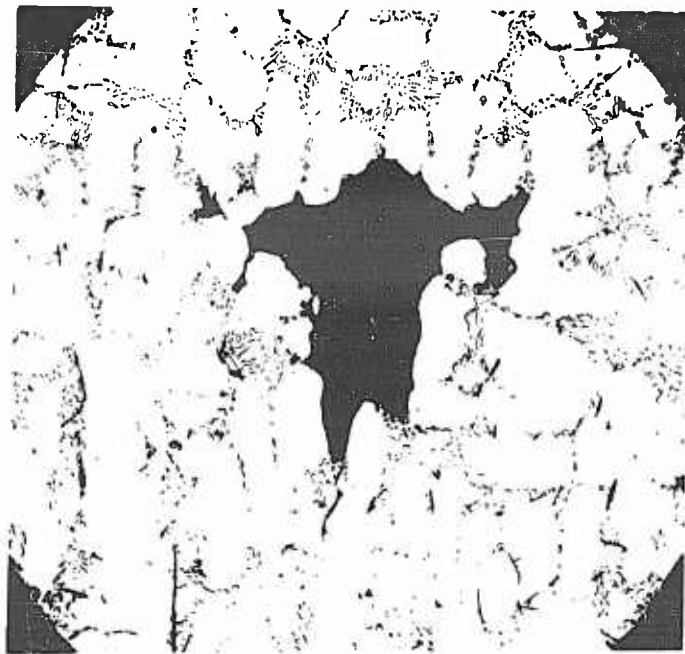
5. Enclosure (8) illustrates the microshrinkage porosity observed during the microscopic examination of the case casting.

**MICROSTRUCTURE OF ENGINE CASE, SHRINKAGE CAVITY**
