27 December 1960

U. S. NAVAL CIVIL ENGINEERING LABORATORY  
Port Hueneme, California

# CORROSION SURVEY OF STEEL SHEET PILING

Type C Final Report

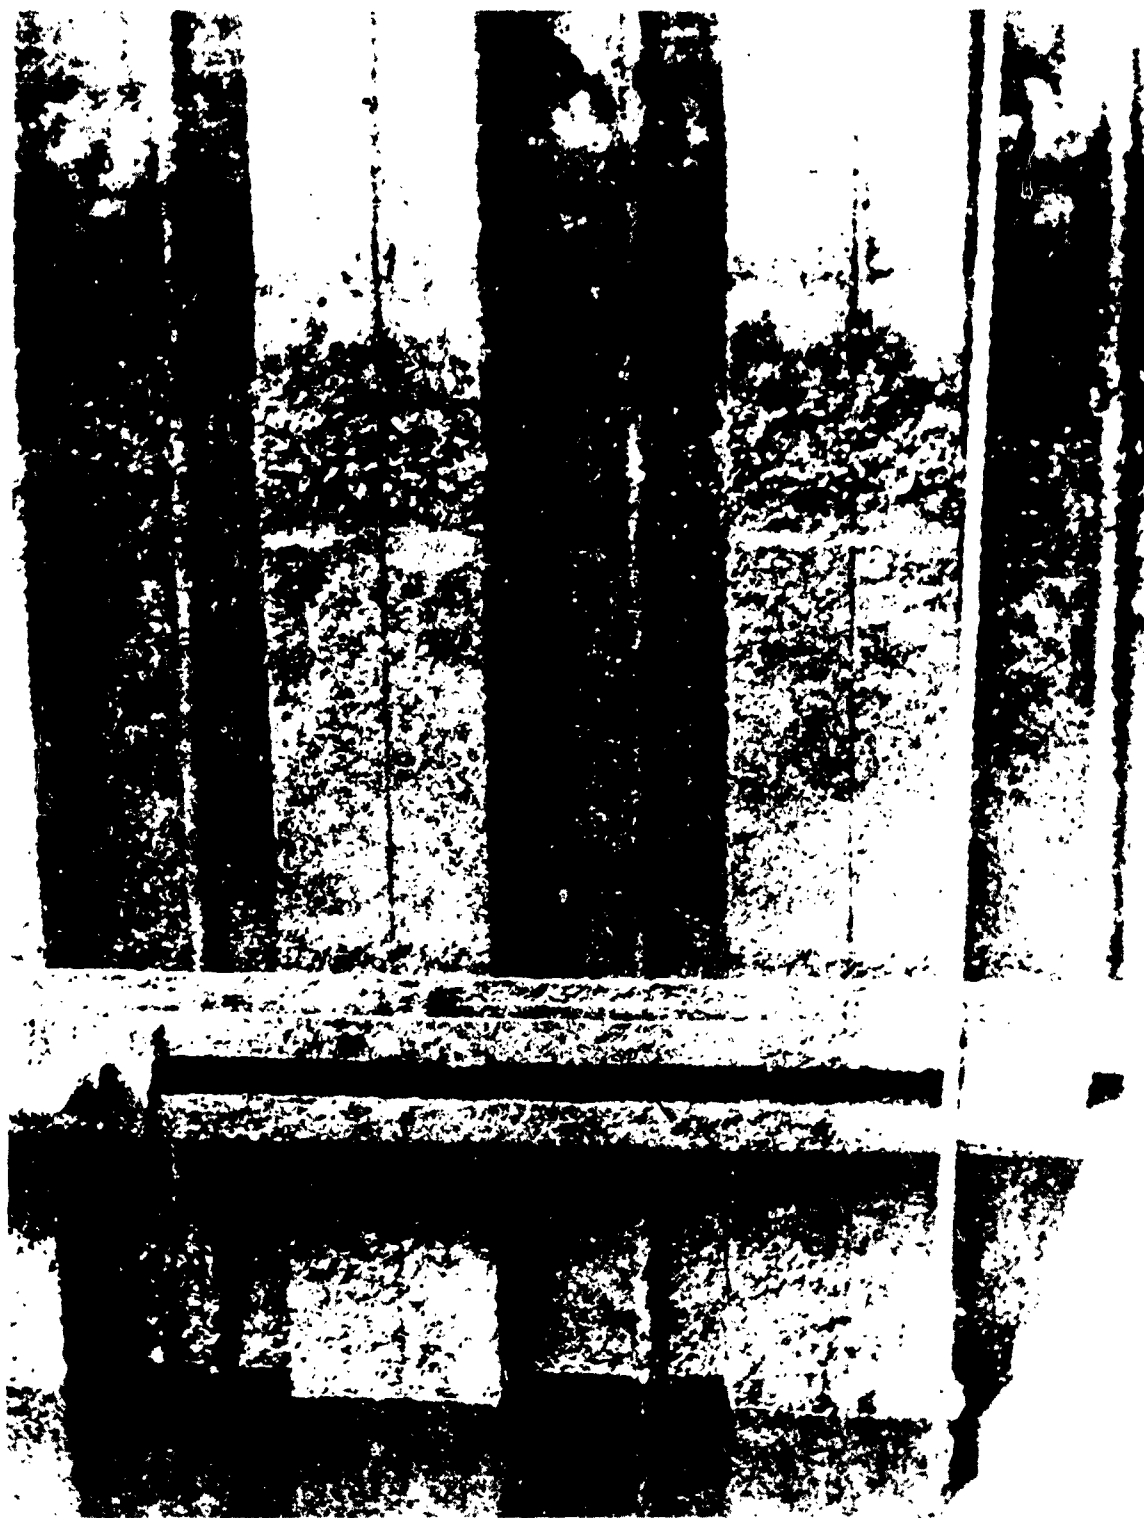
Figure 5. Test area, Boston.

Boston Naval Shipyard, Boston, Massachusetts. The area of most severe corrosion at this shipyard appeared to be on the sheet piling bulkhead facing north approximately 500 feet north of Dry Dock No. 5. A total of twenty-two test samples were cut from the three test piles. Samples at both one and three feet below the mud line on pile No. 2 were not cut because of an over-stressed condition reported on the pile at this location. Figure 5 shows the general appearance of the piling in the sample cutting area.

The greatest corrosion rate was 8.2 mpy at about one foot above MLW on the center pile. The next greatest corrosion was 7.9 mpy at the mud line on the pile 100 feet east of the center pile. The mud line at this location was 1.7 feet above MLW.

The corrosion rate in the splash zone was slightly lower than that for the area about one foot below MHW. The sample taken at the 2 foot level above MHW was only 2 feet below a 1.5-foot concrete capping. Also the test area was in a section of the harbor sufficiently narrow to minimize wave and spray action during periods of high tide. Under these conditions, the corrosion in the area just below MHW would be expected to be more severe than that in the splash zone.

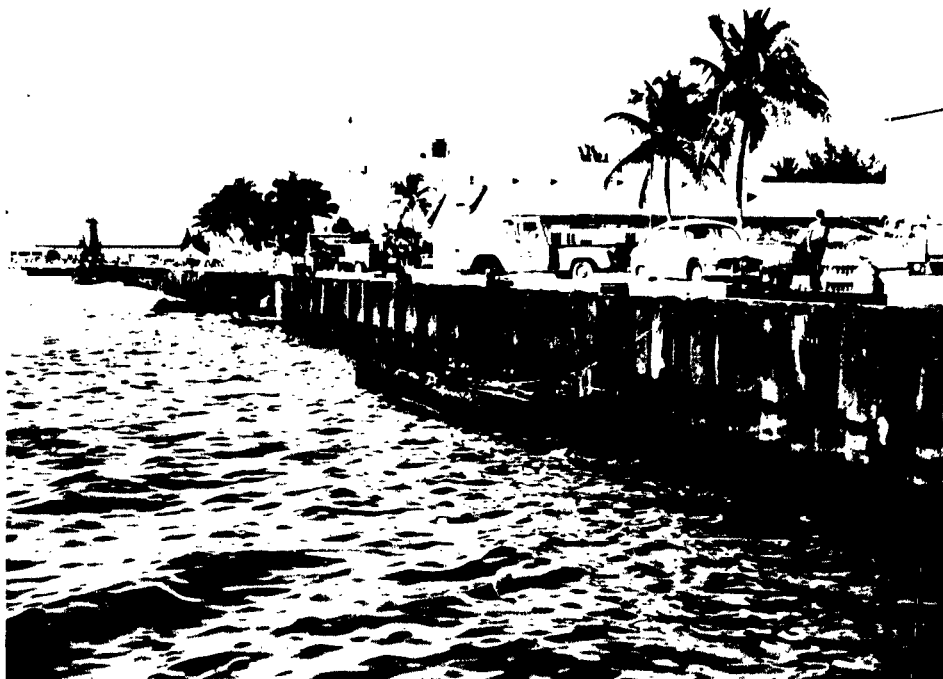
Figure 7. Key West quay test area.

Twenty samples were cut from the three piles at Key West. No samples could be obtained below the mud line because the piles were imbedded in coral. In the areas where the samples were cut, corrosion at inner corners had penetrated completely through the piling in the splash zone.

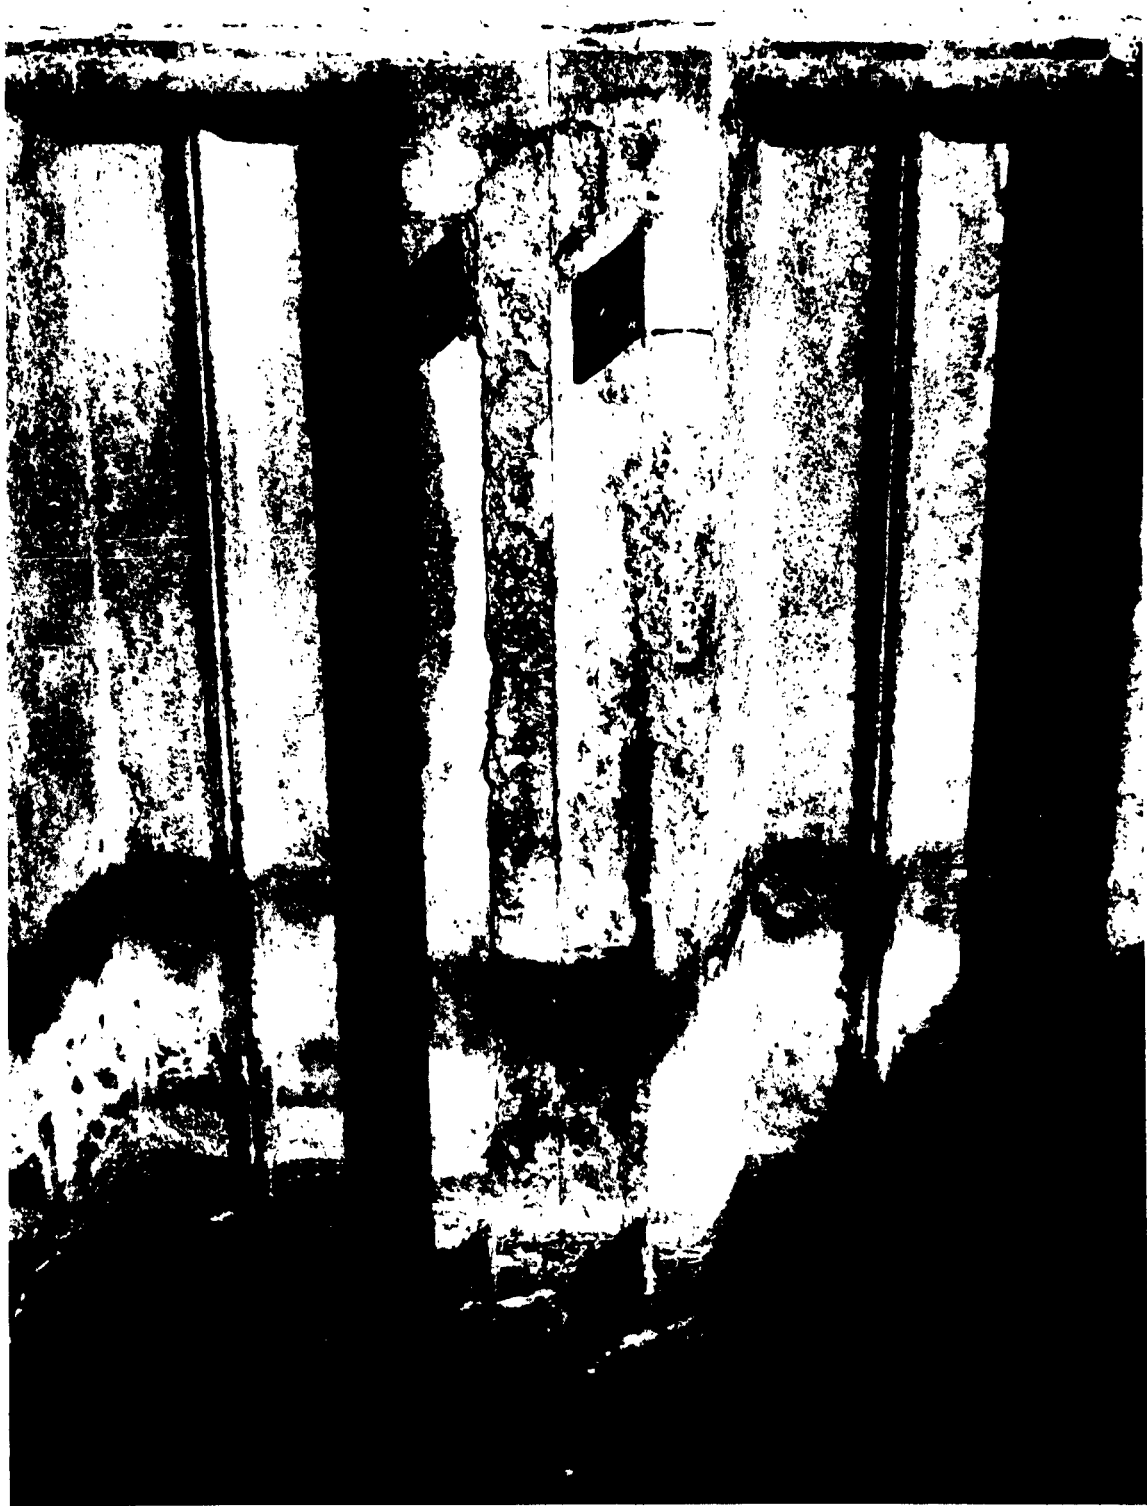
Figure 8. Piling corrosion at Key West.

At the time that the samples were cut a maintenance program had started. Rusted piling, Figure 8, was cleaned of rust by chipping and a protective paint coating was then applied from MLW to the top of the piling. The rust adhering to the vertical area of the piling between the upper and lower brackets, Figure 8, had not been chipped away in this photograph. A comparison with the remaining area from which the rust had been chipped shows the heavy rusting which had occurred along this quay wall.

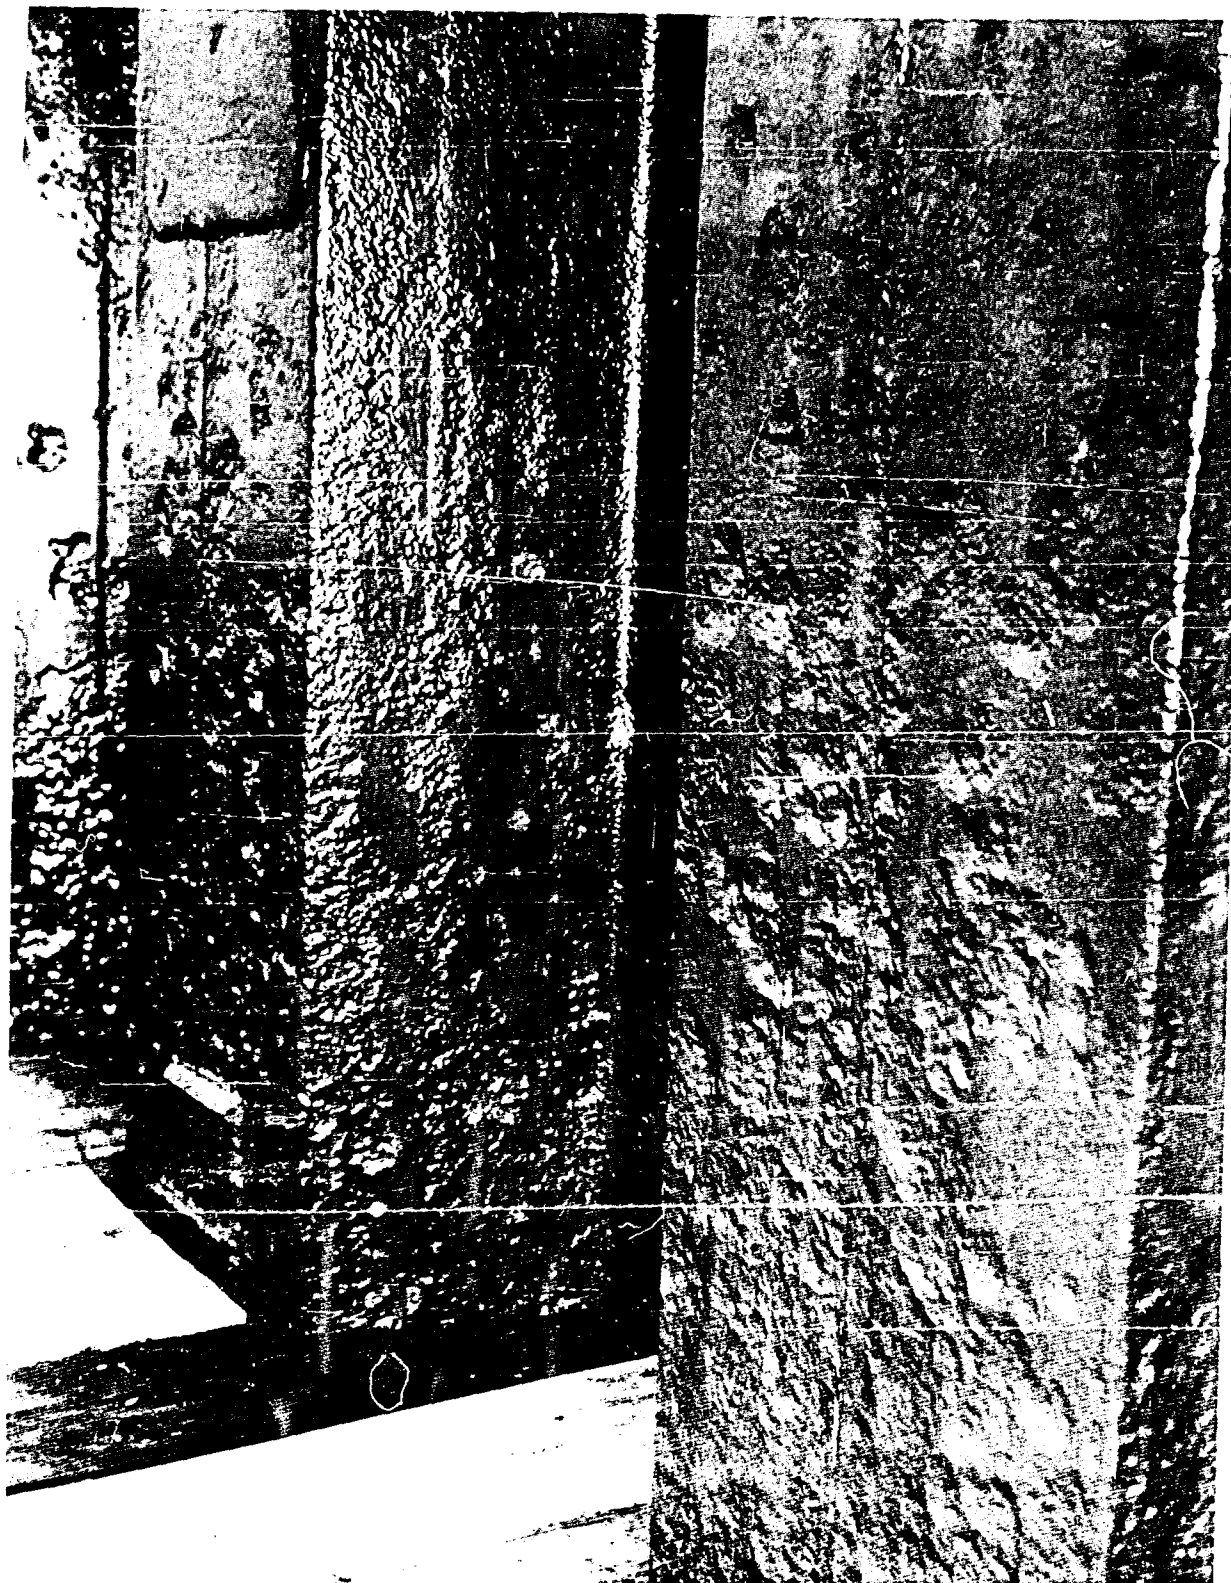
Figure 9 shows a close-up of a section of the piling after the paint coating had been applied. The results of pitting can be seen in this photograph.

Figure 9. Coated section of piling showing effects of pitting, Key West.

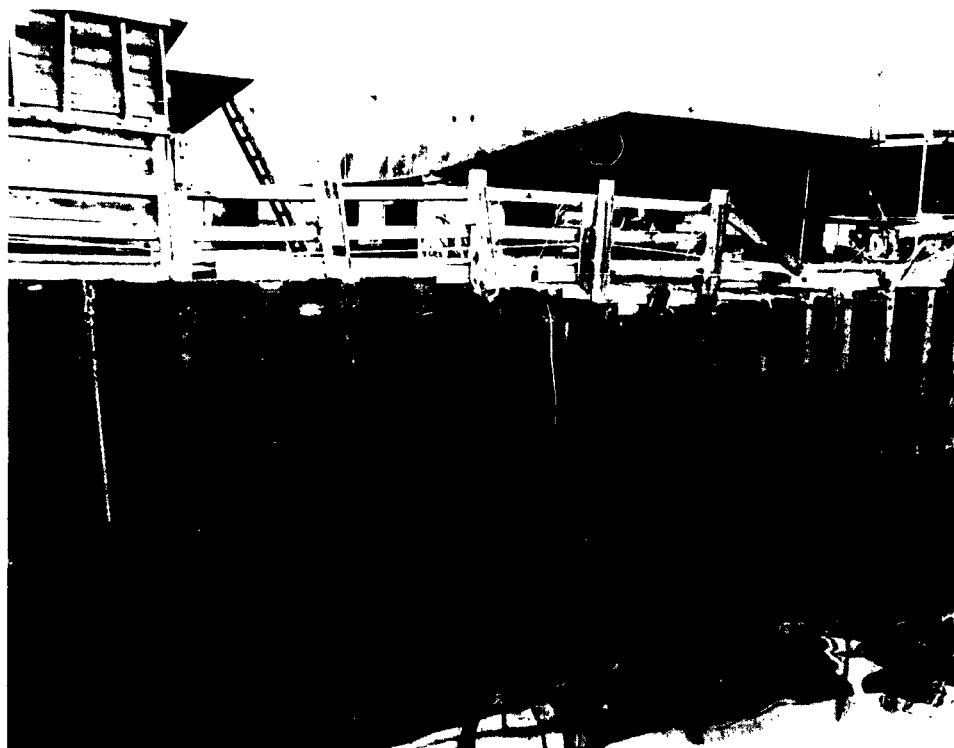
Figure 12. Sheet pile, wet basin, San Diego.

U. S. Naval Station, San Diego, California. The only area in the harbor using sheet piling is the "wet basin." Currently, this area is being used to bring in small craft from naval vessels; from the wet basin they are lifted up onto land and given a hull reconditioning. The harbor in this area is reported to receive discharge from sewage treatment plants and has little regular change of water other than that caused by tidal action.

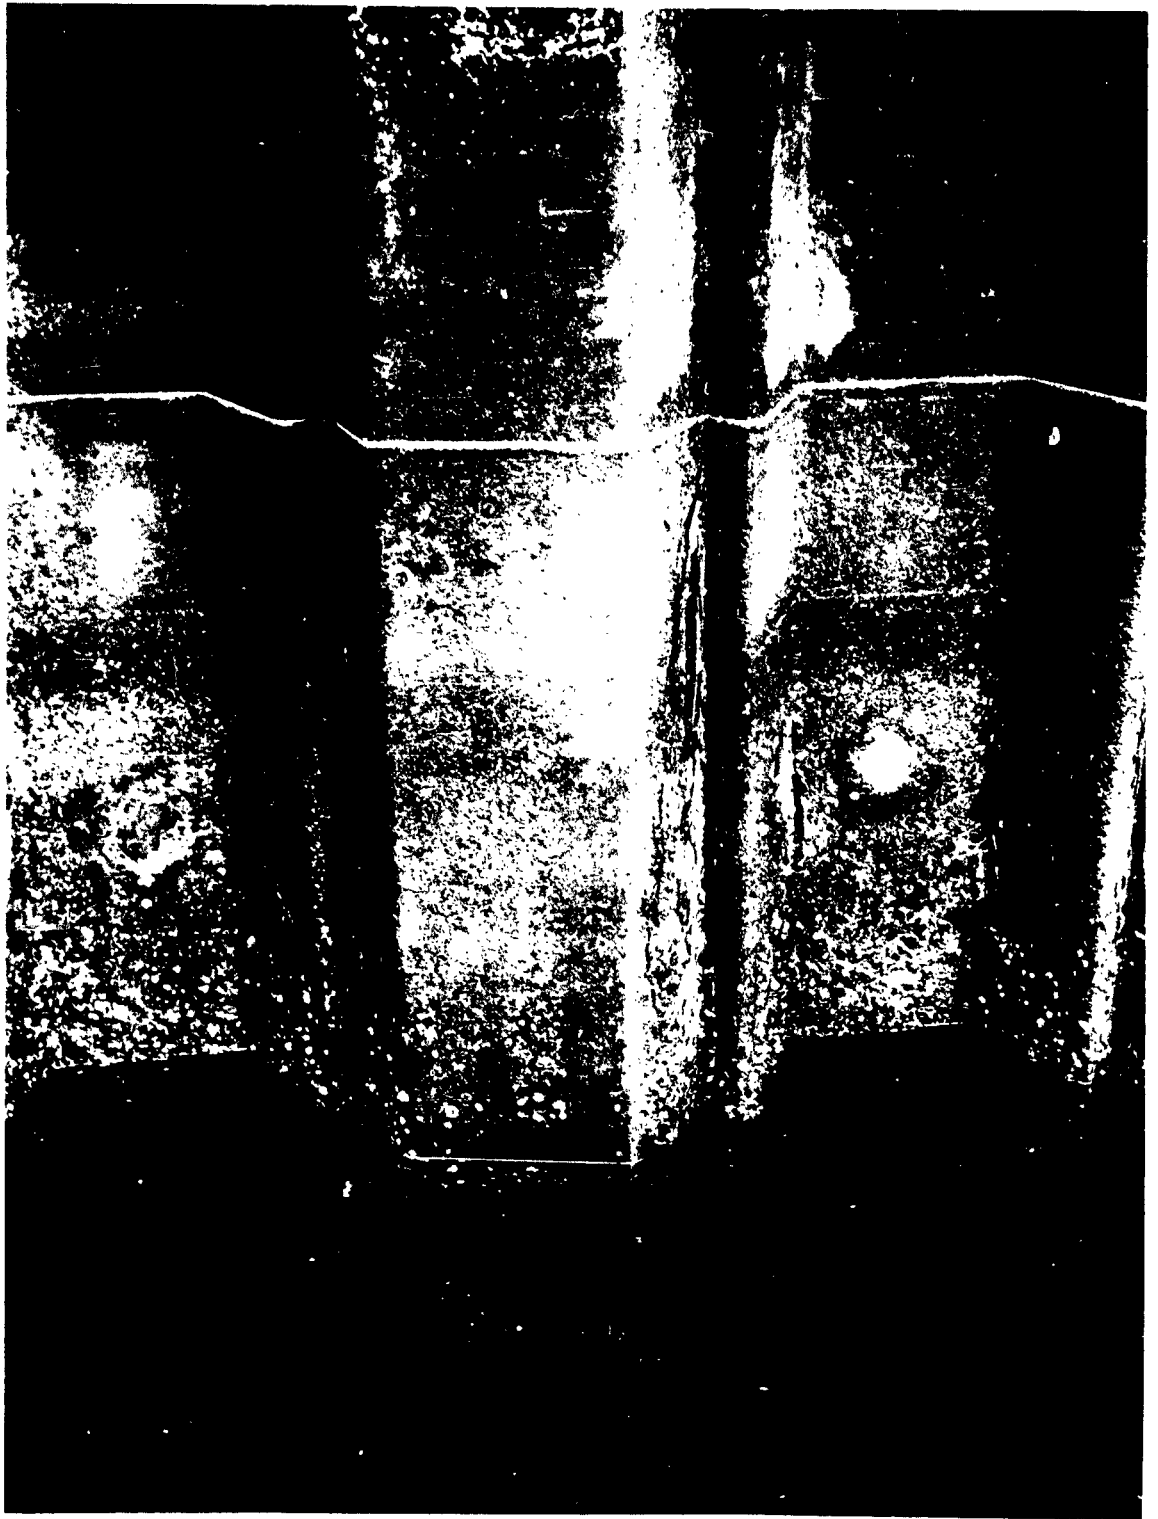
The maximum rate of corrosion, 14 mpy occurred at approximately one foot above MLW and again at about 2 feet above MHW, in the splash zone, Figure 13. A high rate of 12.6 mpy was found 3 feet below the mud line. The average rates of corrosion based on weight loss measurements were found to be about 7 mpy 2 feet above MHW, 8 mpy one foot above MLW and 10 mpy at 3 feet below the mud line, Appendix C.

Corrosion in the lower levels of the tidal range was aggravated by the continuous scraping effect from camels and small boats coming along side of the piling. An appreciable thickness of oxide scale could not form thus reversing the anodic-cathodic relationship normally present in the MLW area.

Figure 13. Close-up of piling near MLW, San Diego.

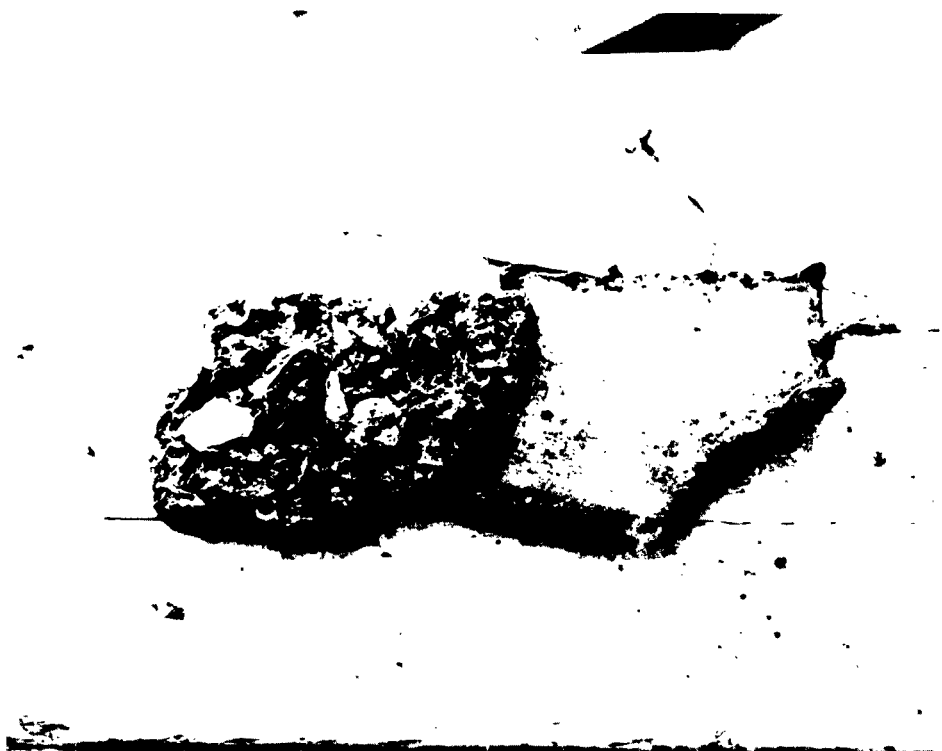
Figure 18. 34Yb coating and test sample, one foot above mud line, Pearl Harbor.
