U. S. NAVAL CIVIL ENGINEERING LABORATORY
Port Hueneme, California

Technical Note N-360

CORROSION STUDIES ASSOCIATED WITH AN AIR
BLAST CLOSURE UNIT

30 July 1959

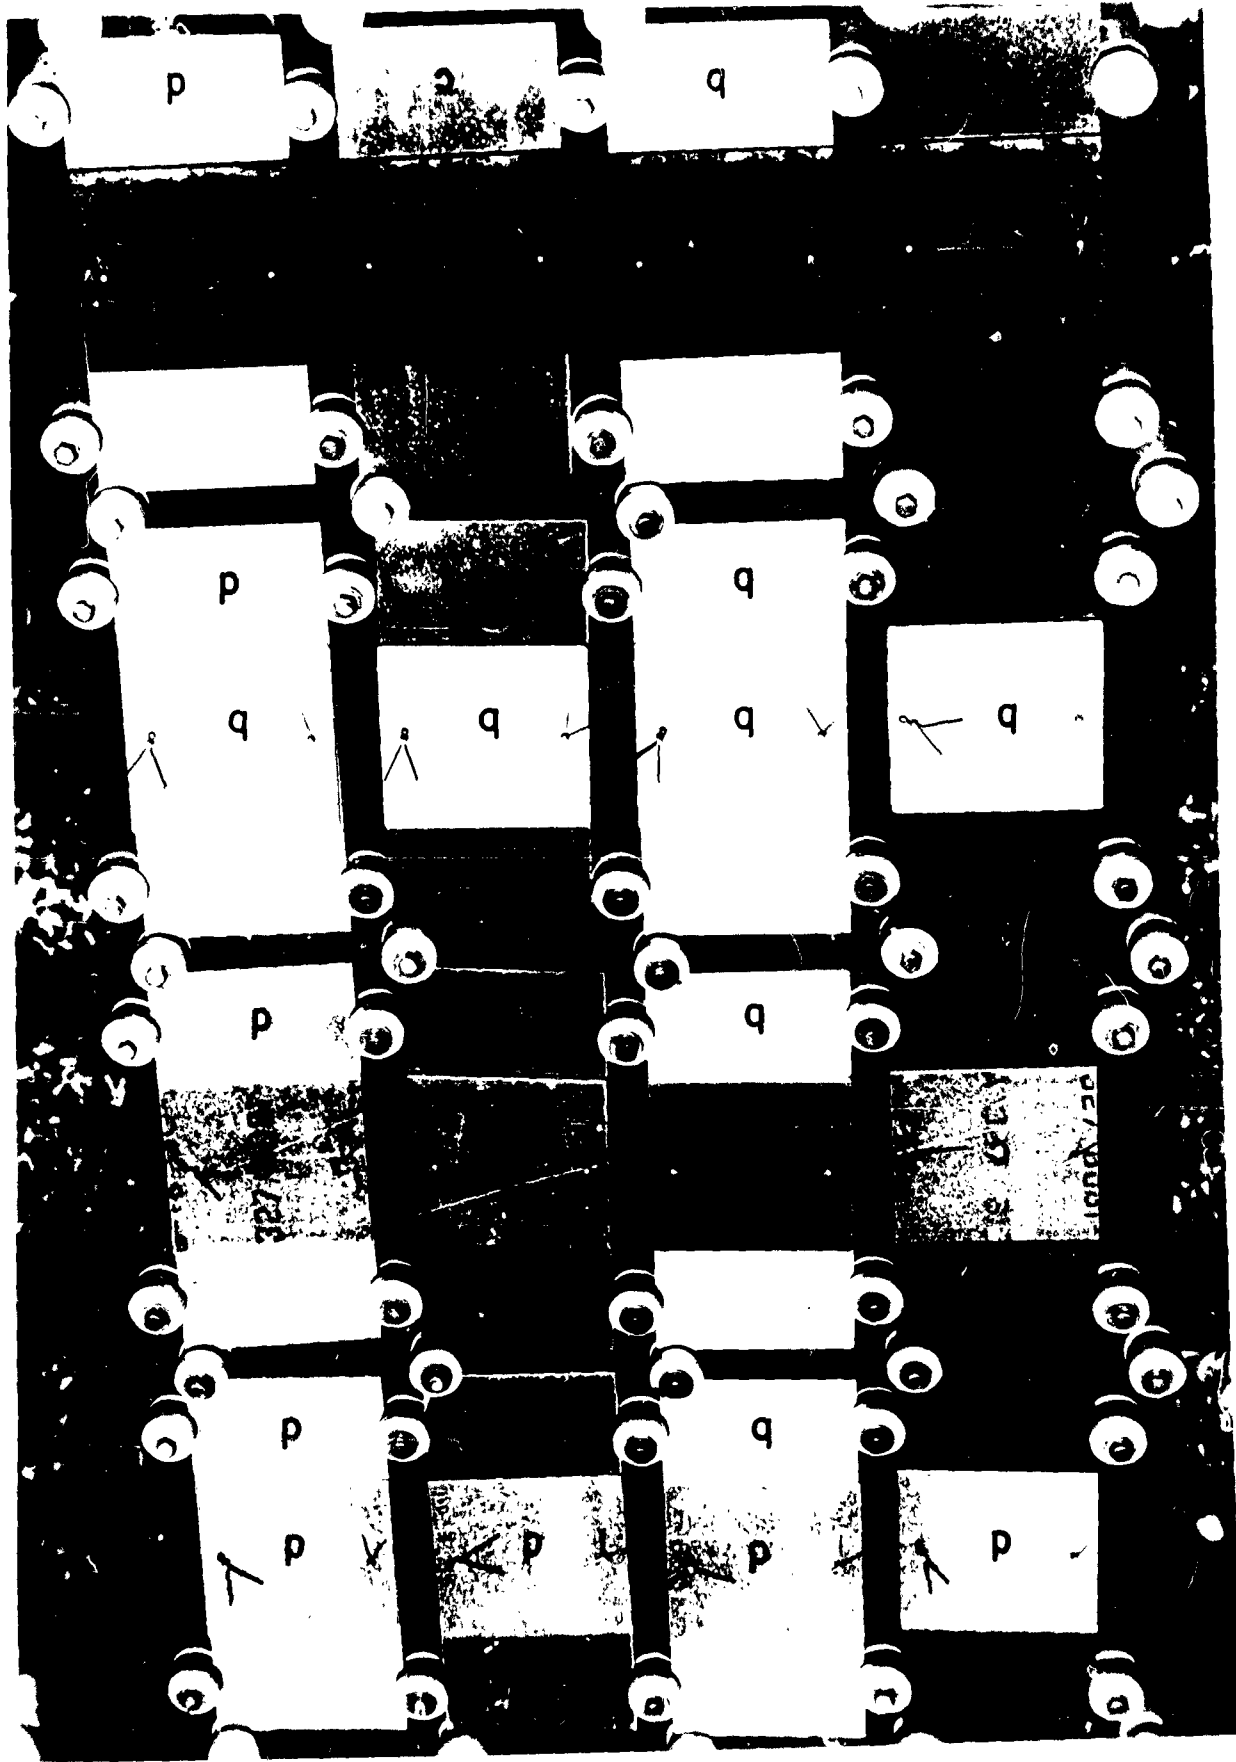
No corrosion was observed on the cadmium plated panels after three weeks exposure. Very slight general attack appeared on the 6061 aluminum alloy and slight pitting attack appeared on the 2024 aluminum alloy. The mild steel shows normal rust over the whole surface of the panel (Figure 8).

Examination of the edges of the smaller (4" x 4") panels at the point of contact with the larger panels showed that some corrosion products had formed between the iron to iron panels (Figure 8, a-a). No corrosion which can be attributed to metal to metal contact was observed at this time between the remaining pairs of metal panels.

Figure 8. Test panels after 3 month exposure. a- Mild steel; b- Cd plate; c- 6061 Al; d- 2024 Al.

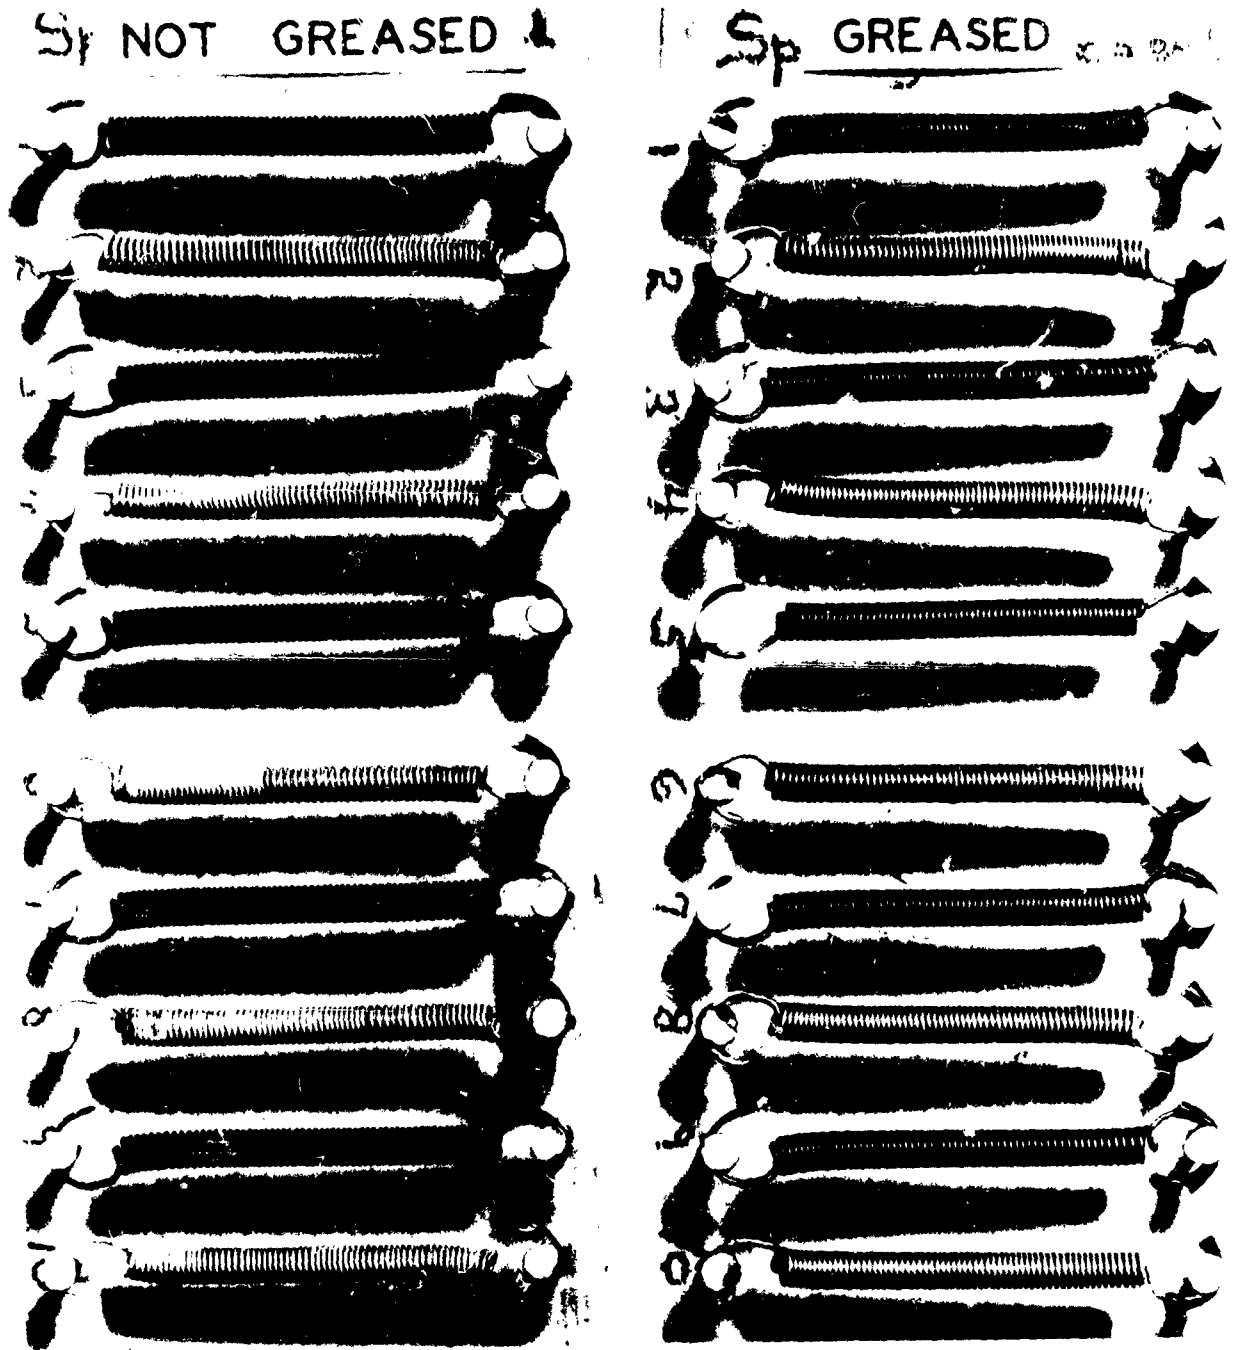
The condition of the test springs after three weeks of both unsheltered and sheltered exposure is shown in Figures 13, 14, and 15. Severe corrosion was observed on the bare steel springs in unsheltered exposure (Figure 13 - not greased - odd numbered). The corrosion of the springs in the sheltered exposure was considerably less (Figure 14). The bare steel springs containing the grease coating appeared to be protected satisfactorily in both types of exposure. Very slight corrosion attack was observed on the cadmium plated steel springs in unsheltered exposure (Figure 13 - not greased - even numbered), and no attack was observed on these springs in sheltered exposure (Figure 14). The greased cadmium springs showed no attack by corrosion in either type exposure.

Figure 13. Unsheltered test springs after 3 weeks exposure.

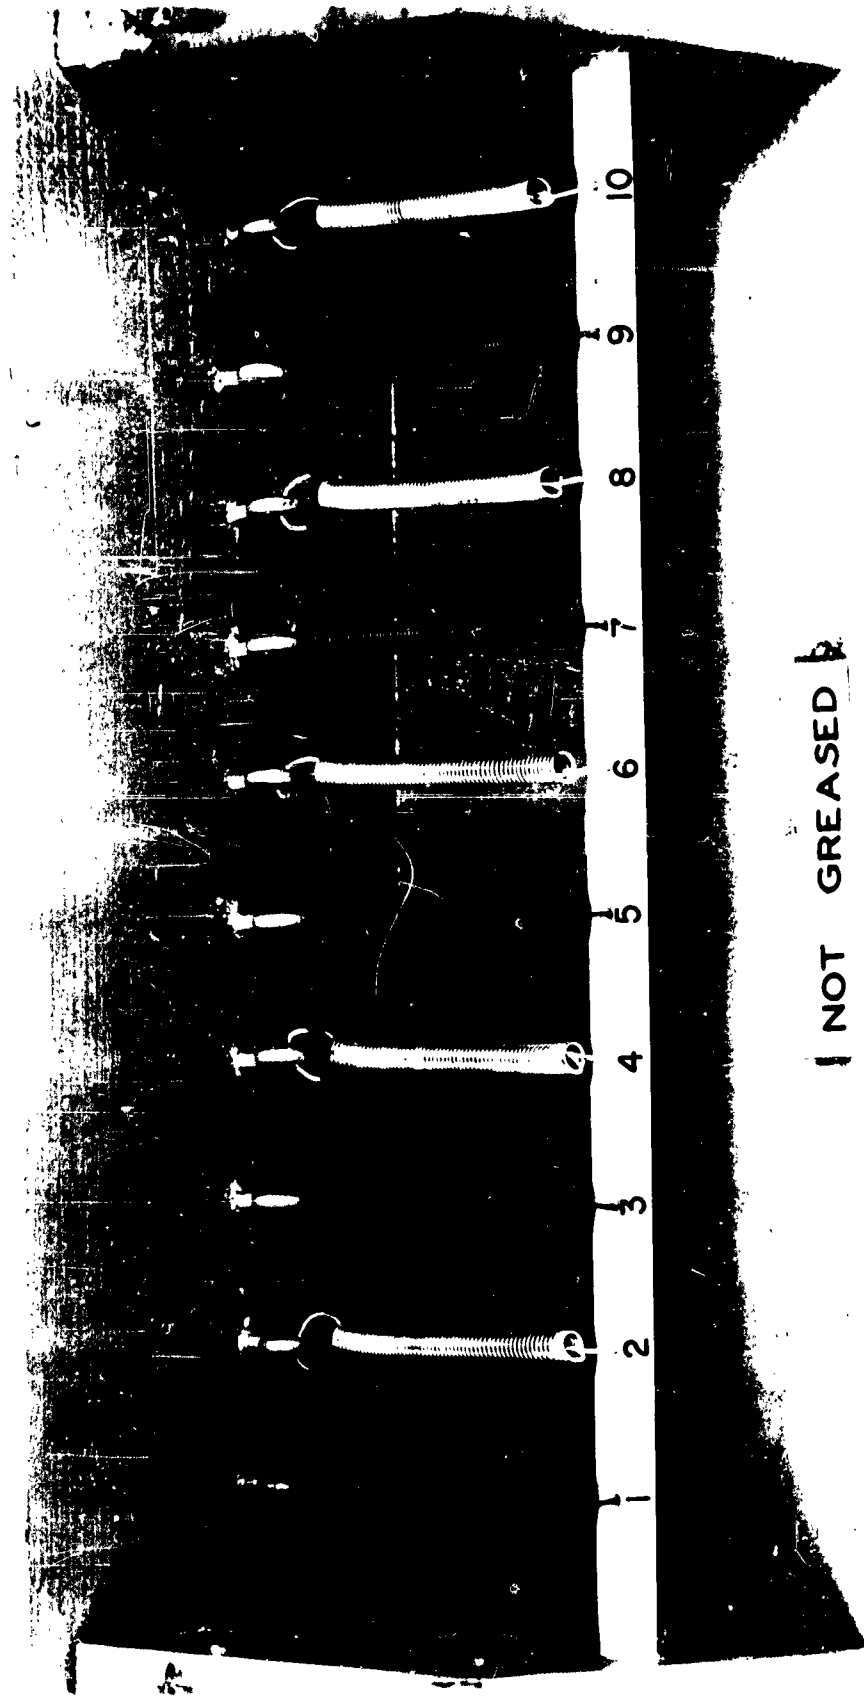
Figure 14. Sheltered test springs after 3 weeks exposure.

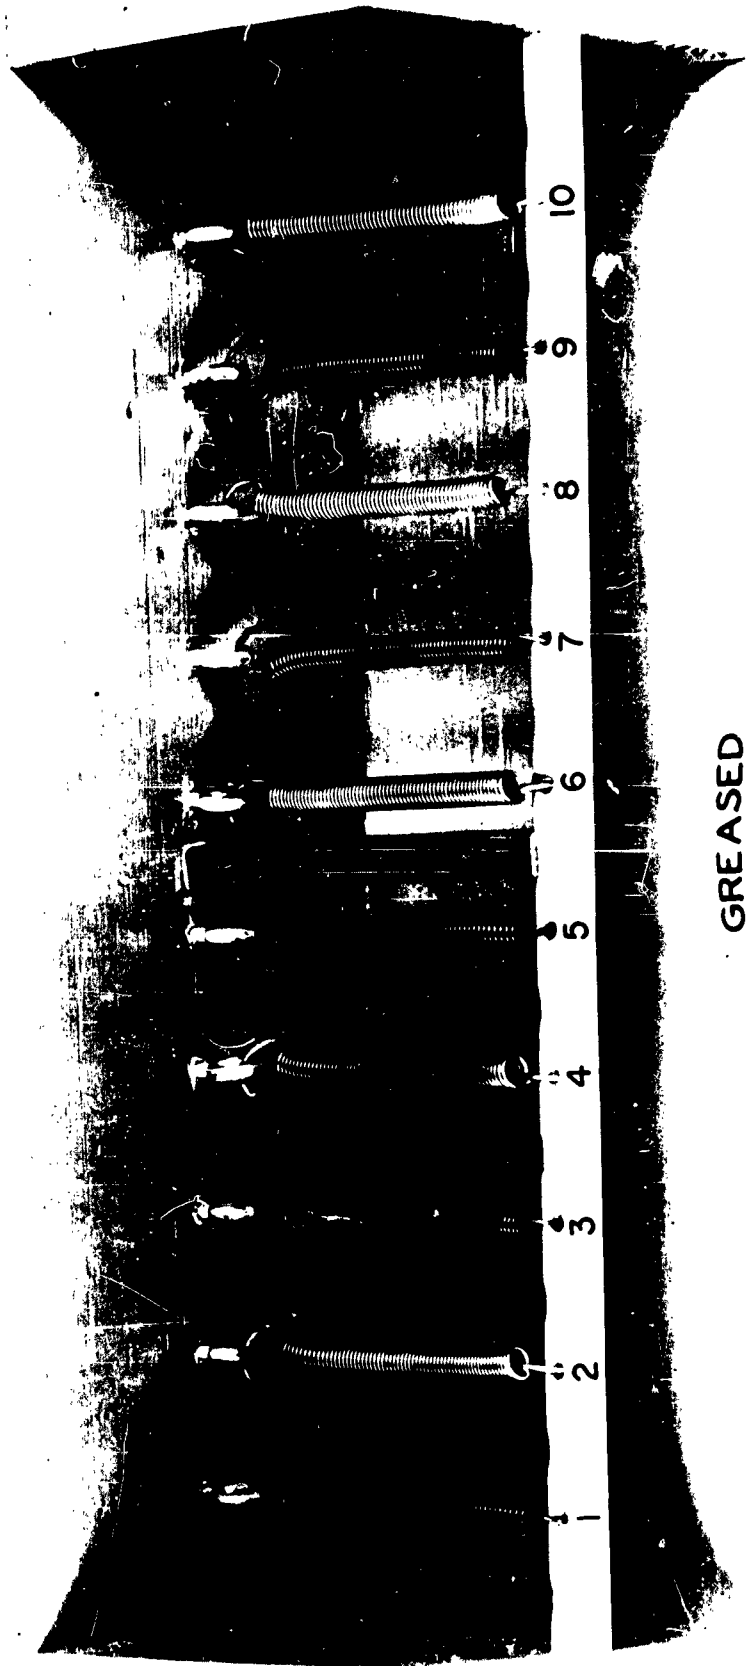
Figure 15. Sheltered test springs after 3 weeks exposure.

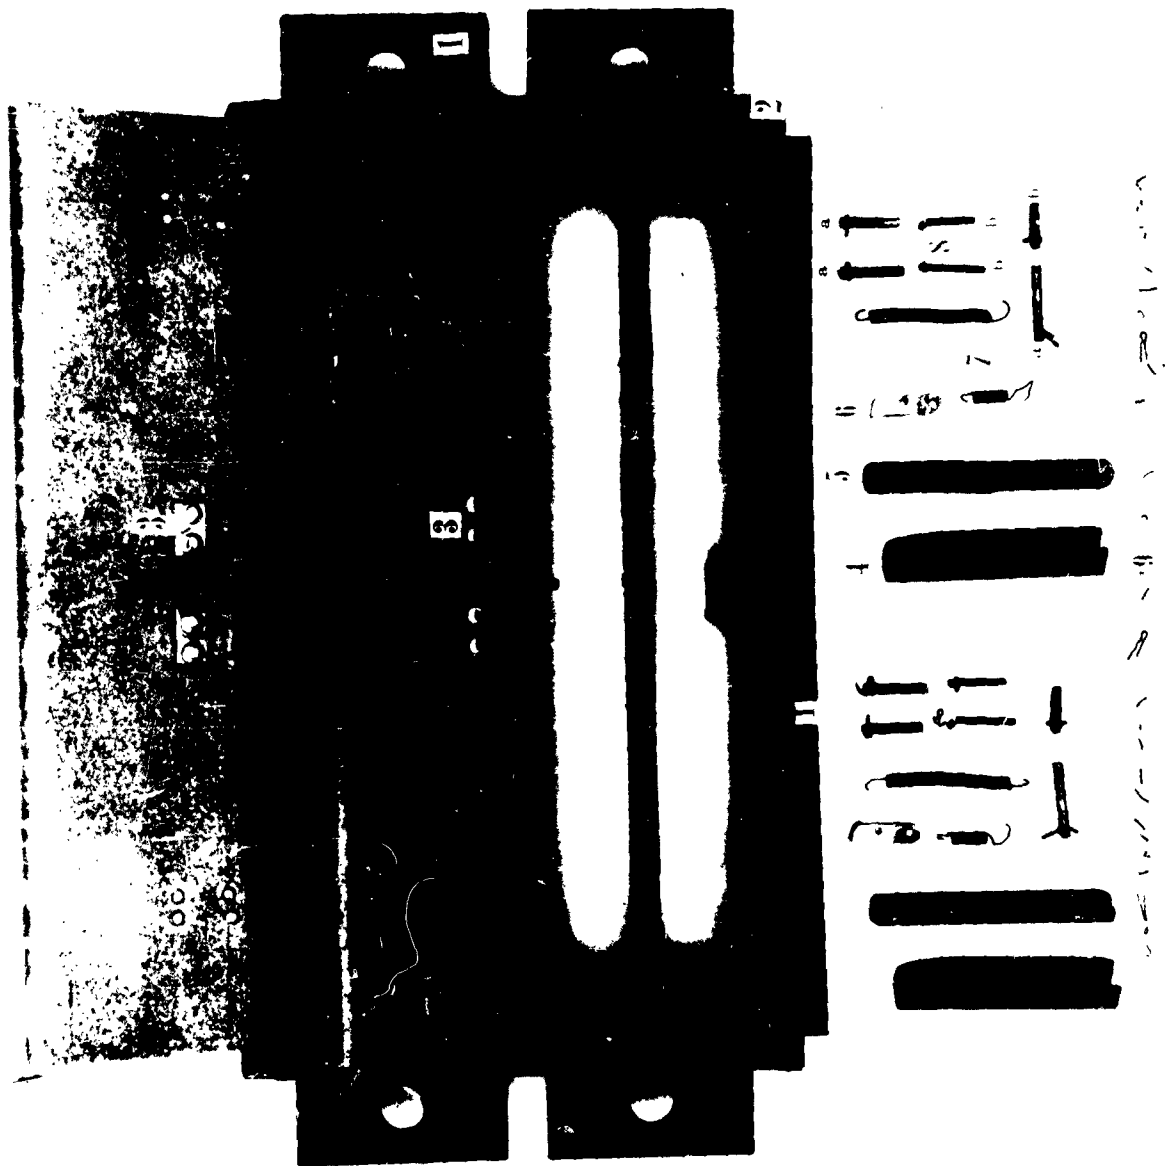
Figures 16, 17, and 18, show the functional parts of the closure unit as they appeared at the end of the eleven months exposure to marine atmosphere at Port Hueneme. Figures 16 and 17 view the closure assembly from the inside. Figure 16 shows the louver doors closed and Figure 17 shows them open. Figure 18 views the closure assembly from the outside with the doors closed; the linkages have been turned over in order to view the convex or outer surface.

The foam gasketing material (2), Figures 16, 17, and 18, appeared to be a cellulose product and was in poor condition. After five months atmospheric exposure, a specimen of neoprene foamed rubber and a specimen

The 2024 aluminum alloy doors (3) showed very mild pitting over the entire surface, both on the inside and outside areas. These pits were covered with aluminum salts or corrosion products and were so shallow that their depth was not discernable with the eye. The strength of the louver doors would not be weakened as a result of this corrosion.

The 6061 aluminum alloy linkage (5) and lock or latch lever (6) were corroded in the same manner as the 2024 aluminum alloy doors. The larger pits on the linkage measured 0.0001 inch, but were only slightly discernable on the lock lever. The strength of the linkage and lock lever did not appear to be impaired.

The steel springs (7) were severely corroded. The spring tension was reduced to such an extent that the springs would not return to their original position after being very slightly extended.

The steel pins (8a), which were cadmium plated, were very slightly corroded. The steel pins (8b) containing no plating were corroded so badly that the lock lever (6) would not operate. The cadmium plated steel linkage (4) could be operated manually in either direction only with extreme difficulty. The unplated steel pins were reduced in diameter by approximately one-third by corrosion attack. Likewise, the steel cotter pins (9) and the unplated pins (8b) were cemented together by corrosion products so that the cotter pins could not be removed without breaking them apart.

Figure 17. Moving parts of Closure Unit after 11 months exposure, View 2.

1. Use neoprene foam rubber for the gasketing material (2), Figures 1, 2, and 3.
2. Fabricate the louver frame, (1) Figures 1, 2, and 3, and brackets (11a, 11b) Figures 3 and 21, from 6061 aluminum alloy.
3. All supporting pins (8) and cotter pins (9), Figures 16, 17 and 18, should be heavily cadmium plated (0.001 inch) and grease coated with an inhibited soft grease such as AN-C-124a, AM3 Type II.
4. All metal springs should be coated with an inhibited soft grease such as AN-C-124A, AM3 Type II.

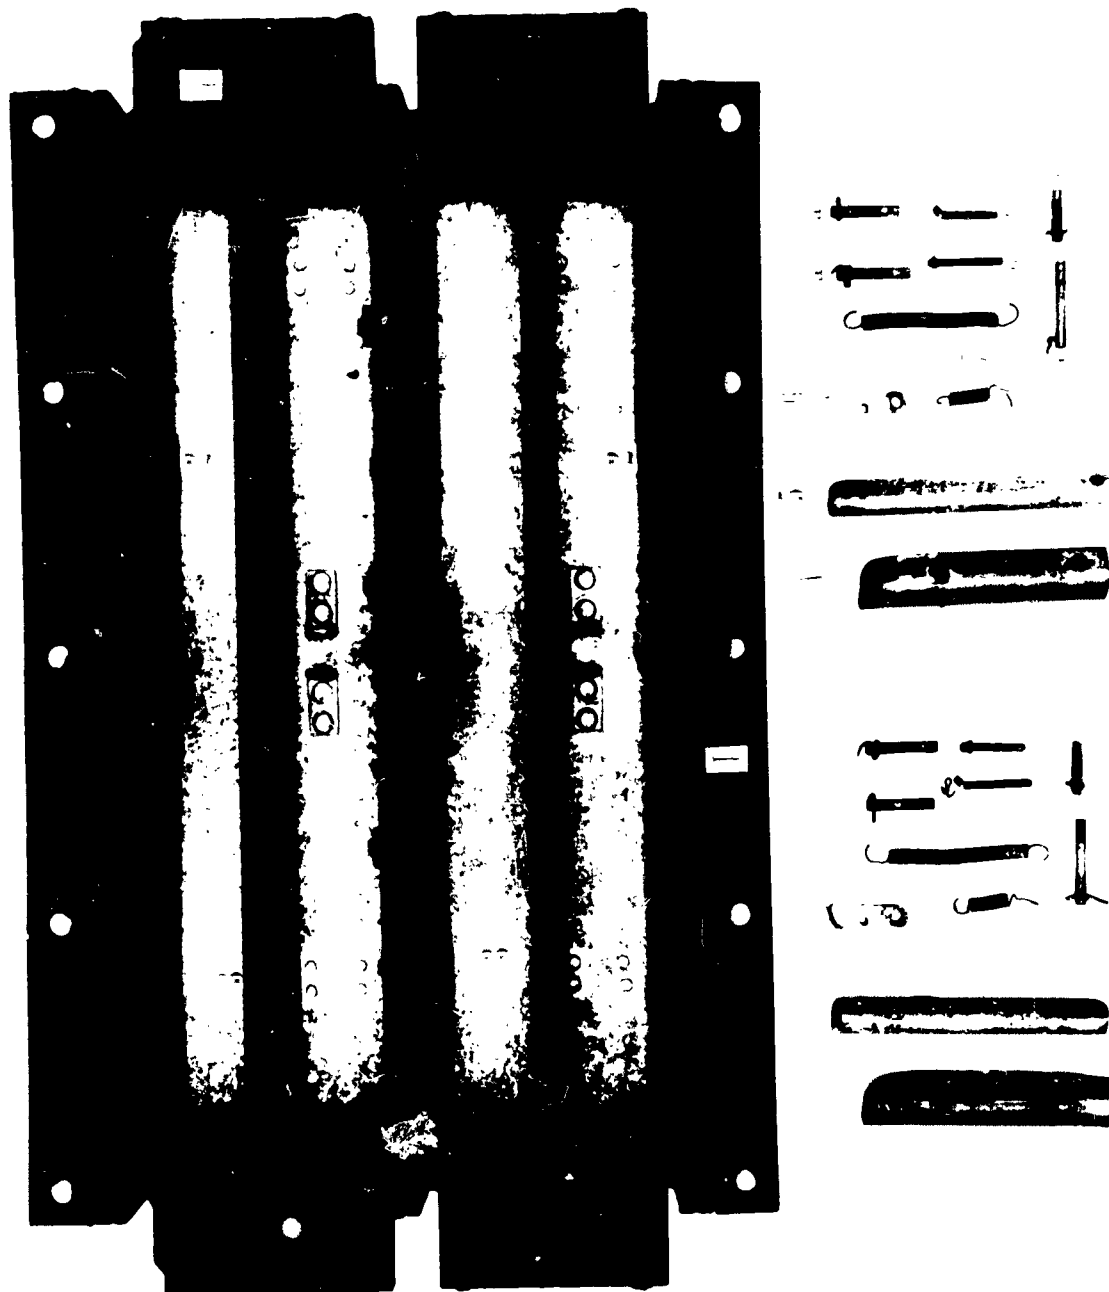
Figure 18. Moving parts of Closure Unit after 11 months exposure, View 3.

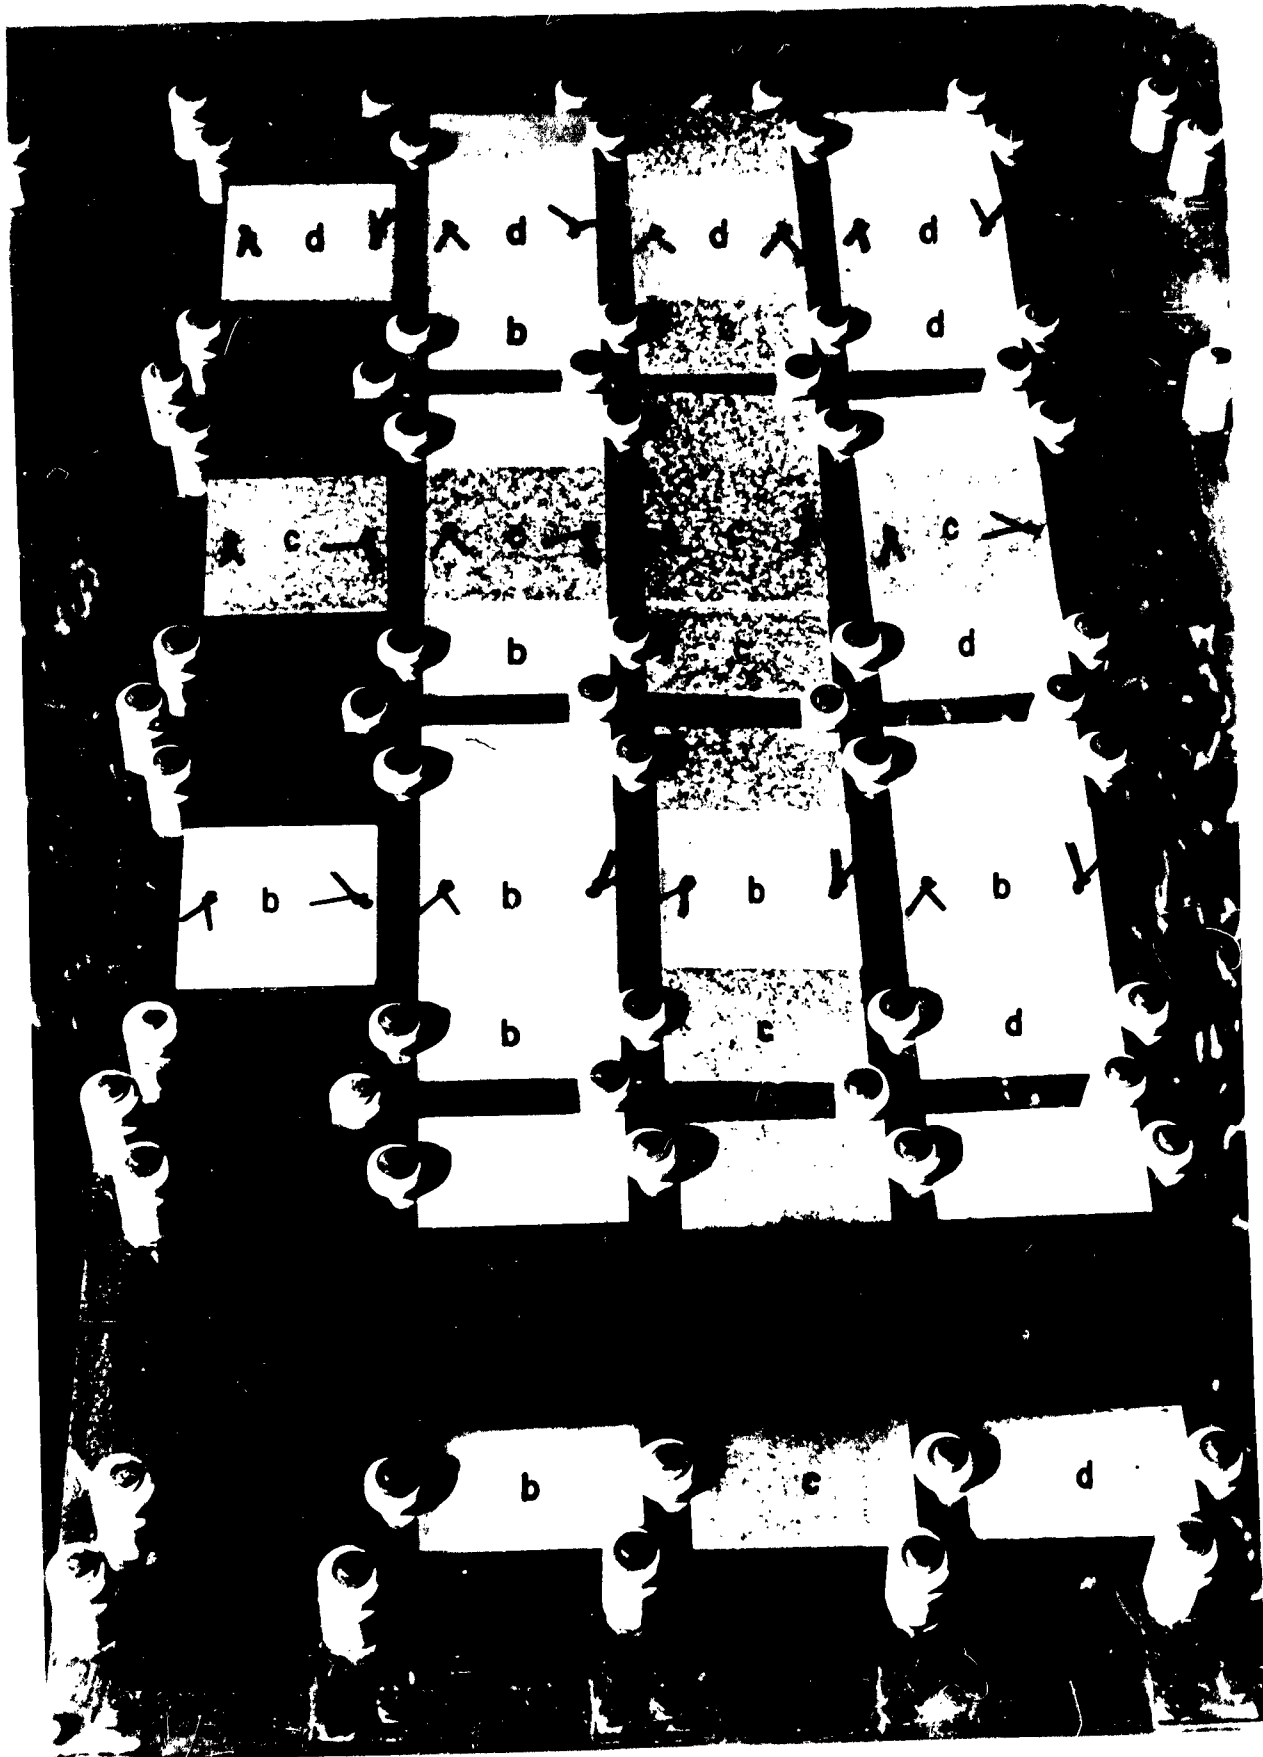
The corrosion on the specially prepared metal test panels, Figures 19 and 20, was of the same severity as that which occurred on similar

metal combinations of the closure unit. However, the contact between the large and small metal test panels did not result in increased corrosion products, and the small panel was easily lifted from the larger panel. Corrosion products were not sufficient in quantity to cause the two panels to become cemented together during the period of exposure (Figure 20). Possibly sufficient aeration was present to prevent a condition of prolonged dampness between the panels. As expected, the unplated steel panels (a) were severely corroded. The cadmium plated panels (b) were free of corrosion attack. The cadmium plating on the metal test panels measured 0.001 inches and is considered a heavy coating. The 6061 aluminum alloy (c) and the 2024 aluminum alloy (d), Figure 20, showed varying amounts of corrosion products over their entire surfaces. The quantity of corrosion products appeared to be slightly more on the 2024 aluminum alloy (d), than on the 6061 aluminum alloy (c). However, the pitting which occurred beneath the corrosion products appear to be insignificant in either case and was not measured.

In Figures 19 and 20 the cotter pins at the left (a) were cadmium plated and those on the right (b) were uncoated mild steel. The round steel pins which held the two metal panels together were cadmium plated and were not corroded. However, the steel cotter pins which were not cadmium plated (b) corroded so badly that they broke apart and could not be removed from the hole in the end of the round steel pins. The cadmium plated cotter pins (a) were corroded but could be loosened in the holes at the end of the round steel pins, yet they were sufficiently weakened by corrosion that they also broke apart upon being removed from the round steel pins.

Figure 19. Special test panels after 9 months exposure.
a- Mild steel; b- Cd plate; c- 6061 Al; d- 2024Al.
