WADD TECHNICAL NOTE 60-296

## F-102 HIGH-ALTITUDE FLAMEOUTS IN AND AROUND THUNDERSTORMS

Project Nr 201A(1)

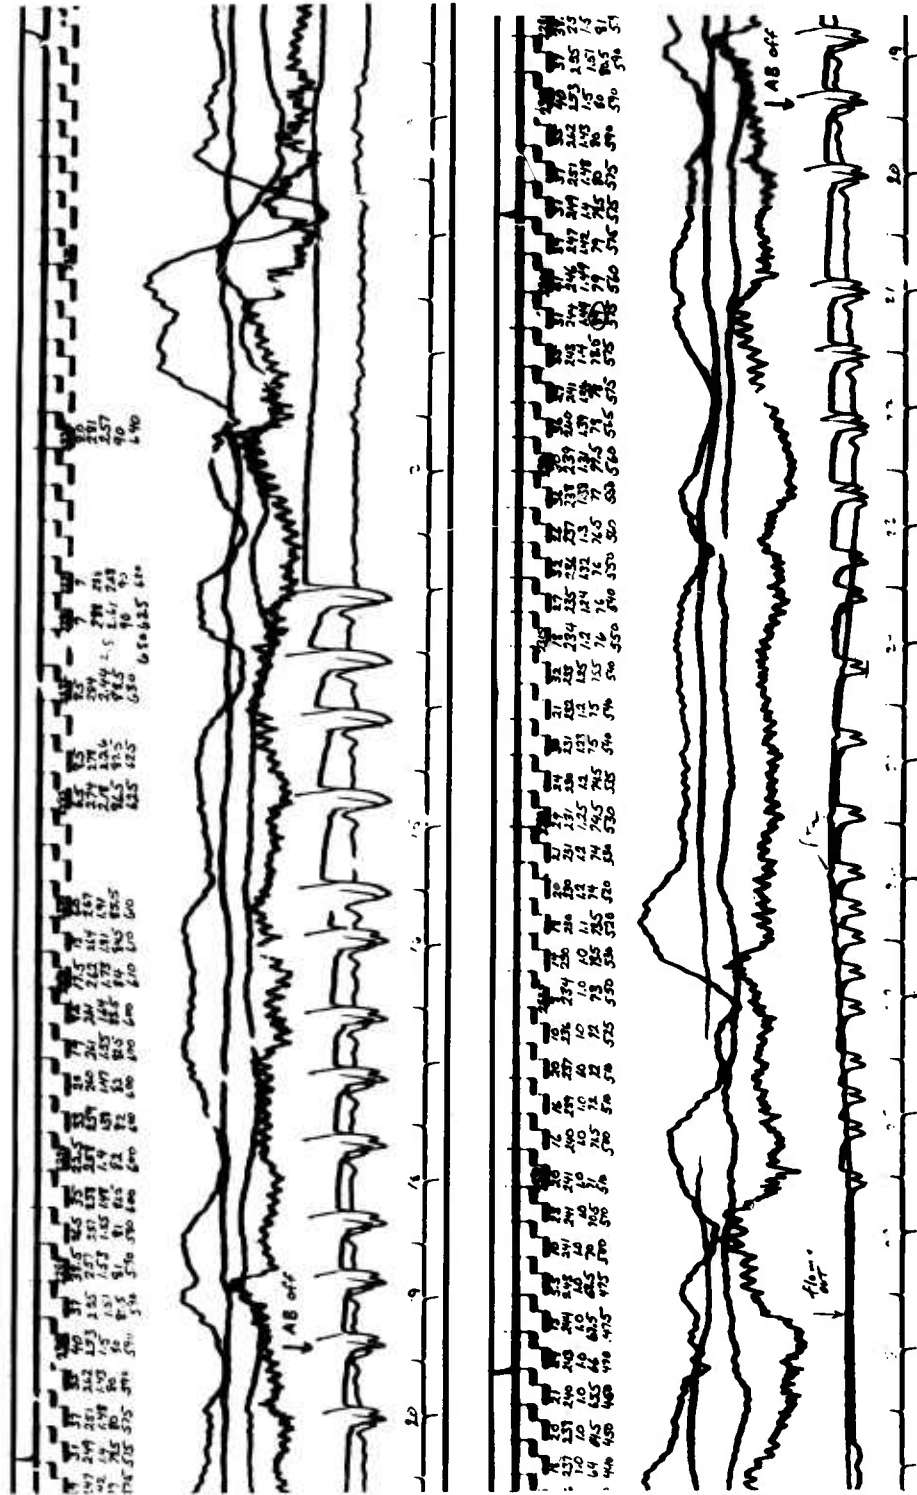
35. The flight handbook 220 KIAS best glide and best engine restart speed which is also recommended in the flight safety supplement was well proved in the tests. On Flight Nr 12, Pass Nr 8, after the flameout, in order to clear the storm center quickly, the pilot maintained the airspeed at least 20 knots above the recommended 220 KIAS, and at times, was as high as 300 KTS. He was unable to restart the engine until he brought the airspeed down to 220 KTS. By this time he had tried three restarts and was close to 31,000 feet altitude.

Figure B4. Oscillograph recordings of compressor stalls experienced during Pass Nr 8 of Flight Nr 12, Project "Rough Rider," 27 May 1960.

"On the last pass, I had the burner going, and with the speed brakes out to keep from going supersonic. In fact, I was playing with the speed brakes to try to maintain around .9 to .92 Mach number. Very shortly after entering the storm, through heavy clouds, the engine started stalling just as it had before with 'military' power. I was in turbulence and had experienced probably a half-dozen stalls or more when I pulled the throttle out of AB into military power. Shortly thereafter, the thing just flamed out. I continued on heading. When the RPM wound down to below 70 percent, I knew the thing had quit, so I pulled the throttle back to idle and then, while still in the storm, selected dual ignition rather than single, and just set up a glide to continue on out of the storm. Broke out about 36,500, as I recall, and the fire never did start again by using the continuous ignition switches. However, I feel sure this was due to the fact that the RPM was still a little bit too high. When the RPM finally stabilized between 25 and 30 percent, I 'stop-cocked' the throttle and turned the ignition off for a few seconds; then made a normal air start using the ignition button on the throttle. The first time I attempted this at about 34,000, it didn't work, so I shut it off again. The second time, it fired at about 31,000. I feel quite sure it would have been impossible to 'deadstick' the thing due to the canopy's and windshield's icing over, which it does on every flight; so it was fortunate that we got the thing started."

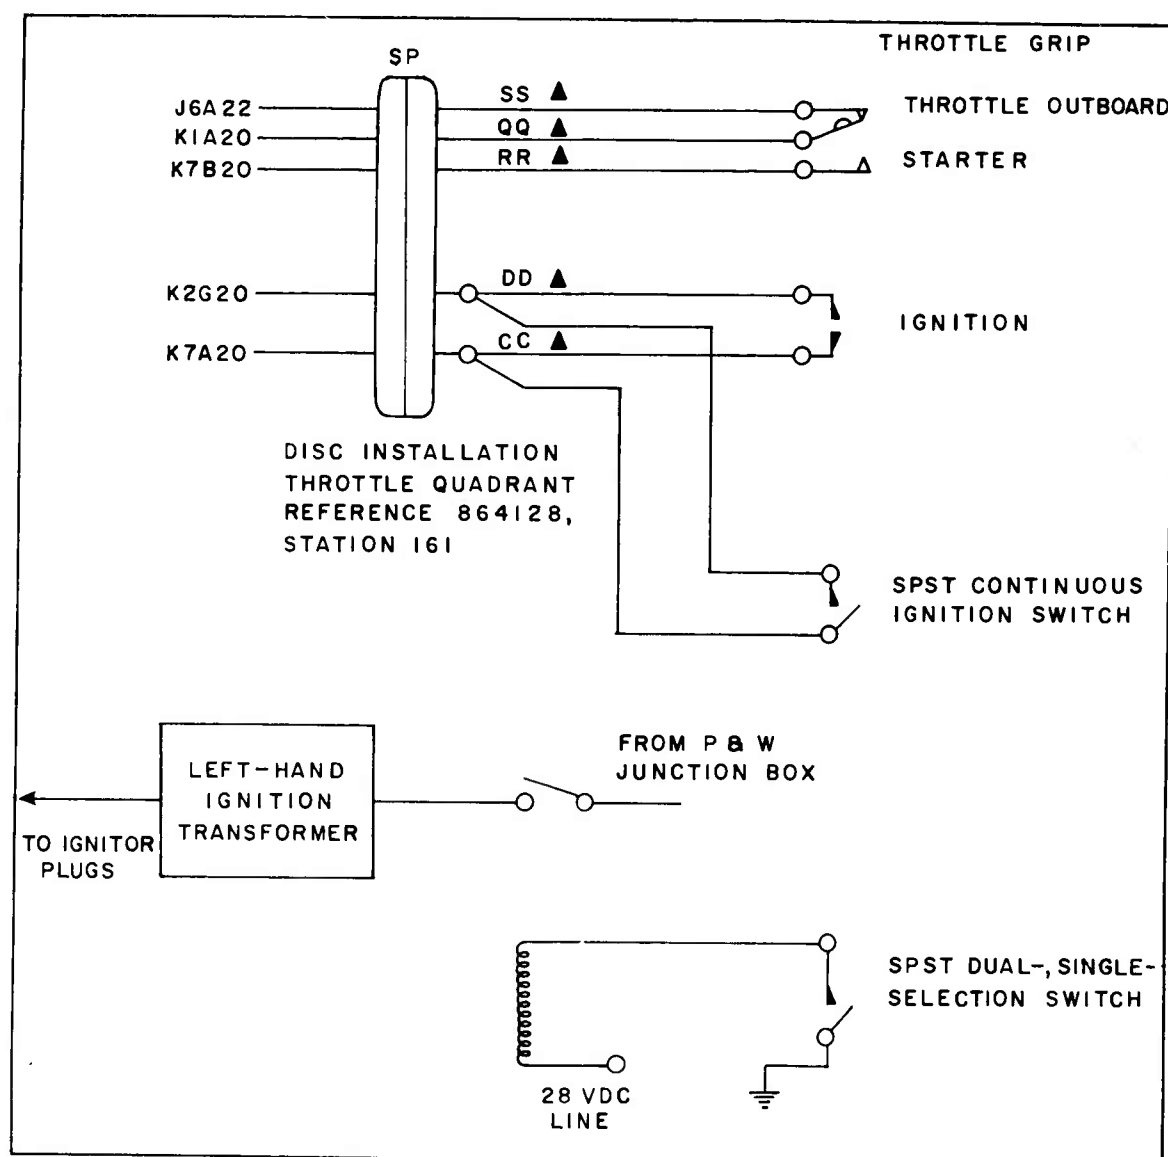
Figure C1. Recommended continuous ignition system, as used in the test aircraft for flights over Oklahoma City, Oklahoma, for installation in all F-102A aircraft. (The only alteration necessary to the present wiring system of the F-102's is the SPST switch installed in parallel across the pilot's push button switch, which is installed on the throttle. The extra switch is installed in a convenient location and relieves the pilot from having to hold the throttle button during each thunderstorm penetration. The relay shown at the bottom of the drawing was installed in the test aircraft to provide single- or dual-mode ignition. Only one side of the ignition system was used during actual tests, the other being left in reserve as a safety factor. This dual capability would not be necessary in the normal installation since the ignition system would not be subject to such long periods of use.)

37. It was recommended that a simple electrical connection for continuous operation of the ignition system by means of a single switch on the pilot's panel be installed in all F-102 aircraft. (See Figure C-1.) The ignition system on the test aircraft has been operated in this manner for many hours with no malfunction.
