# *U.S. ARMY ENGINEER REACTORS GROUP*

**Report OSB 15**

**Preliminary  
Investigation of SM-1 Control  
Rod Seal Failure**

18 April 1961

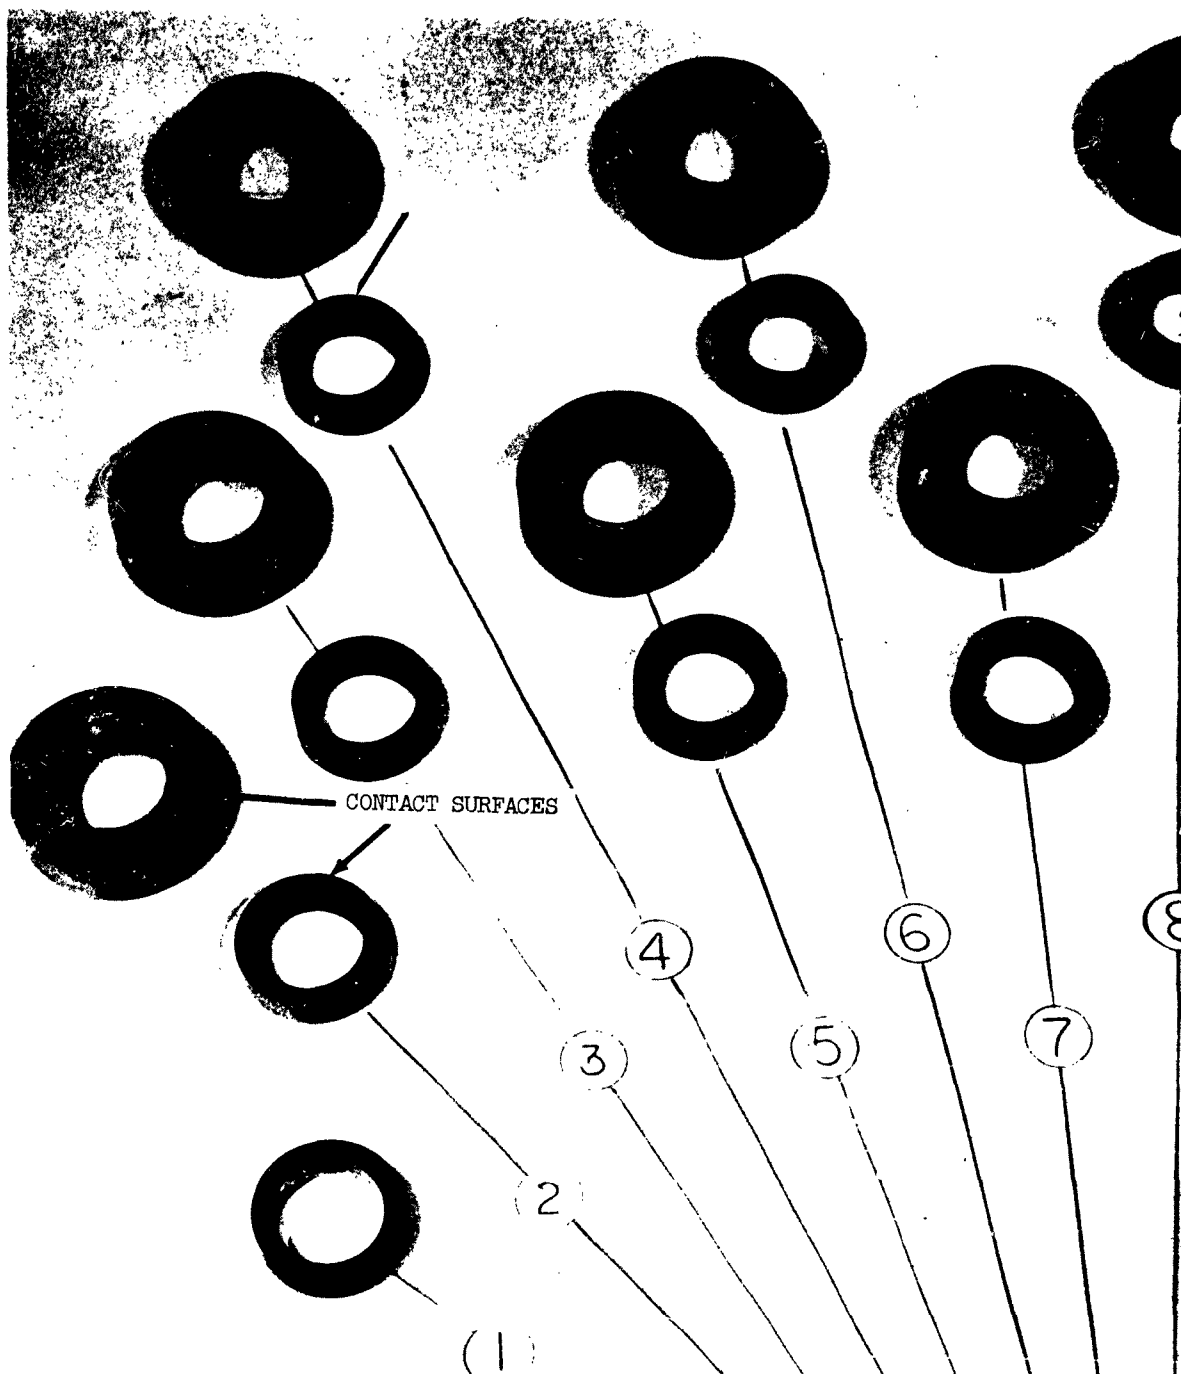
The defects believed to be blistering and cracking (Fig 7 and 8) of the chrome plating at seal ring locations 10 and 11 (Fig 2) could conceivably be caused by overheating. It may be possible that useful life would have been longer if the chrome plating had not been used. It was noticed that the seal rings were only worn on the outboard side where the thrust forced them to ride against the contact surface on the diaphragm as designed. Figures 7 and 8 show close-ups of these surfaces. It should be noted that on most seal ring faces there is a groove corroded into the seal ring concentric with the contact surface which is believed to contain crud. There was no obvious wear on the seal ring inside diameter, although some is expected.

Fig. 7. SM-1 Seal Rings & Diaphragms of Control Rod Seal "B" (1)
