# Development and Proof Services

AUTOMOTIVE DIVISION

EVALUATION TEST OF ANTISEIZE COMPOUND  
FOR TANK AND VEHICLE APPLICATION

Report No. DPS-232

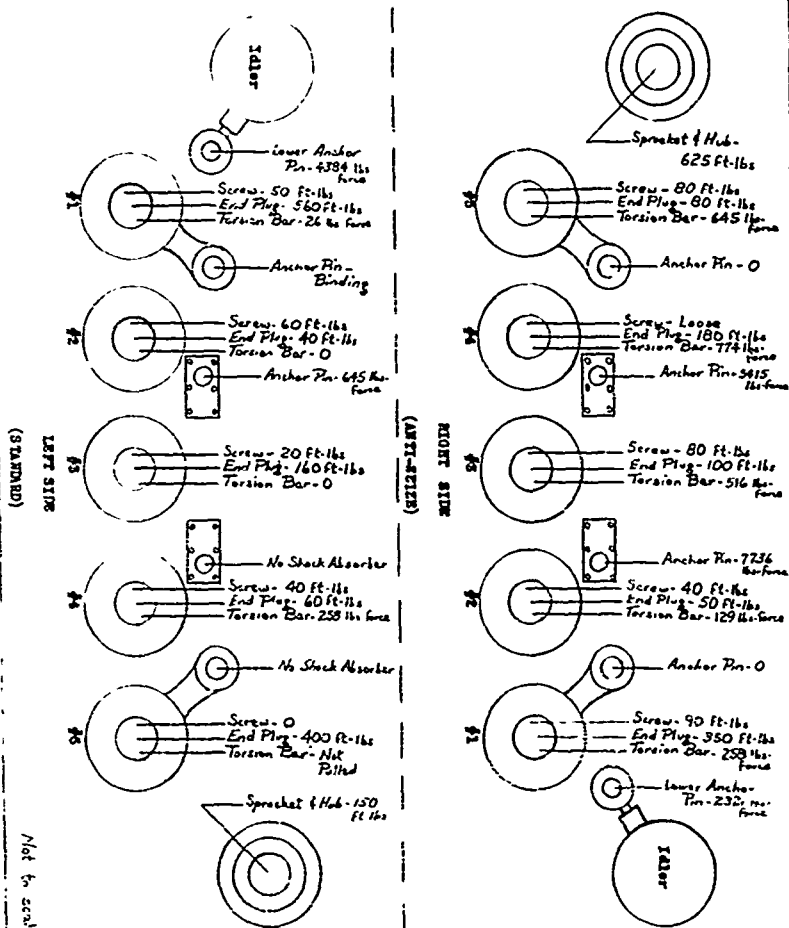
3.4.10 Comparative Efforts. Figure 2 shows the comparative efforts required to break loose parts on the T95 vehicle.

Figure 2: Comparative Amounts of Effort Required to Break Loose Parts on Tank, T95ED.
