TR-959

AN INVESTIGATION OF THE DYNAMICS
OF THE ELECTROLYTE DISTRIBUTION SYSTEM
IN THE PS502-502A POWER SUPPLY

24 July 1961

DIAMOND ORDNANCE FUZE LABORATORIES
ORDNANCE CORPS ● DEPARTMENT OF THE ARMY
WASHINGTON 25, D. C.

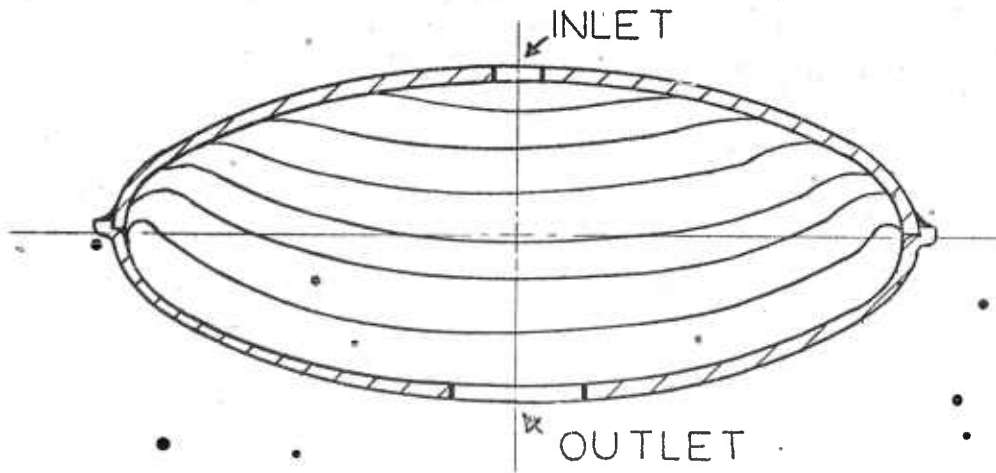
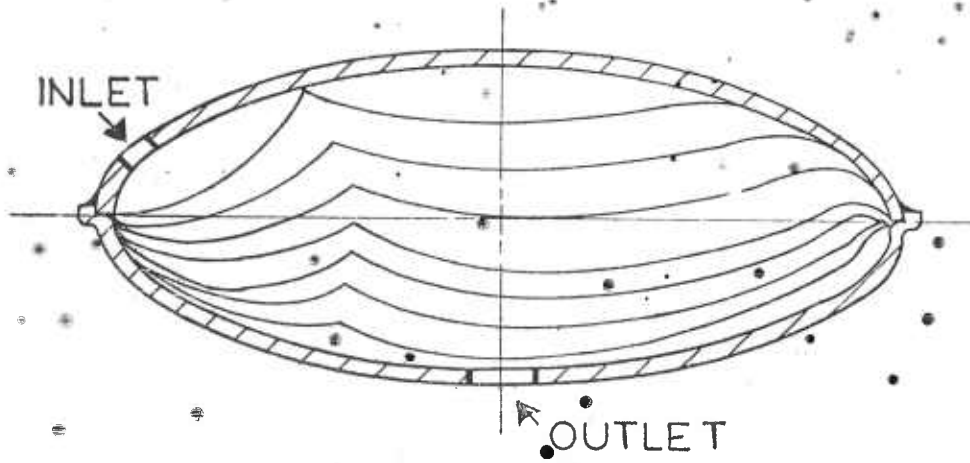
Recent tests have shown that the diaphragm does not fold from the center, but from one edge (at the gas inlet point) and then from the

center (fig. 2). This improper folding results in sharp creases and occasional fracture of the diaphragm, particularly after extreme vibration (ref 2). A highly stressed point where two creases had intersected is shown in figure 3. A failure zone is shown in figure 4. These 10X microphotographs were made of dissected reservoirs taken from expended batteries. Careful examination under higher magnification showed that the failure is entirely mechanical and is not caused by local corrosive action or foreign inclusions (ref 3). Figure 5 shows the location with respect to the gas inlet of diaphragm failures found in 15 batteries from a group of 30 in a recent laboratory test (ref 4).

Figure 2. Proper diaphragm inversion and actual inversion.

(1) Move the point of gas entry into the reservoir from the edge toward the axis of the reservoir to allow the diaphragm to fold properly. This could be done without changing the container dimensions if the gas inlets are arranged as in Setup A4 and A5. A single inlet on the axis would require a substantial increase in one dimension.

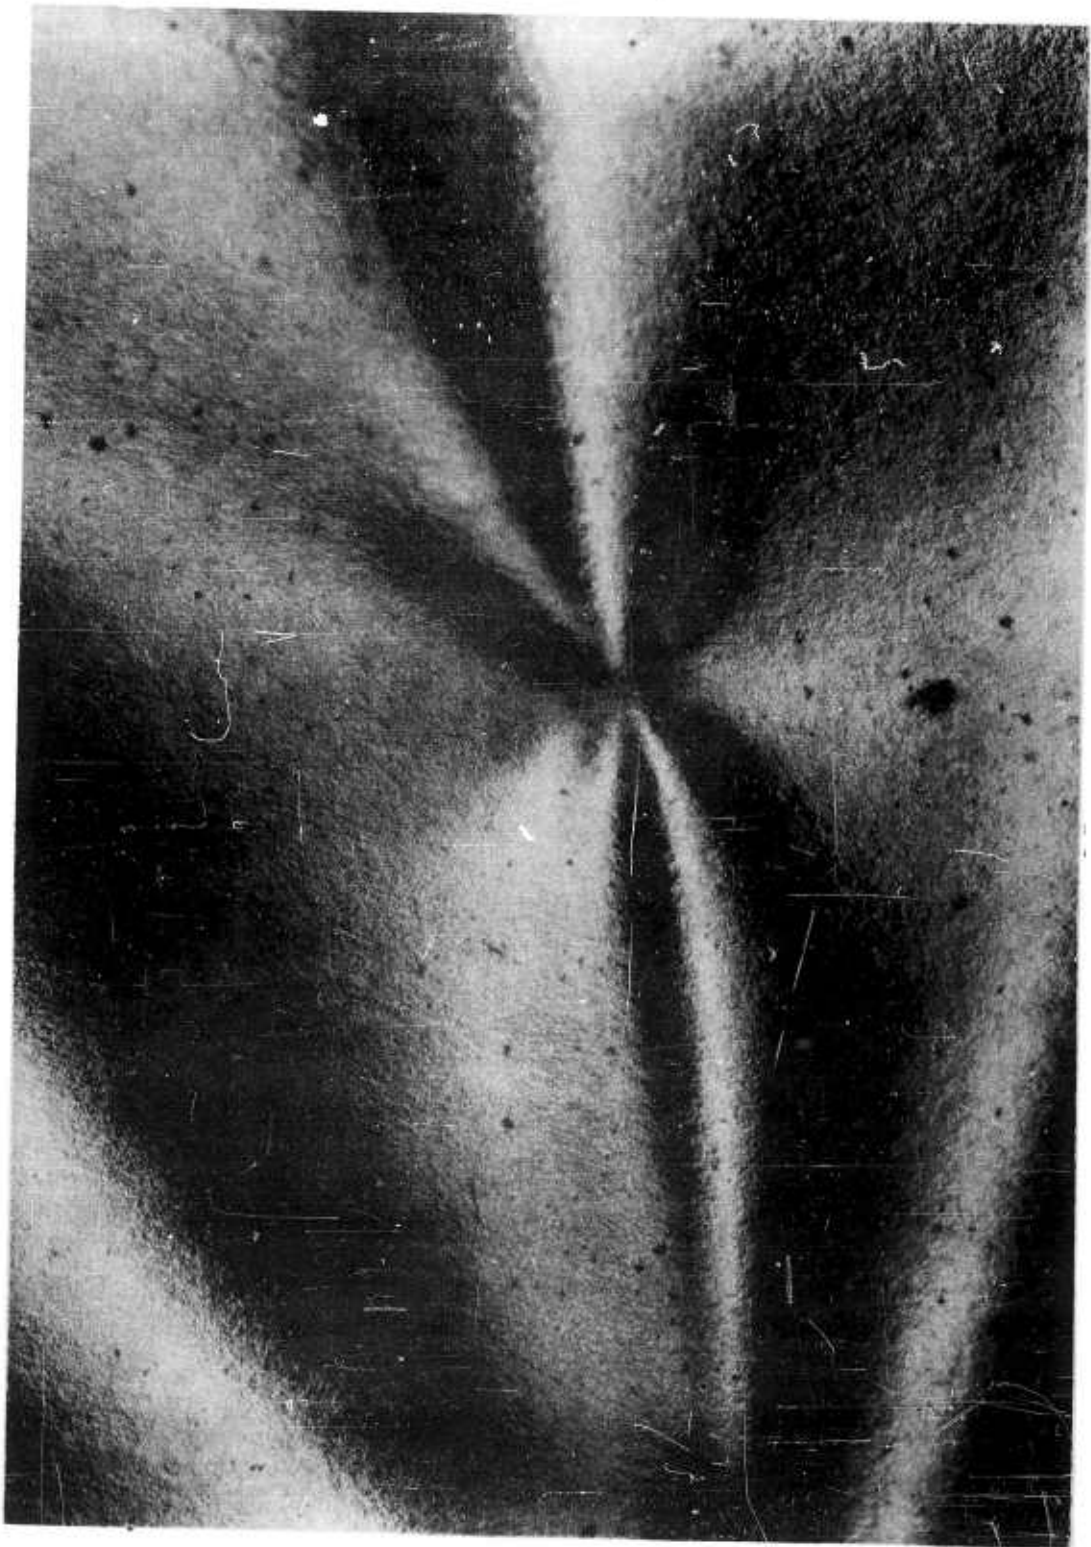
Figure 3. Microphotograph of stressed point in diaphragm - 10X.

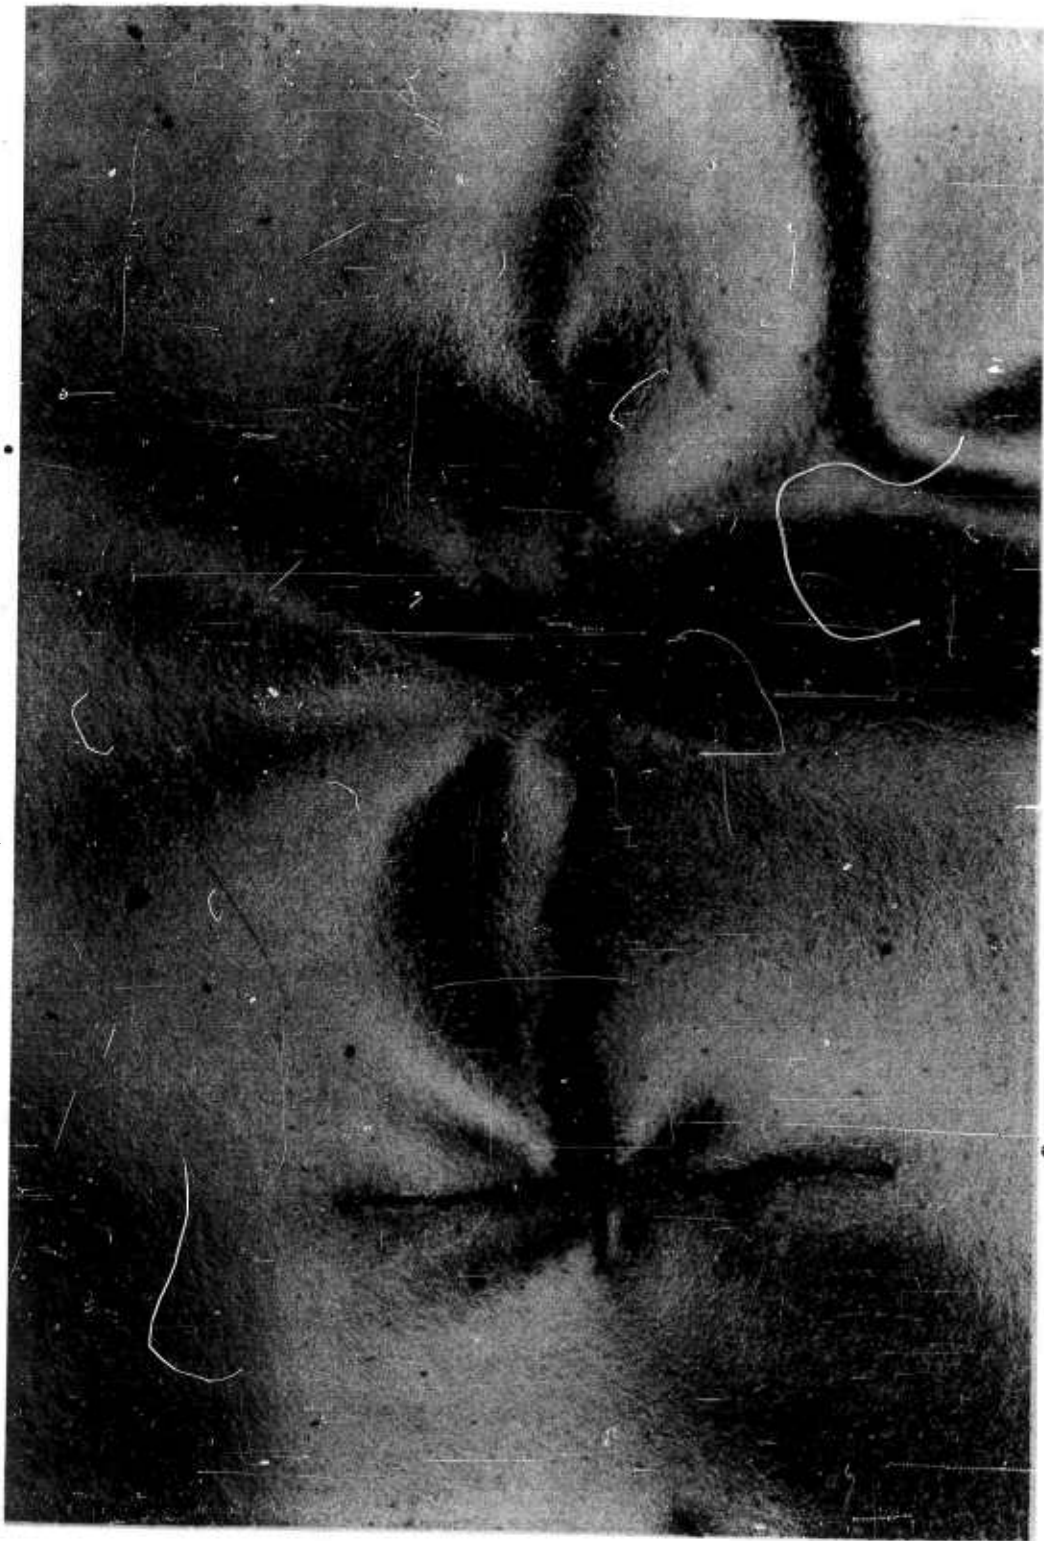
Figure 4. Microphotograph of failure zone in diaphragm - 10X.

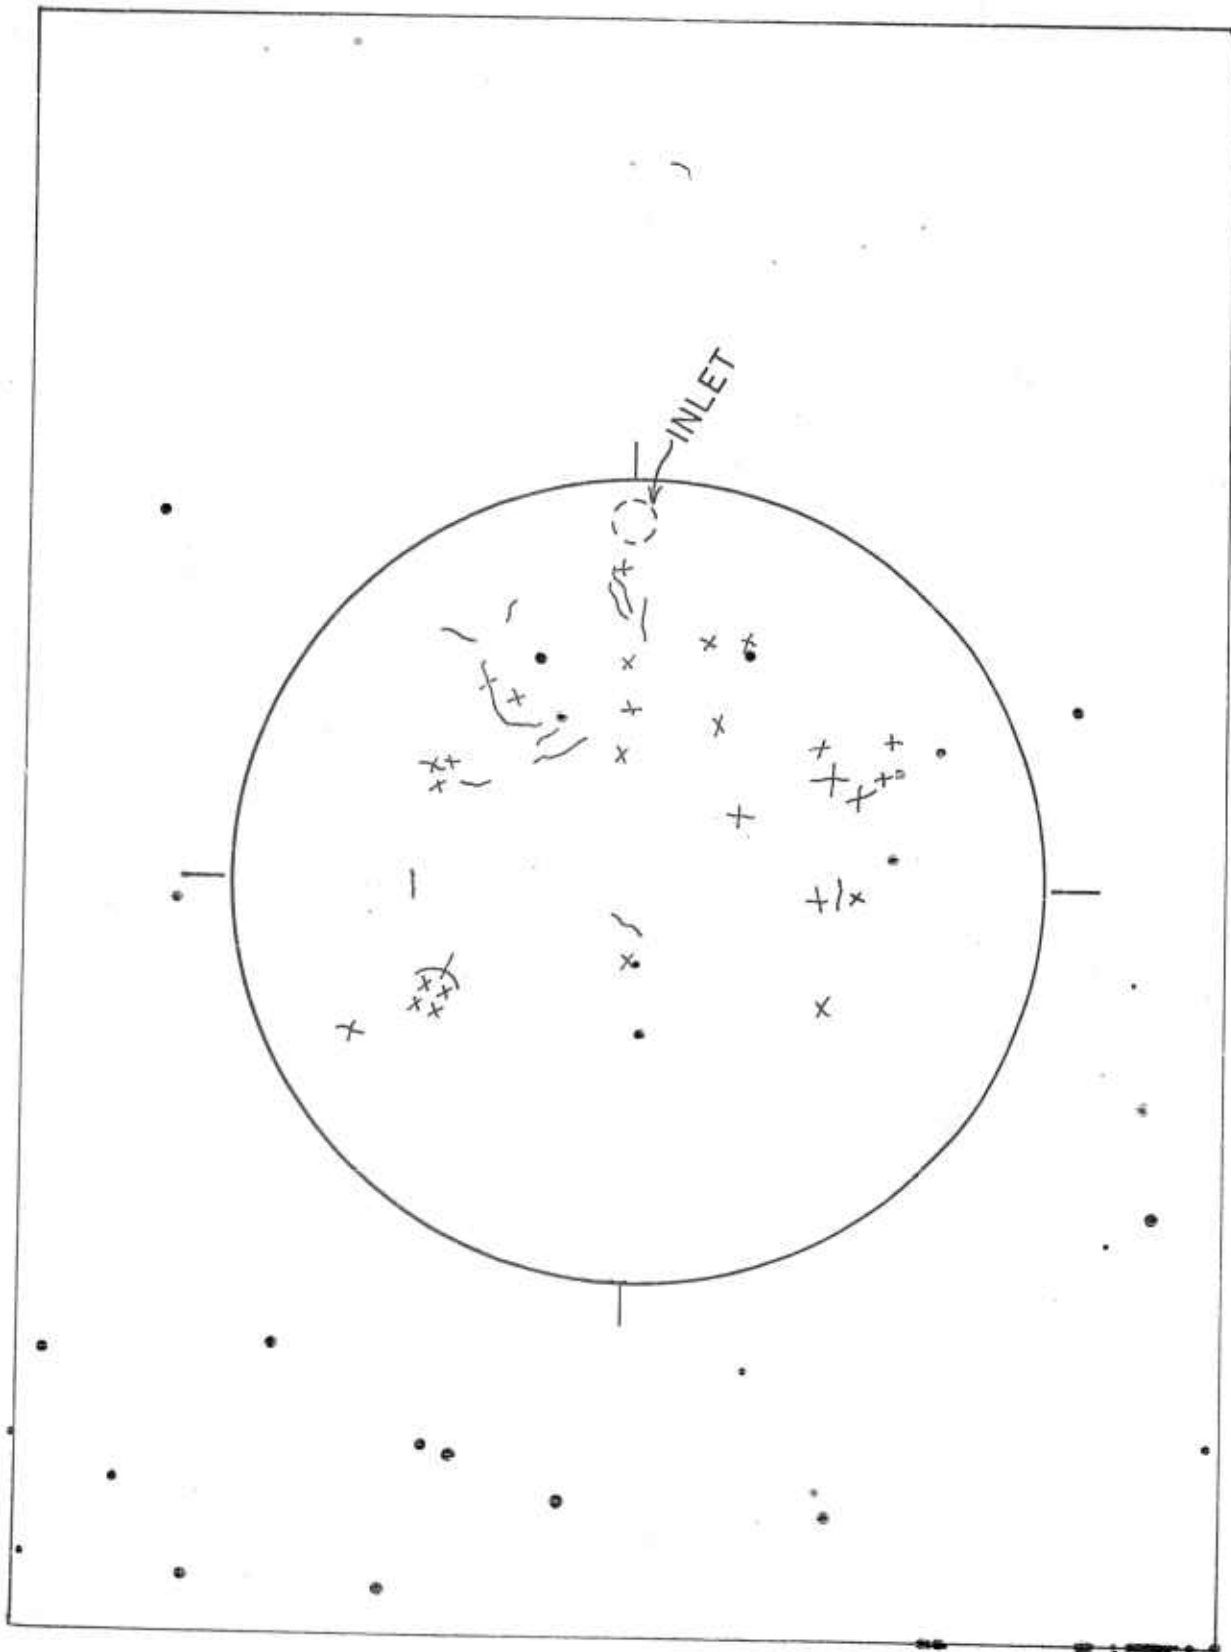
Figure 5. Locations of diaphragm failures compiled from 15 battery post-mortem examinations.

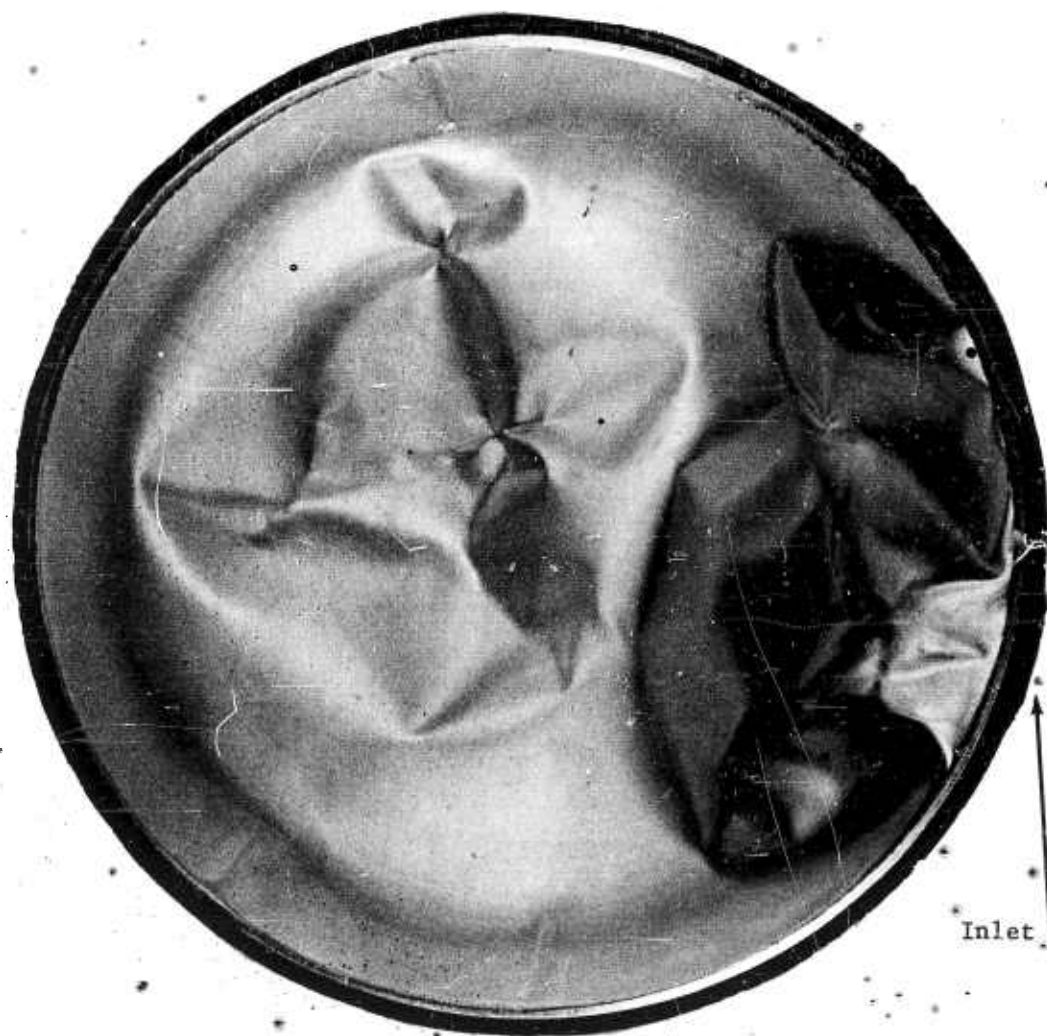
Figure 6. Dissected reservoir showing diaphragm failure. 1.

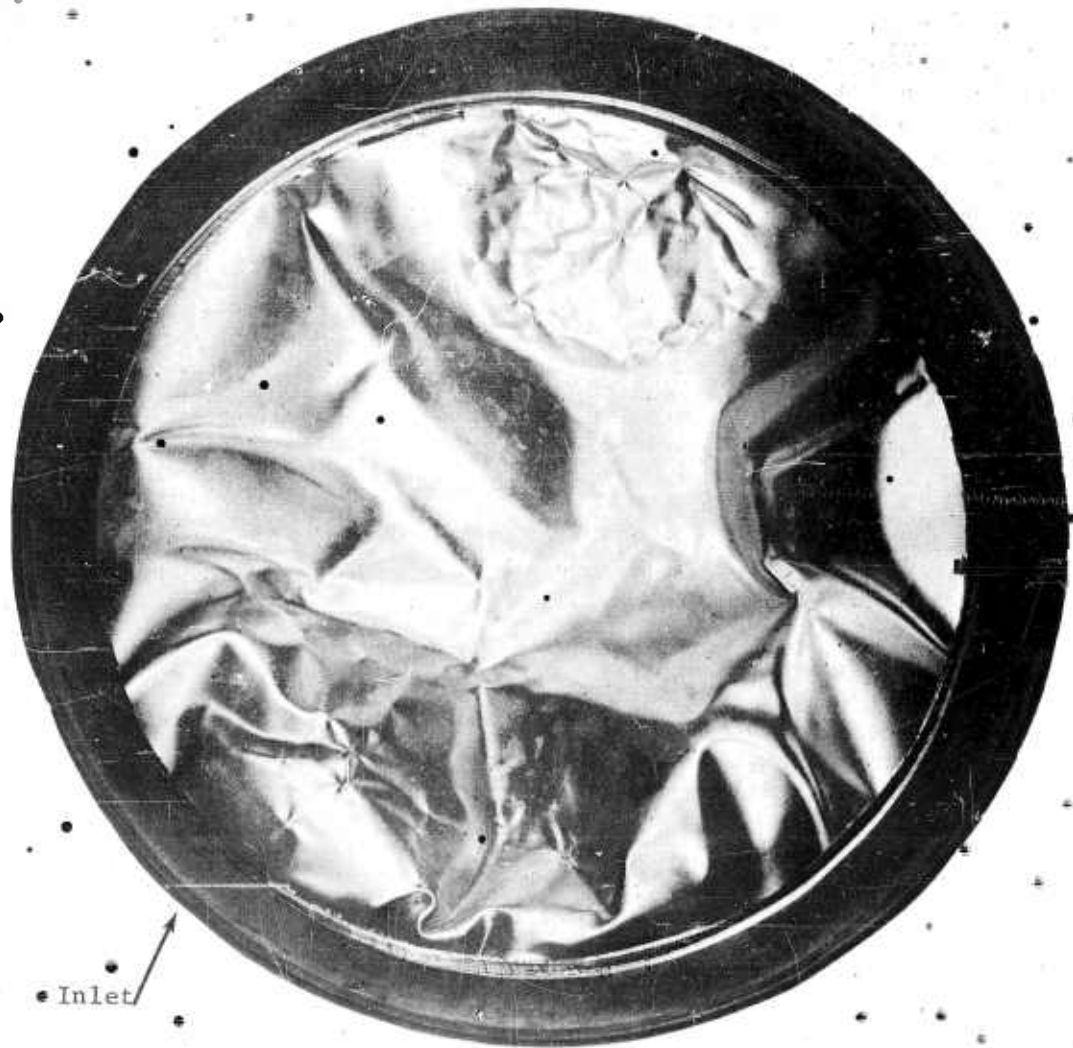
Figure 7. Dissected reservoir showing diaphragm failure, II.

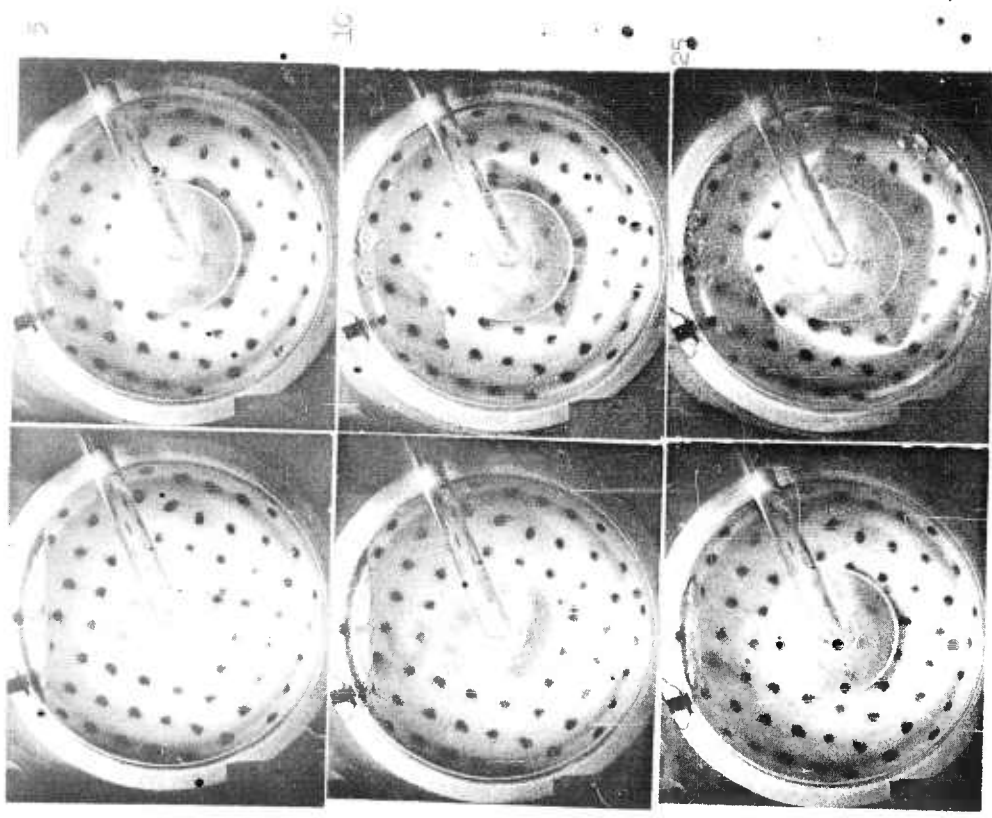
Frames from the films of 5 tests are shown in figures 13, 14, and 15. With the exception of test No. 3 (fig. 15), the tests were all filmed from the liquid side. Test No. 3 shows how the smoke from the squibs obscures part of the diaphragm when the test is filmed from the gas side. Test No. 18, (fig. 13), is typical of the folding action when squibbed activators are used. The initial movement is at the point of gas entry and is followed by inversion near the center. Figure 14, test No. 8, shows proper folding. Here pressurized nitrogen at 500 psi was valved into the reservoir through the inlet at the edge of the reservoir. In figure 15, test No. 42 is of interest because it shows at very high speed the fluttering of the diaphragm caused by the squib detonation (note the temporary blisters in the upper right side). Test No. 42 was performed with the squibbed activator, but the gas inlet diameter was reduced to 0.040 in. The folding is proper.

Figure 14. Folding sequence, test 8, at 128 frames per second.
(Numerals identify the frame number.)

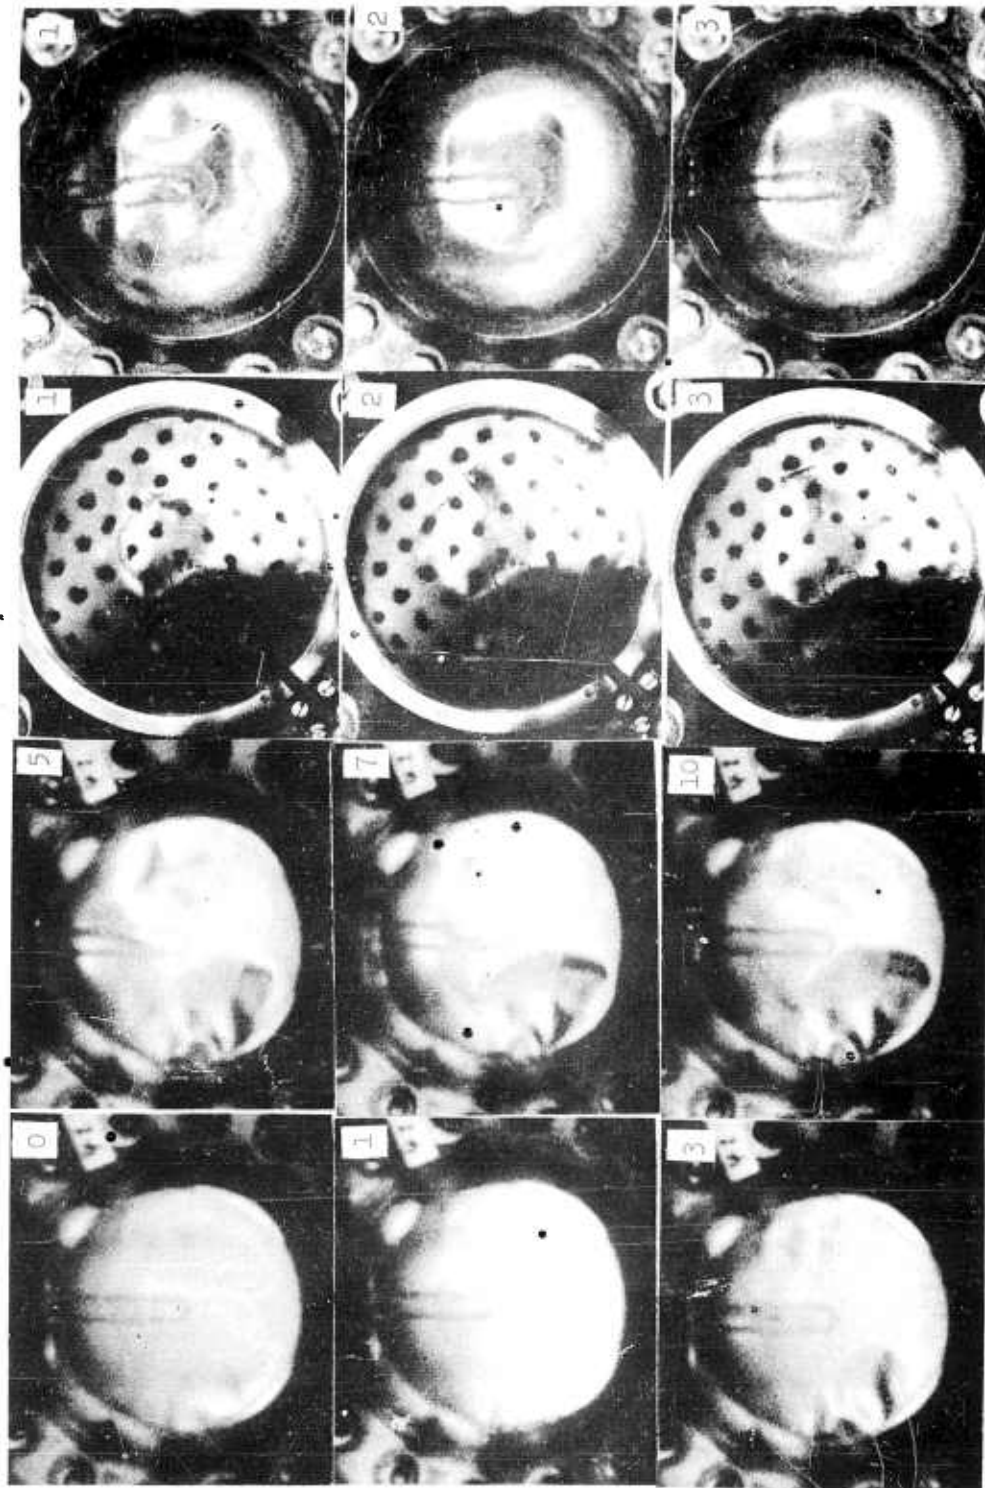
(Test No. 42) (Test No. 3) (Test No. 53)
 Figure 15. Folding sequences, tests 42, 3, and 53 taken at 1500, 400, and 400 frames per second.
 (Numerals identify the frame number.)

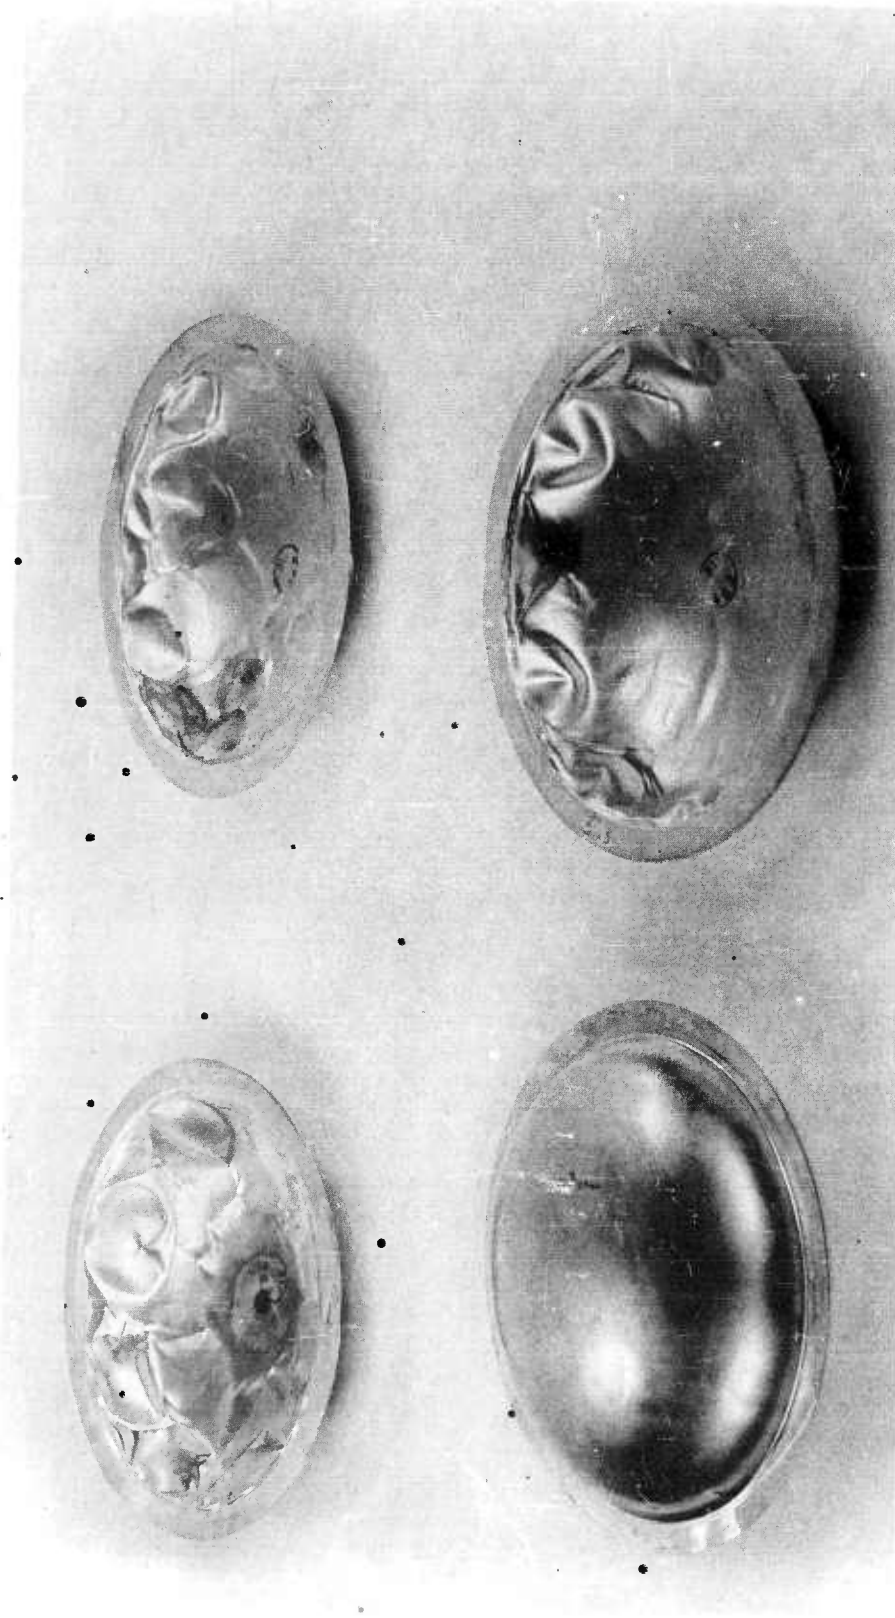
Figure 16 shows one unused and three inverted diaphragms. The dark smudges show the position of the gas inlet before inversion. The smoothness is a function of freedom from liquid leaks during the test. The diaphragms were used in tests 52, 51, and 53, respectively.

Figure 16. Samples of diaphragms before and after folding.

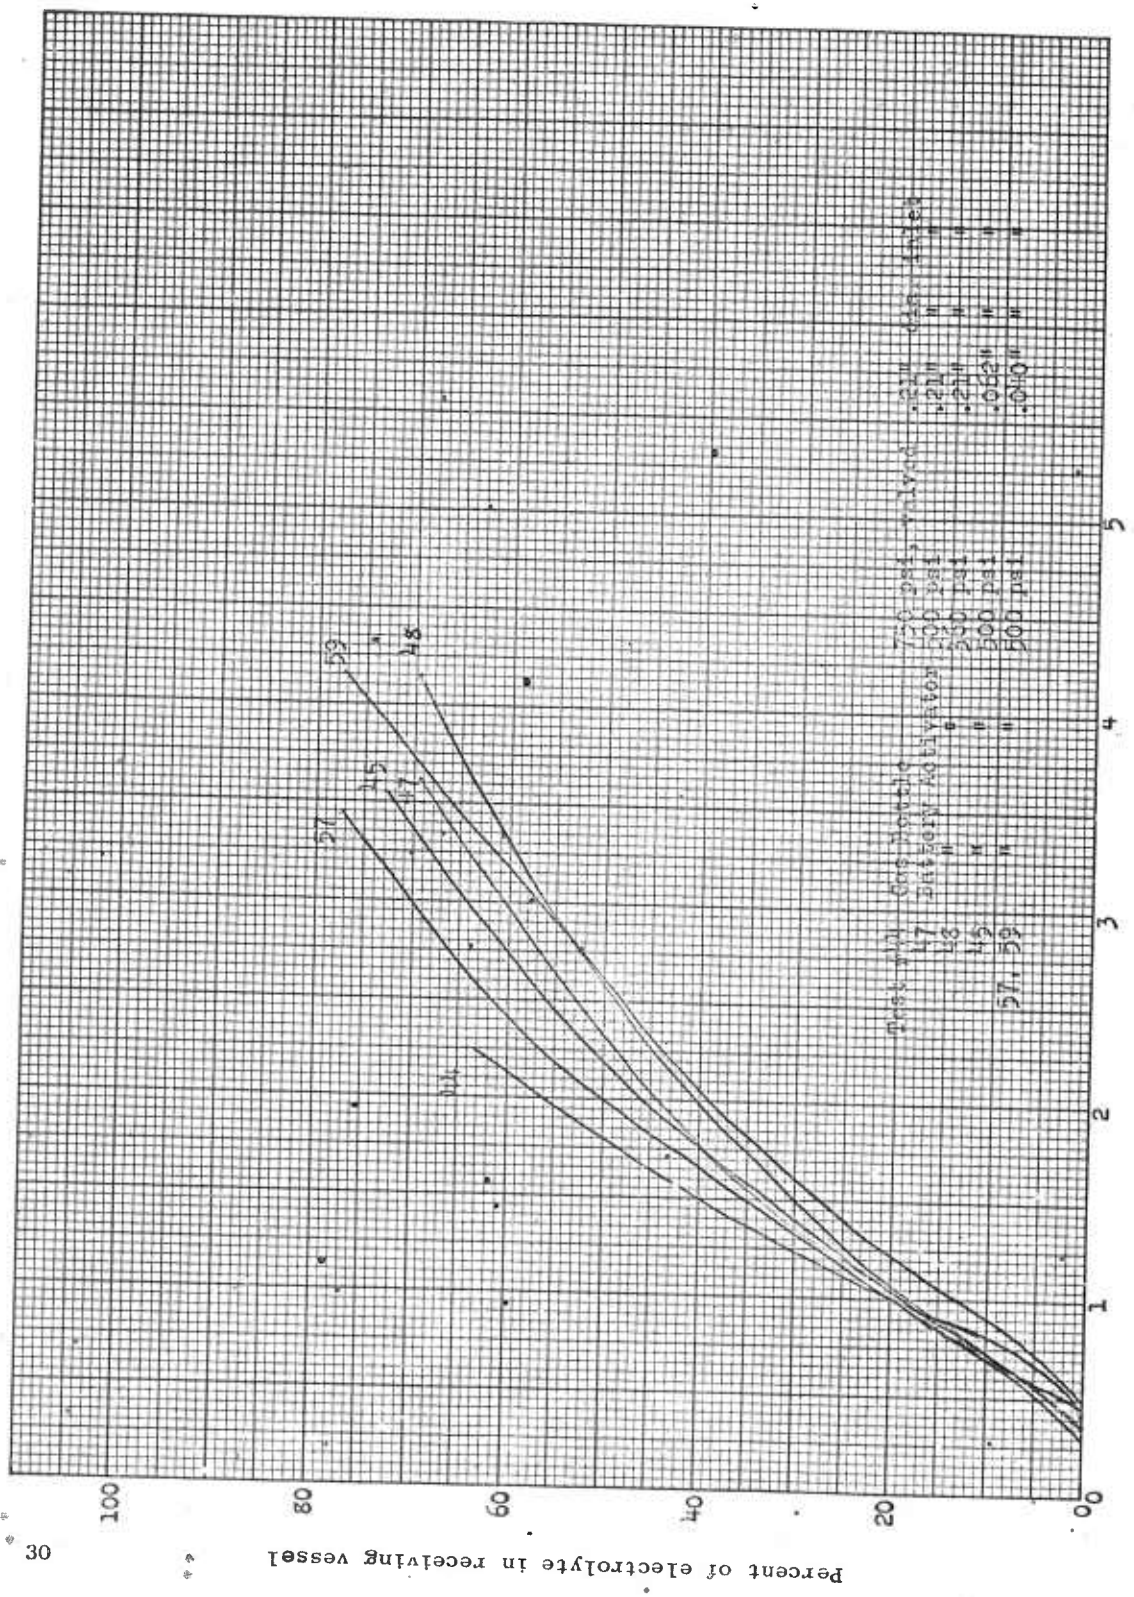
(4) The electrolyte flow rate is fairly independent of the pressure of the activating gas and whether or not activating squibs are used (fig. 17). The flow rate is controlled by the restriction of the manifold holes and the electrolyte viscosity (no low temperature tests were made here). The electrolyte reaches the cell pack in about 0.5 sec, flows at a reasonably constant rate, and the flow is completed in about 6 sec.

Figure 17. Electrolyte flow rates with different activators. Seconds after initiation.
