**U.S. ARMY**  
**H-25 HELICOPTER DROP TEST**  
**22 October 1960**

By  
James W. Turnbow, Ph.D.

TREC  
Technical Report 60-76

March 1961

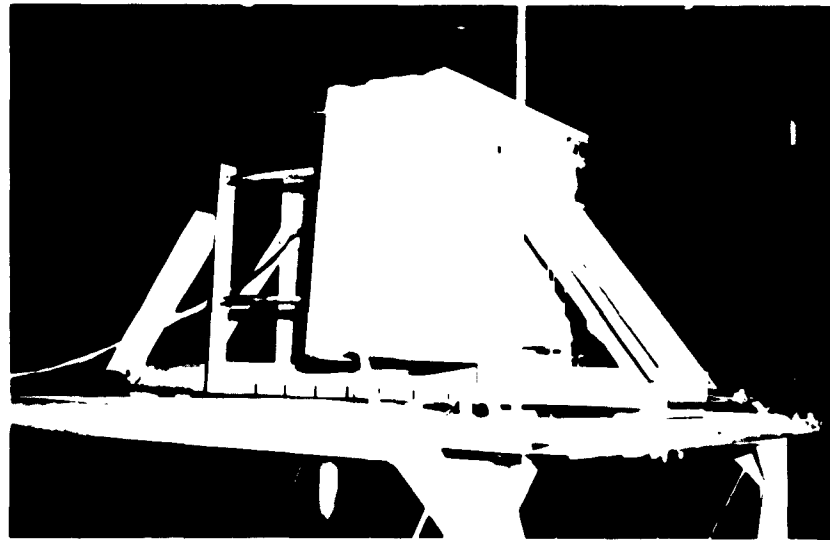
Figure 18. FSF Oscillograph Shock-Mount  
Showing Energy Absorption Device  
After Test Drop

Two separate energy absorption devices were installed in the helicopter for the crash tests. The vertical shock device limiting the maximum loading to the electronic package to 12.0 G's was mounted externally on top of the helicopter. The longitudinal shock device limiting the maximum loading to the electronic package to 8.0 G was mounted in the helicopter on the shelf above the main fuel cell. The resultant design loading on the electronic package from the simultaneous loading of the two devices was 14.5 G.

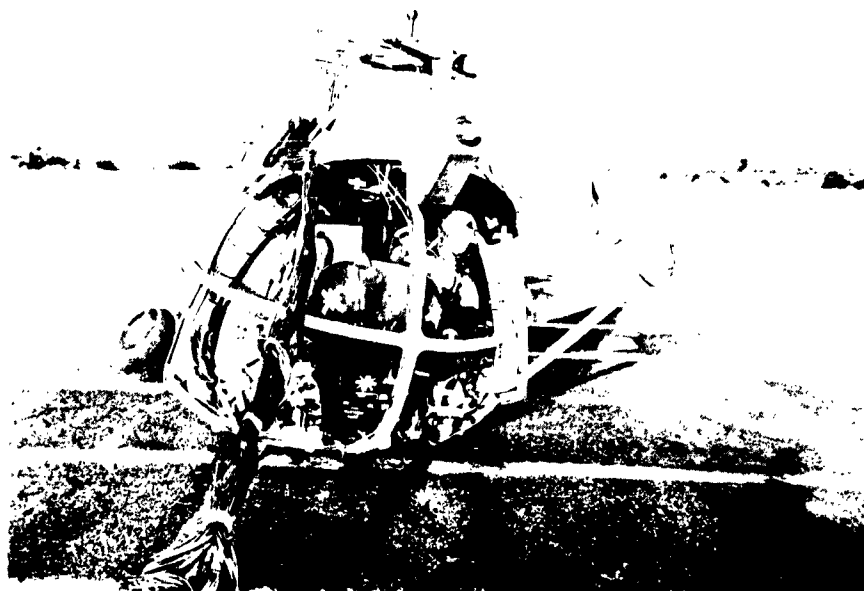
Figure 20. Post-Crash Front View

A post-crash examination was made to determine the extent of damage to the vehicle and injury to its occupants. The following observations were made:

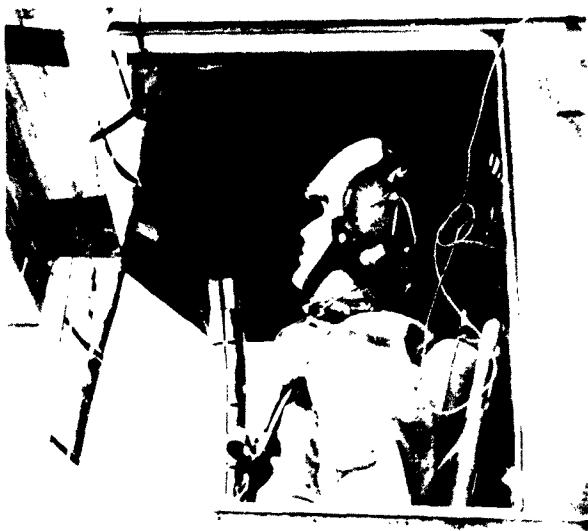
Figure 41. Pilot Dunn: Position Before and After Impact

Film records from cameras 1A and 2A (Figures 2 and 11) indicate that the pilot seat started to fail (rotate about rear floor attachments) at 0.11 second. A post crash inspection showed this to be due to the buckling of both front legs of the tubular steel seat.

3. The head impacted the main fuselage ring, splitting the visor and cracking the helmet (Army APH-5) as shown in Figure 41; however, the helmet remained intact and was not permanently dented. Some damage to the airframe structure did occur in the vicinity of the point of impact (Figure 41), but this damage was apparently due to compression and bending loads in the fuselage frame introduced by the deceleration of mass of the forward transmission system. The fiber-glass fairing over the fuselage frame was destroyed by the impact.
