Final Report

TESTING  
OF  
TRANSPIRATION AIR COOLED TURBINE BLADES

Report on Item Ic  
Contract NOas 58-404-c

*Curtiss-Wright*

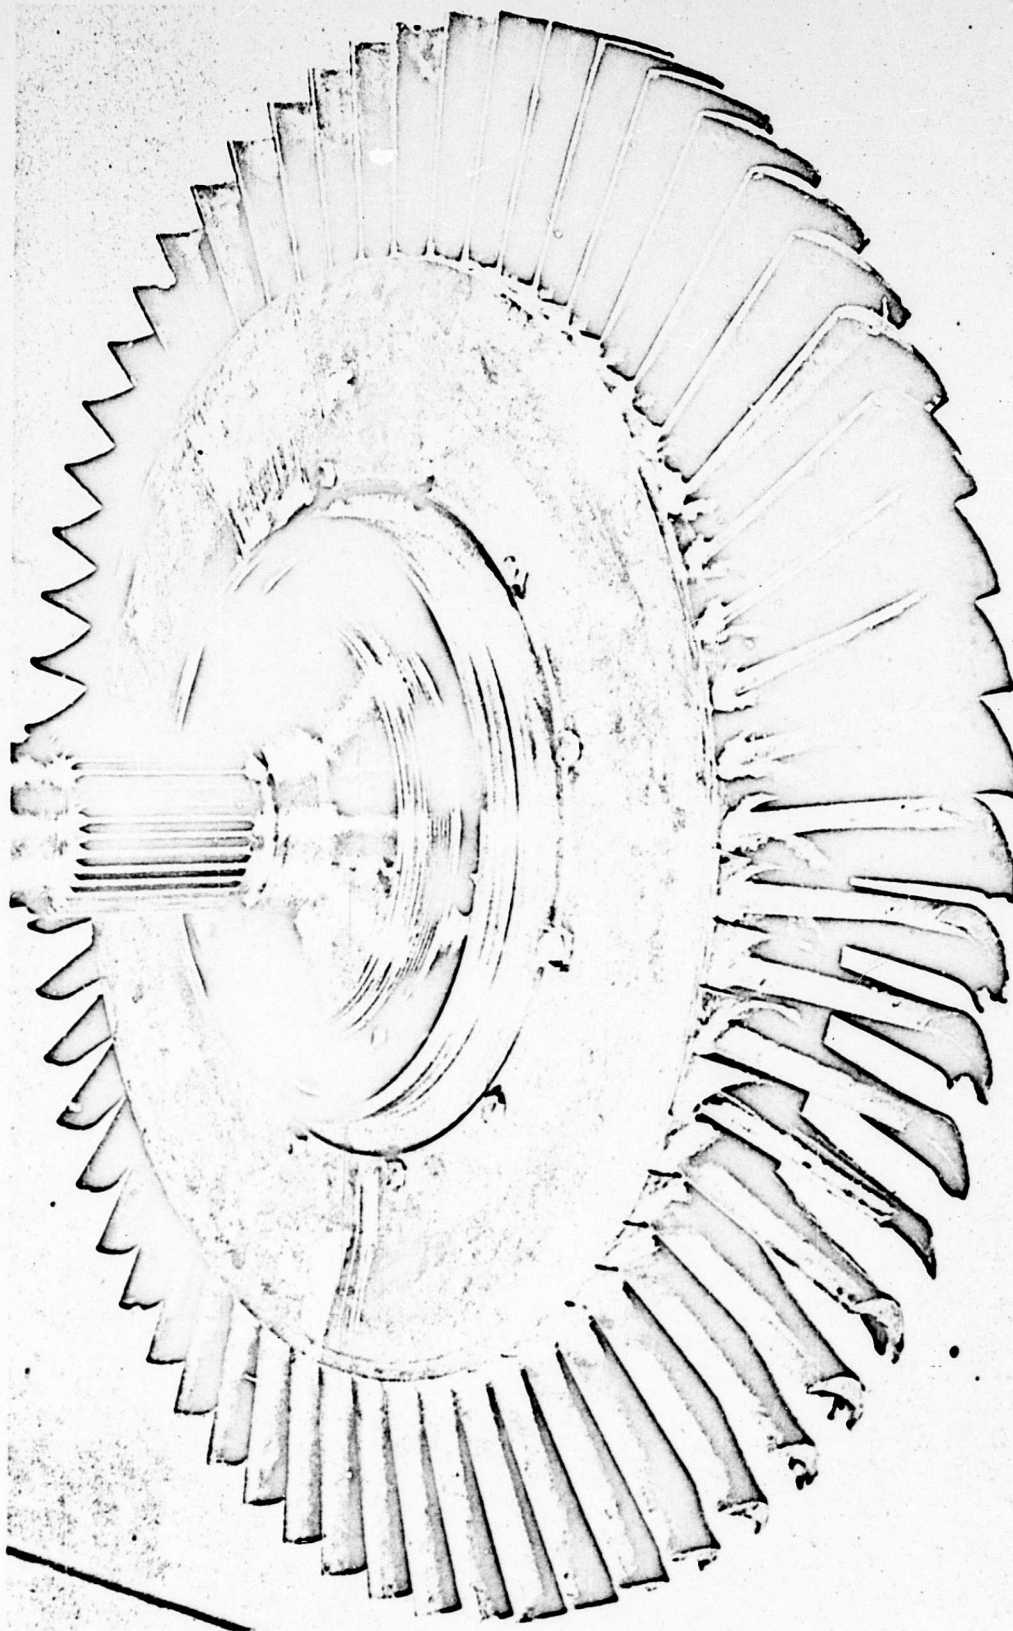
Figure VI-9

The initial tests were conducted to check cooling air flows, temperature distribution in the combustion chamber, and general test rig operation at relatively low turbine inlet temperatures. Difficulties were encountered with blades fabricated with the Rigmesh porous airfoil material. Upon attaining a little above 55% design speed one of the Rigmesh airfoils separated from the

blade supporting strut. Inspection of the blade revealed that poor brazing existed on the porous material due to oxide films in the porous material fibers. Replacement of the blade was made and further testing was carried on. In the next series of tests conducted loss of another Rigimesh porous airfoil occurred just above 80% speed (6050 rpm). Figures VI-9 and VI-10 shows the blade with the missing airfoil, and the minor resulting secondary damage to the remaining rotor blades. No damage was incurred to the transpiration cooled stator blades or any other engine component. Inspection of this blade also revealed poor bonding of the braze to the Rigimesh porous material, due to oxide films. It was decided at this time to replace all the blades made from Rigimesh material, approximately 50% of the wheel, with blades made from Poroloy material.

TRANSPARATION COOLED TURBINE ROTOR ASSEMBLY  
SHOWING BLADE WITH MISSING AIRFOIL AFTER TEST (FRONT)

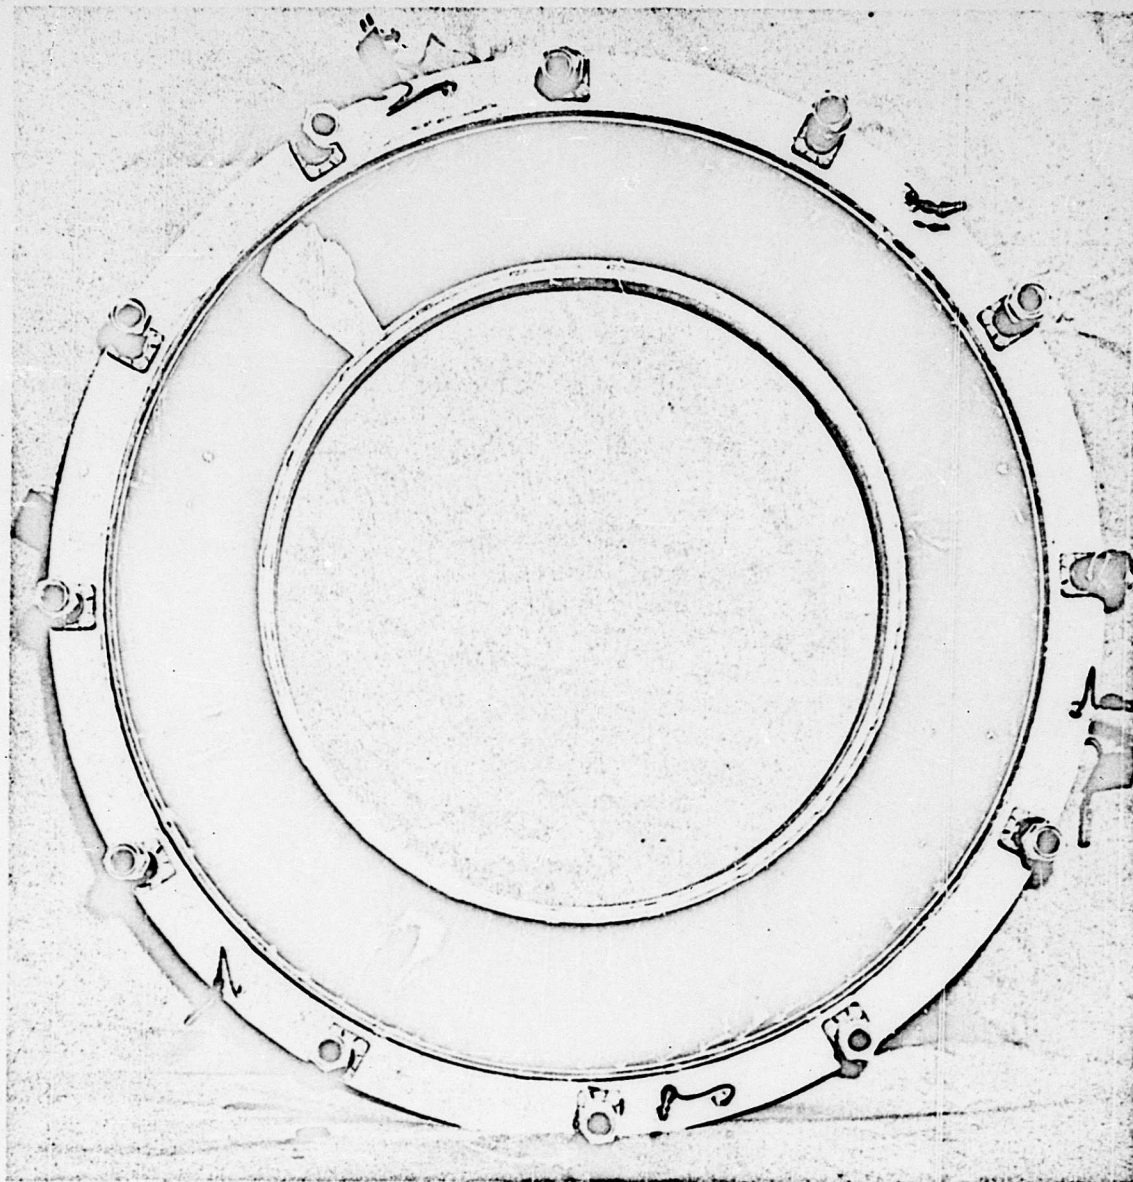
Figure VI-12

In the next series of tests with higher turbine inlet temperatures, ranging from 1850°F to 2000°F, the loss of another airfoil occurred. This blade was replaced and testing was continued to design speed, 7460 rpm, with a turbine inlet temperature average of 2100°F or above. This point was set the next day and shortly after stabilizing, an increase in vibration was indicated along with a surge in exhaust gas temperatures. Inspection of the engine after shutdown showed that the stator blades were burned at six points, and had seriously damaged all the rotor blades. Figures VI-11 and VI-12 show the transpiration cooled turbine stator assembly. It can be seen on these photographs that there are six definite burned areas resulting from combustion chamber "hot spots". It also can be noticed on Figure VI-11 the four double cooling air lines supplying the exhaust duct cooling air. These four bleed air lines tie in directly to the location of four of the "hot spots". The other two "hot spots" are also directly in line with the two bleed points for stator blade cooling air. It is quite apparent that these cooling air bleed stations created the six torching areas in the combustion chamber, and starved the secondary air liner cooling supply in these areas.

TRANSPIRATION COOLED STATOR BLADE ASSEMBLY  
AFTER COMBUSTION CHAMBER TORCHING CONDITION (FRONT)

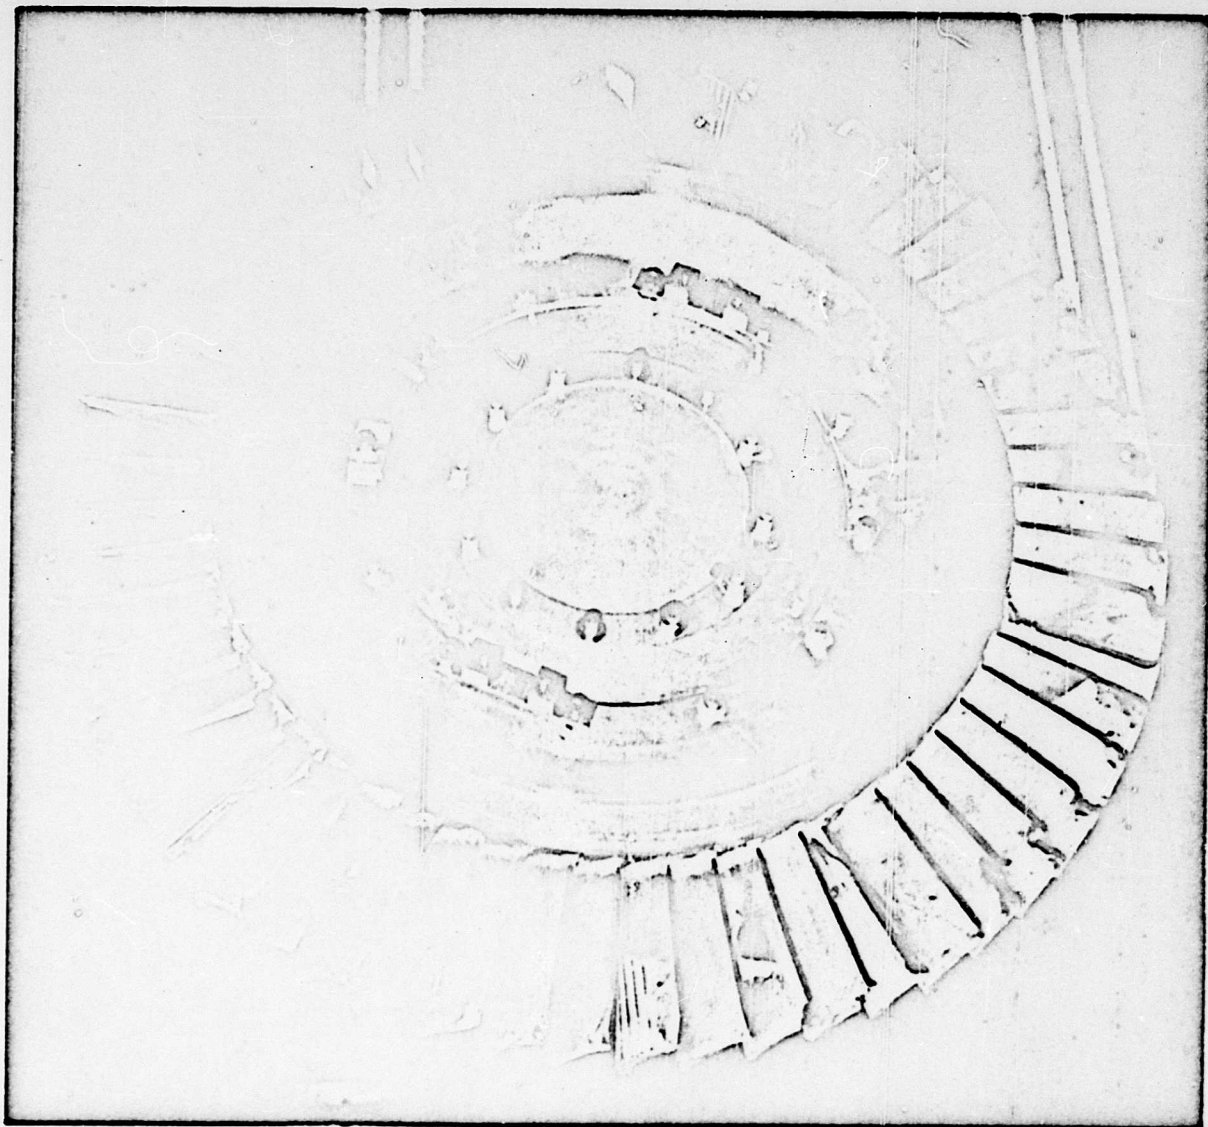
**Figure VI-13**

As a result of the torching condition in the combustion chamber and the burning through of the stator blades the rotor assembly was damaged beyond repair. Figures VI-13 and VI-14 show the damaged incurred on the turbine rotor assembly.

**TRANSPIRATION COOLED TURBINE ROTOR ASSEMBLY  
SHOWING DAMAGES RESULTING FROM BURNED STATOR (REAR)**

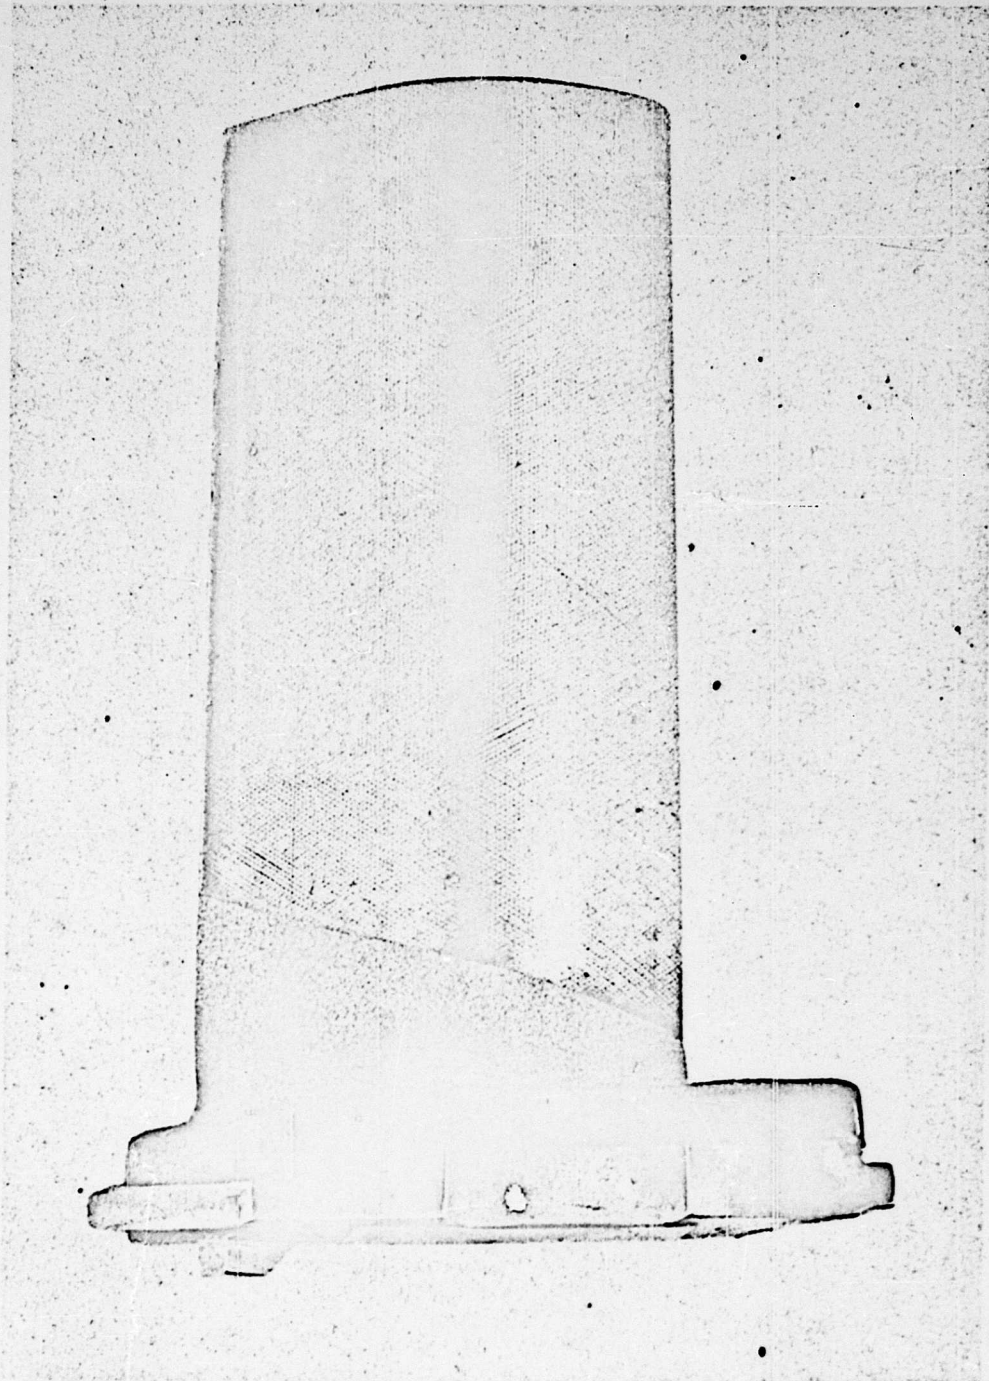
Closer observation of the blades revealed that excessive cooling was occurring on the suction side of both the rotor and stator blades. In the theoretical heat transfer analysis discussed in Section I, Volume I of the report the pressure distribution around the blade periphery was determined by the use of an analog. However, due to the fact that this was an entirely new turbine design only one section, the mean section of the blades, was analyzed in this manner for chordwise pressure distribution. As the spanwise pressure profile was assumed to obtain the chordwise pressure distribution without any background on this particular turbine it was felt that the accuracy of any pressure profile determined by the analog method would be highly questionable at any other section than the mean.

TRANSPIRATION COOLED STATOR BLADE  
METALIZED ON THE SUCTION SIDE AT THE ROOT

In order to improve the cooling air distribution on the blades it was felt that masking of the blade was necessary in the areas that appeared to be receiving more than the required amounts of cooling air. The method evolved to mask these cooler areas was by utilizing a metal spray technique generally known in industry as "metalizing". By this metalizing technique it was possible to mask the desired areas and distribute cooling air to the hotter portions of the blade. Laboratory checks of these metalized areas showed that the areas were still somewhat porous. Again time did not permit a detailed study, but an investigation in the future would be of value to possibly use this method to obtain variable permeability over the blade airfoil surface area. Figure VI-17 shows a stator blade that has been metalized on the suction side at the root of the airfoil.

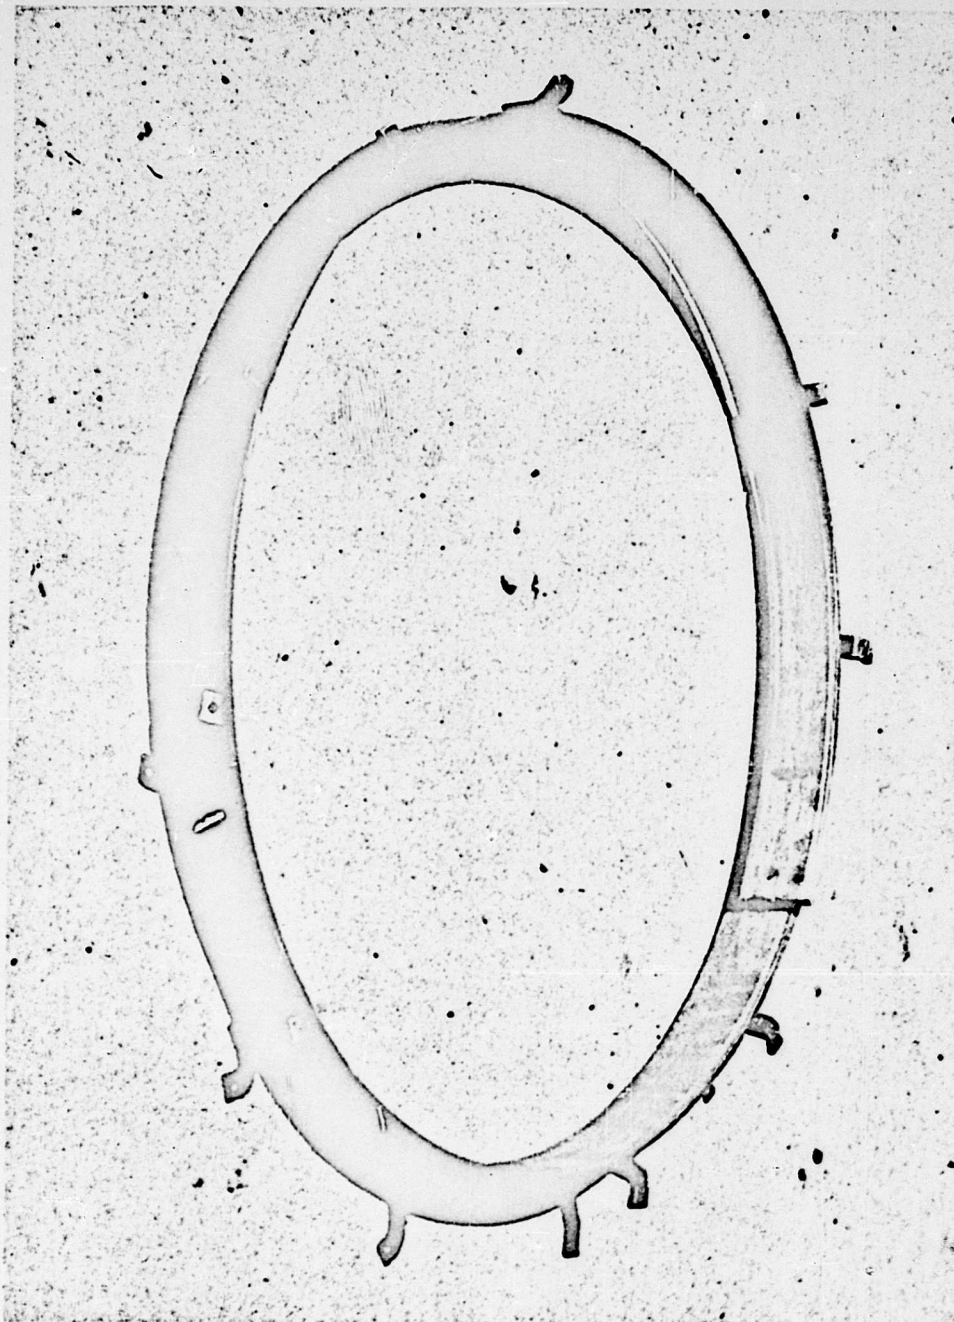
During this initial testing it was also noted that the turbine rotor shroud was distorted. The cause of this was believed to be that the fabricating vendor had not properly stress relieved the part after welding. As a result of this distortion higher tip clearances existed.

The engine test program was terminated because as the rated speed point was being set at approximately 2200°F turbine inlet temperature, engine surge was noted, indicating an engine component had failed. Inspection of the engine, after shut-down, showed the turbine rotor shroud had broken loose from the engine casing, and it was resting (wrapped around) the turbine rotor stage. The turbine blade tip areas showed signs of severe tip rub. The airfoil skins of two turbine rotor blades were completely torn loose, and damage was noted on the remaining airfoils. An analysis of the damaged rotor, Figure VI-19, shows that the blades were running relatively cool, and discounting the secondary damage, were in excellent condition considering the severe conditions encountered. Figure VI-20 shows the turbine shroud, after it was removed (unwrapped) from the rotor stage. Analysis of the part indicated failure was caused by, primarily, faulty welding of the shroud. While this was the immediate cause of the failure, the extreme distortion of the shroud noted in previous running leads to the belief that the true cause of failure was the improper heat treatment of the shroud. As the temperature level of the engine was increased, the distortion increased, until finally the attaching lugs failed, loosening the shroud from the engine casing.

FAILED TURBINE ROTOR SHROUD

1. Redesign turbine shroud of test vehicle.
2. Revise location of compressor bleed air for stator coolant air flow.
3. Continue the engine test program to demonstrate operation at 2500°F average turbine inlet temperature.
