**CRASH INJURY BULLETIN**

**MODIFICATIONS TO THE PASSENGER SEAT-BELT  
TIEDOWN ATTACHMENTS IN THE**

**U.S. ARMY HU-1 SERIES BELL IROQUOIS HELICOPTER**

TCREC Technical Report 62-45

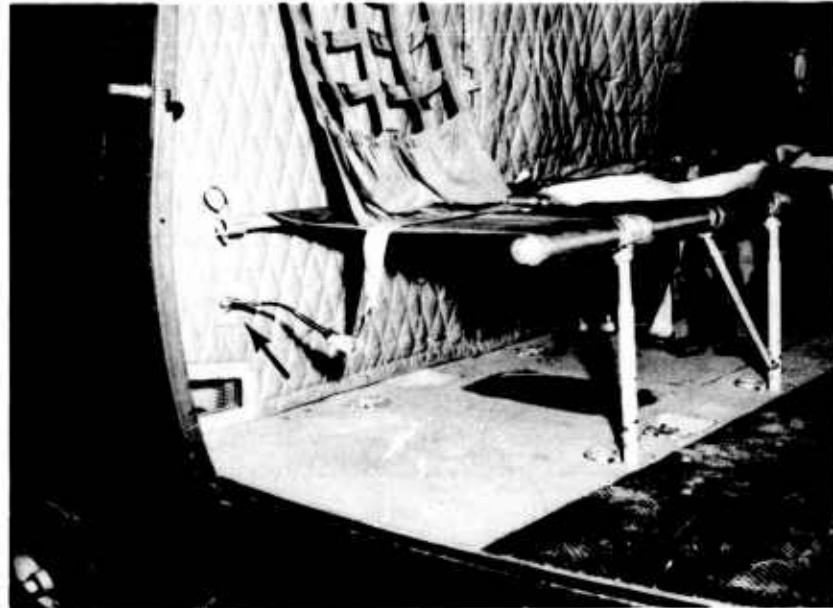
Figure 2. Typical Seat-Belt Tiedown Installation in the HU-1 Helicopter.

A review of several HU-1 helicopter accidents\* reveals that failure of the passenger seat-belt tiedown occurs at the casting where the cable clevis is attached.

Figure 2 illustrates the tiedown installation as presently installed in HU-1 helicopters.

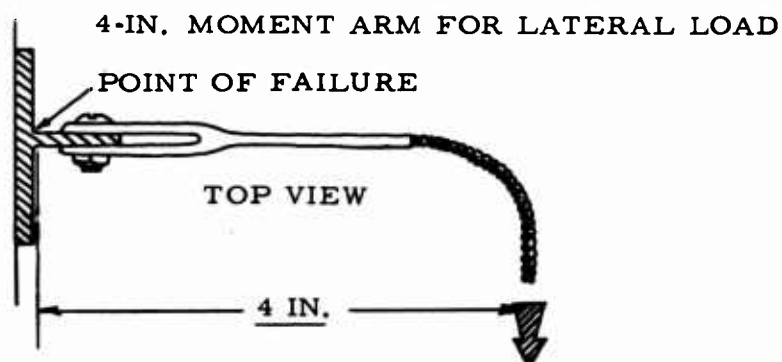
Figure 4. Present Tiedown Configuration.

Only 1 degree of freedom (vertical) is available with this attachment system. Spot checks of several HU-1A helicopters revealed that the fork-end cable terminals were tightened on the casting so tight that the vertical freedom was eliminated, resulting in a rigid connection from the cable to the casting.

The present cable attachment provides a moment arm of approximately 4 inches when side loads are applied as shown in Figure 4. With this moment arm, only 800 inch-pounds (4 inches x 200 pounds) of direct side moment are required to break the attachment casting.
