Report No. RR-49

AN ELECTROLYTIC PAINT SYSTEM

U. S. Army Ordnance Tank-Automotive Command  
1501 Beard  
Detroit 9, Michigan

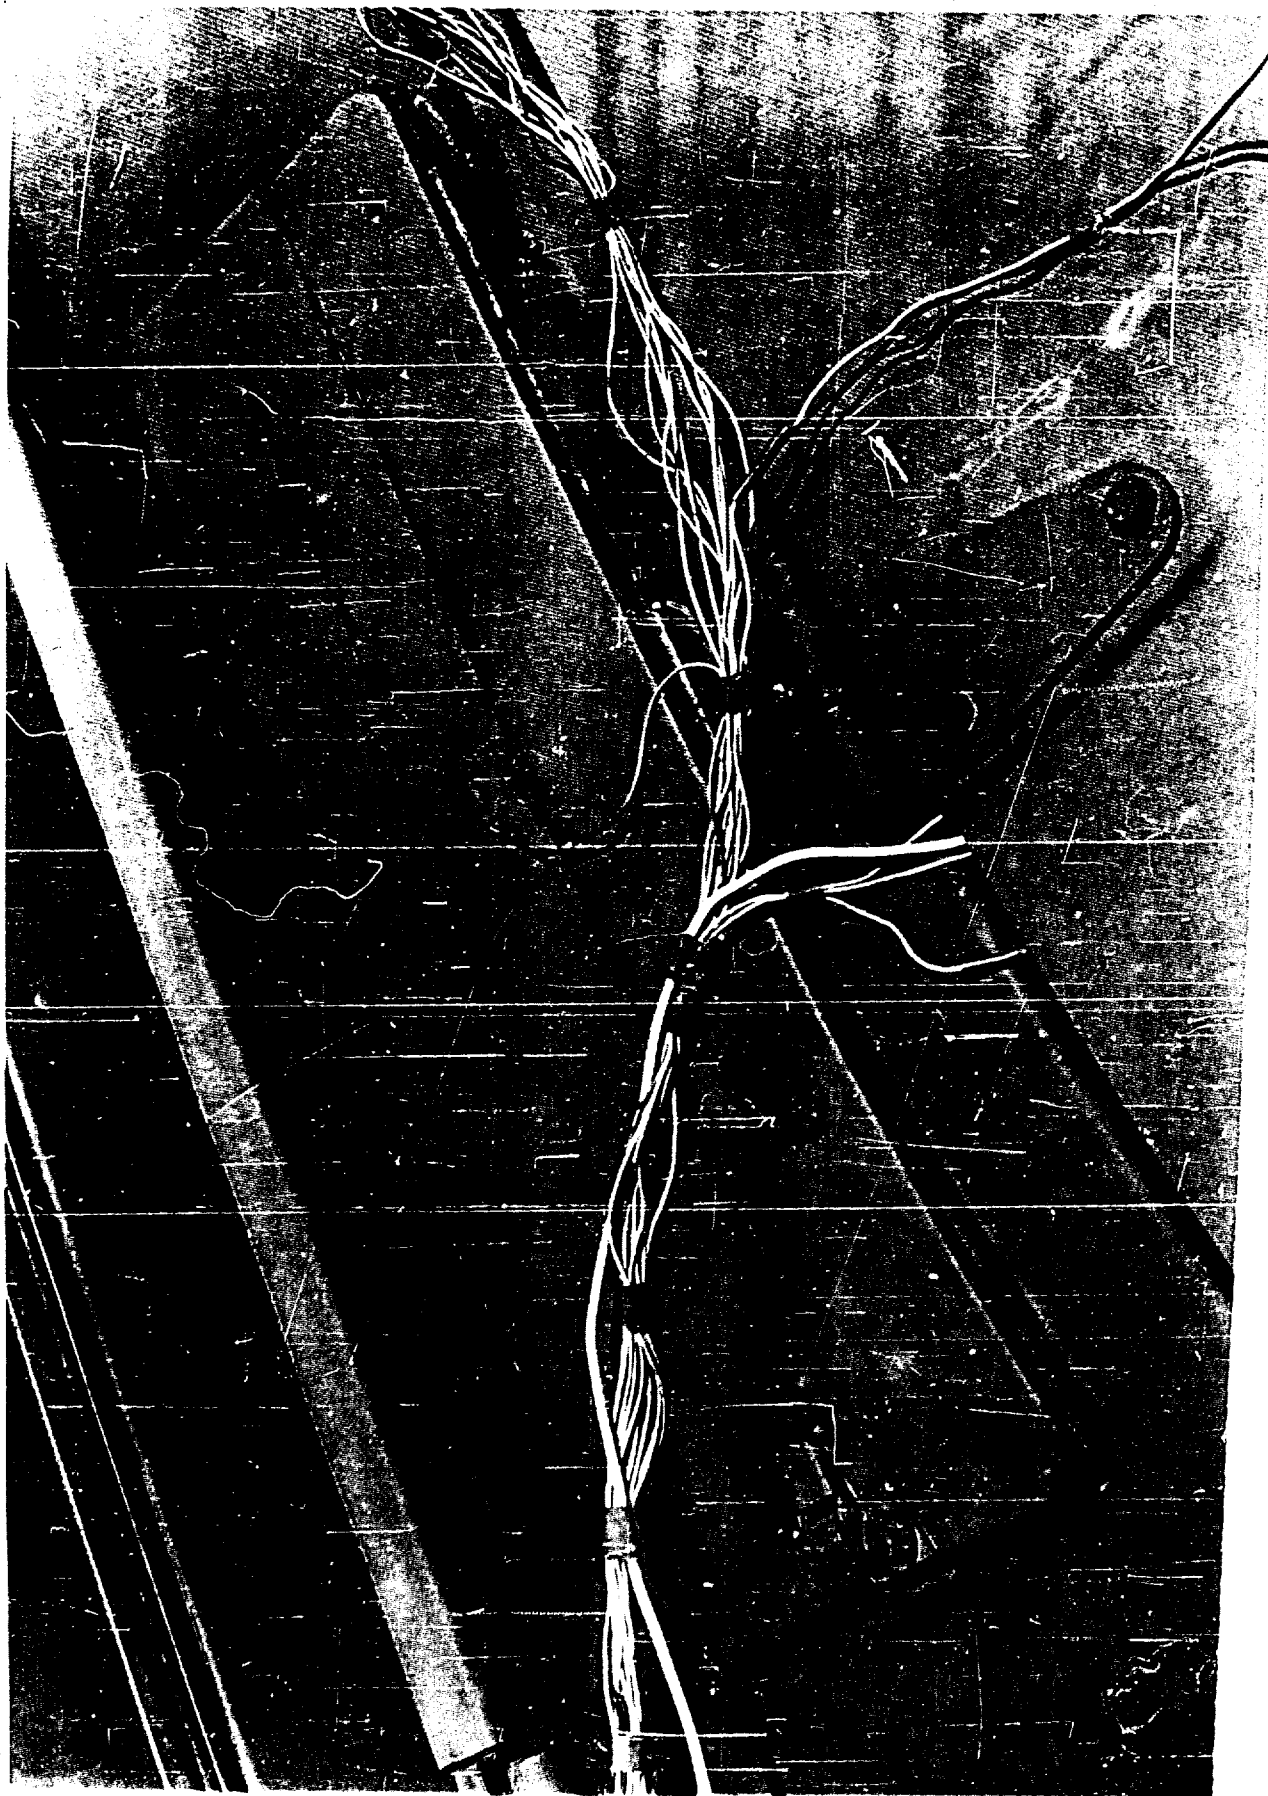
Figure 37

Fig 37 - Corrosion along seam of battery cover plate.  
Paint System N

Battery cover after one year exposure. Note Corrosion along seam and blister.

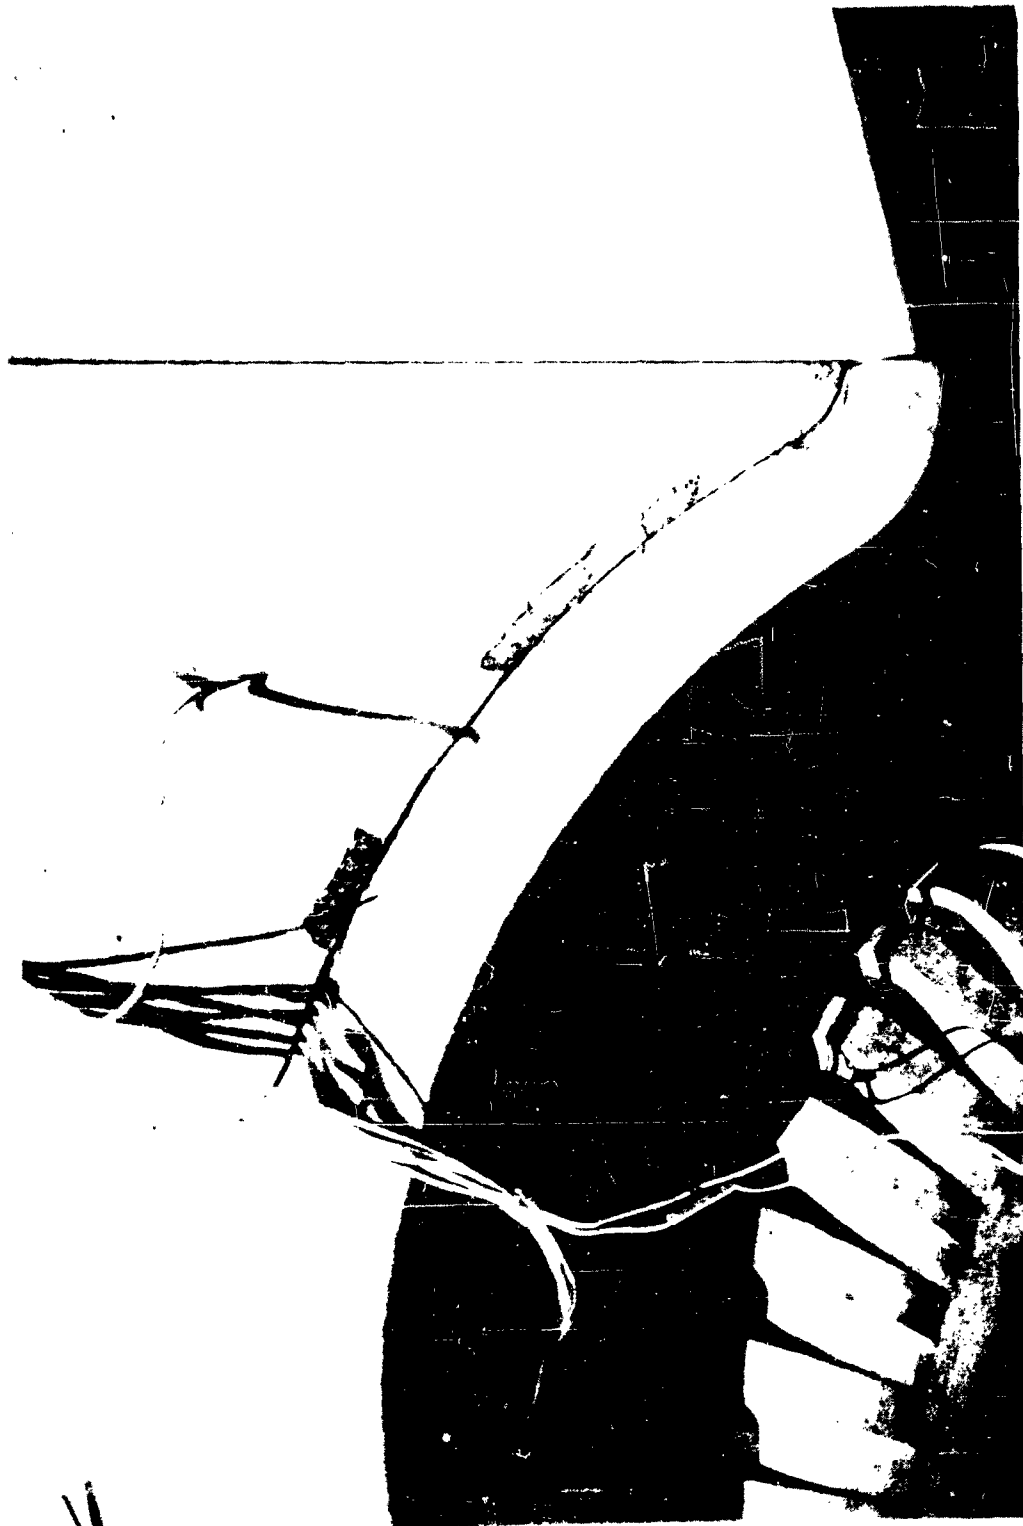
FIGURE 46

CORROSION ON MASKED EDGE OF LEFT FRONT QUARTER PANEL AFTER  
25 MONTHS EXPOSURE

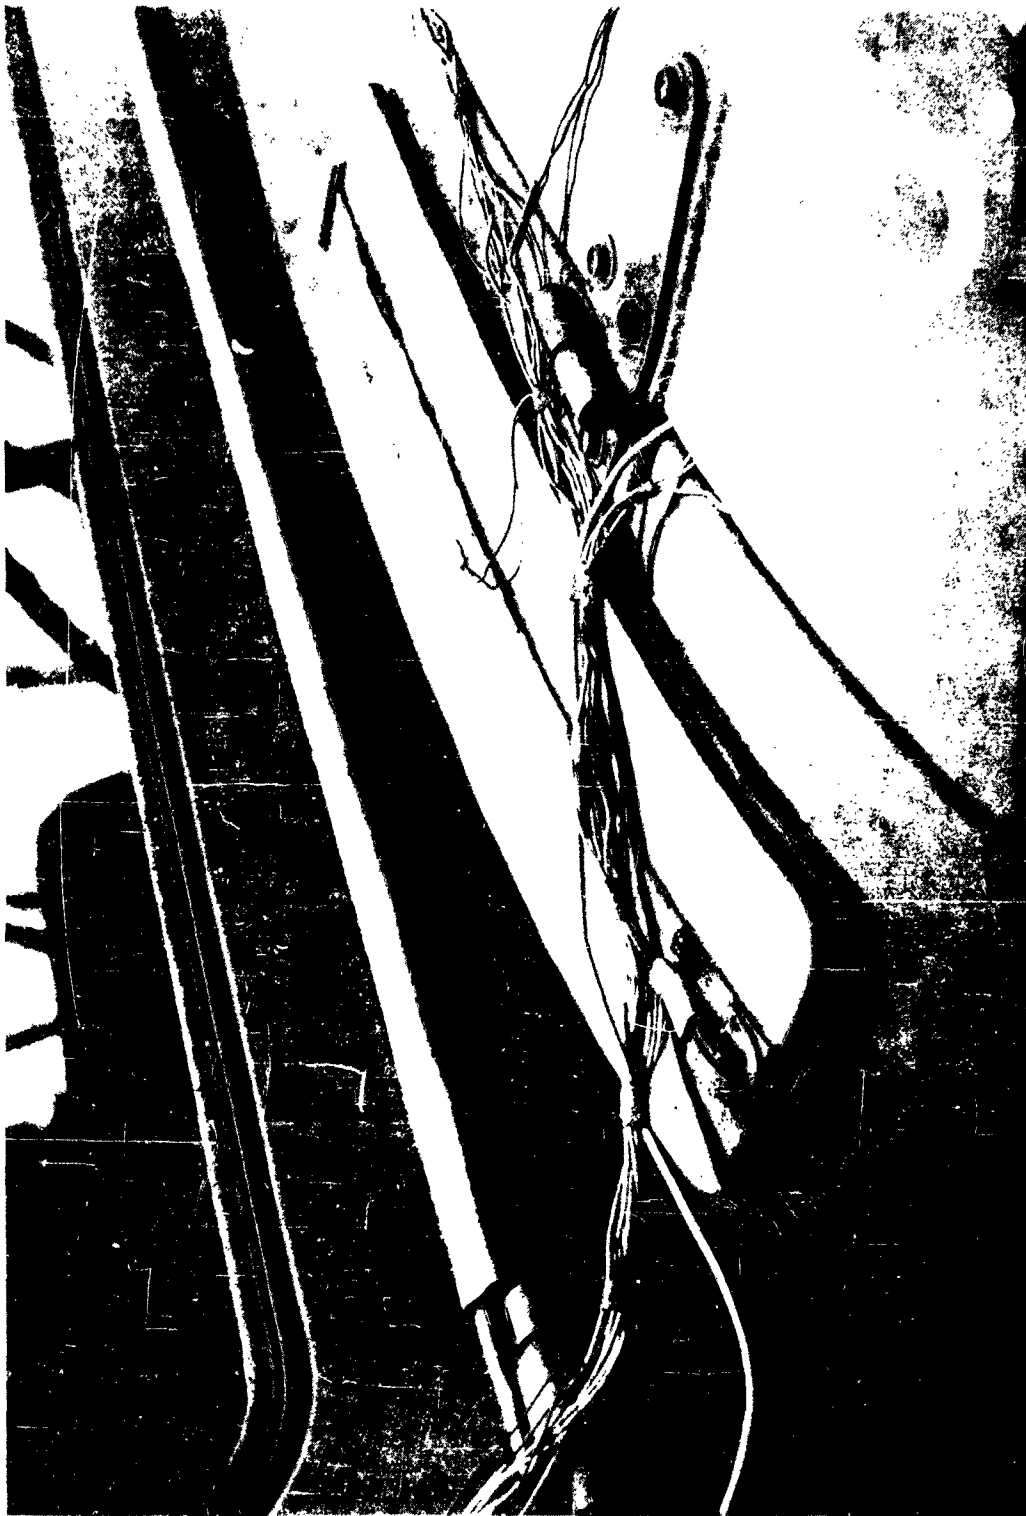
FIGURE 49

CORROSION ON BATTERY COVER PANEL AFTER 25 MONTHS EXPOSURE

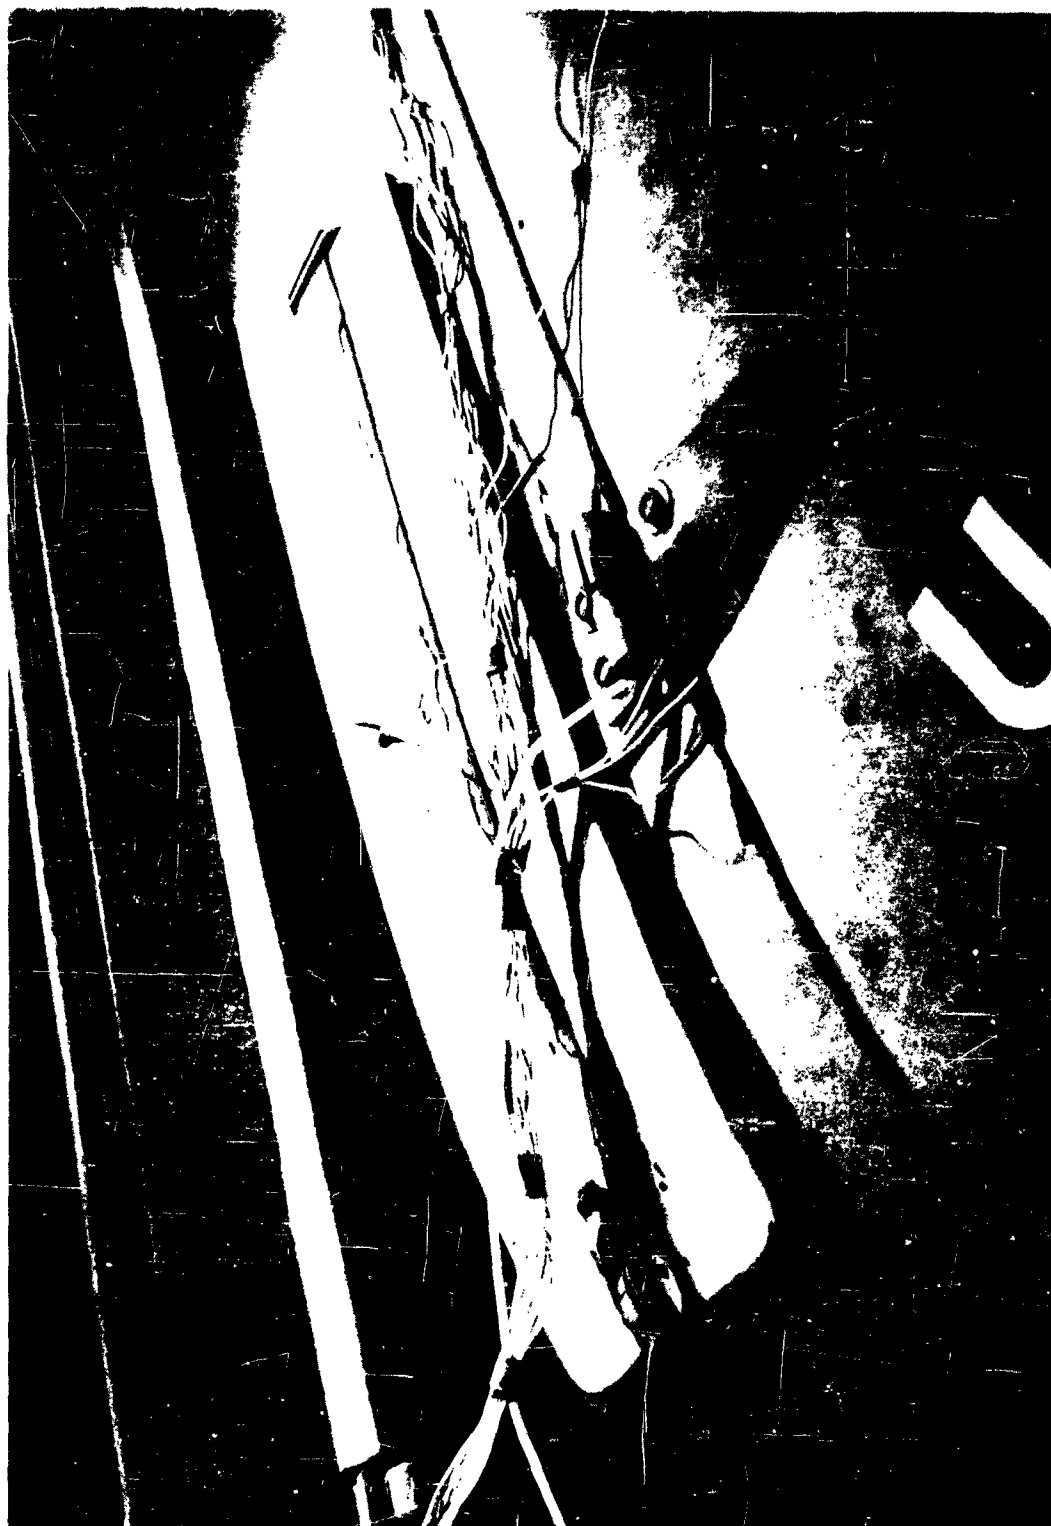
FIGURE 50

Fig 50 - Corrosion on battery cover. Paint System N

M38A1. CORROSION ON BATTERY COVER PANEL AFTER 34 MONTHS  
EXPOSURE

| BODY ITEM | PAINT SYSTEM | GENERAL CONDITION AT END OF TEST | PHOTOGRAPHIC EVIDENCE (Figure Numbers) |
|---|---|---|---|
| Battery Cover | N | Advanced corrosion over<br>surface and along seams | 50 |

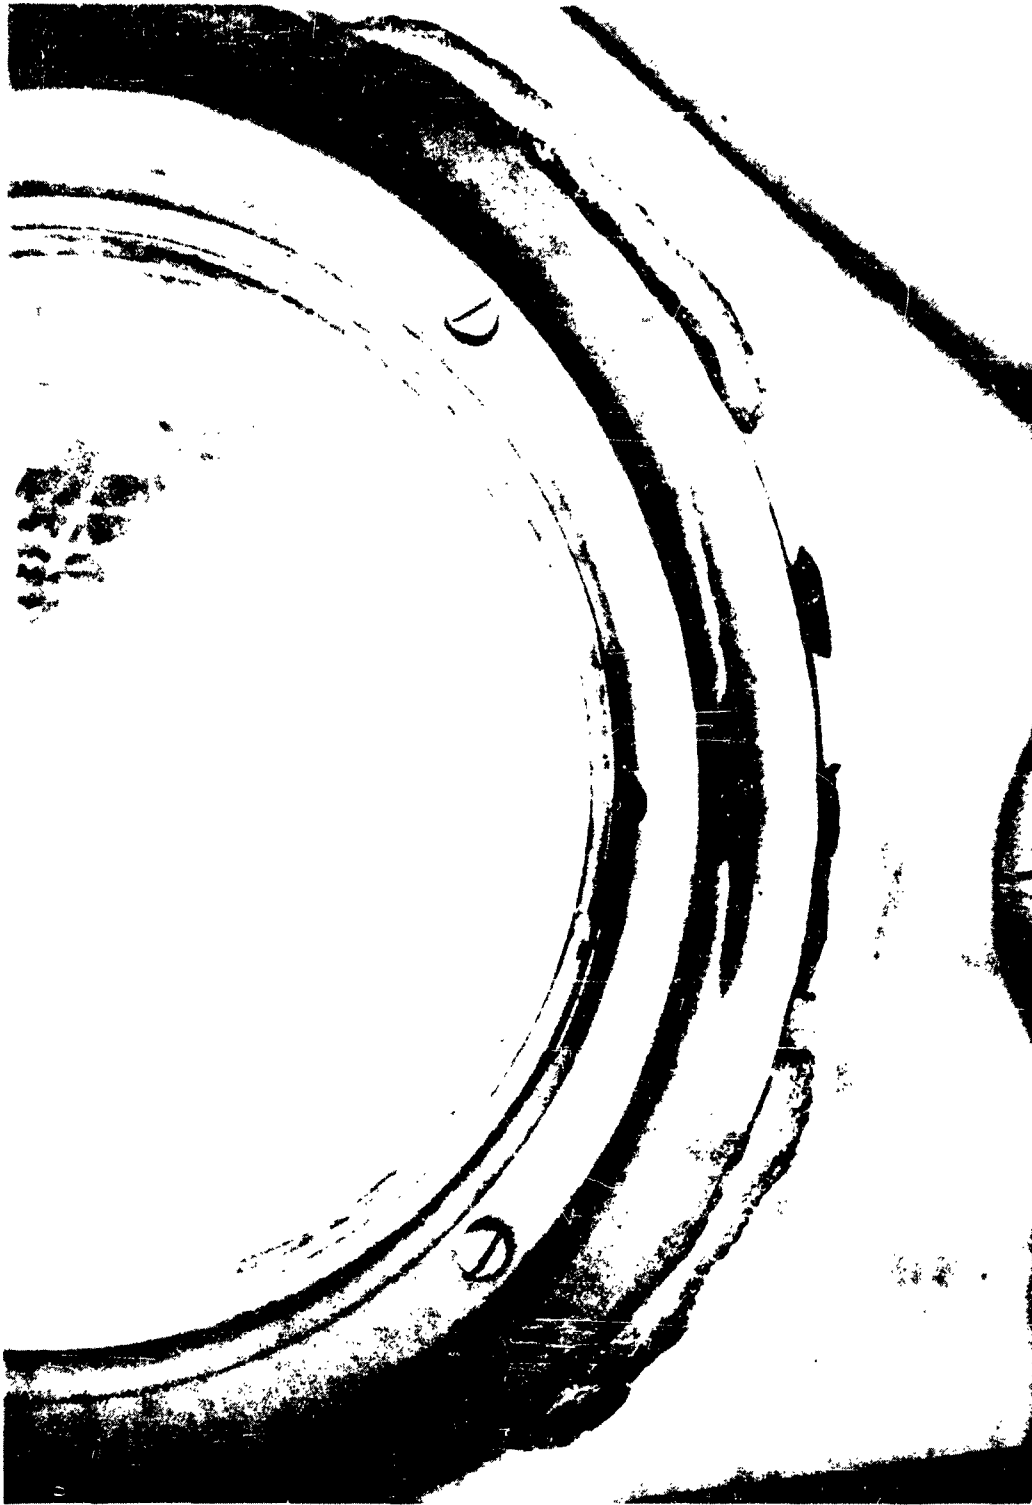
FIGURE 51

Fig 51 - Corrosion under right head lamp assembly. Paint System O

M38A1, CORROSION UNDER RIGHT HEADLAMP AFTER 34 MONTHS  
OUTSIDE EXPOSURE

| BODY ITEM | PAINT SYSTEM | GENERAL CONDITION AT END OF TEST | PHOTOGRAPHIC EVIDENCE (Figure Numbers) |
|---|---|---|---|
| Headlamp Assemblies<br>Right & Left | O | Severe corrosion around<br>lamp housings | 52, 51 |

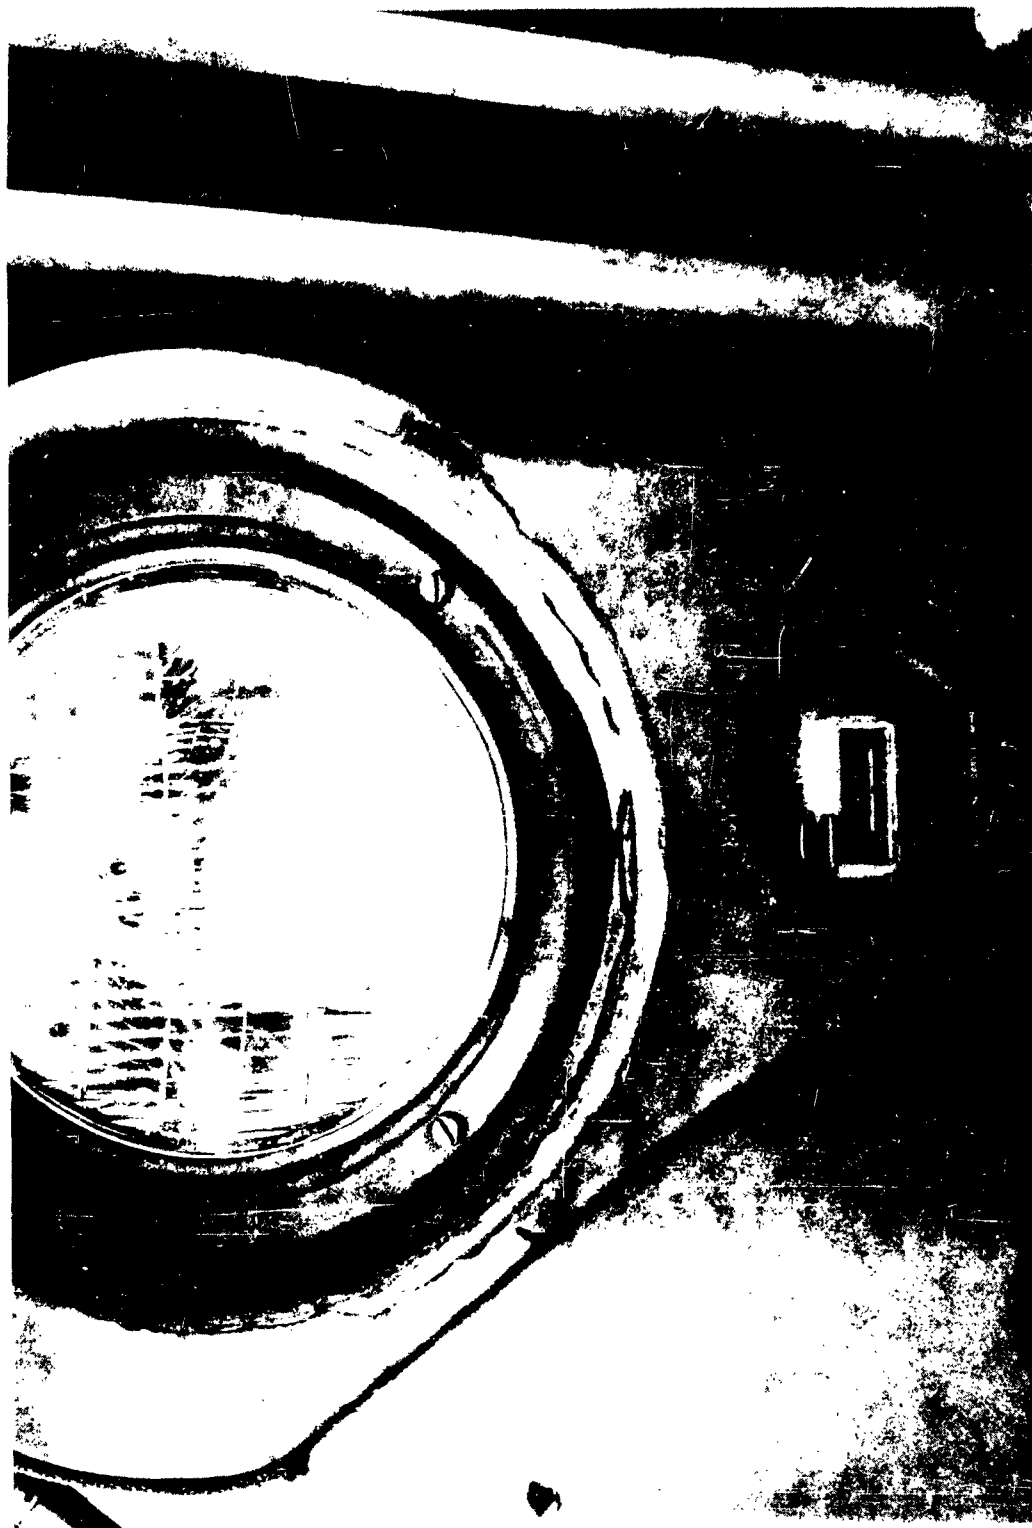
FIGURE 52.

Fig 52 - Corrosion under left headlamp assembly. Paint System O

M38A1, CORROSION UNDER LEFT HEADLAMP AFTER 34 MONTHS  
OUTSIDE EXPOSURE

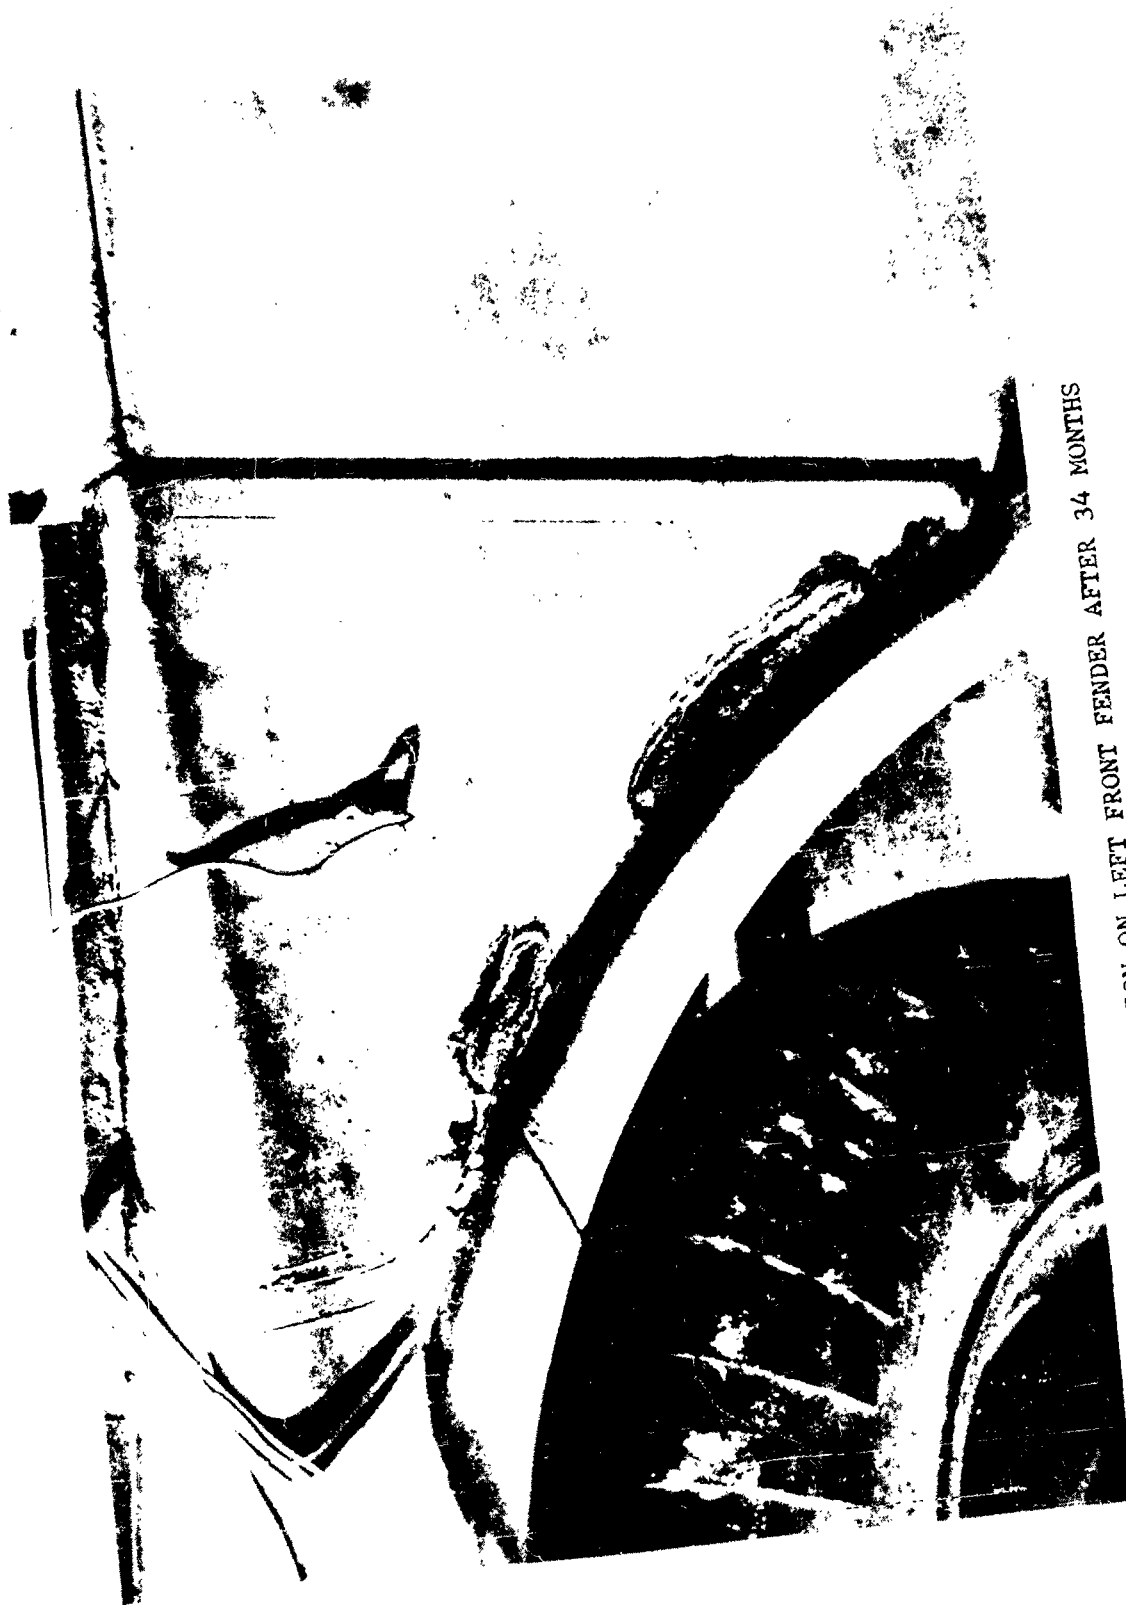
FIGURE 56.

Fig 56 - Corrosion on left front fender. Paint System N

M38A1, CORROSION ON LEFT FRONT FENDER AFTER 34 MONTHS  
OUTSIDE EXPOSURE

| BODY ITEM | PAINT SYSTEM | GENERAL CONDITION AT END OF TEST | PHOTOGRAPHIC EVIDENCE (Figure Numbers) |
|---|---|---|---|
| Left Fender | N | Corrosion along masked edge | 56 |

Severe corrosion occurred along seams and masked edge members of Systems P and O. (See Figure 56) Loss of paint adhesion and corrosion was confined in general to the edge area. This type of failure appeared to be due to a galvanic condition resulting from the lack of protecting voltages on edge and bearing members.

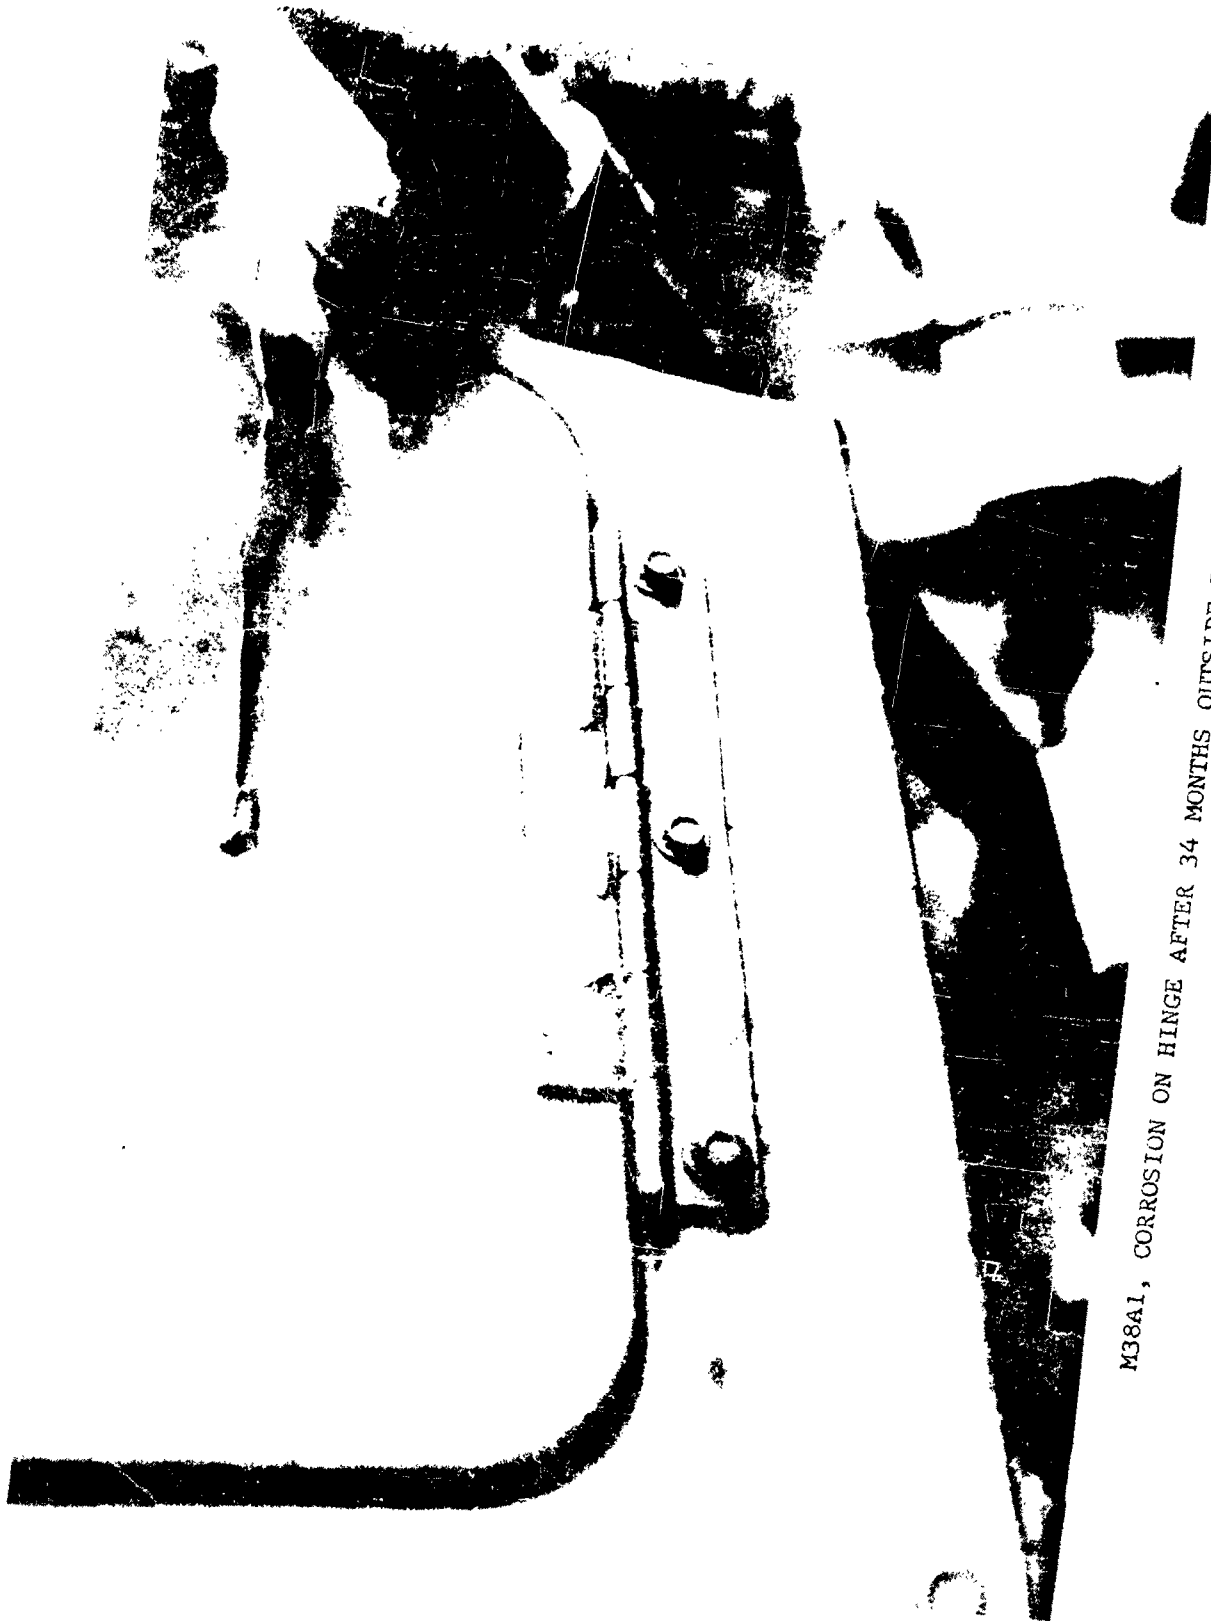
M38A1, CORROSION ON HINGE AFTER 34 MONTHS OUTSIDE EXPOSURE  
FIGURE 57.

Fig 57 - Corrosion on hinge of panel door. Paint System P

| BODY ITEM | PAINT SYSTEM | GENERAL CONDITION AT END OF TEST | PHOTOGRAPHIC EVIDENCE (Figure Numbers) |
|---|---|---|---|
| Dash Panel | E | Corrosion on Hinge | 57 |

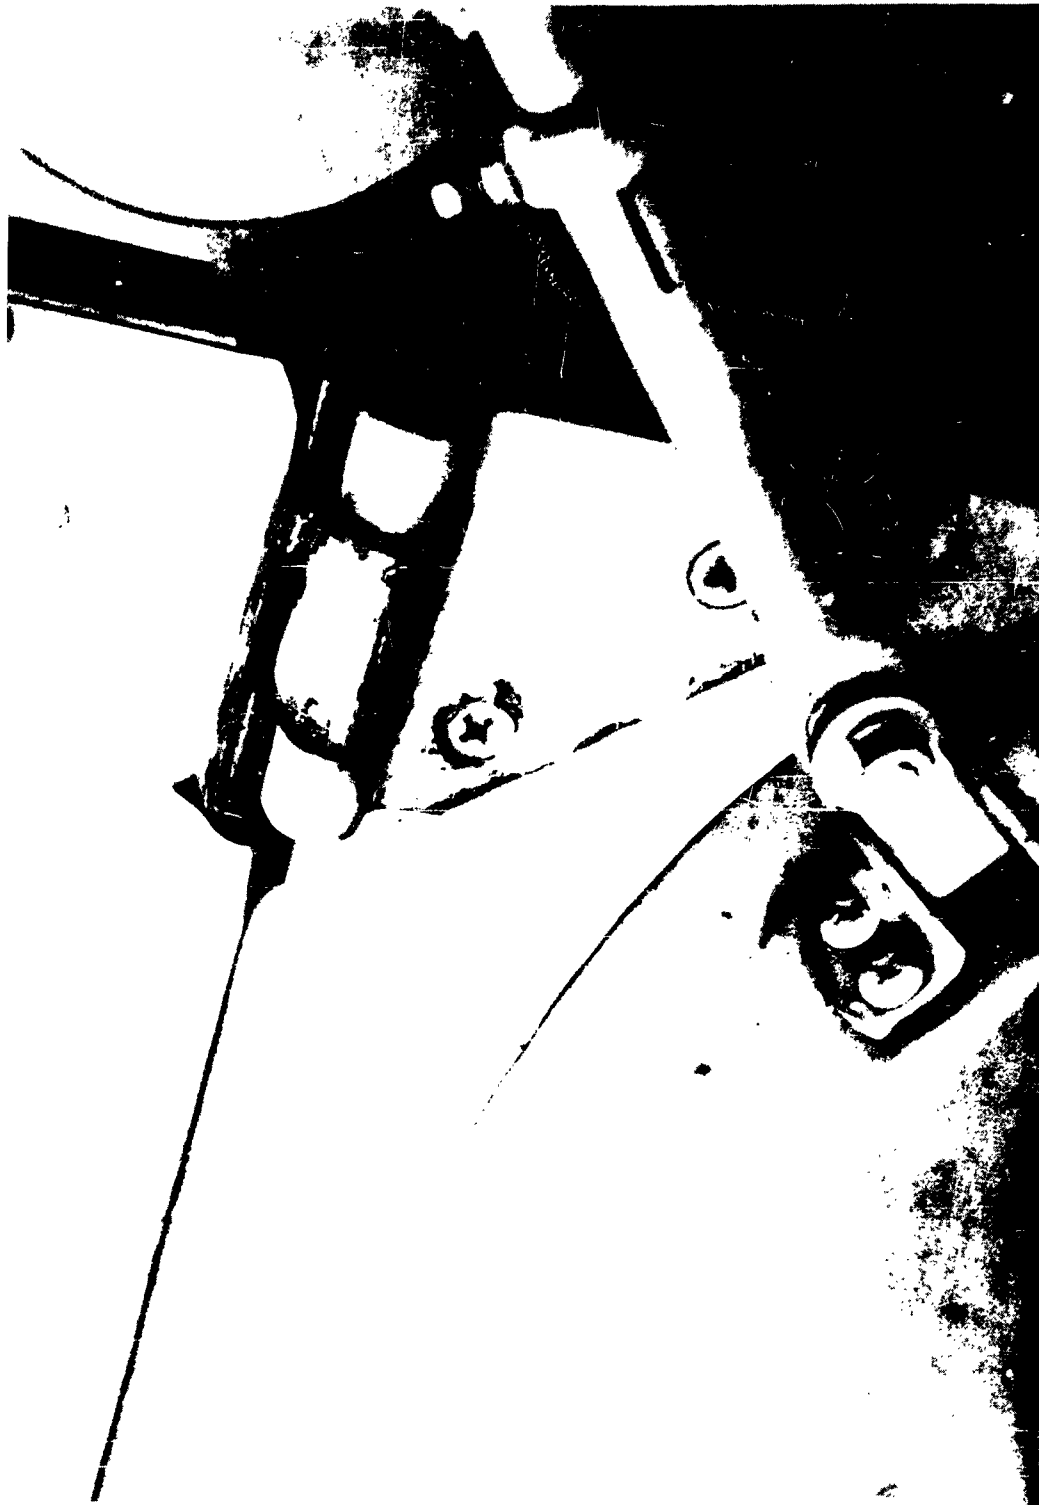
FIGURE 58.

Fig 58 - Corrosion on windshield hindge. Paint System O

M38A1, CORROSION ON WINDSHIELD HINGE AFTER 34 MONTHS  
OUTSIDE EXPOSURE
