Technical Note 441

EVALUATION OF METHODS FOR PROTECTING BURIED COLD
PIPES FROM EXTERNAL CORROSION AT CHINA LAKE, CALIFORNIA

25 June 1962

U. S. NAVAL CIVIL ENGINEERING LABORATORY
PORT HUENEME, CALIFORNIA

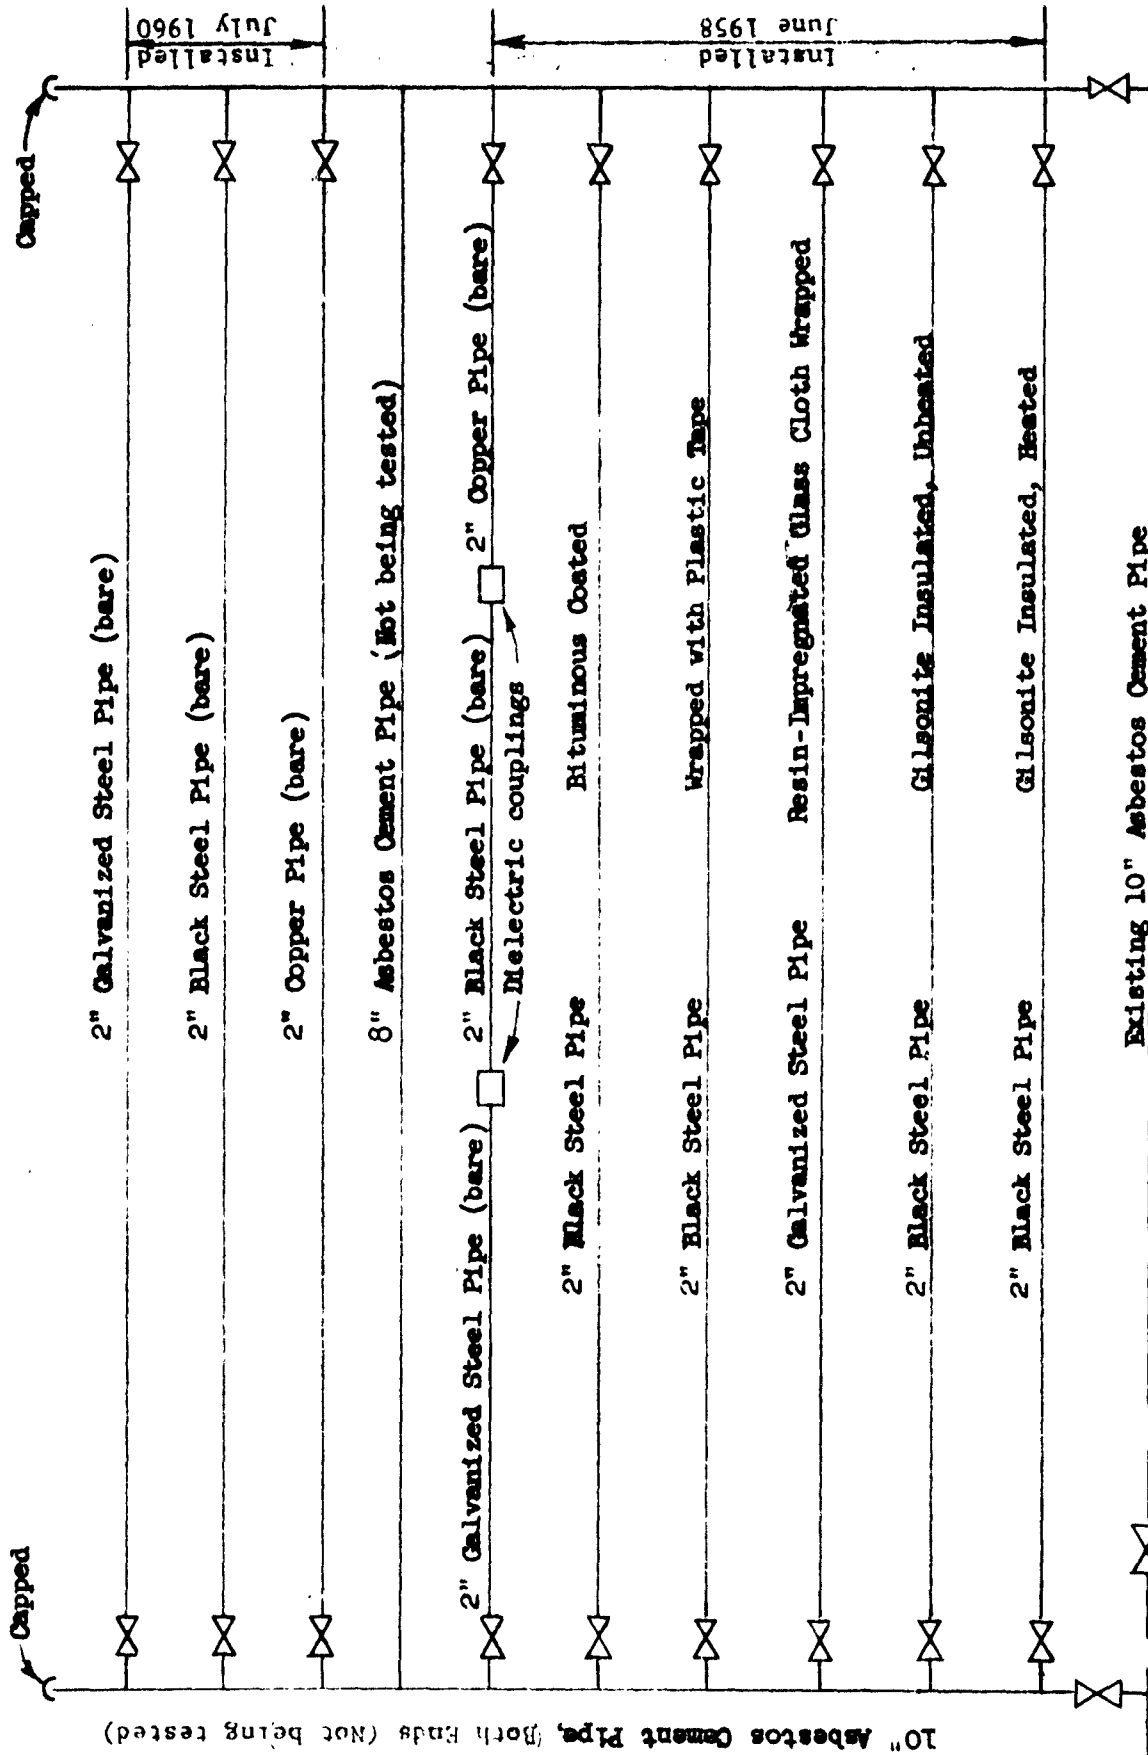
Figure 1. Diagram of Underground-Pipe Test Installation. Pipes are spaced 4 feet apart and Buried Approximately 3 Feet Deep
