### COATING STUDIES AT KWAJALEIN, KANEHOE, AND PORT HUENEME

U. S. NAVAL CIVIL ENGINEERING LABORATORY  
Port Hueneme, California

Y-R007-08-001

C. V. Brouillette, R. L. Alumbaugh

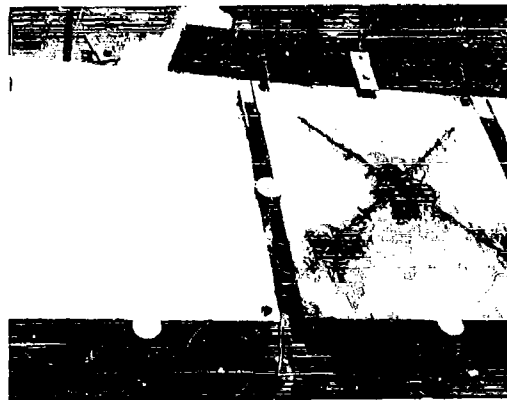
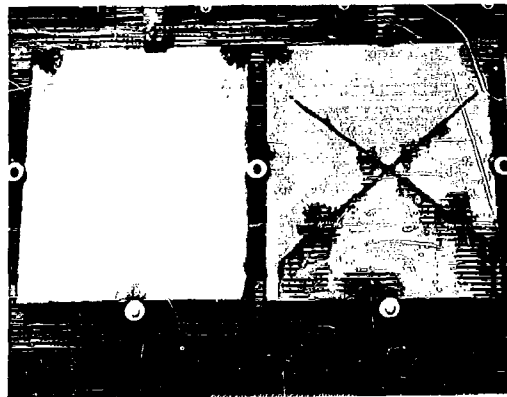
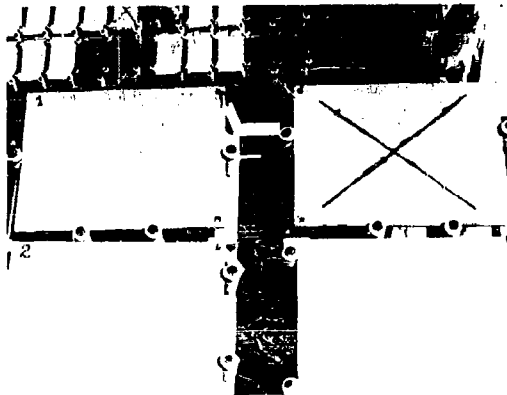
On the scribed panels this system failed at Kwajalein after 4-1/2 years as a result of blistering and rusting and was removed from test. The degree of blistering at the scribe was rated 2/M at Kaneohe after 5 years and 2/F at Port Hueneme after 5-1/2 years; protection was rated 8 and 10, respectively. Light rusting was occurring in the scribed mark at these two test sites.

The unscribed panels, after 5 years at the three test sites, have received very good protection, except at mechanical breaks or pinholes which exposed the steel substrate. Also slight rusting and blistering, aggravated to some extent by edge effects, has occurred at the corners and sides of the test panels that remain on exposure. The over-all rating for the unscribed panel at each test site was 9 at Kwajalein and Kaneohe and 10 at Port Hueneme.

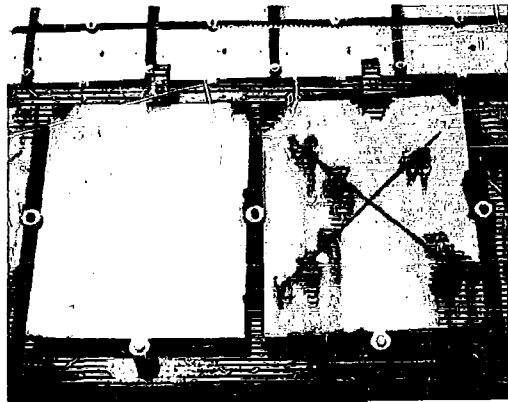
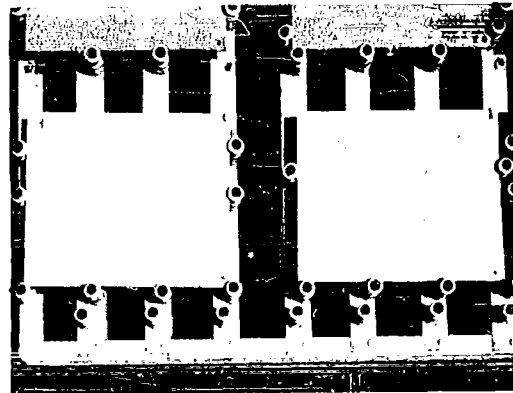
The scribed panel failed at Kwajalein in 3 years because of blistering and rusting originating at the scribe, and was removed from test. Blistering of the scribed panel at Kaneohe after 5 years was rated 2/MD and protection was rated 8; at Port Hueneme after 5-1/2 years the coating was rated 10 on over-all protection.

This system has given very good protection to the unscribed test panel at Kwajalein (rate 9) after 5-1/2 years exposure and excellent protection (rate 10) at Kaneohe and Port Hueneme after 5 and 5-1/2 years, respectively. The initial failure of this coating on the unscribed panels was progressing from the edges and corners and was most pronounced at Kwajalein.

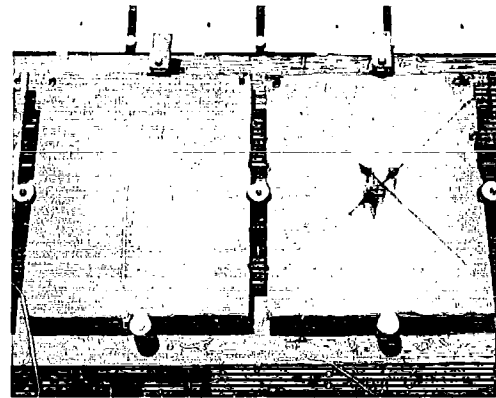
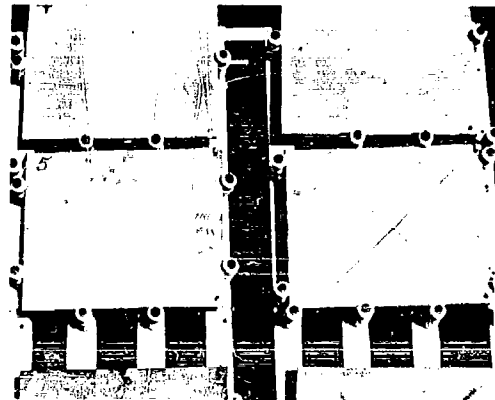
This vinyl system failed because of blistering and rusting along the scribed mark at Kwajalein after 4-1/2 years and was removed from test. The scribed panel at Kaneohe has only a few blisters (2/F) and light rusting after 5 years, and the scribed panel at Port Hueneme has no blisters after 5-1/2 years.

The unscribed panel at Kaneohe after 5 years and at Port Hueneme after 5-1/2 years was rated 10; the unscribed panel at Kwajalein was rated 9 after 4-1/2 years. The first signs of failure on the unscribed panel at Kaneohe and Port Hueneme were found at edges and corners. Coating breakdown has also occurred at pinhole breaks in the coating.

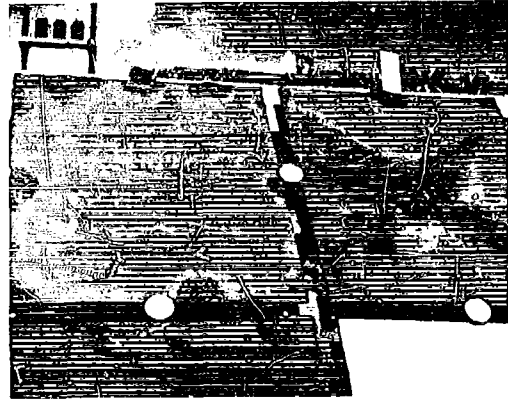
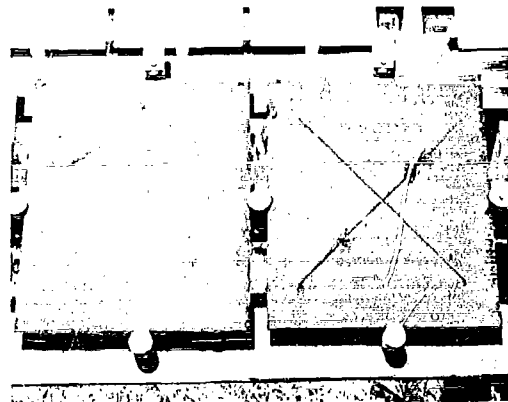
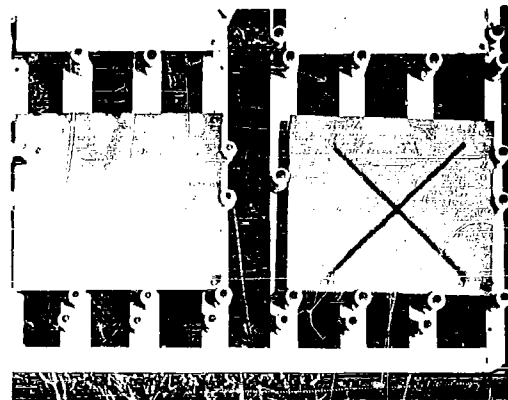
The vinyl mastic failed along the scribed mark, after 4-1/2 years at Kwajalein, because of blistering and was removed from test. Only a few blisters (rated 2/F) had appeared along the scribed mark at Kaneohe after 5 years, and no blistering was present after 5-1/2 years at Port Hueneme.

The unscribed panel was rated 9 after 5-1/2 years at Kwajalein. Failure started with the formation of blisters and rusting at corners and edges. The unscribed panel was rated 10 after 5 years at Kaneohe and 5-1/2 years at Port Hueneme. Only very slight evidence of weathering was found at the edges and corners of these panels.

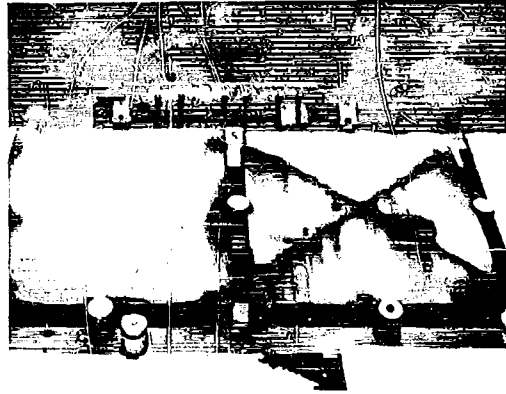
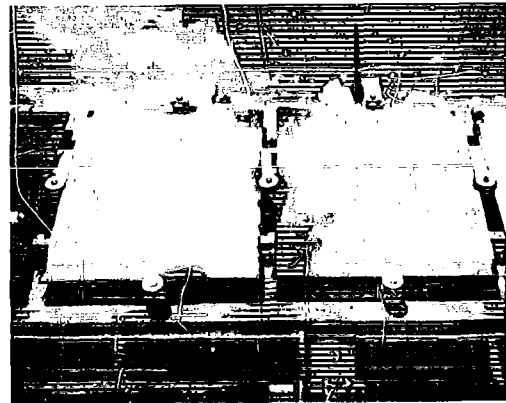
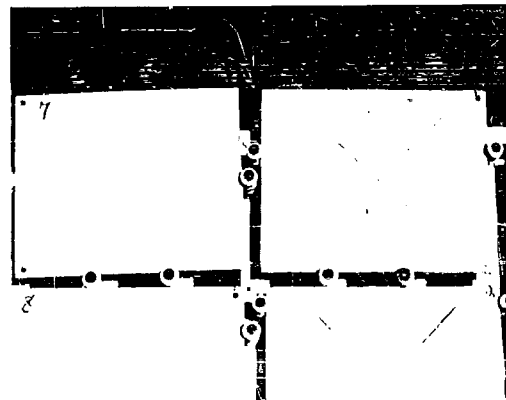
The blistering of this coating at the scribed mark was rated 2/MD after 5-1/2 years exposure at Kwajalein. Although heavy rusting along the scribed mark was causing discoloration of the paint film, the over-all protection given by this coating was rated 7. After 5 years at Kaneohe, rusting along the scribed mark was light, and blistering was rated 2/F. At Port Hueneme, no blistering had occurred along the scribe after 5-1/2 years.

The protection given to the un-scribed panel was rated 8 at Kwajalein, 9 at Kaneohe, and 10 at Port Hueneme. Failure of the coating on the unscribed panels has proceeded from the corners and edges.

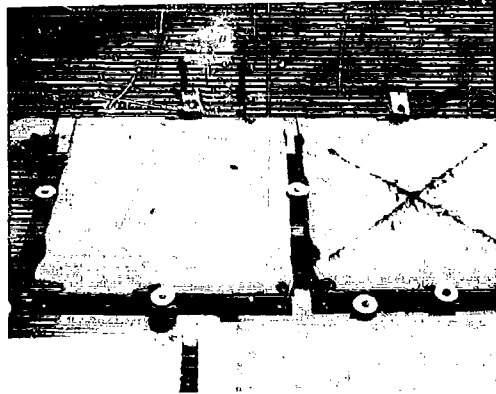
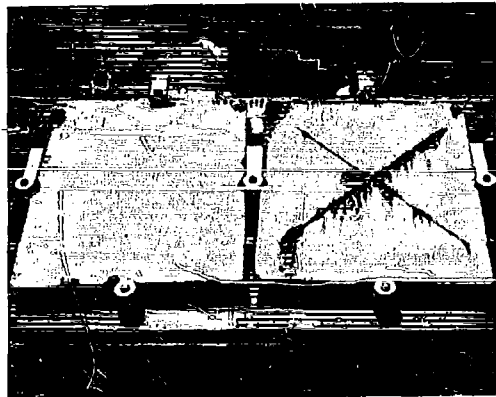
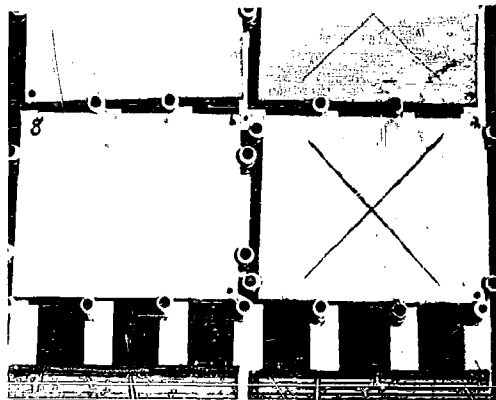
Blistering, rated 2/MD, and considerable rusting have occurred along the scribed mark, during 5-1/2 years at Kwajalein and 5 years at Kaneohe. However, the over-all protection was rated 7. No blistering has occurred along the scribed mark after 5-1/2 years at Port Hueneme.

Initial attack by blistering and rusting has occurred at the corners and edges of the unscribed panels at Kwajalein and Kaneohe, and the panels were rated 9. The panel at Port Hueneme was rated 10.

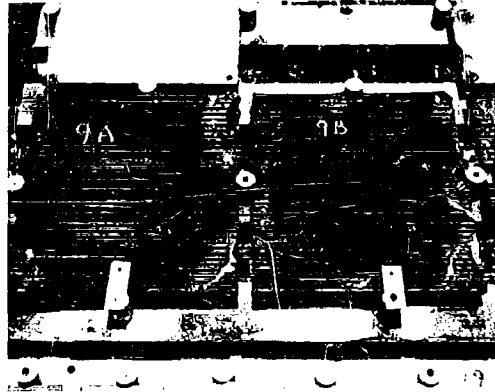
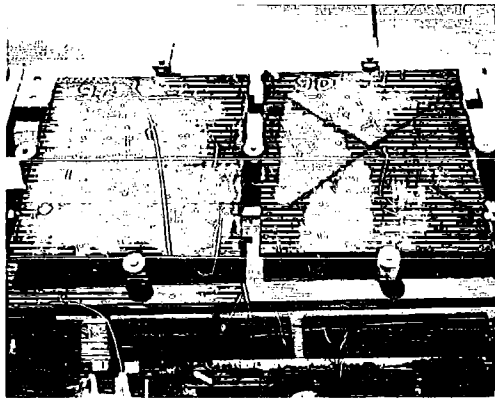
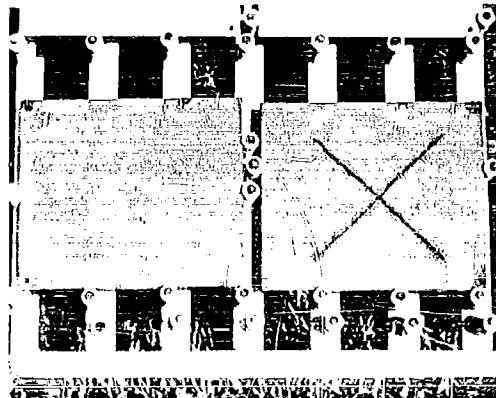
The blistering along the scribed mark was rated 2/D after 5-1/2 years at Kwajalein and was aggravated by slight undercutting. This failure had not progressed outward from the scribed mark to any extent, but because of rusting, blistering, and undercutting at the corners and edges, the over-all rating was 6, and the panel was removed from exposure. The scribed panel at Kaneohe after 5 years was rated 2/M on blistering along the scribed mark, and 9 on over-all protection. After 5-1/2 years at Port Hueneme, it was rated 10.

Light checking covered the surface of the neoprene at Kaneohe and Port Hueneme. This checking was not observed at Kwajalein.

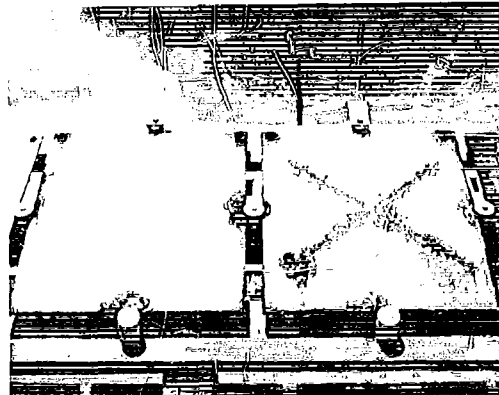
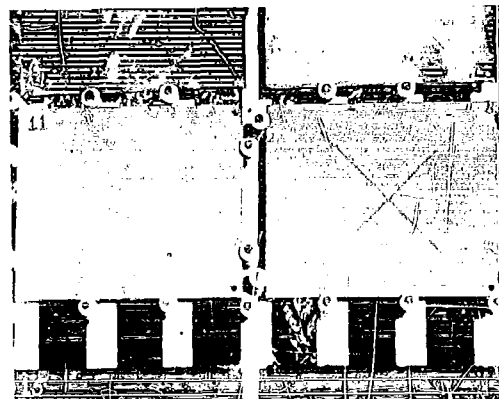
The chlorinated rubber coating failed completely because of blistering along the scribed mark, after 3 years at Kwajalein, and was removed from test. The blistering of the scribed panel, after 5 years at Kaneohe, was rated 2/D, and the protection given to the test panel was rated 7. After 5-1/2 years at Port Hueneme, no blistering had occurred.

On the unscribed panel at Kaneohe, blistering was occurring at points where slight pressure was applied by the porcelain insulators. The over-all rating was 9 at Kaneohe and 10 at Port Hueneme. The panel at Kwajalein was lost after three years of exposure, at which time the rating was 9.

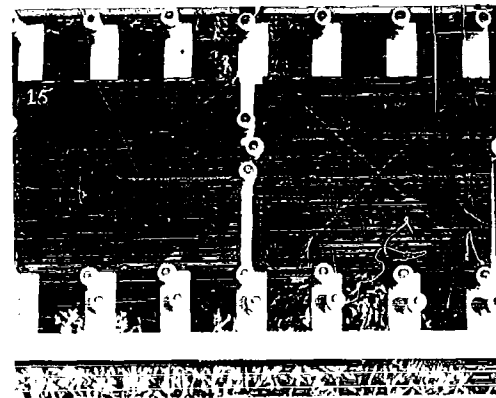
The scribed panel failed at Kwajalein after 4-1/2 years, because of blistering, and was removed from test. Blistering had occurred over about 60 per cent of the plain surface and was rated 2/D along the scribed mark. After 5 years at Kaneohe, blistering along the scribed mark was rated 2/MD, and 10 after 5-1/2 years at Port Hueneme. Overall protection was rated 8 at Kaneohe and 10 at Port Hueneme.

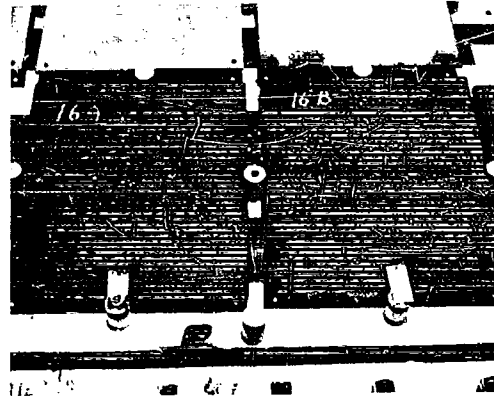
The general appearance of this coating was good, and the protection being given to both the scribed and unscribed test panels after 5 years exposure at Kaneohe and 5-1/2 years at Kwajalein and Port Hueneme was rated 10. Very light rusting had appeared in the scribed marks, but no blistering had occurred.

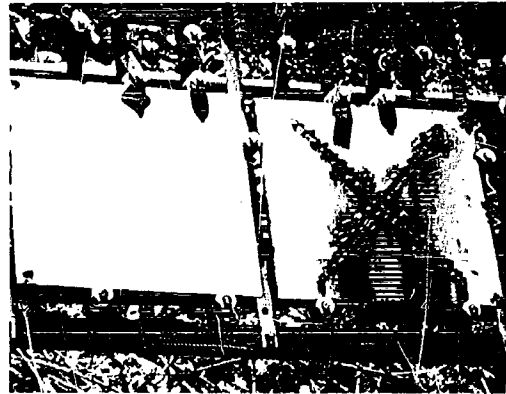
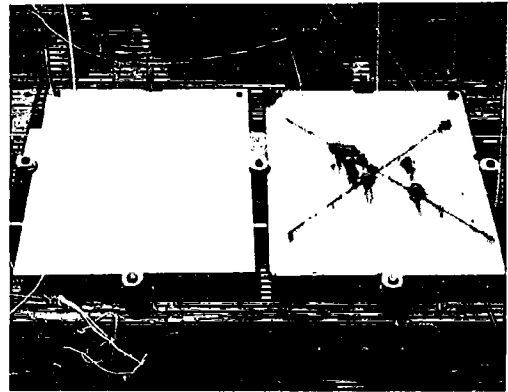
The scribed panel coated with Saran failed after 3 years at Kwajalein because of blistering along the scribed mark. At Kaneohe after 5 years, blistering along the scribed mark and edges was rated 2/MD, and at Port Hueneme after 5-1/2 years, the blistering was rated 4/M.

The protection to the unscribed panel at Kwajalein after 5-1/2 years was rated 8 because of slight blistering at edges and pinhole rusting over the surface. No blistering had occurred on the unscribed panel at Kaneohe; but many very small pinhole rust spots were present, and the panel protection was rated 9. At Port Hueneme, the panel was rated 10 after 5-1/2 years.

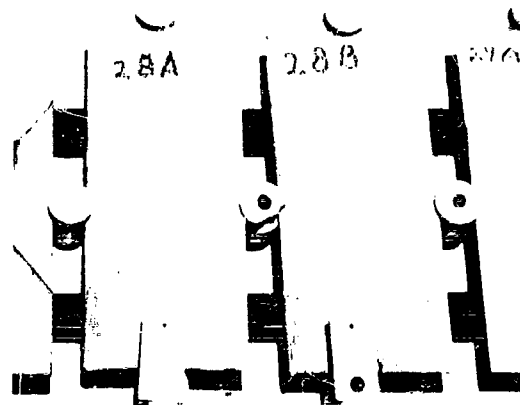
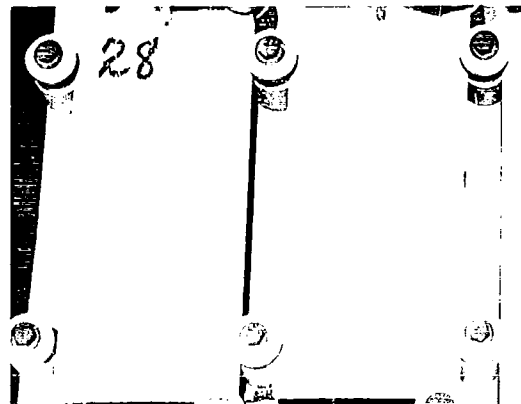
After 2-1/2 years at Kwajalein, white zinc salts had formed over about 10 percent of the surface; however, no rusting had occurred along the scribed mark or on the unscribed surface and the overall protection was rated 10. Zinc salts had formed at minute blisters; blistering over the surface of the two panels was rated 8/M.

At Kaneohe and Port Hueneme after 2-1/2 years, surface weathering had produced some zinc salts. But no blistering had occurred, and the coating was rated 10.

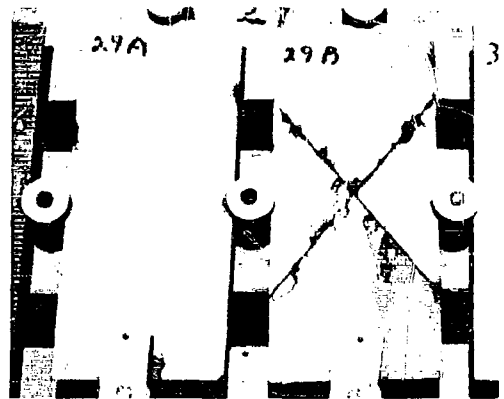
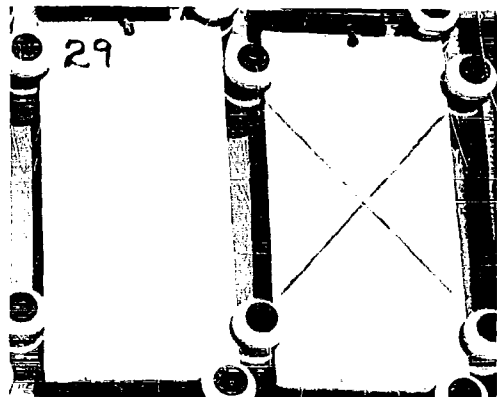
After 2-1/2 years at Kwajalein, there was blistering along the scribed mark, and the coating was rated 2/D. At Kaneohe after 2-1/2 years, blistering of the scribed panel was rated 4/F. No blistering or rusting had occurred after 2-1/2 years at Port Hueneme, and the coating on the scribed panel was rated 10.

The protection to the unscribed panels was rated 9 at Kwajalein and 10 at Kaneohe and Port Hueneme.

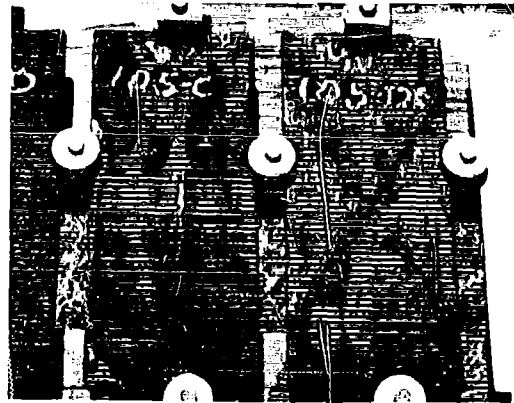
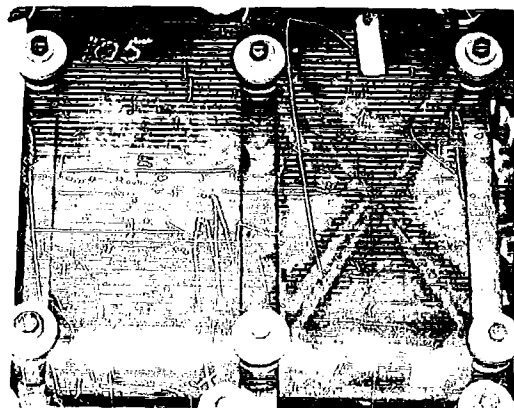
The scribed panel failed after 2-1/2 years at Kwajalein. Blistering along the scribed mark was rated 2/D; blistering at the edges reduced the protection to a rate of 6, and the panel was removed from test. The condition of the coating on the scribed panel at Kaneohe after 2-1/2 years exposure was slightly better than that at Kwajalein, and the protection was rated 9. At Port Hueneme after 3-1/2 years, rusting was occurring along the scribed mark, but no blistering had occurred and protection was rated 10.

The protection given to the un-scribed panel at the various test sites was rated 8 at Kwajalein after 3 years, 9 at Kaneohe after 2-1/2 years, and 10 at Port Hueneme after 3-1/2 years.

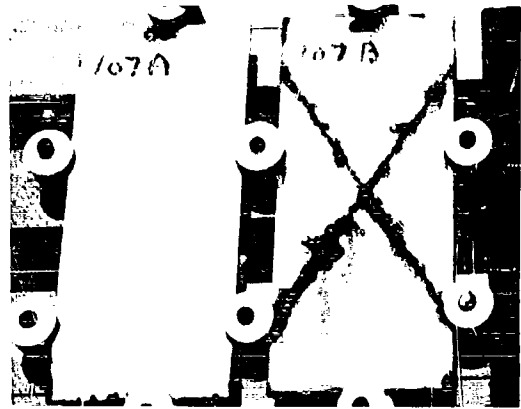
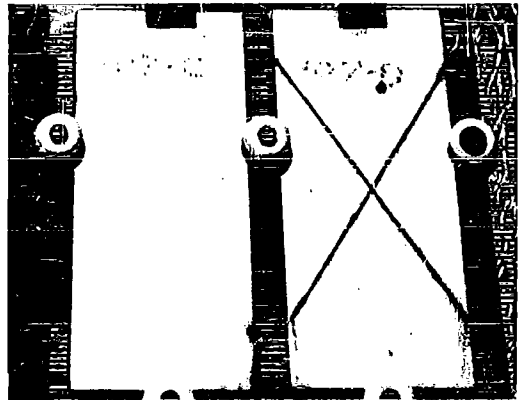
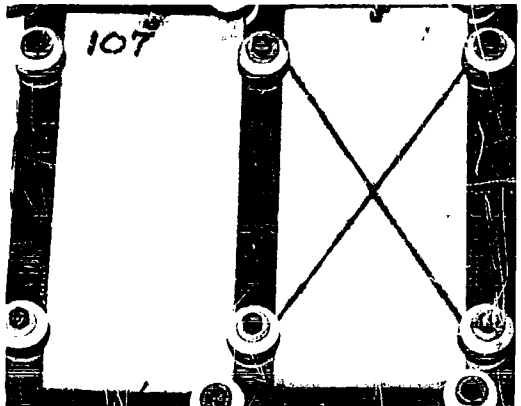
Blistering of the scribed panel at Kwajalein after 3 years was dense and was rated 2/D. Rusting along the scribed mark was heavy. The over-all protection was rated 8. Damage was confined to the scribed area. Blistering of the scribed panel at Kaneohe after 2-1/2 years was light and rated 2/F; the over-all protection was rated 10. At Port Hueneme after 3-1/2 years, the coating was rated 10.

The protection of the unscribed panel at Kwajalein was rated 9 because of edge blistering and rusting; at Kaneohe and Port Hueneme, the rating was 10.

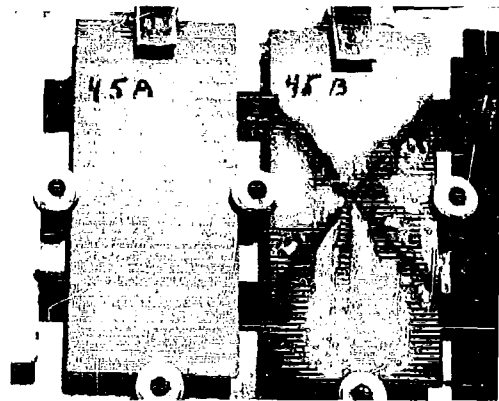
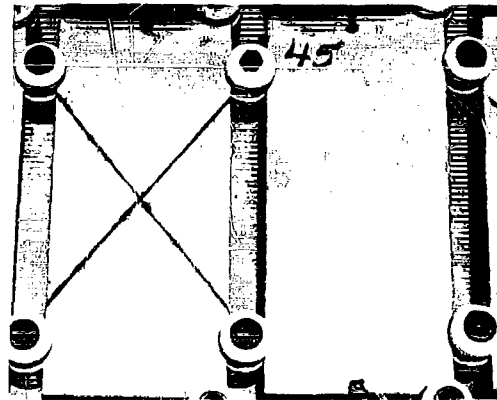
The scribed panel at Kwajalein after 1-1/2 years had dense blistering along the scribed mark, rated 2/D. There was heavy rusting in the scribed mark, and the overall protection was 7. After 2 years at Port Hueneme no blistering had occurred, and this panel was rated 10.

The unscribed panel had received excellent protection at both test sites and was rated 10.

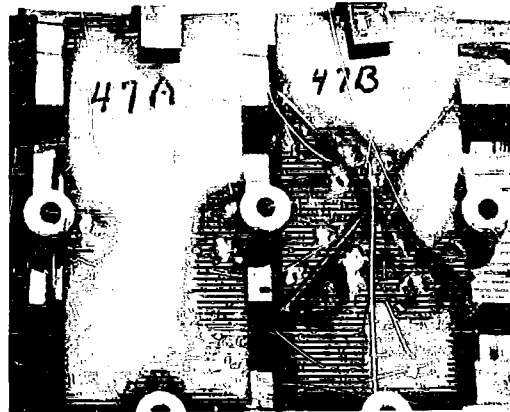
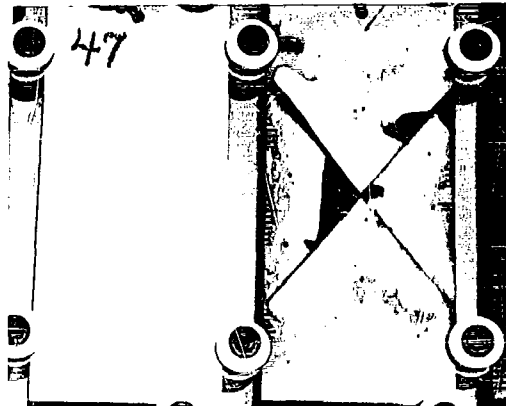
The scribed panel at Kwajalein failed after 1-1/2 years and at Port Hueneme after 2 years and was removed from test. Blistering at Kwajalein was rated 2/D. At Port Hueneme there was no blistering but the coating flaked over 50 percent of the surface of the panel.

The unscribed panel at Port Hueneme had received excellent protection, rated 10; the panel at Kwajalein had blistered and rusted at the edges and was rated 8.

This coating was applied directly over a wash primer. This type of primer does not appear suitable for urethane.
