HUGHES TOOL COMPANY · AIRCRAFT DIVISION
Culver City, California

Report 285-18 (62-18)

HOT CYCLE ROTOR SYSTEM
MATERIALS & PROCESSES

March 1962

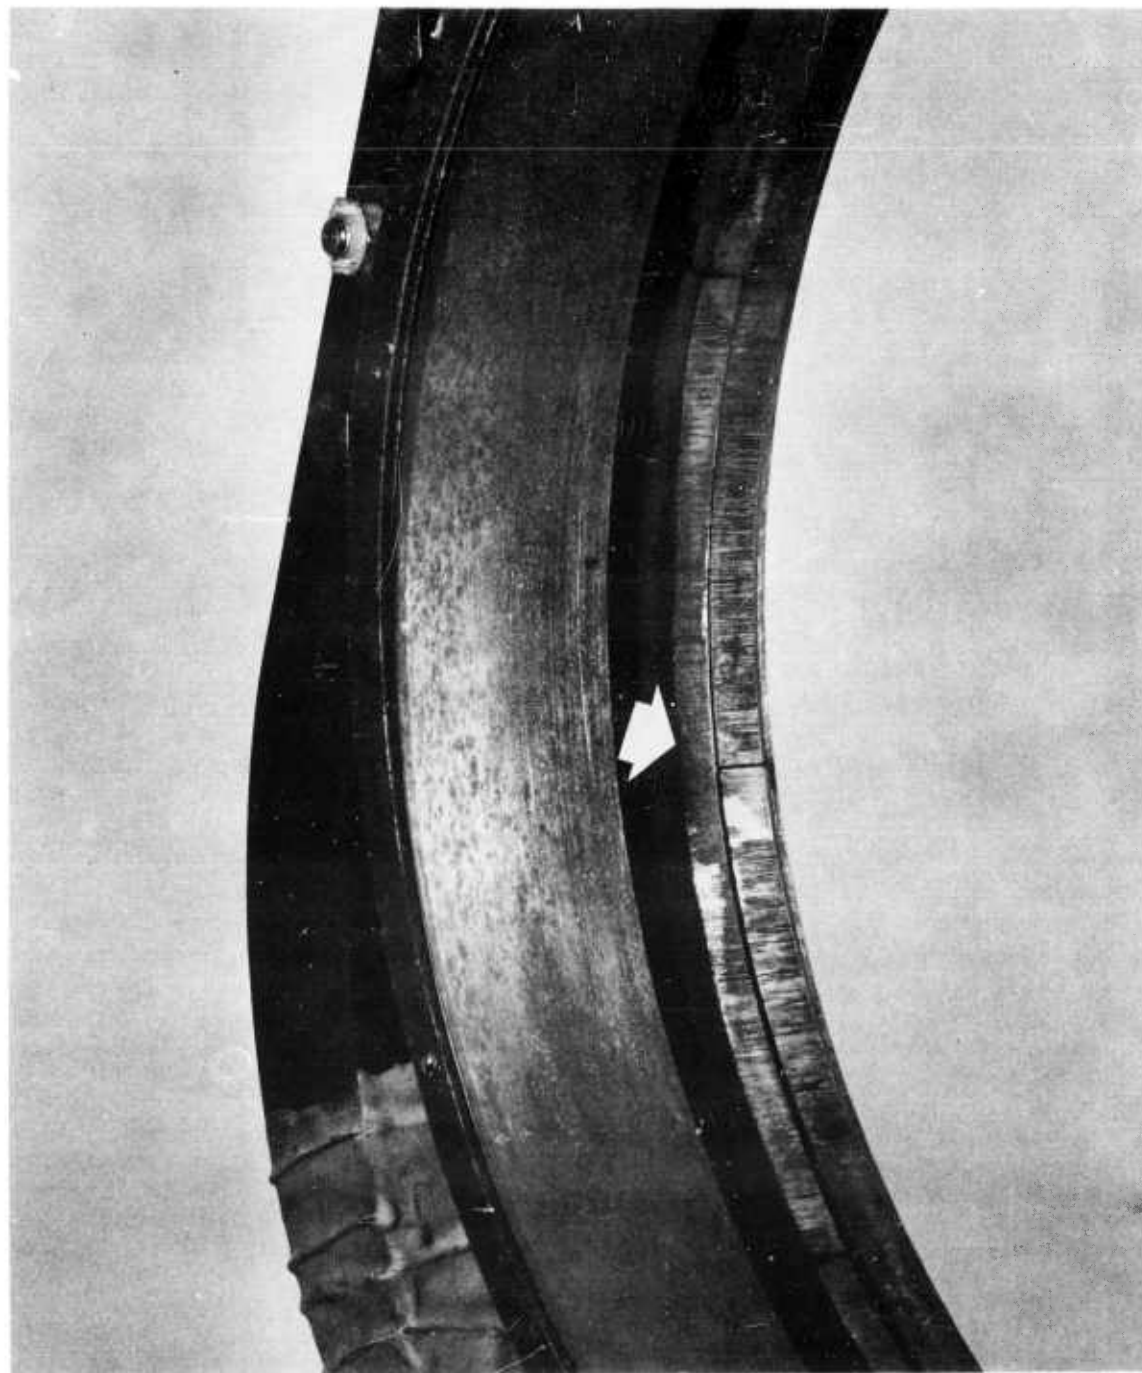
After 18 hours of whirl tests, inspection of the carbon seal materials disclosed some local soft spots in the U. S. Graphite No. 2490 and in the National Carbon Company's No. CDJ-83, which resulted in a tendency toward erosion. The softening and edge erosion can be seen in Figure 2.2-1. In contrast to the above, the Pure Carbon Company's No. 56 HT showed no evidence of softening in any portion of the material.

Figure 2.2-1 Close-up of Articulate Duct Inboard Seal Segmented Carbon Rings.
Note local softening of carbon and resulting erosion of edge.

The 56 HT segments, because of damage in service or handling, were replaced. The #2490 face seal ring, because of leakage through the soft eroded area, was reground flat and smooth and reinstalled. However, since the CDJ-83 seals showed no signs of appreciable leakage, these particular segments were again utilized for an additional 17 hours of whirl tests. At the end of that time, inspection revealed the following:

- a. The 56 HT segments were in excellent condition and were re-installed.
- b. The #2490 ring was again eroded to form a leak path, and because of diminished thickness, was replaced.
- c. The CDJ-83 segments appeared essentially as before and since leakage rate was actually lower, two sets of these were re-installed. The third was damaged in handling and, therefore, was replaced.

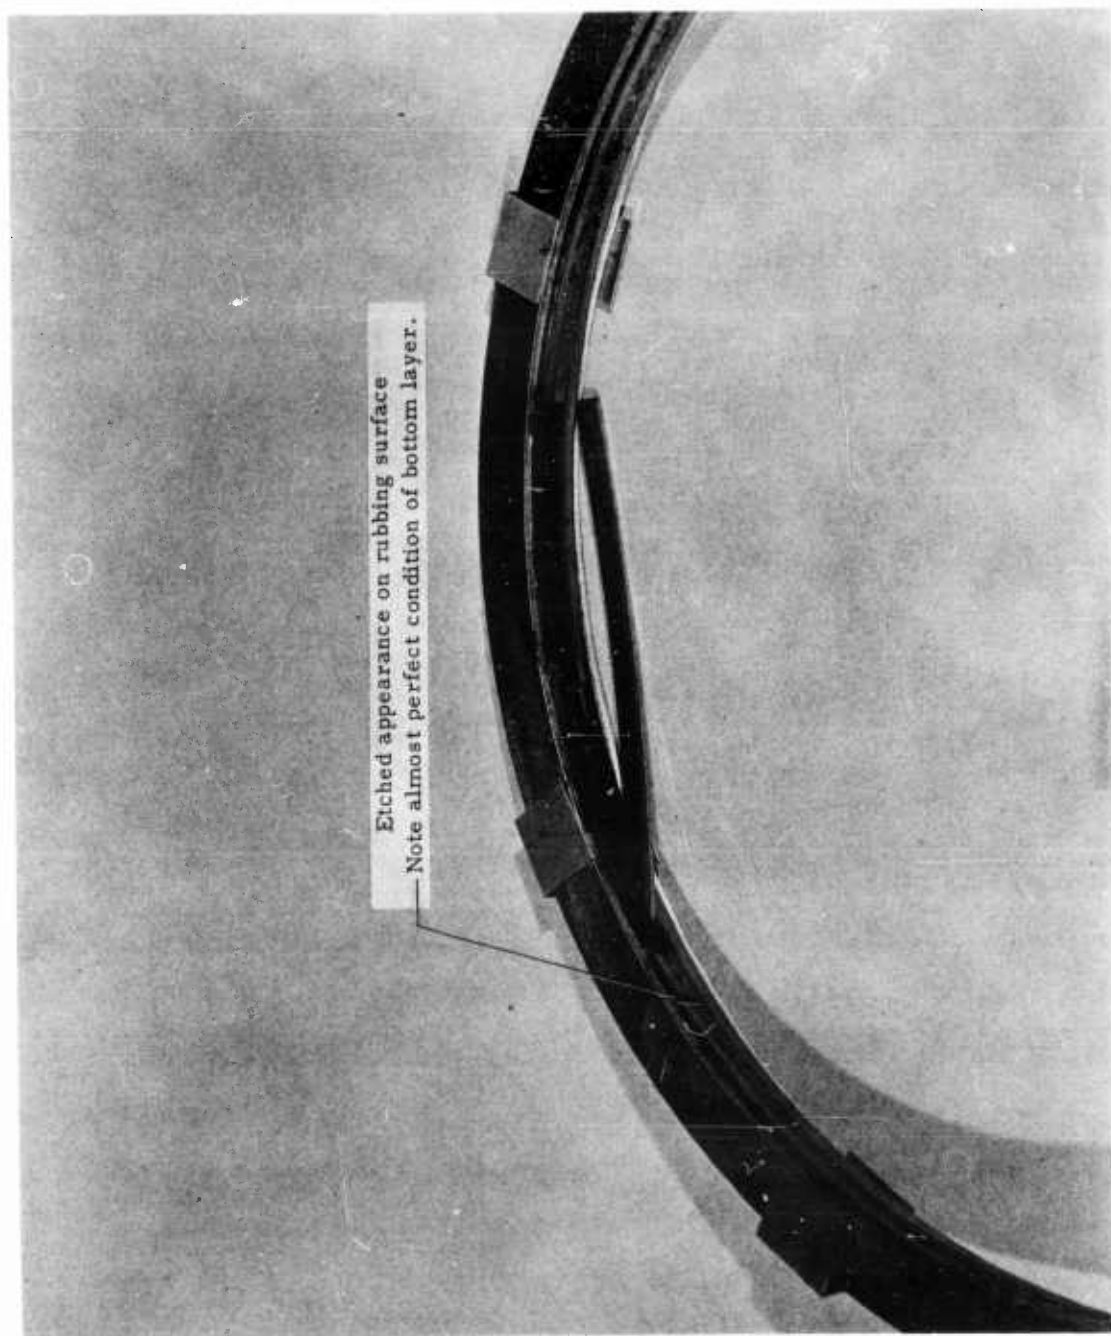
Figure 2.2-2. Etching of Carbon Seals.

- a. The 56 HT, on the upper ring of segments almost exclusively, showed an etched appearance, possibly from the effects of rain water prevalent at that time. The condition is shown in Figure 2.2-2.
- b. The #2490 ring was in excellent condition.
- c. The CDJ-83 segments appeared essentially as before, and leakage rate was essentially identical to the previous values.

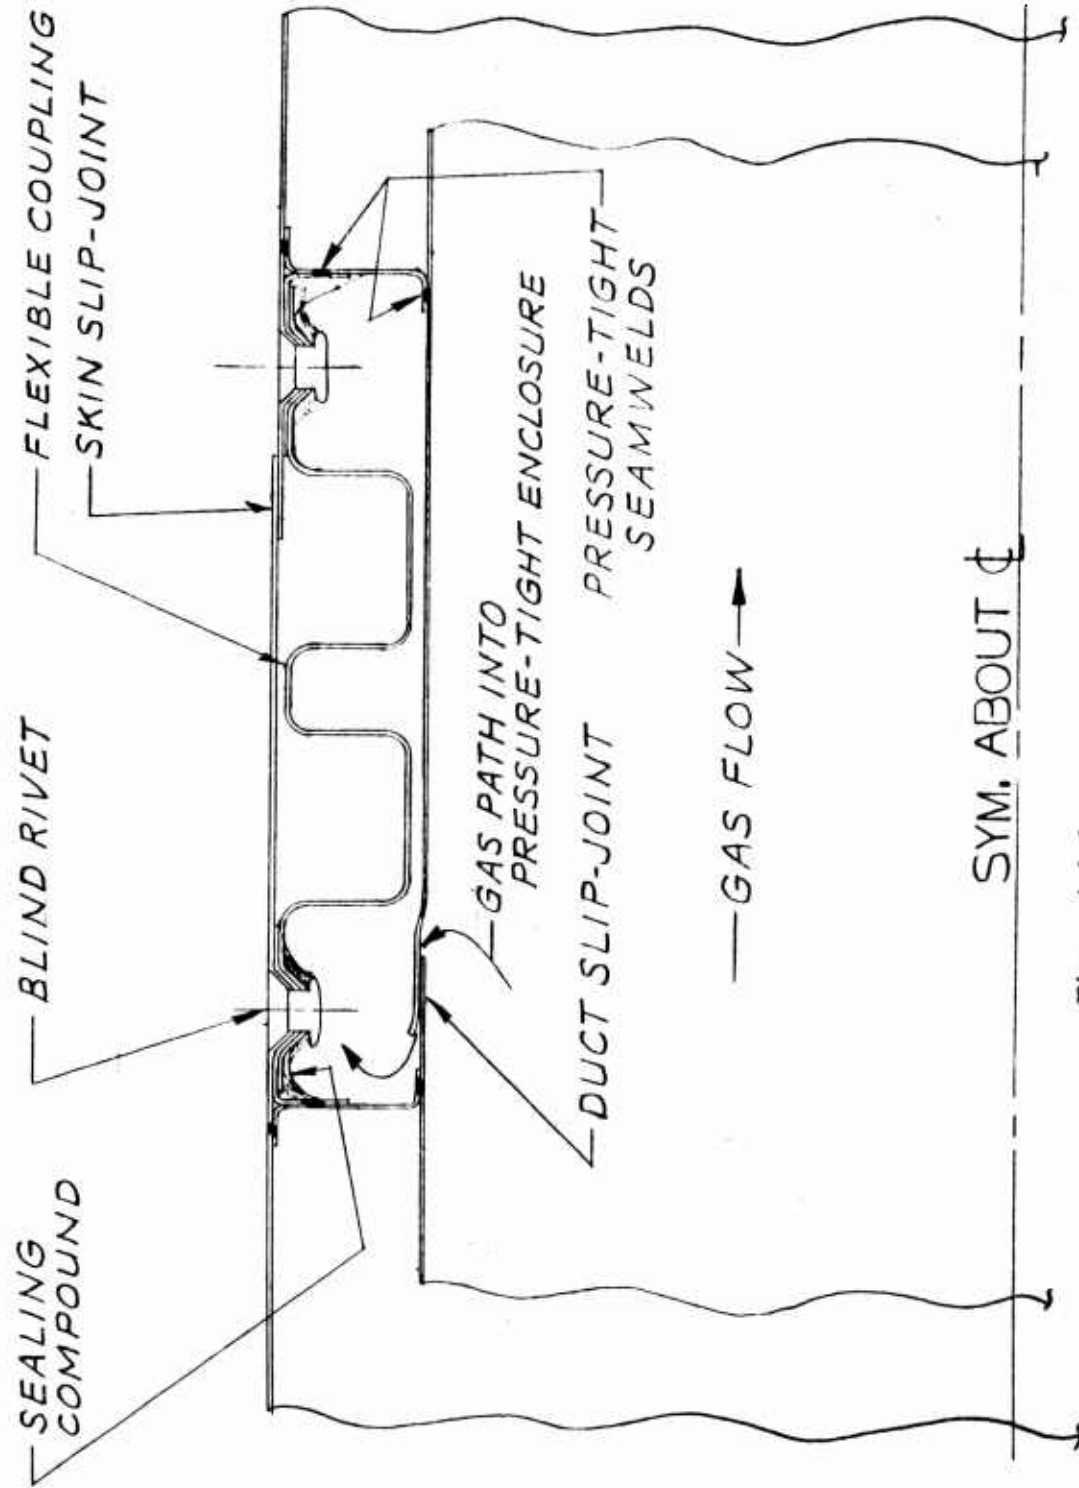
Figure 4.1-1
Typical Blade Segment Joint

Production use of S 5350 (which was subsequently identified as RTV601) was closely controlled. Each batch was tested after mixing to assure that it cured properly and that the adhesion was satisfactory prior to using it in the blades. However, after all blades had been assembled and subjected to a pressure test of 23 psig, many leaks were apparent. The Silastic material extruded from between the flexures and from under the rivet heads. A study showed that the RTV601 had not completely cured in many areas.

An intensive investigation and test revealed that a defective batch of primer had been furnished by Dow Corning which prevented adhesion of the compound. It was also found that because of the difficulty in drilling and

dimpling the blade materials, a sulphur bearing cutting oil had been used. The surfaces were then flushed with M50 solvent prior to assembly. Brushes were also used, where possible, to agitate the solvent. However, removal of the remnants of this type of oil is very difficult even under more ideal conditions. A report from Dow Corning shows that it requires only a very minute amount of sulphur to poison the catalyst system and prevent cure.

Because of the extensive rework involved in disassembling the blades, a repair was attempted by placing a bead of RTV601 Silicone over the existing material. Laboratory tests had indicated that by coating the existing silicone material with Dow Corning A 4094 Primer a satisfactorily cured seal could be produced. A pressure gun with a 1/8" O. D. tube attached was used through a rivet hole to lay the bead. This was by nature a blind operation and in several areas RTV601 Silicone was forced into the duct area, similar to that shown on the test specimen of Figure 4.1-2. This in turn created a question of the stability of RTV601 at 1100 to 1150°F.

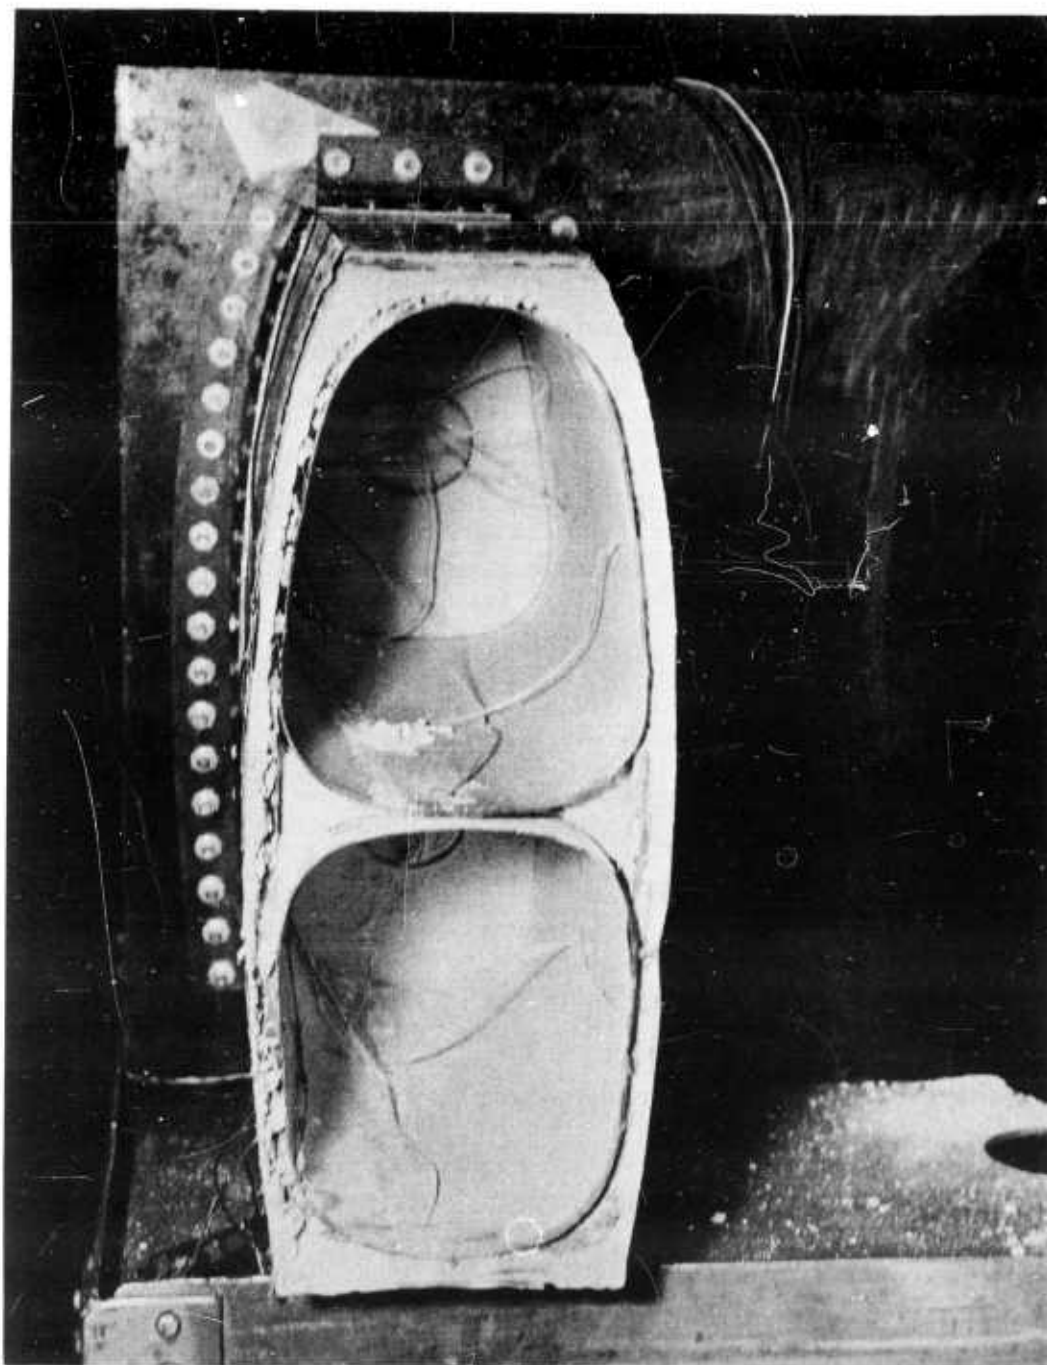
Figure 4.1-2. Results of the Sealant Decomposition Test.
Note material decomposed around ducts -
pliable around outer surfaces

Preliminary laboratory tests gave evidence of burning of the RTV601 at 850 to 900°F. Tests were run at Truesdale Laboratories of Los Angeles which established the autoignition temperature of RTV601 Silicone gases to be in the range of 850° to 900°F, confirming HTC-AD tests indicating ignition at 900°F. In addition, actual blade specimen tests with operational temperatures were conducted by HTC-AD to determine effects under simulated operating conditions. These are reported in Reference 1.

The completely sealed blades, which had a pressure loss of less than 4 CFM per blade at 23 psig, were installed on the whirl tower. Based on recommendations of Dow Corning and the results of the tests at Truesdale, the initial whirling was done at 800°F maximum duct temperature for 7 hours. When no difficulty was experienced, the duct temperature was raised gradually to an eventual 1188°F without difficulty being experienced with the RTV601 sealant. The blades were pressure tested several times during the whirl tests and, without reworking the RTV601 sealant areas, produced leakage comparable to that obtained when the blades were originally installed. The blade subsequently completed 60 hours of whirl testing without further problems involving the RTV601 Sealant.

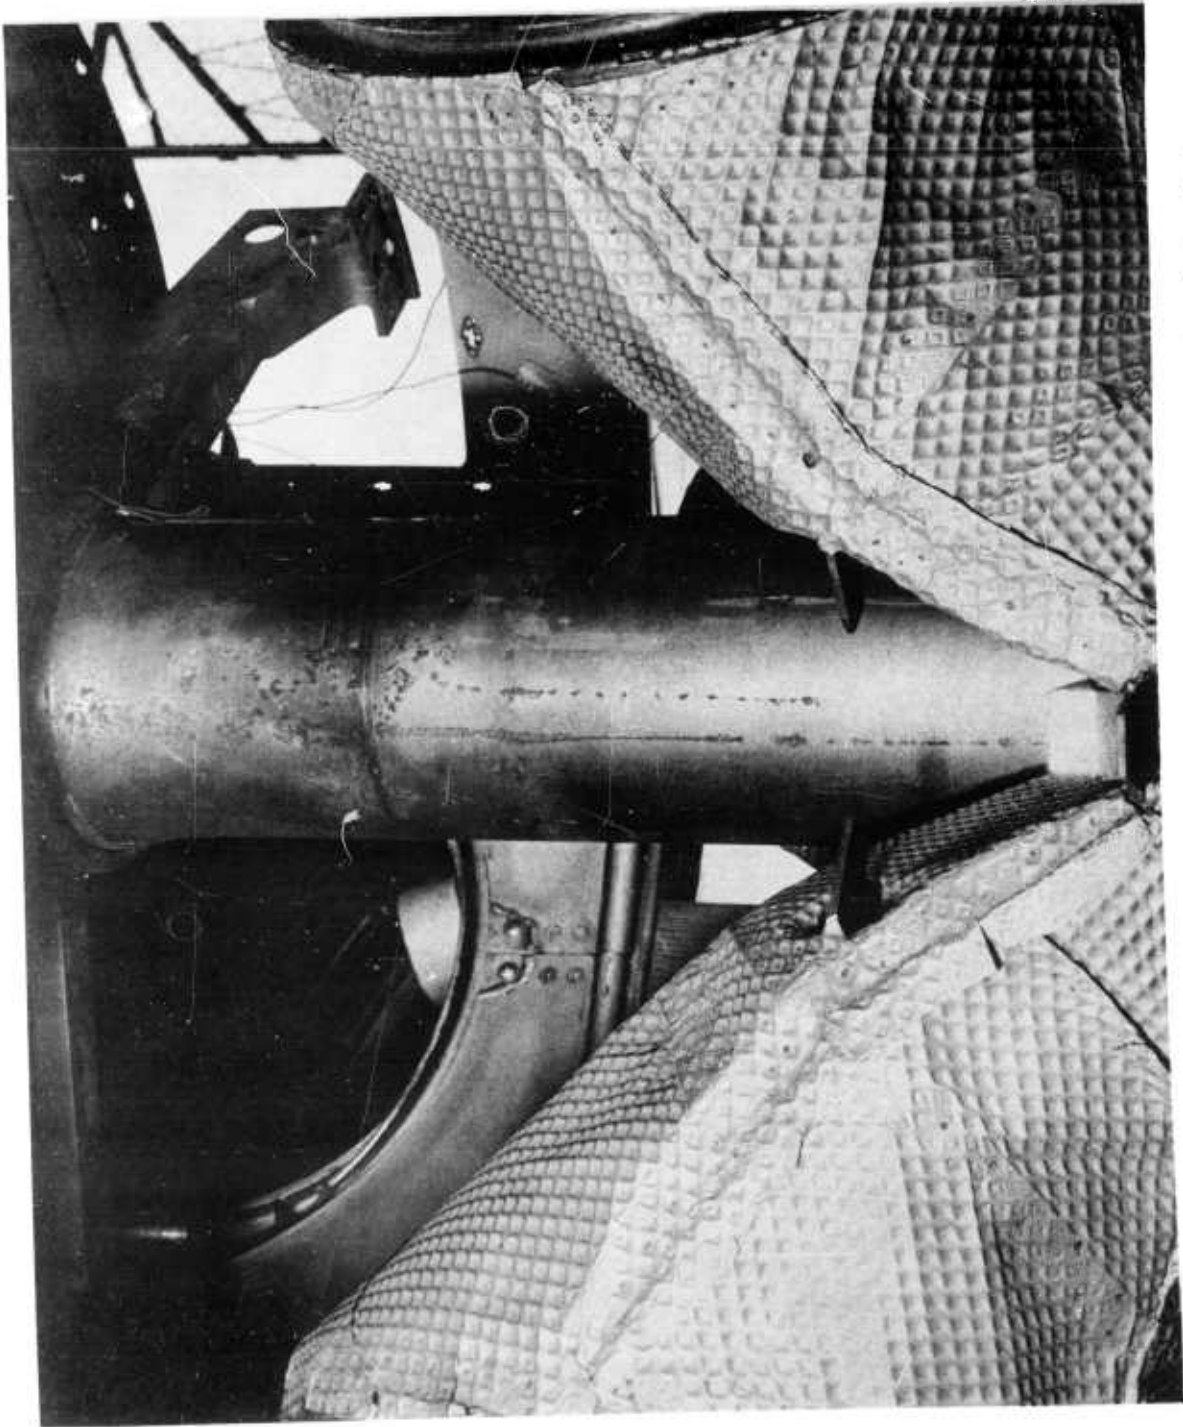
Testing of specimens in salt spray atmosphere showed that the gold paint reduced the corrosion resistance of the nickel surface. However, since the tests showed the reduction in corrosion resistance was relatively small, and because of the desire for a surface of maximum reflectivity to the heat radiated from the ducts, the gold paint was applied to the mast and spoke piece.

The corrosive action of the atmosphere in the area of the shaft, however, was apparently more severe than was expected, because extensive corrosion and deep pitting occurred, as shown in Figure 4.2-1. In contrast it is noteworthy that the spoke piece was free of corrosion. Temperatures recorded for the various portions of the shaft, on the other hand, were considerably lower than those anticipated. For these reasons the gold paint was removed after 18 hours of whirl test (6 months elapsed time) and the surfaces covered with an aluminum filled silicone base paint. This paint has a lower reflectivity but a substantially improved corrosion resistance. It performed quite satisfactorily in both corrosion protection and heat reflection functions during 42 hours (4 months elapsed time) of whirl testing.

Figure 4.2-1. Close-up of Hub Shaft and Support Spoke, Gold-Painted for Heat Reflectivity. Note corrosion on shaft, and absence of same on spoke.
