HUGHES TOOL COMPANY · AIRCRAFT DIVISION
Culver City, California

Report 285-9-8 (62-8)

HOT CYCLE ROTOR SYSTEM
RESULTS OF COMPONENT TEST PROGRAM

FINAL REPORT

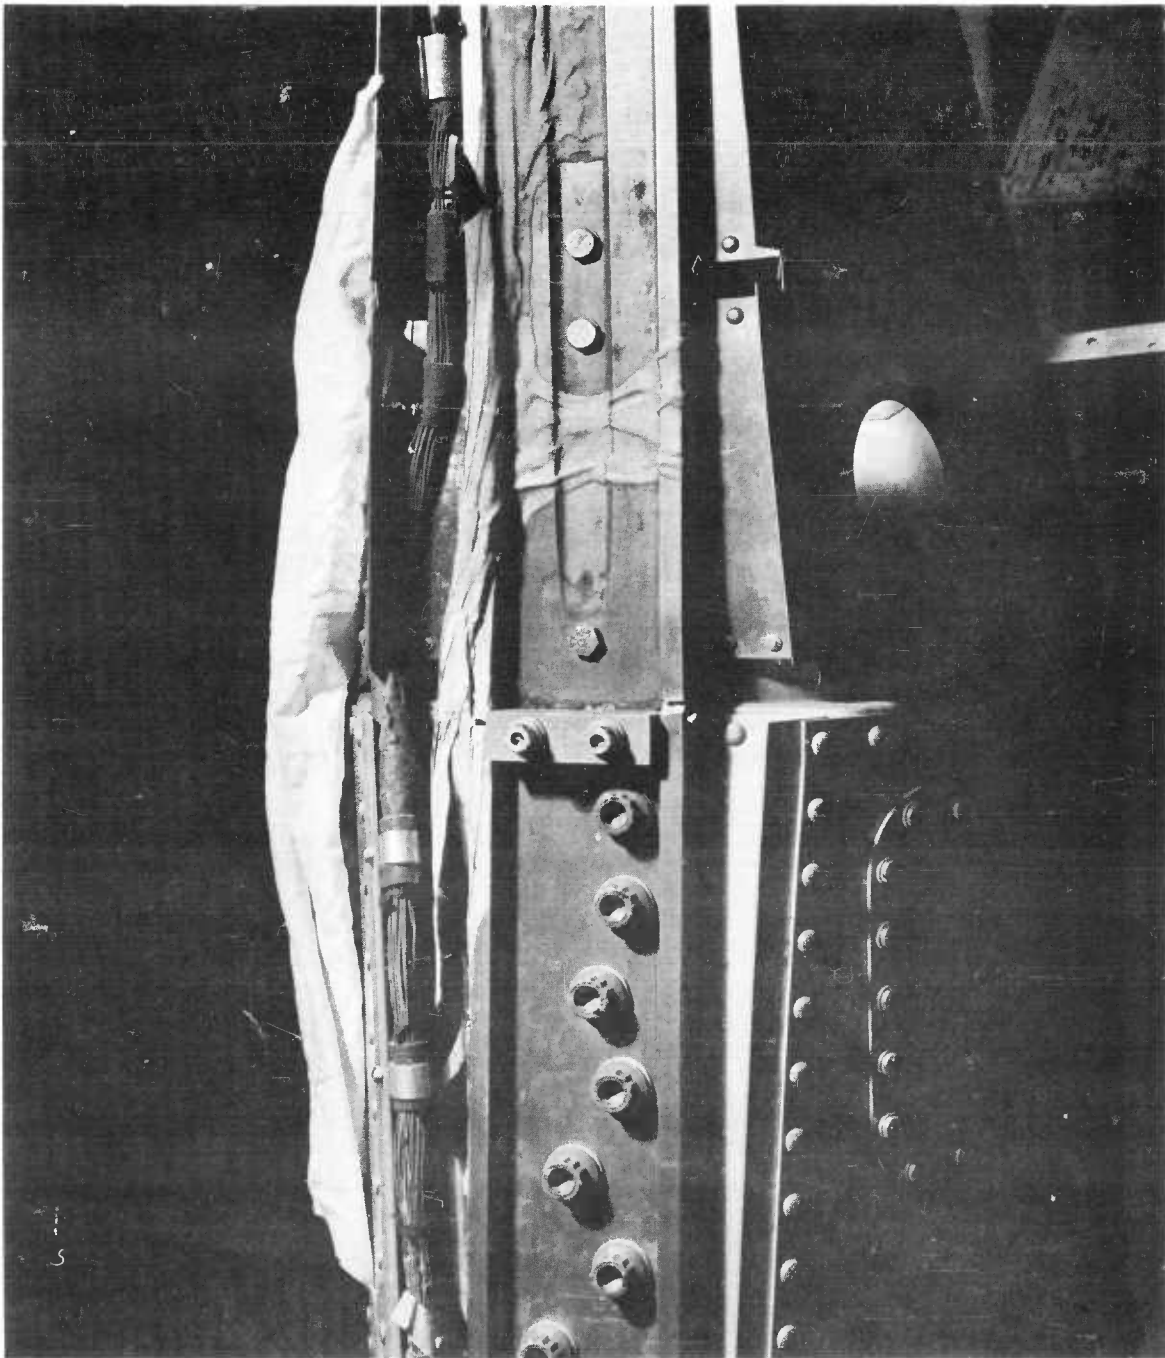
b. At 266,000 cycles of load simulating the Weighted Fatigue Condition, the aft spar of the fatigue blade failed. The rupture consisted of a vertical break at Station 73 through two 5/16 inch bolt holes in the spar webs (Figures 3-14 and 3-15), which are provided for bolts that react the loads induced by a slight change in direction of the spars. Inspection of the failure area revealed that the fatigue crack had started at the upper hole (Figures 3-16 and 3-17) and worked out through the upper flange. The remainder of the failed section had the appearance of a ductile failure. Laboratory examination; showed normal Alpha structure for the Ti 6al-4V with no inclusions present. Burrs and galling were evident in the holes with minute cracks visible in the burrs at the edge of the hole. Figures 3-18, 3-19, 3-20 and 3-21. This condition was the result of a reaming operation on final assembly. Although it was intended that the ends of the holes through the spar web have rounded edges, the .005-.010 radius called out in Drawing No. 285-0170 was lost when it was found necessary to enlarge the holes during final assembly after the spars were partially attached to the blade structure. The burred and cracked condition discussed above escaped detection, particularly on the back side of the spar web where it bears against the blade segments and is not accessible to inspection except by removal of the spar.

Ti 6al-4V, in a polished specimen, has an endurance limit of 60,000 psi or greater at the steady stress noted above. Although it is difficult to explain the initiation of a conventional fatigue failure at the low calculated stress levels, propagation of an existing crack that extends into the base material is readily understood even at the low calculated stress levels.

Figure 3-14. Rear Spar Failure at Station 73.0

The failed rear spar was replaced with a spare whirl test blade spar. The outboard portion of the rear spar was strengthened with a titanium doubler. HTC-AD Drawings 285-0224, 285-0225 and 285-0226 show the rework of the outboard portion of the rear spar. The rework of the inboard portion of the rear spar is shown in HTC-AD Drawing 285-0223. Figures 3-22 and 3-23 show the inboard reworked area. The front spar was reinstalled with new bolts replacing the bolts that were sheared due to secondary failure.

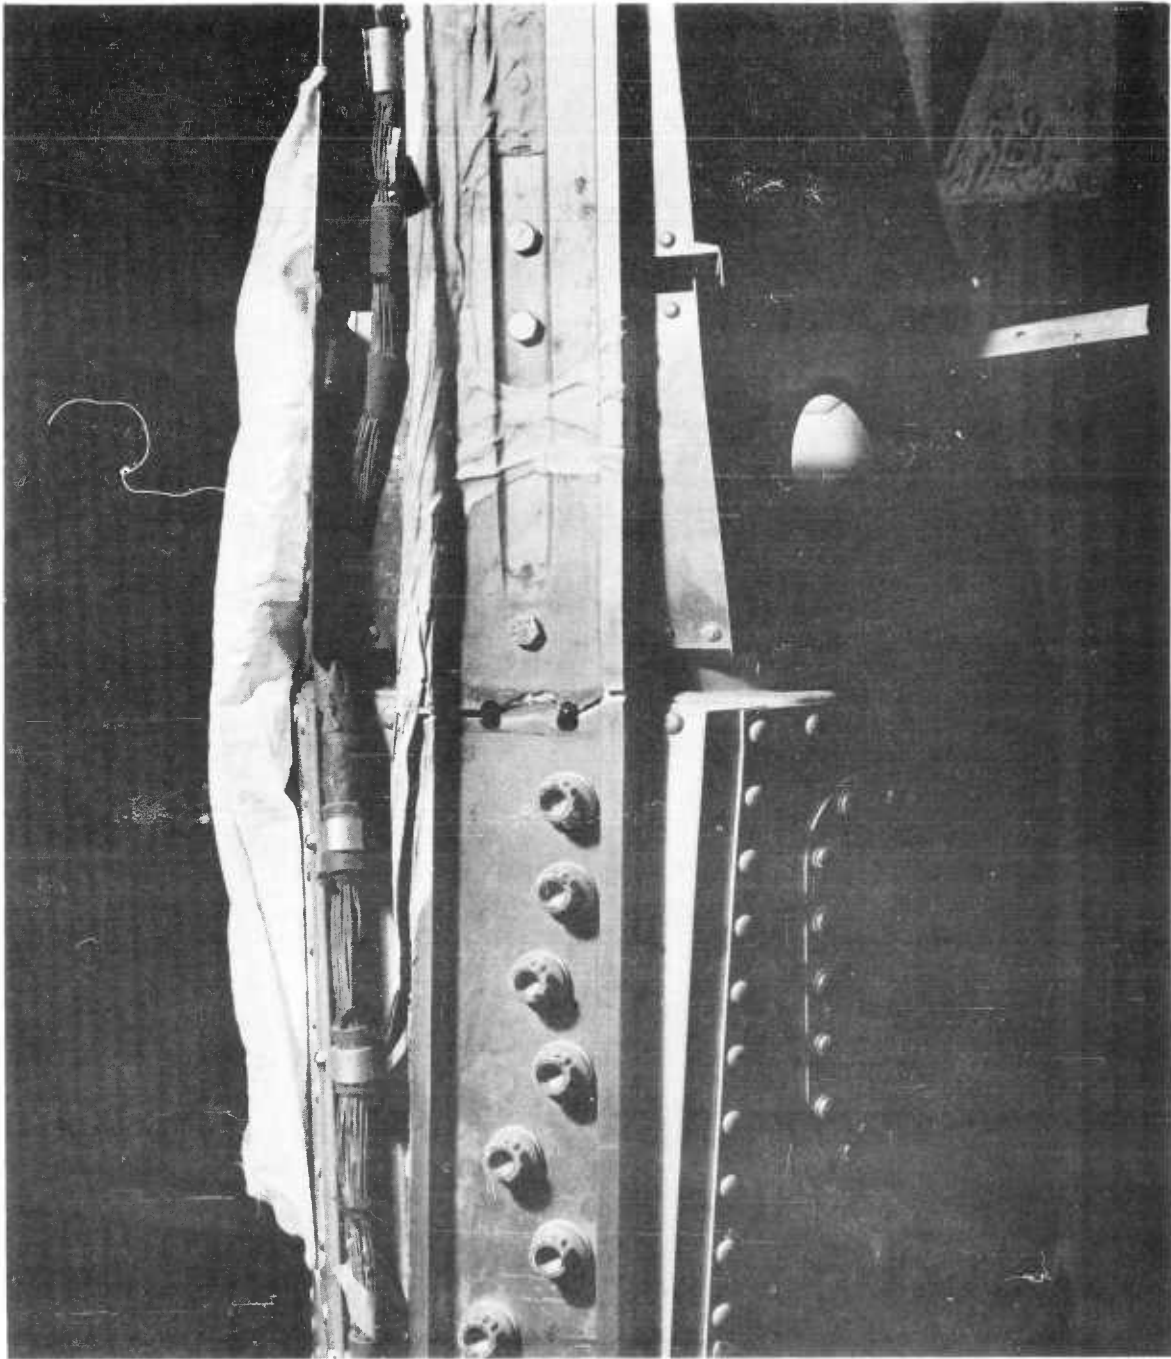
Figure 3-15. Rear Spar Failure at Station 73.0, Bolts Removed

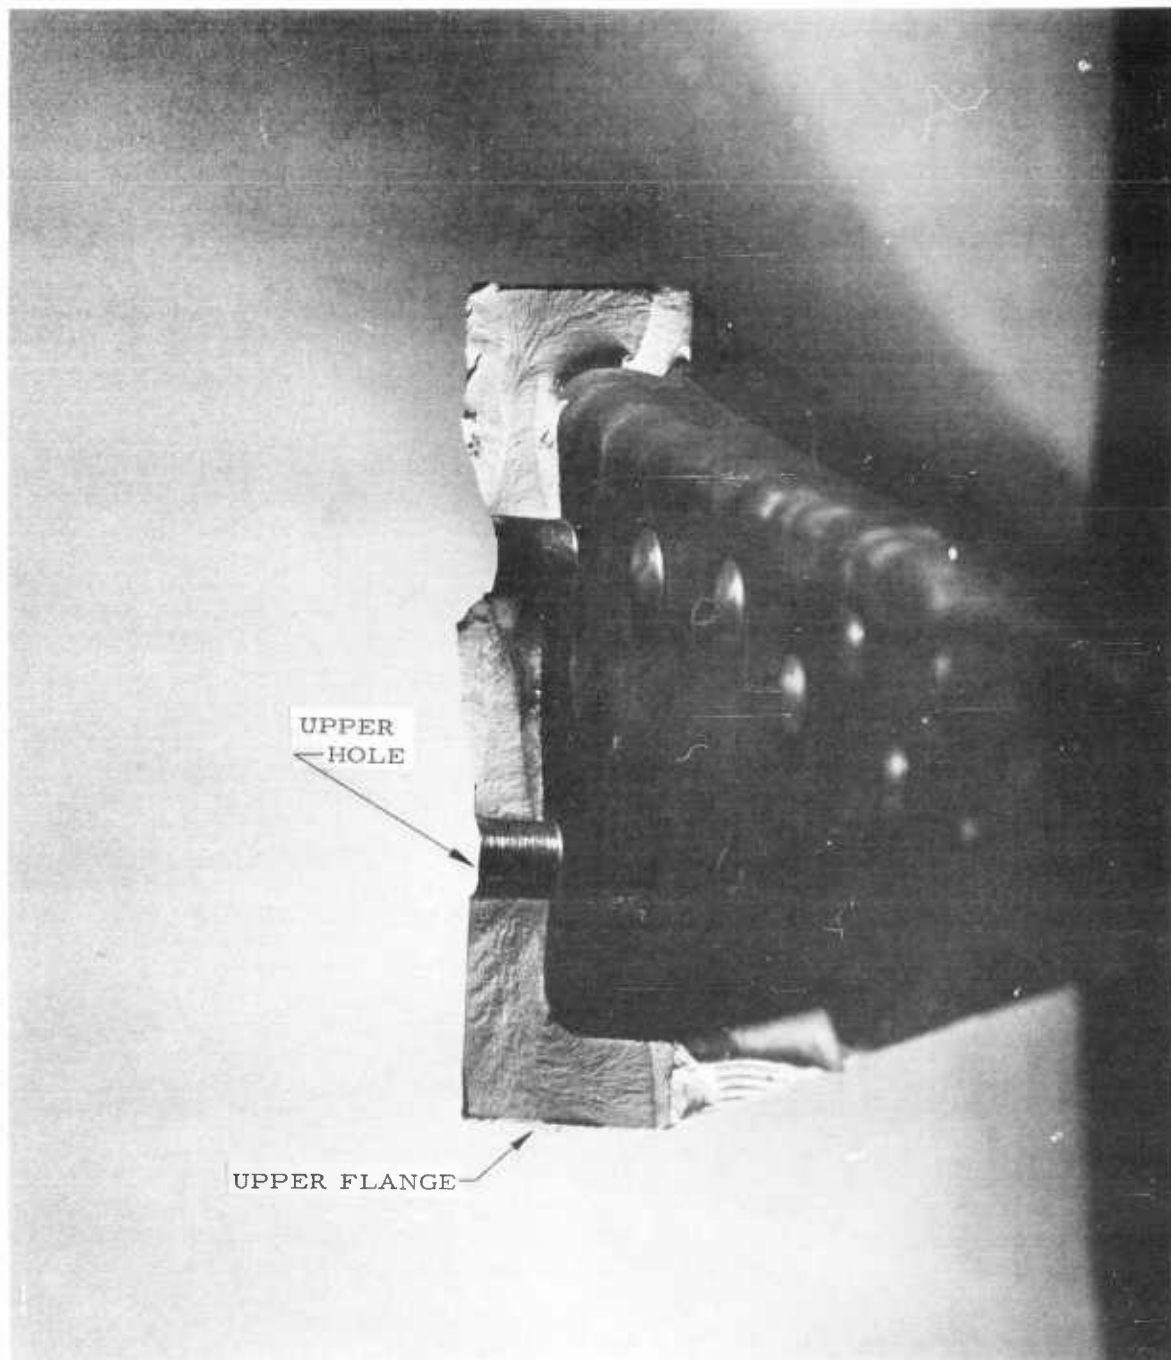
Figure 3-16. Rear Spar Fracture Area -- Inboard Portion

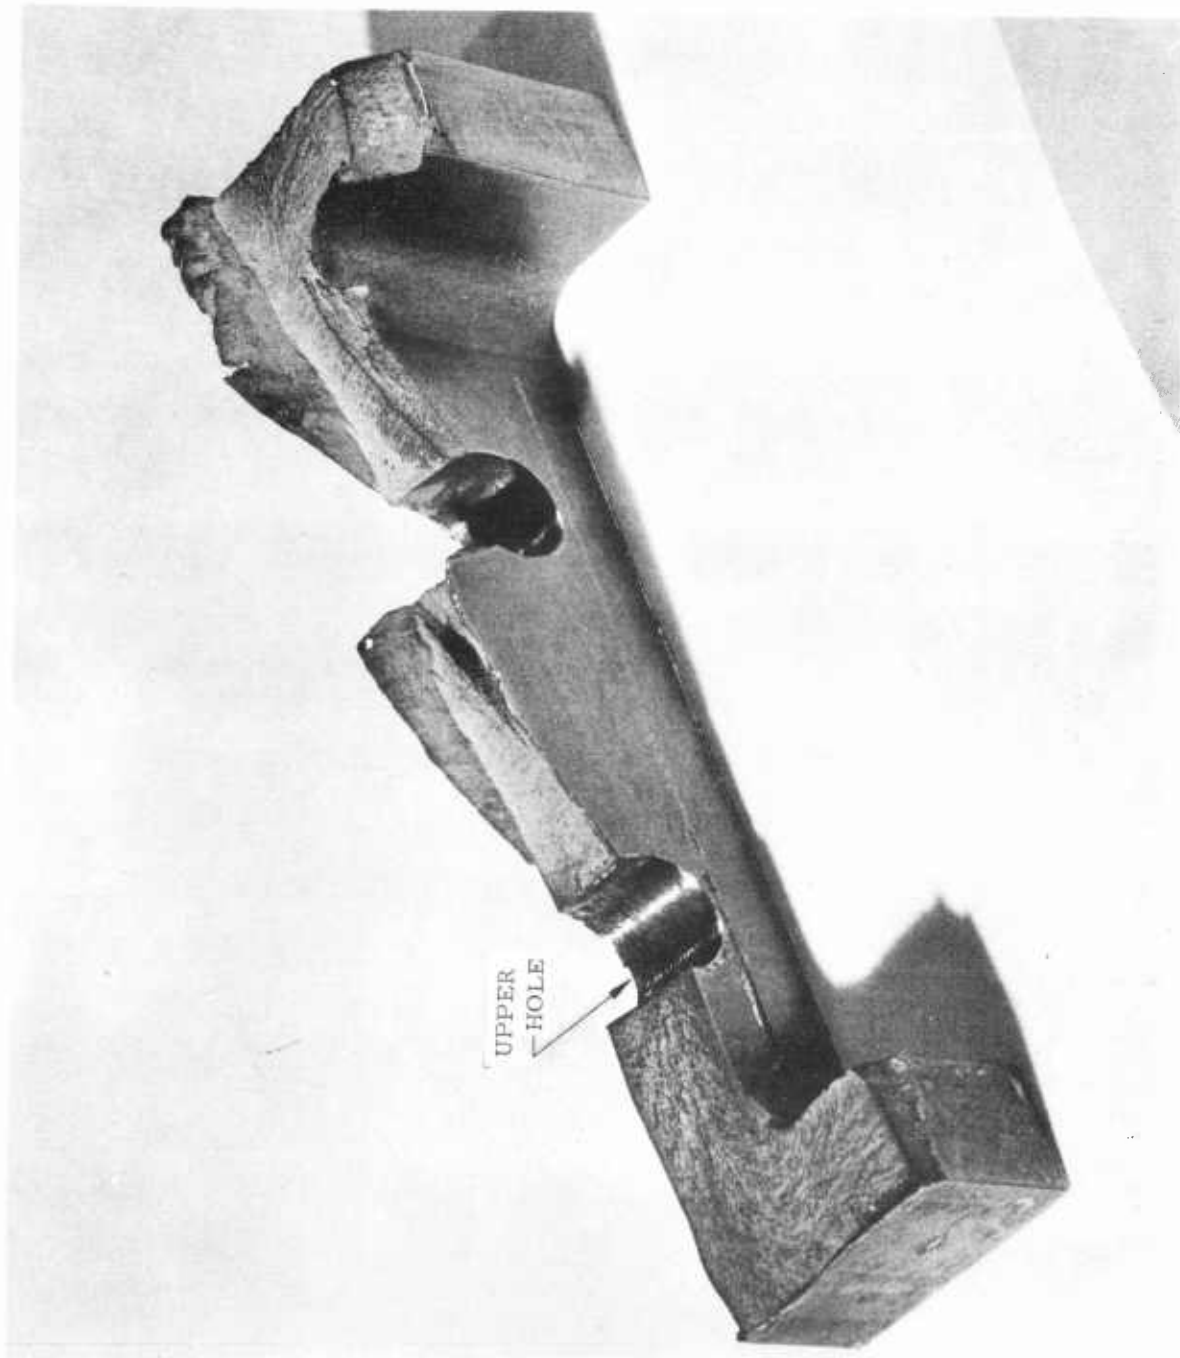
Figure 3-17. Rear Spar Fracture Area -- Inboard Portion

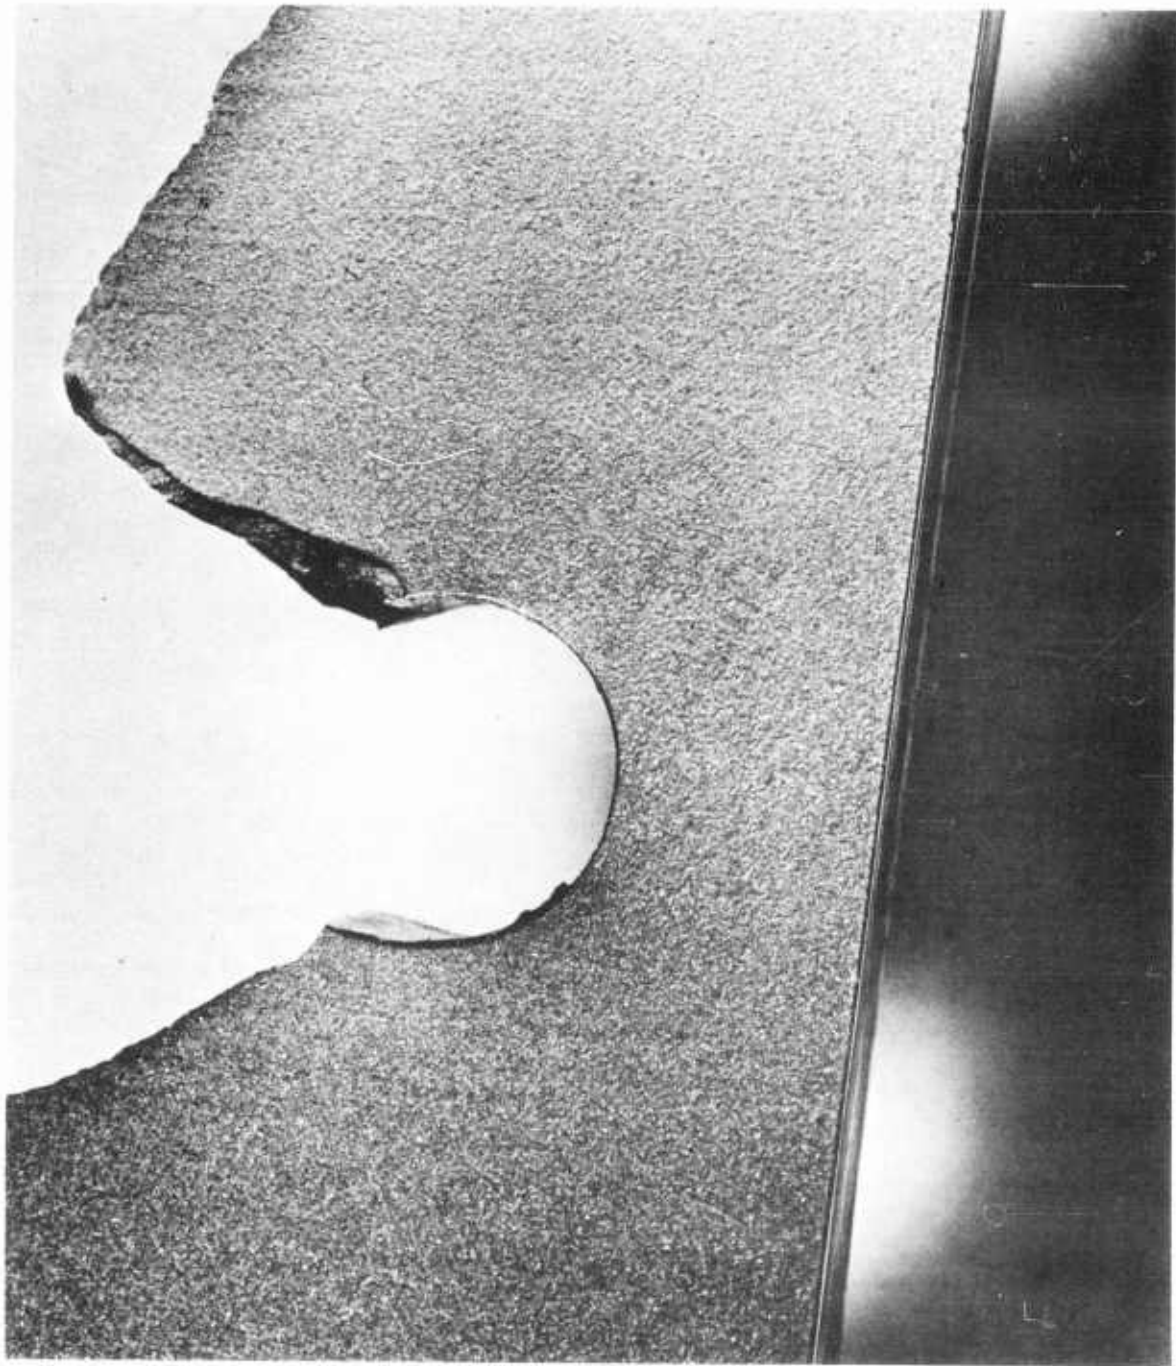
- (1) Burrs and galling present in holes.
- (2) Minute cracks visible in burrs.

Figure 3-18. Rear Spar Fracture Area -- Burrs on Edge of Hole

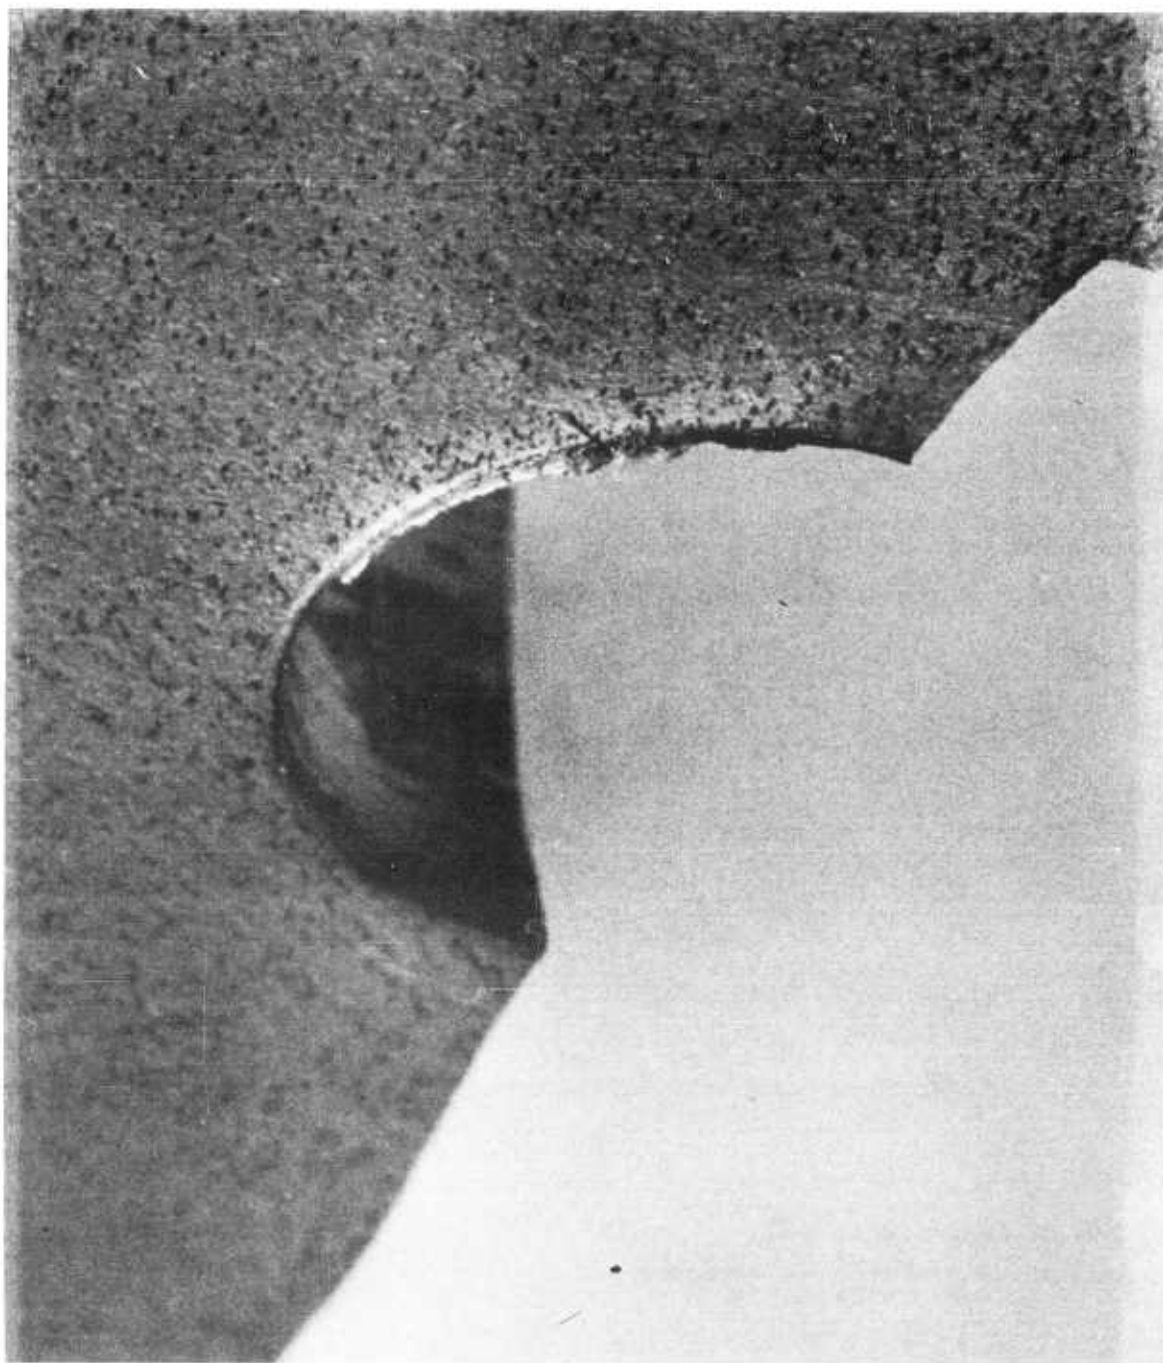
The results of the failed aft spar specimen fatigue tests are shown in Table 3-2. Due to the limited number of specimens tested and the difficulty in reproducing the type of burr as shown in Figure 3-19 conclusive evidence of a marked decrease in the fatigue life cannot be stated. The limited data shows only that a trend in the reduction of fatigue life due to a burr is indicated.

Figure 3-19. Rear Spar Fracture Area -- View of Crack in Burr

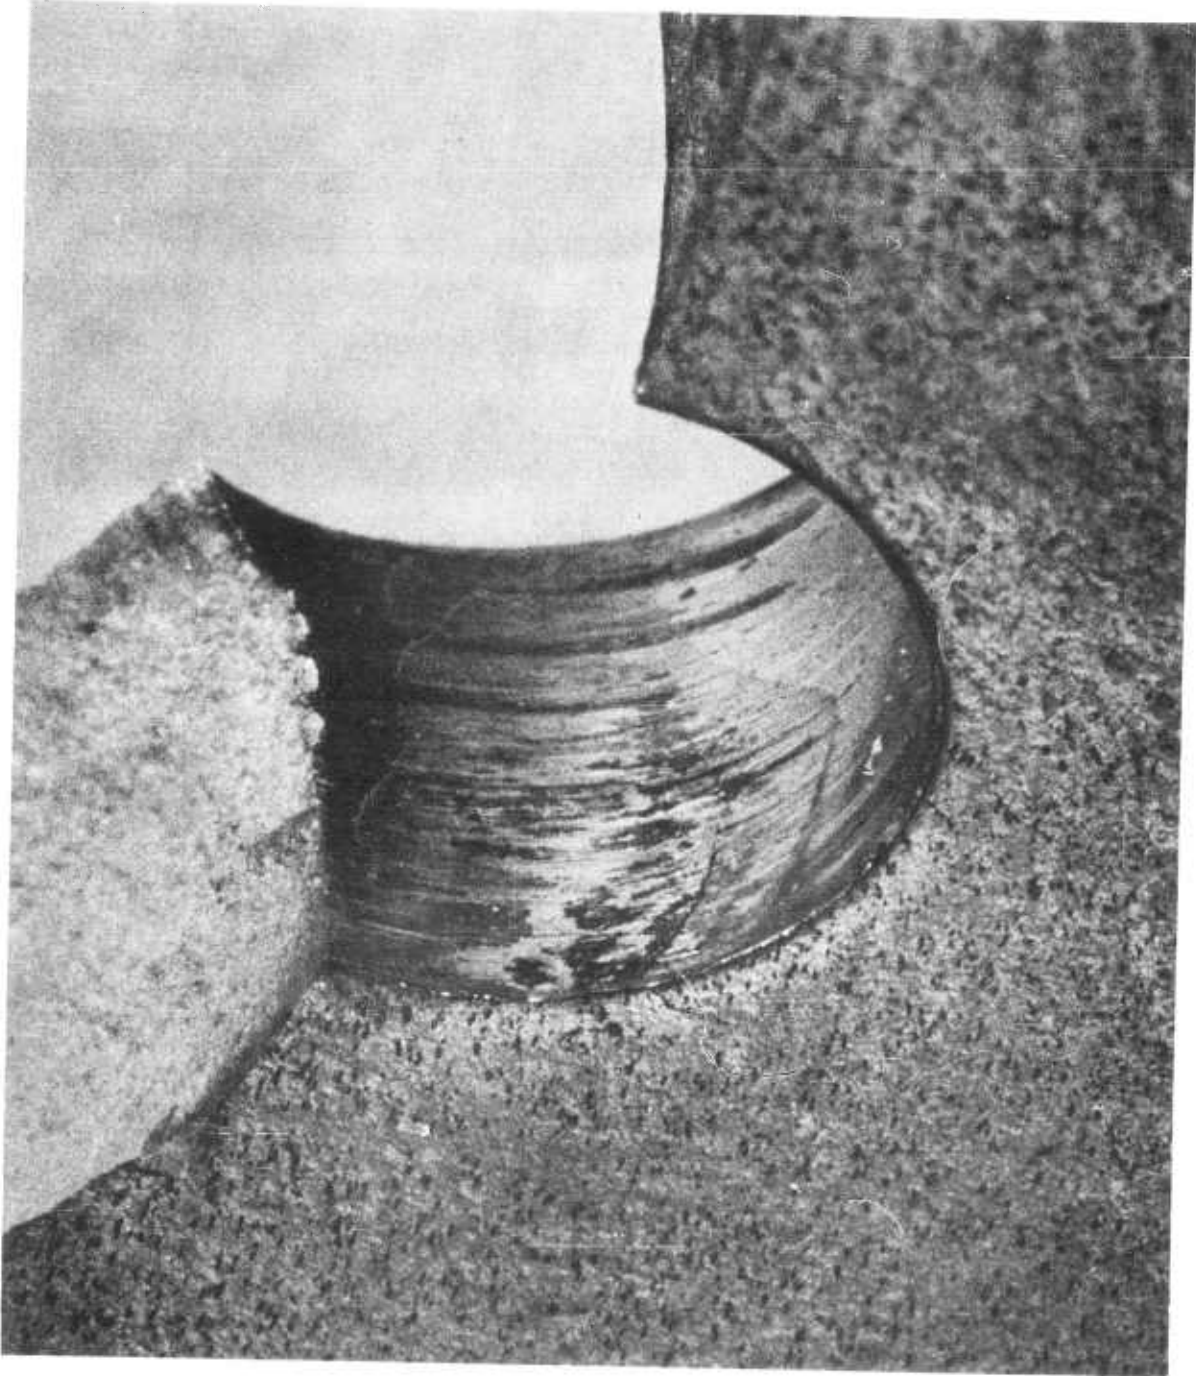
Figure 3-20. Rear Spar Fracture Area -- View of Crack in Burr

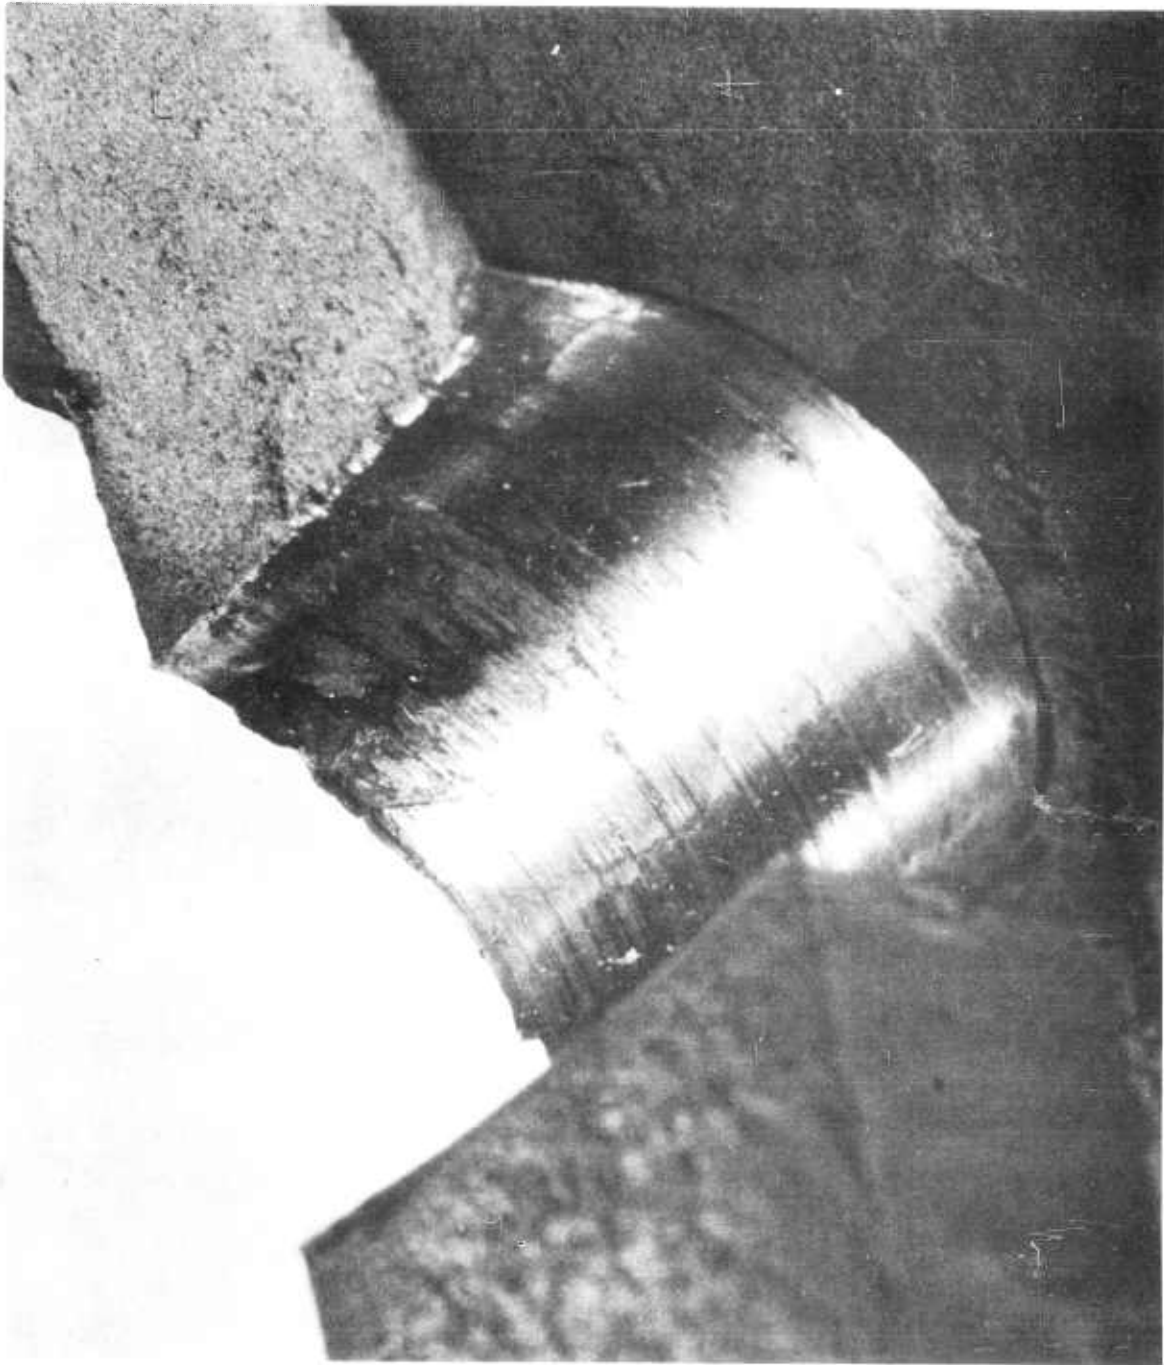
Figure 3-21. Rear Spar Fracture Area -- View of Crack in Burr

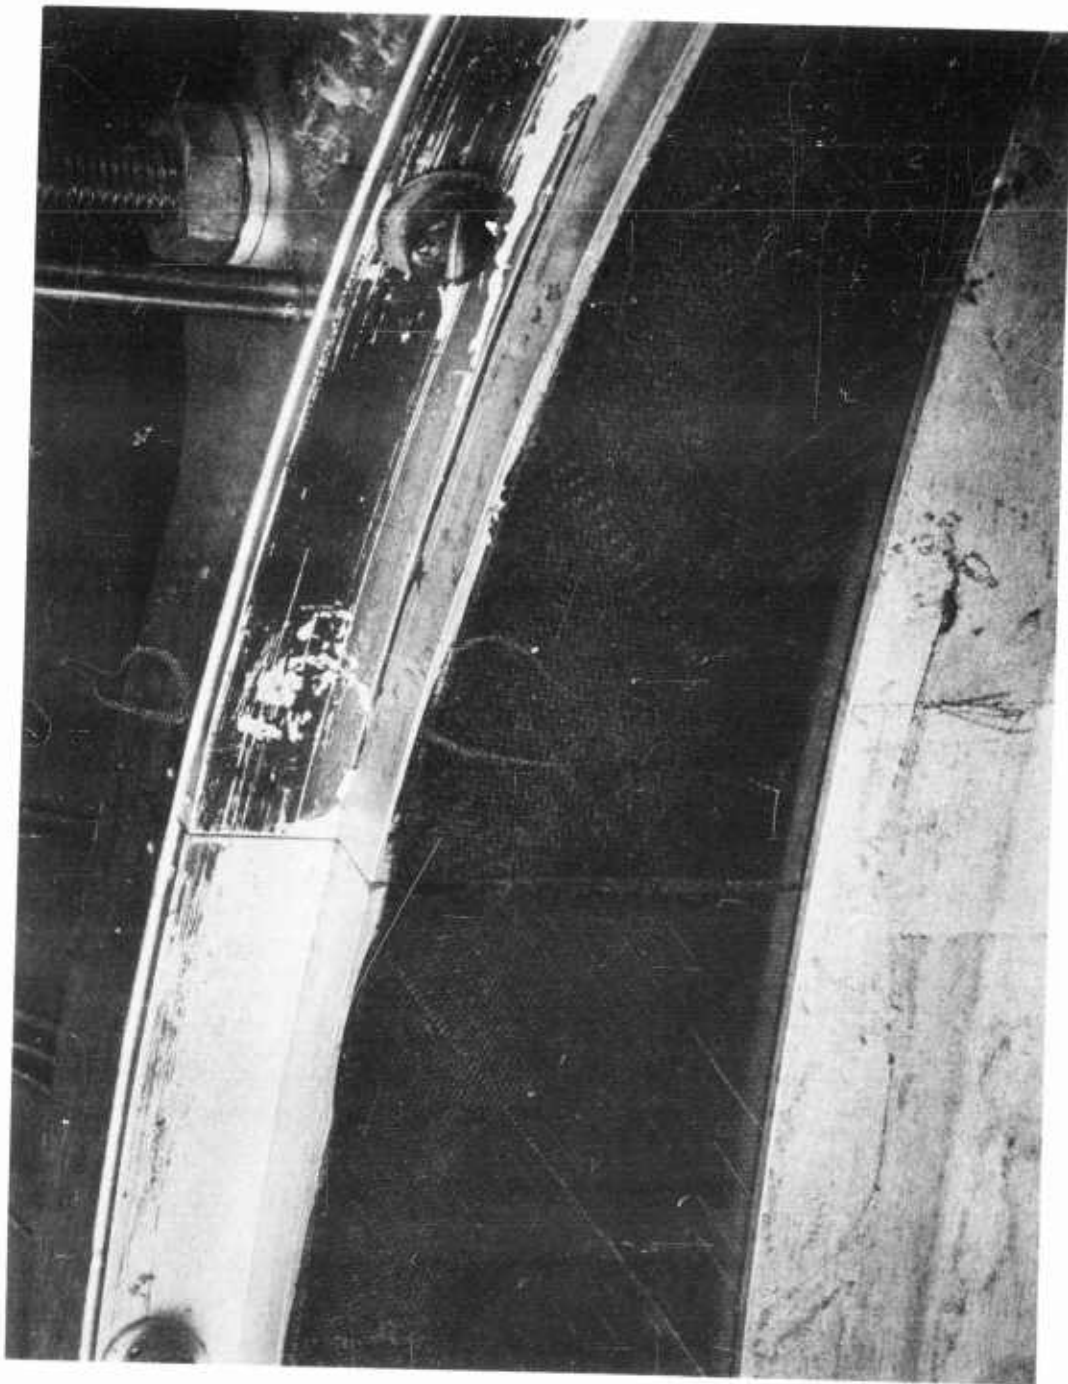
The spherical bearing and retainer was subject to 26.5 hours of cycling. Inspection of the bearing and Fabroid bonded retainer revealed that a small amount of flaking of teflon fibers had occurred. No indication of increased clearance or damage of any kind was noted. The bearing and retainer after test is shown in Figures 7-5, 7-6, 7-7 and 7-8.

Figure 7-5. Fabroid Bearing after 26.5 hrs. of Test (no apparent damage)
Lower Left in Fixture

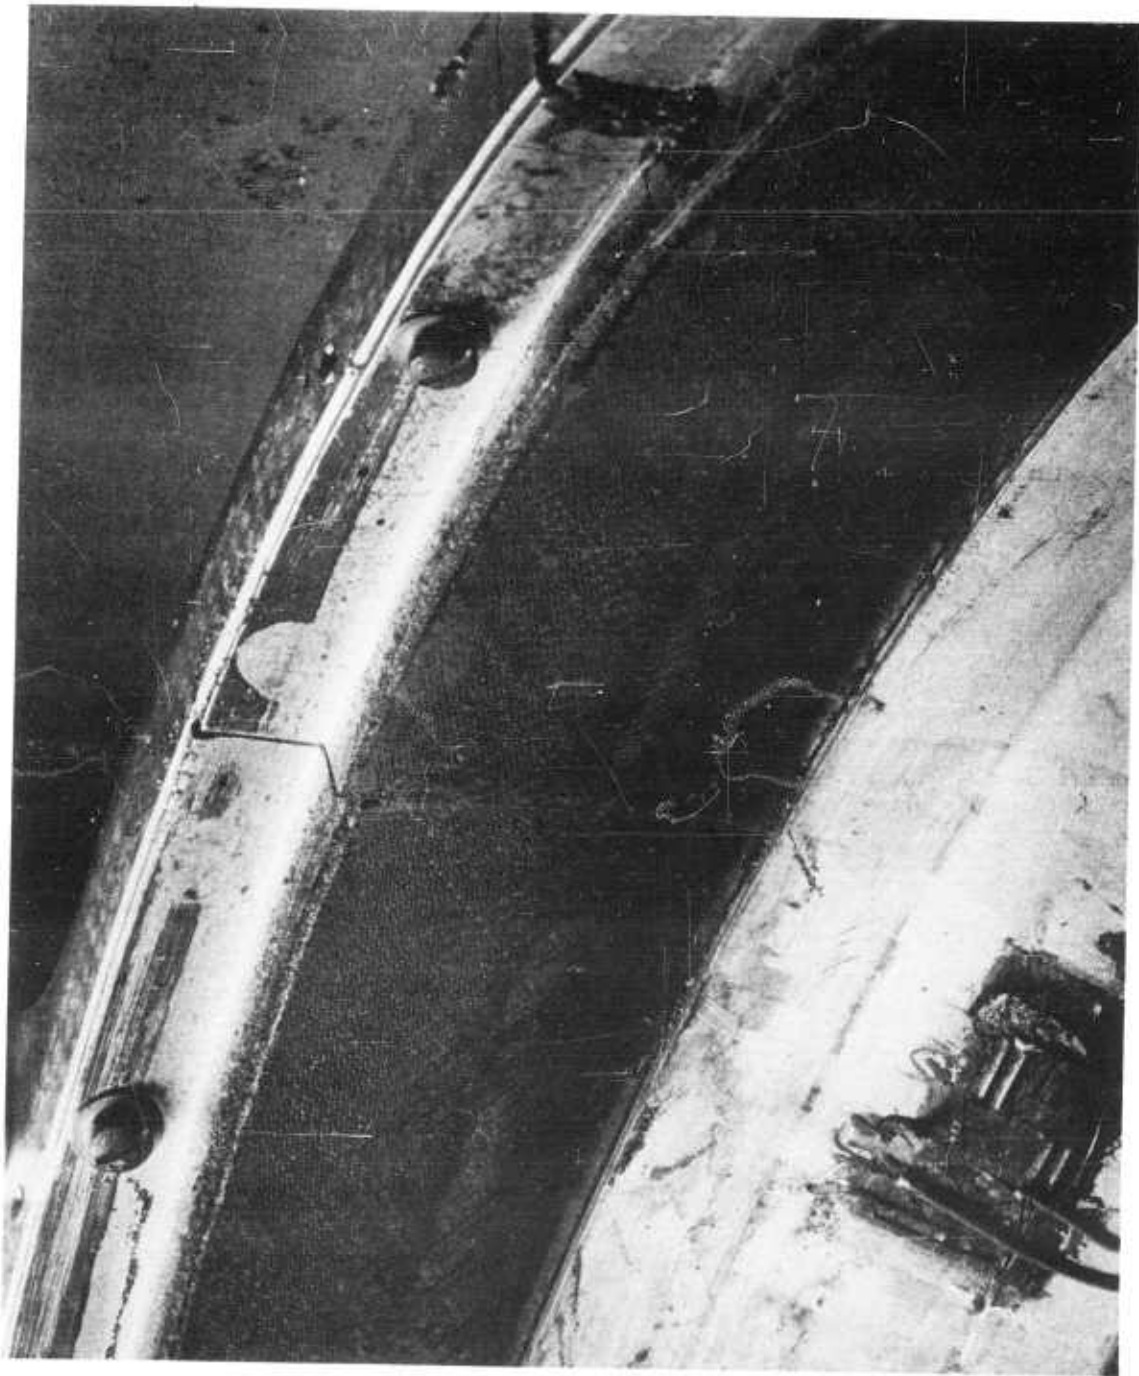
Figure 7-6. Fabroid Bearing after 26.5 hrs. of Test (no apparent damage)
Upper Left in Fixture

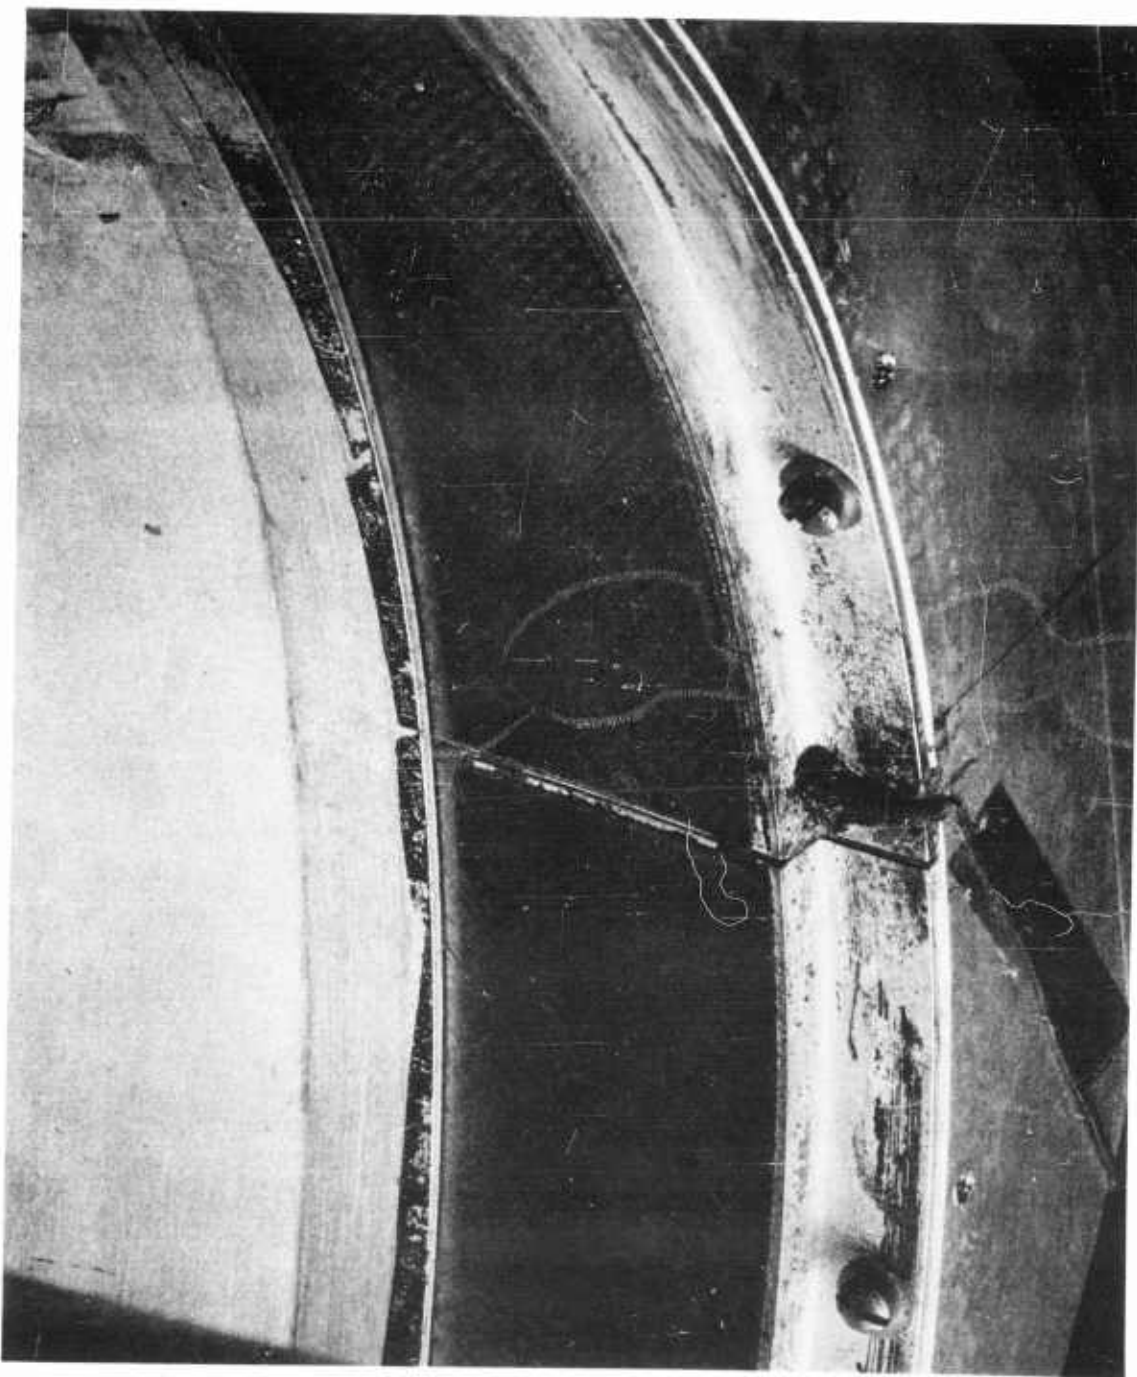
Figure 7-7. Fabroid Bearing after 26.5 hrs. of Test (no apparent damage)
Right Side in Fixture

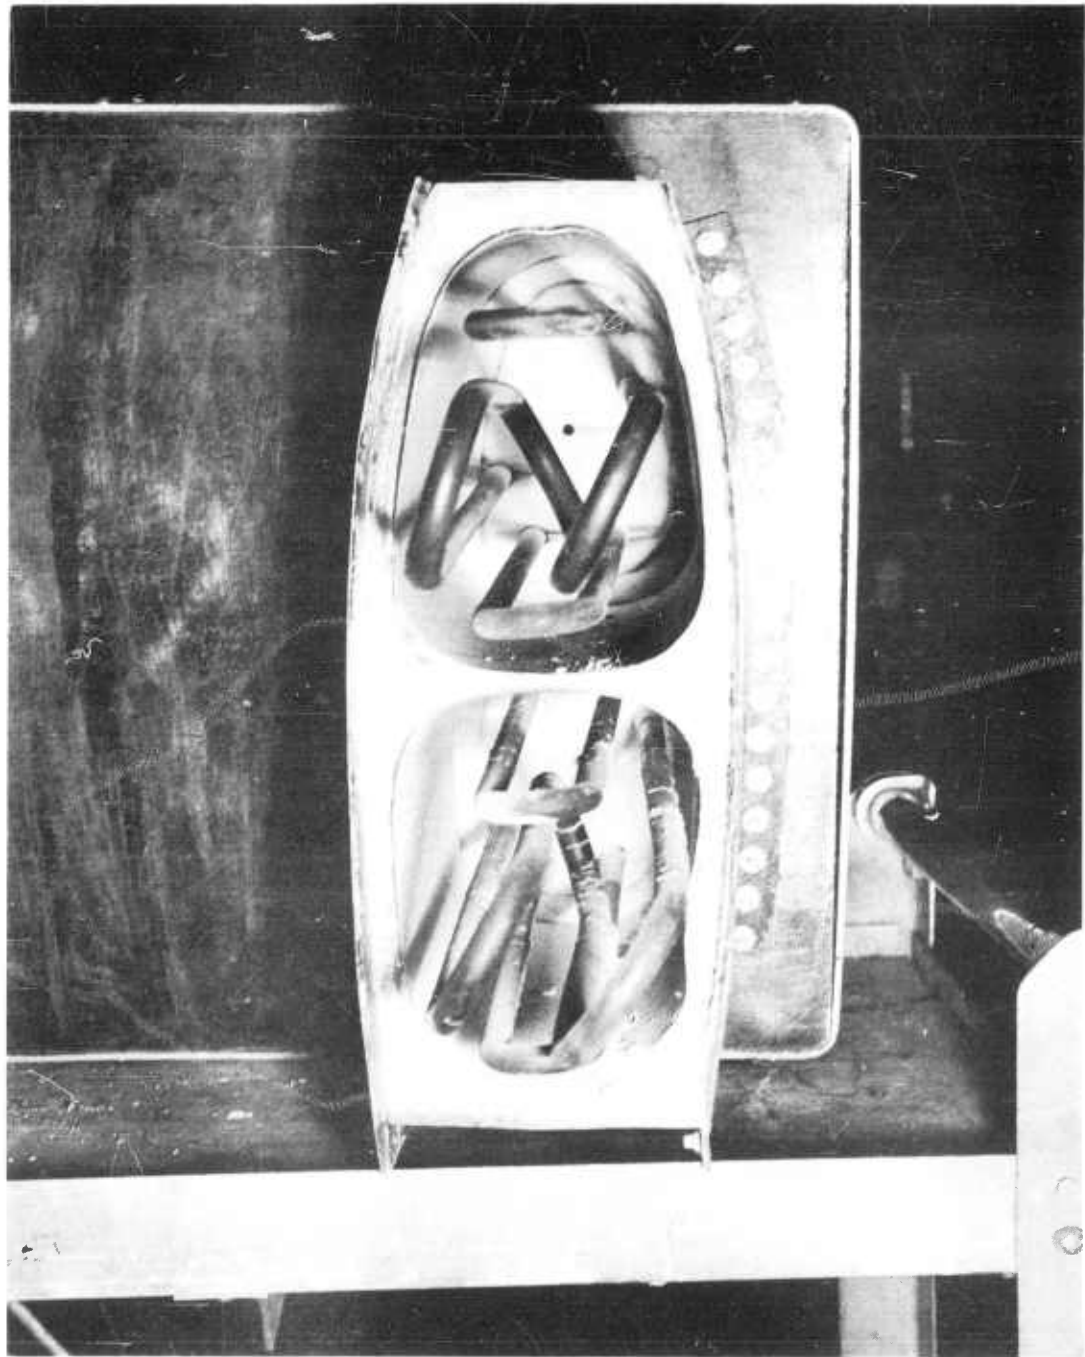
Figure 8-4. View of Flexural Coupling and Sealant

The temperature distribution in the specimen for each test phase is given in Figure 8-1. The condition of the sealant compound after test is shown in Figures 8-4, 8-5, 8-6, 8-7 and 8-8.
