NRL Memorandum Report 1383

ABYSSAL CORROSION AND ITS MITIGATION PART II. RESULTS OF A PILOT TEST EXPOSURE

B. W. Forgeson, L. J. Waldron, M. H. Peterson,
and B. F. Brown

December 1962

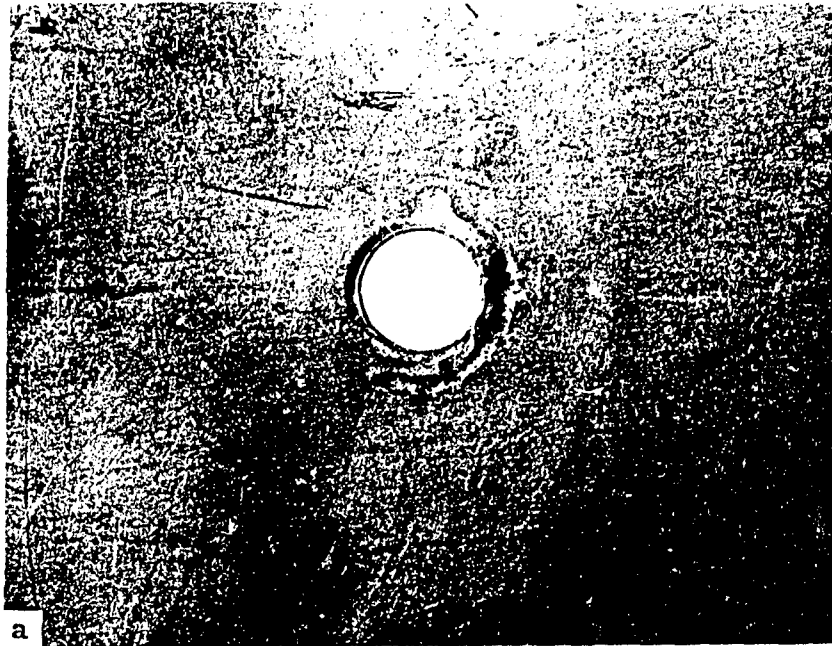
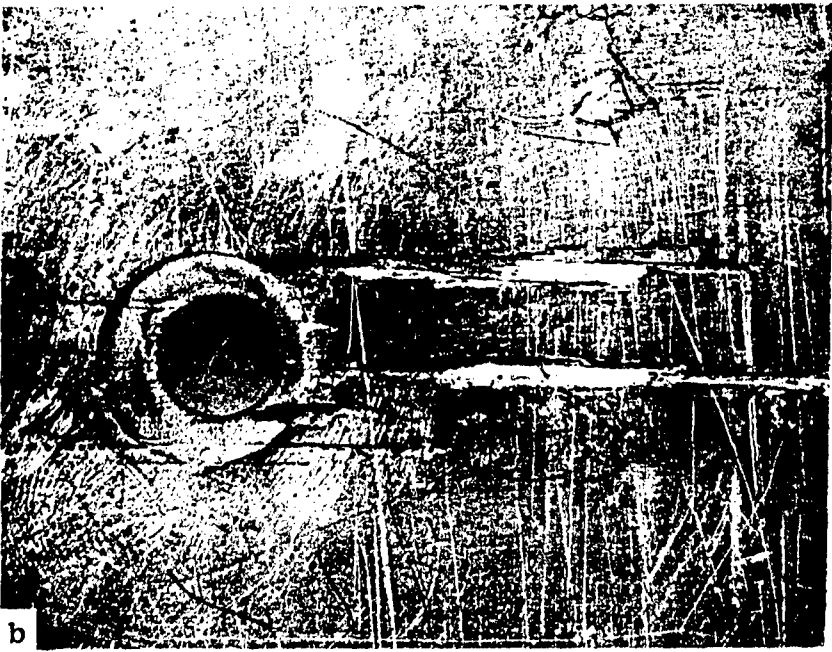
- (8) Proprietary alloy T***, type 410 and type 430 stainless were corroded locally and had suffered perforation of the sheet when exposed at depth. Type 410 suffered much more severe crevice corrosion when exposed at depth as compared with the surface (Fig. 8).

| MATERIAL | SURFACE APPEARANCE | LOSS IN GRAMS WT ⁺ | PITTING - MILS DEEPEST AVG* | CREVICE CORROSION |
|---|---|---|---|---|
| 410 Stainless Steel | Very localized surface pitting | 7 | 63 Perforated | Severe at washers and backing strip |

Fig. 8 - Comparison of crevice corrosion of 410 stainless steel at (a) the surface, and (b) at 5700 feet
