NRL Memorandum Report 1378

**THE PERFORMANCE OF LEAD-SILVER ANODES  
IN CATHODIC PROTECTION OF RESERVE FLEET VESSELS  
AT THE SAN DIEGO GROUP, PACIFIC RESERVE FLEET**

L. J. Waldron

December 1962

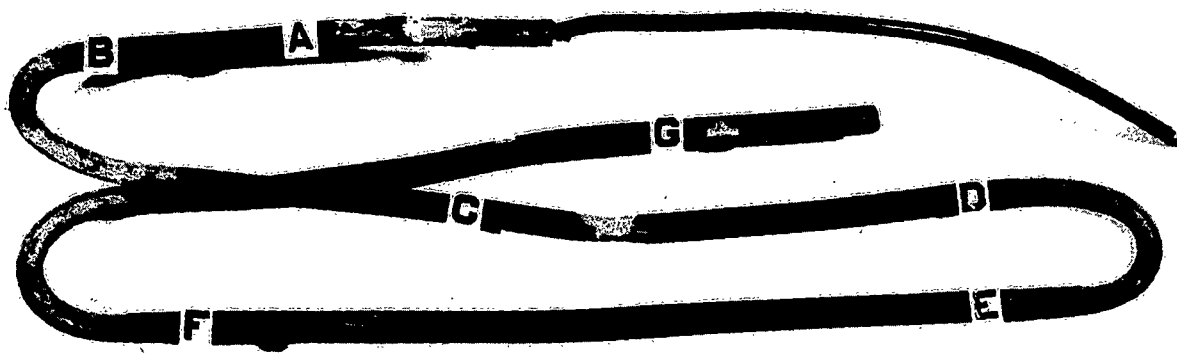
(a) One-half inch diameter lead-silver rod. Three of these 6-foot long anodes were examined after various periods of service. The first, Figure 1, was removed on 21 December 1961 after 255 days of service during which it had passed 26,000 ampere-hours of current for an average of nearly 5 amperes (7 amps/sq. ft.). The lead wire splice has been uncovered in this photograph to show the details of the joint, which was in excellent condition. Flexing of the anode in service has

caused the coating to peel off in spots with slight reduction in the diameter. The minimum diameter of the rod at any of these areas was approximately 7/16 inch. The brittleness of the coating is evidenced by its flaking where the anode was bent after removal from service. Figure 2 is a cross-section view of location "E" of Figure 1 and shows the coating which was estimated to be 15-20 mills thick.

Fig. 1 - View of six-foot length of 1/2-inch diameter lead-silver anode after 255 days of service. x 1/2

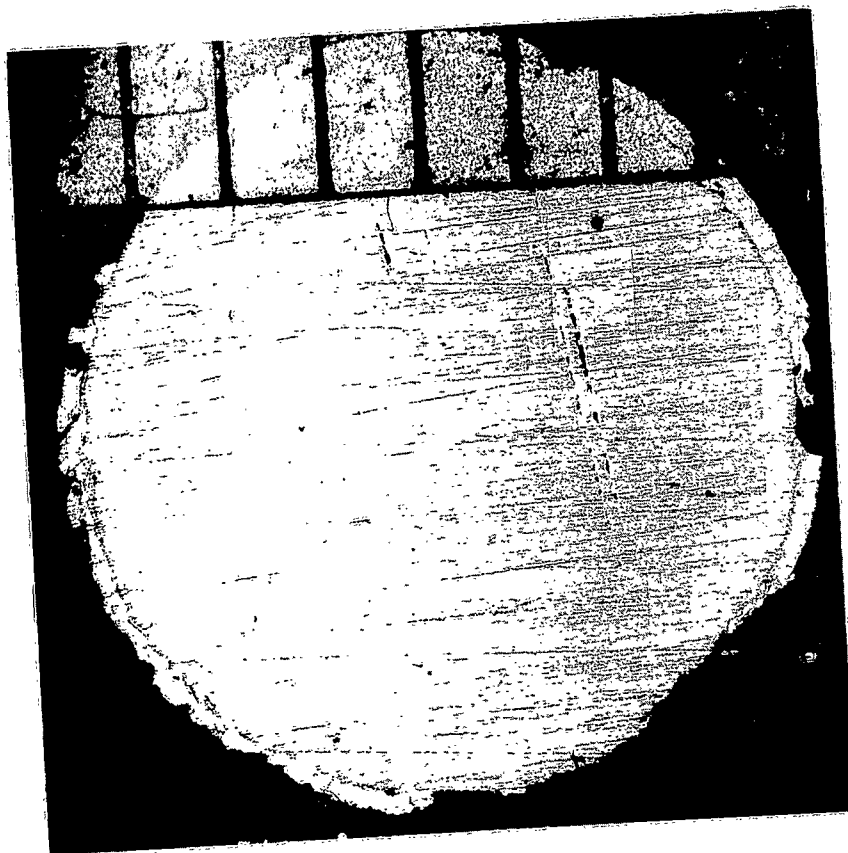
Fig. 2 - Cross-sectional view of location "E" of Fig. 1. x8 Each division of the scale - 1/16-inch.

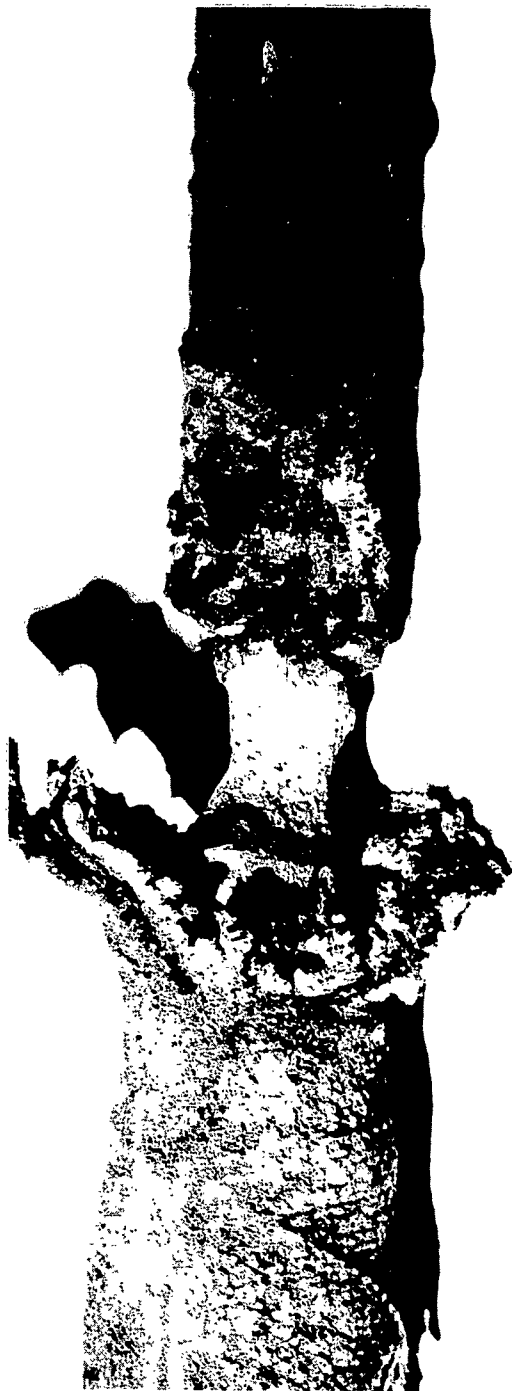
The second anode, whose surface appearance is shown in Figure 3, was installed 21 December 1961 and removed 25 October 1962 after 308 days of service. During this time it had passed 79,800 ampere-hours of current for an average of nearly 11 amperes (14 amps/sq. ft.). The coating was estimated to be approximately 1/16 inch thick and very brittle. It had broken at various locations along the length of the rod from flexing during inspection. The minimum diameter of the rod at these locations was approximately 7/16 inch except at just outside the splice where the metal had necked down to 1/4 inch. However, this splice was different from the others in that the Group used electrical friction tape which apparently disintegrated.

(a) lead splice

(b) area where coating had flaked

Fig. 3 - Appearance of lead-silver anode after 308 days of service.  $\times 1-1/2$

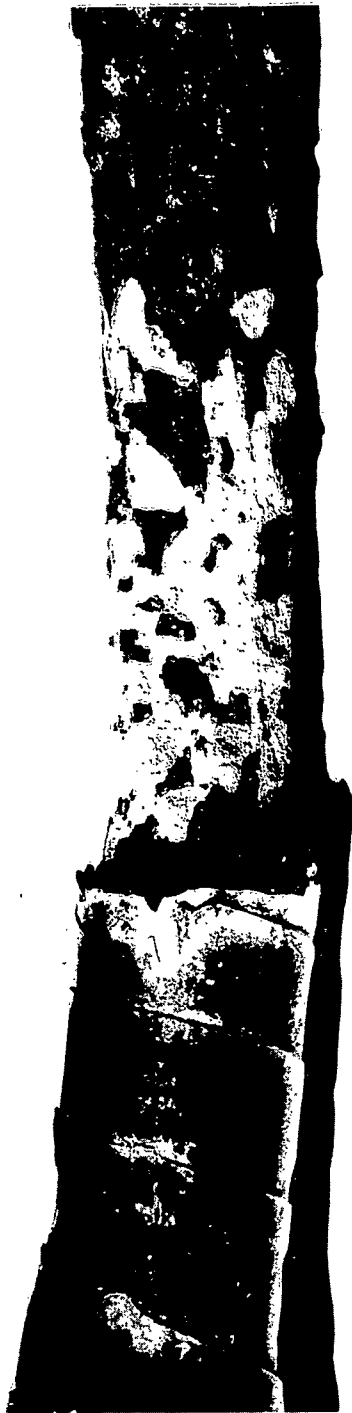
The third anode, areas of which are shown in Figure 4, was removed on 25 October 1962 after 563 days of service. 106,400 ampere-hours of current flowed from this anode for an average of 8 amperes (10 amps/sq. ft.). Like the other two anodes, the coating on this anode had also flaked from flexing and had been reformed at various areas. The coating was approximately 1/16 inch thick. The minimum diameter of metal at the flaked areas was found to be 3/8 inch. The good condition of the splice and vinyl tape after 18 months' service is illustrated in the figure.

(a) lead splice

(b) area where coating had flaked

Fig. 4 - Appearance of lead-silver anode after 563 days of service. x 1-1/2

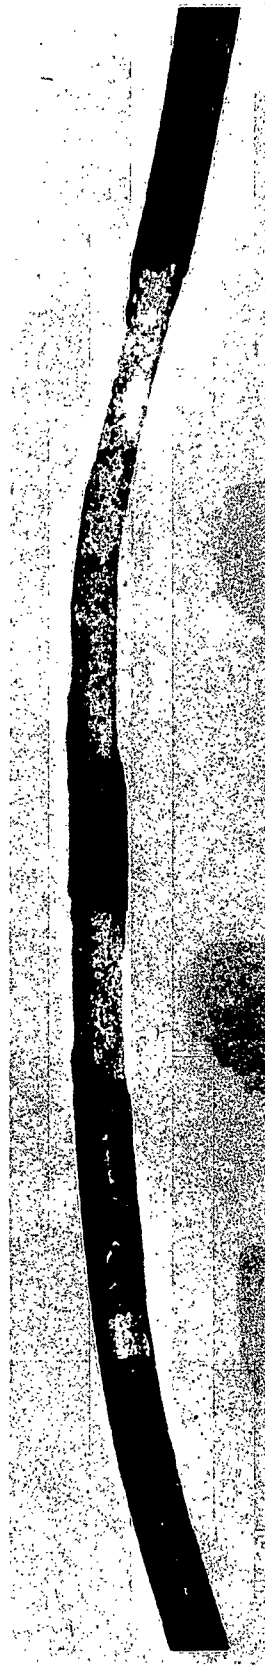
(b) One-fourth inch diameter rod - 10 ft. long. A section of this anode was removed on 21 December 1961 after approximately 255 days, during which 7,500 ampere-hours of current had passed for an average of slightly more than 1 ampere (1 1/2 amps/sq. ft.). A considerable amount of the coating had flaked off and the diameter of the remaining metal at these areas was approximately 1/8 inch. This condition is illustrated in Figure 5. This diameter of rod has insufficient rigidity to prevent flaking of the brittle coating from even slight handling and movement in the water. All anodes of this diameter continued to deteriorate and were lost and replaced after approximately one year of service.

**Fig. 5 - Section of 1/4-inch lead-silver anode removed after 255 days service. x 1-1/4**

3. The rod from which these anodes are assembled should have a minimum diameter of one-half inch. Less thick anodes have insufficient rigidity to prevent flexing of the material with resultant flaking of the protective coatings formed in service. Should this coating be flaked off, the diameter of the rod will be reduced by the formation of a new coating.
