U. S. NAVAL PROVING GROUND  
DAHLGREN, VA.

REPORT NO. 3-43

BALLISTIC PERFORMANCE OF LIGHT ARMOR  
MANUFACTURED BY THE "PLURAMELT" PROCESS

March 2, 1943.

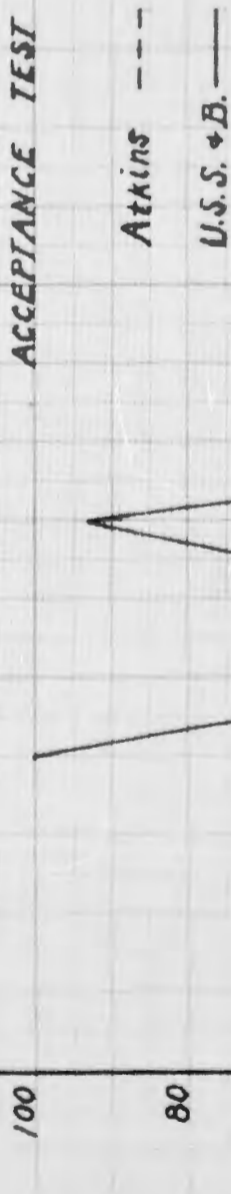
Fig 1 1/2" PLURAMELT

Pluramelt plates had over seven times the percentage of failures of carburized plates in 1942. The facts that Pluramelt is a new type of light armor and that it was treated by manufacturers inexperienced in its production are major factors in the large number of failures. It should be noted that the performance of all manufacturers improved considerably from 1941 to 1942. Thus Atkins reduced the failures of 1/2" BPS from 41% in 1941 to 12% in 1942 and the U. S. Spring and Bumper Company decreased the percentage of failures from 62.5% during the first four months of production to 8% in the second four months period. Table 2 gives the monthly performance of 1/2" BPS during 1942. The percentage of failures is given graphically in Figure 1 for Atkins and for U. S. Spring and Bumper.

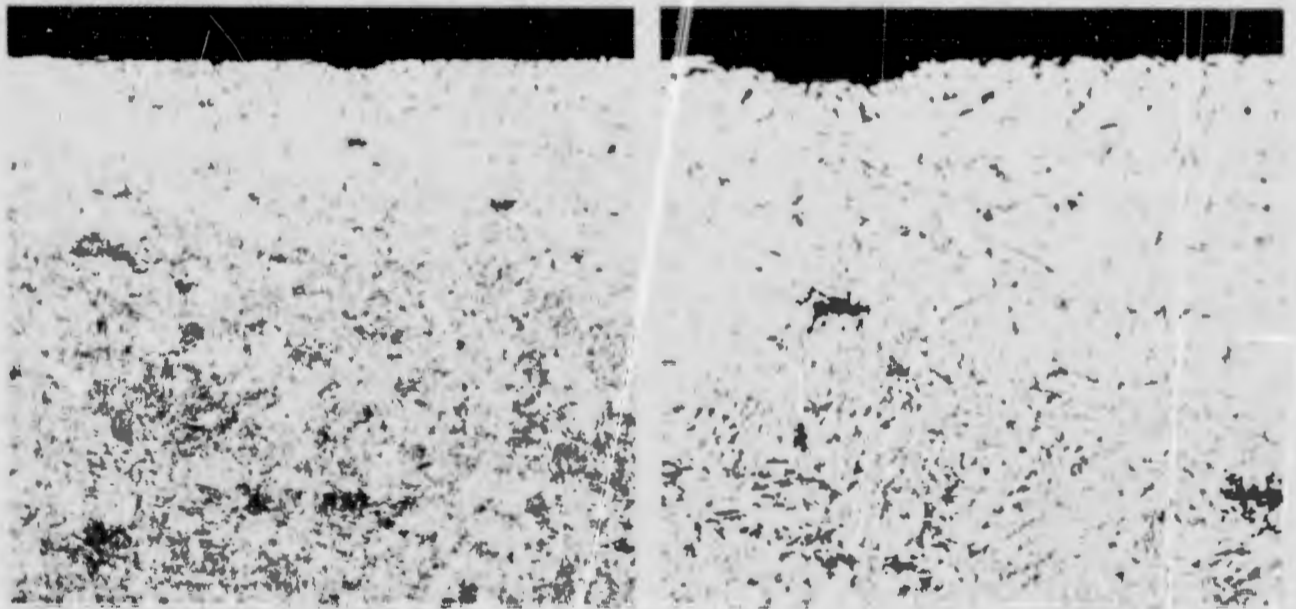
Plate A - Annealed

Partial decarburization of about .007"

Surface defects appear to be more detrimental than defects in the body of BPS plates. In Figure 2, photomicrographs of the edge of plates A and B as annealed show decarburization to a depth of .007" in A and ferrite banding to a depth of .025" in B. When hardened, Plate A had a layer of ferrite at the surface while B had little ferrite at the surface but had long pearlite bands below the surface (Figure 3). These pearlite bands are formed in low alloy regions in oil quenching the plate. The presence of these low alloy regions were shown in the annealed state by the ferrite bands. On ballistic testing, Plate B was found to have 120 ft./sec. higher limit than A. It is thought that this difference is due to the presence of the ferrite layer. The Brinell test does not indicate this surface defect because the ferrite layer is removed by grinding when preparing the sample for hardness testing.

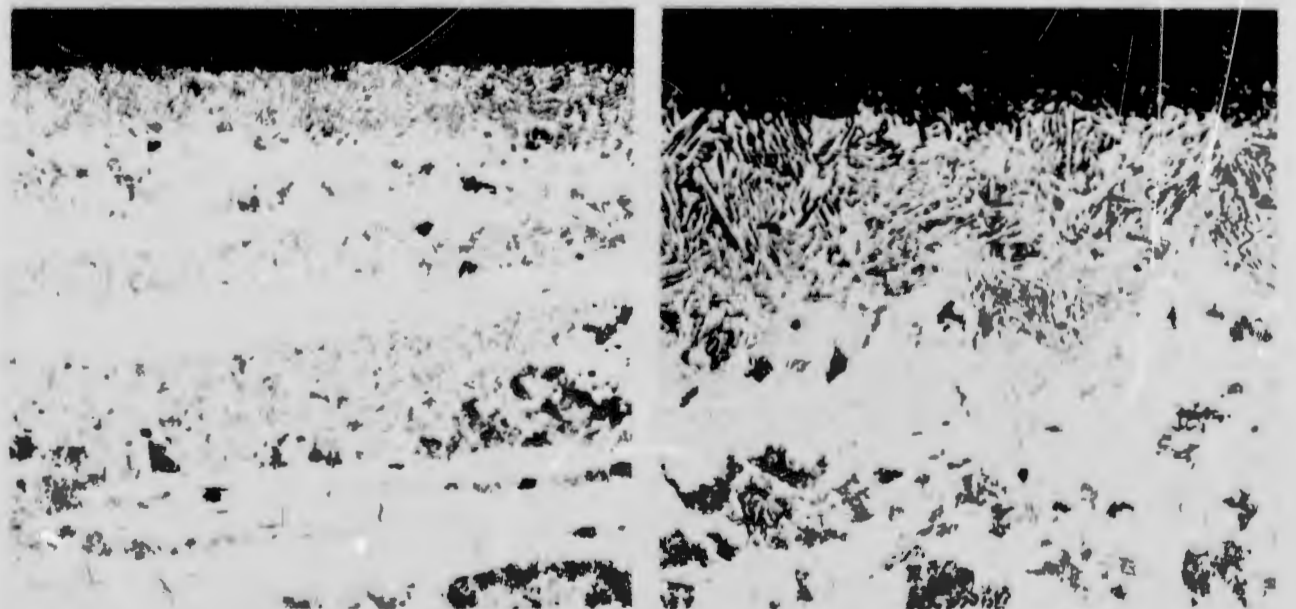
Plate B - Annealed

Ferrite banding to depth of about .025"

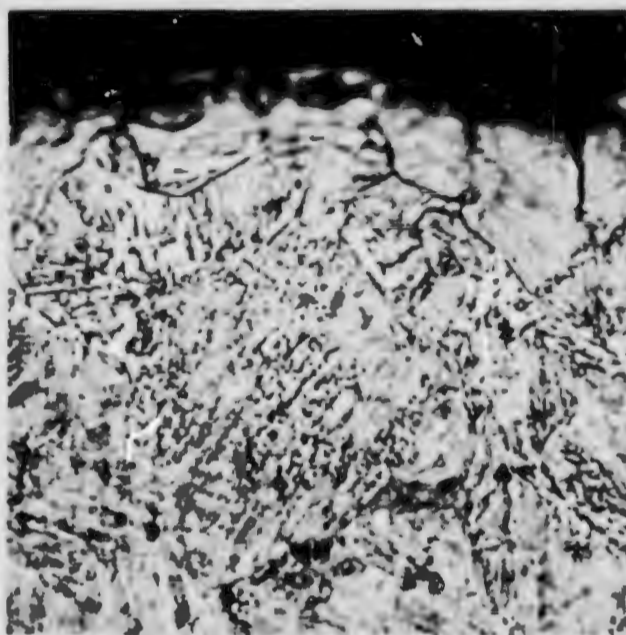
Plate B - hardened  
No banding evident at surface

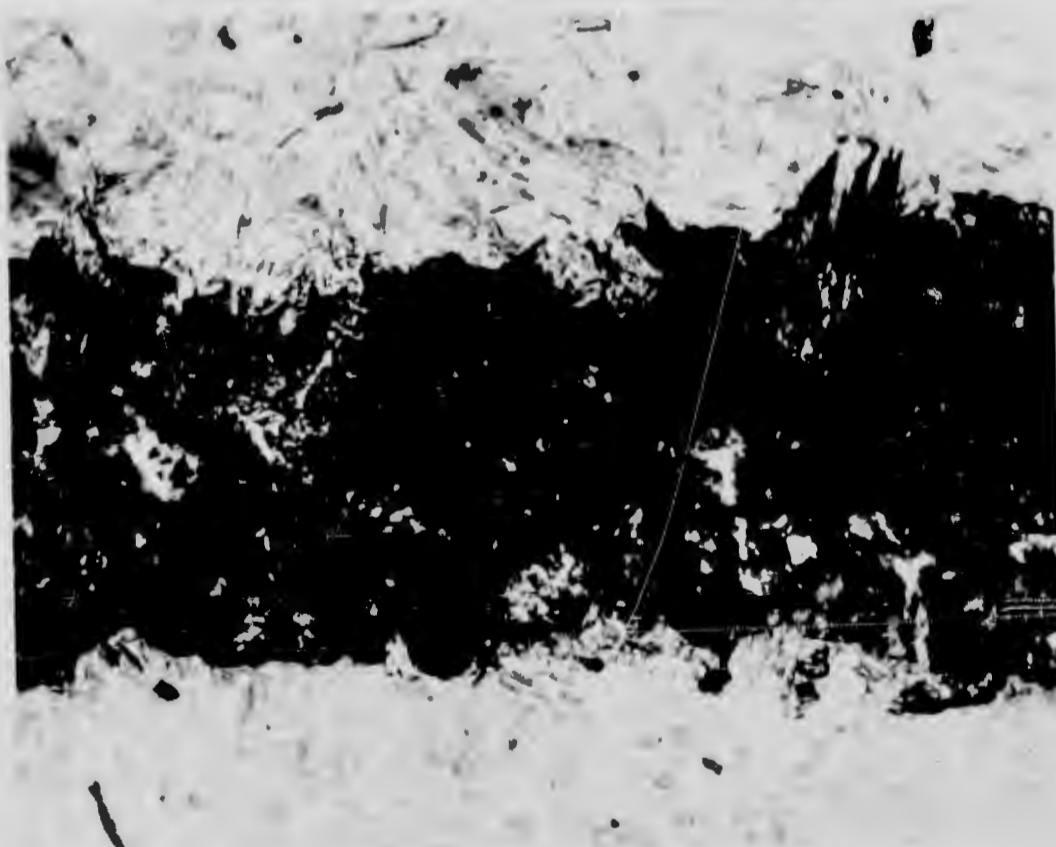
Plate B - Pearlite band below surface
