The objectives were to obtain information on the mechanics of tunnel damage and on the loading and response of various tunnel liners. The ultimate use of such information will be the development of improved design procedures for underground protective construction in rock.

Generally, the results indicated that the measured values of the various shock parameters were within the preshot estimates. The damage at the closest and farthest test drifts was about as expected; however, the damage at the intermediate-range drift was somewhat greater than expected. Data recovery and the results of the electronic and mechanical measurements

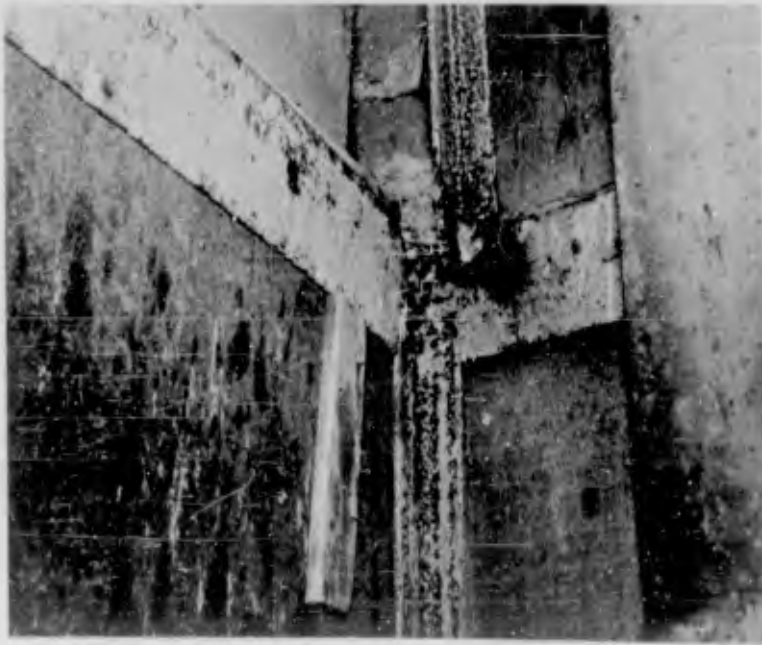
Figure 3.5 Shaft Sta 1+10, NW corner of bearing set. Note failure of hanger angles. (H&N AEC 62-1241-7, 1962).

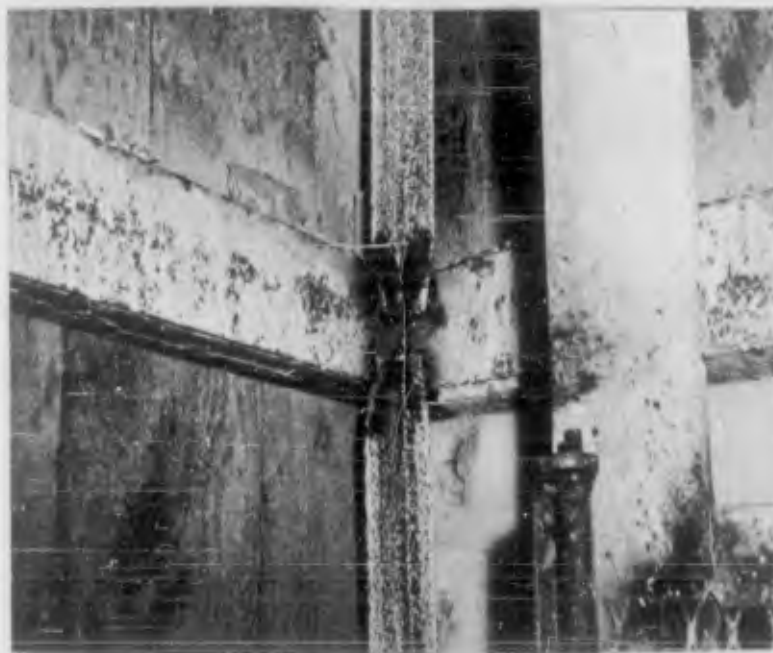
Figure 3.6 Shaft Sta 1+35, SW corner of bearing set. Note failure of hanger angles. (H&N-AEC 62-1241-5, 1962).

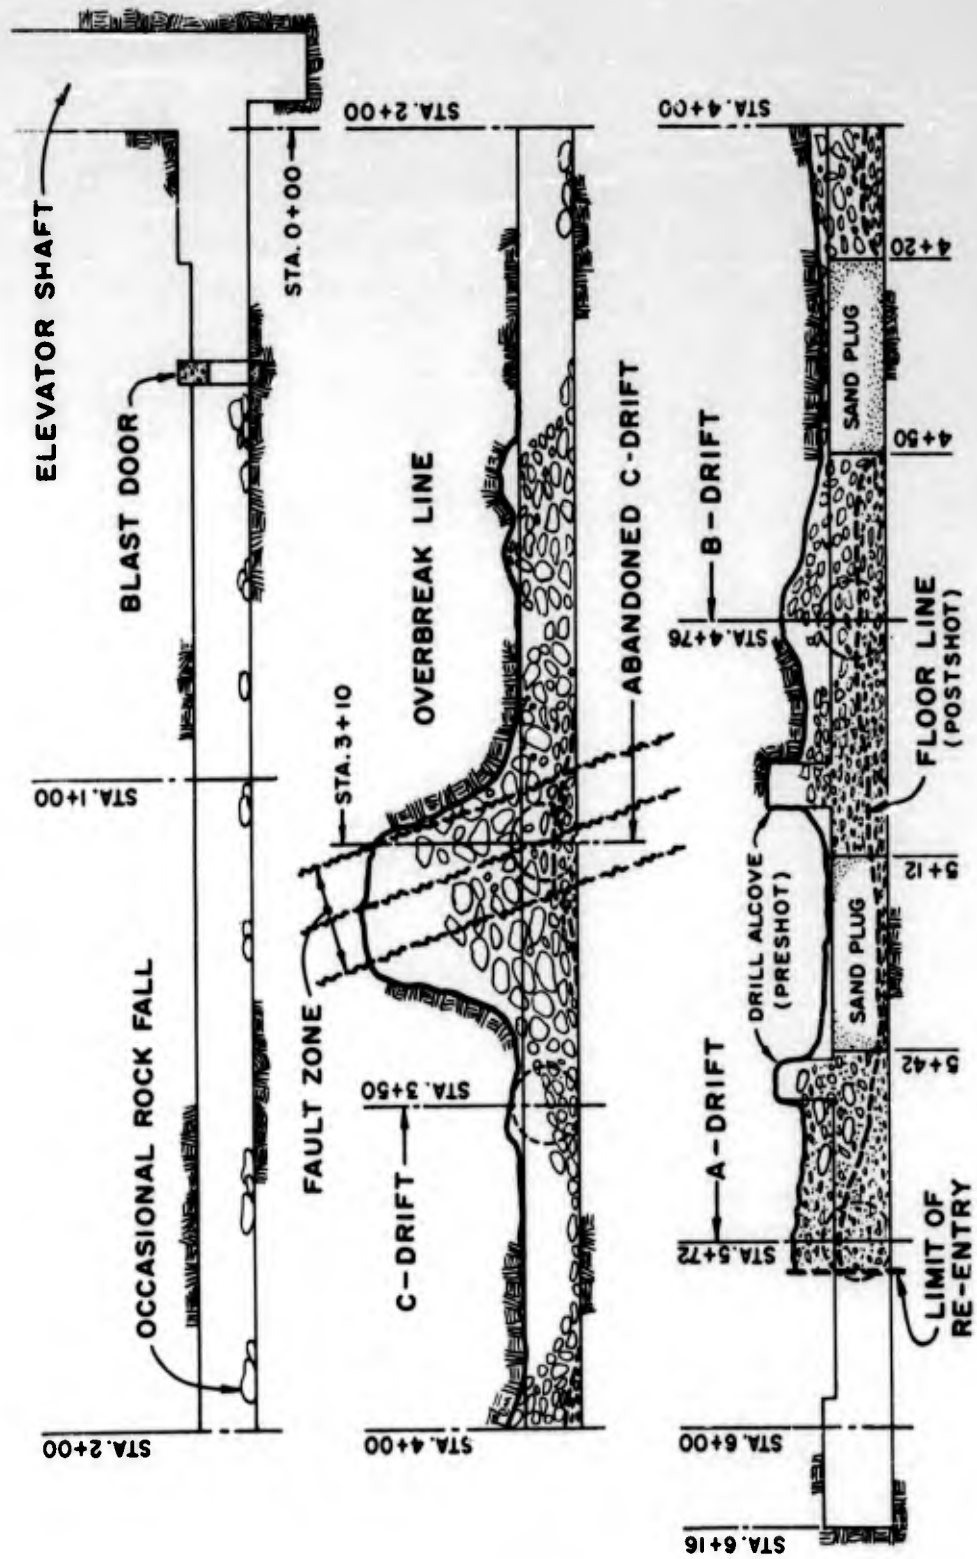
Figure 3.7 Damage profile through access tunnel.

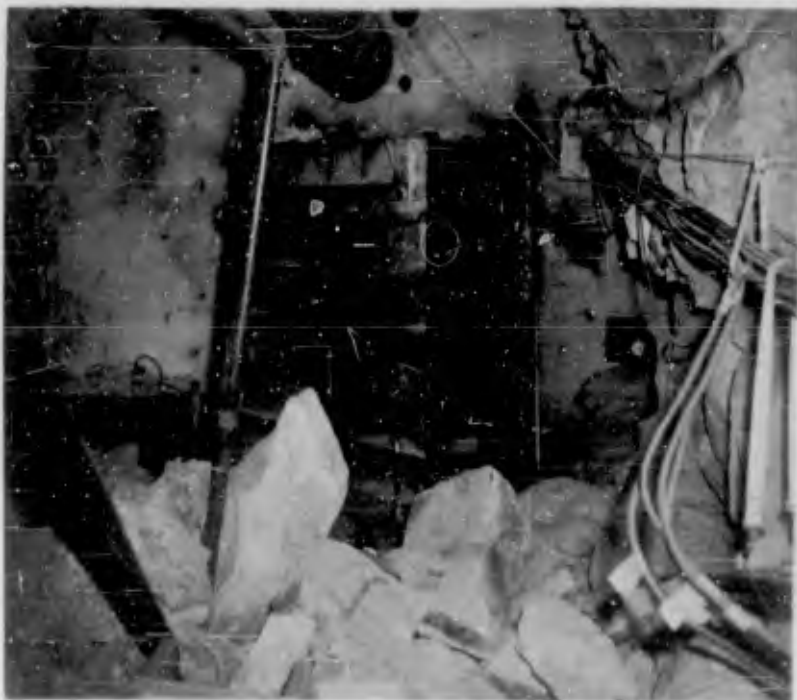
Figure 3.8 Rock fall north side of blast door, Sta 0+42, approximately 760 feet from zero point, looking south (DASA - NOU 160-08 NTS-62).

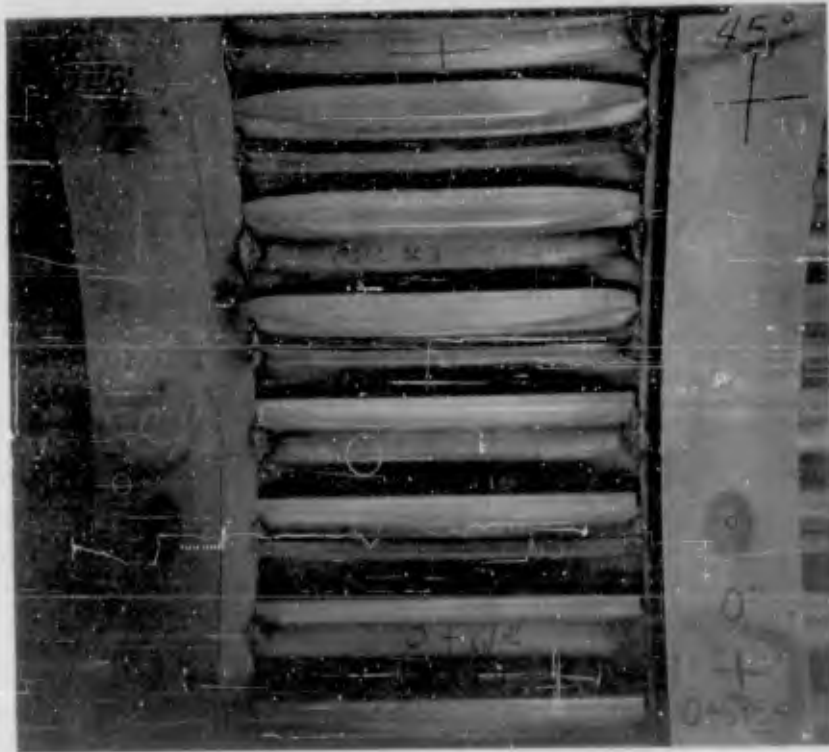
Figure 3.30 Close-up C4a. Note distorted steel decking (DASA - NOU 227-10 NTS-62).

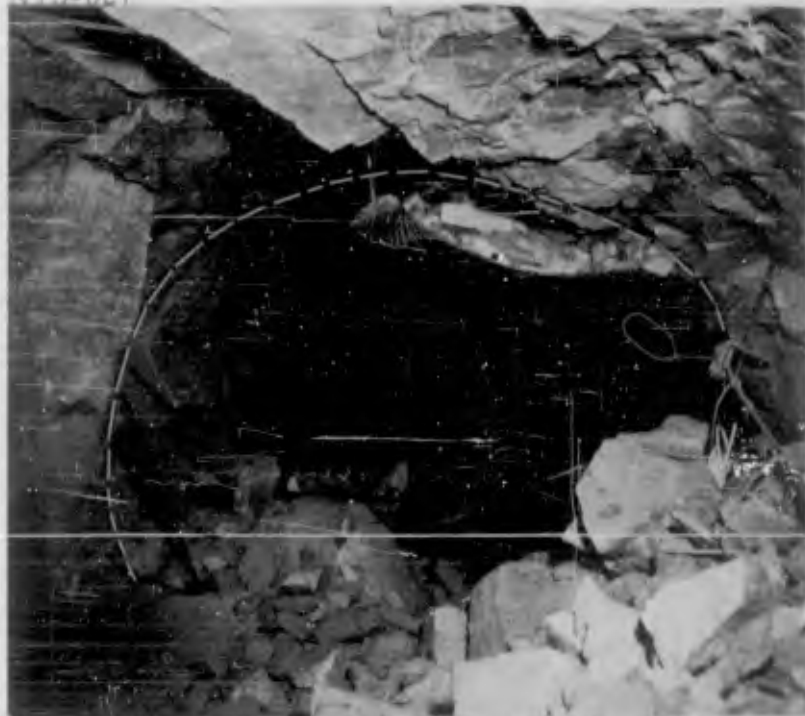
Figure 3.52 Test Sections C2a and C2b (postshot). Dotted line in foreground represents approximate surface of broken rock before clean-up (DASA - NOU 316-04 NTS-62)

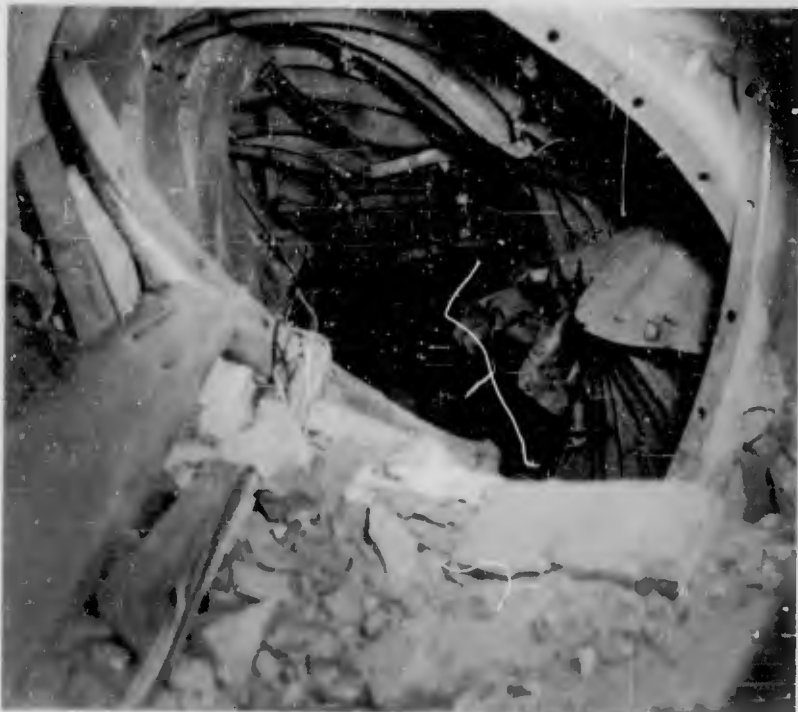
Figure 3.75 B5b from B6b (postshot). Note overlapped tunnel liner plates at the left (DASA - NOU 332-05 NTS-62).

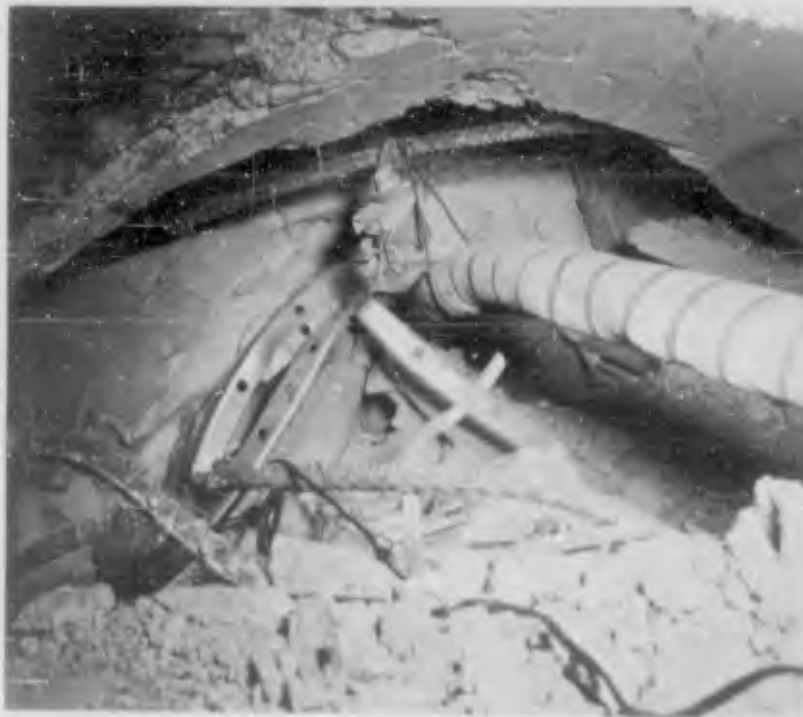
Figure 3.83 Test Section B5a (postshot). Damaged
stereo camera station has been removed (DASA -
NOU 316-07 NTS-62).

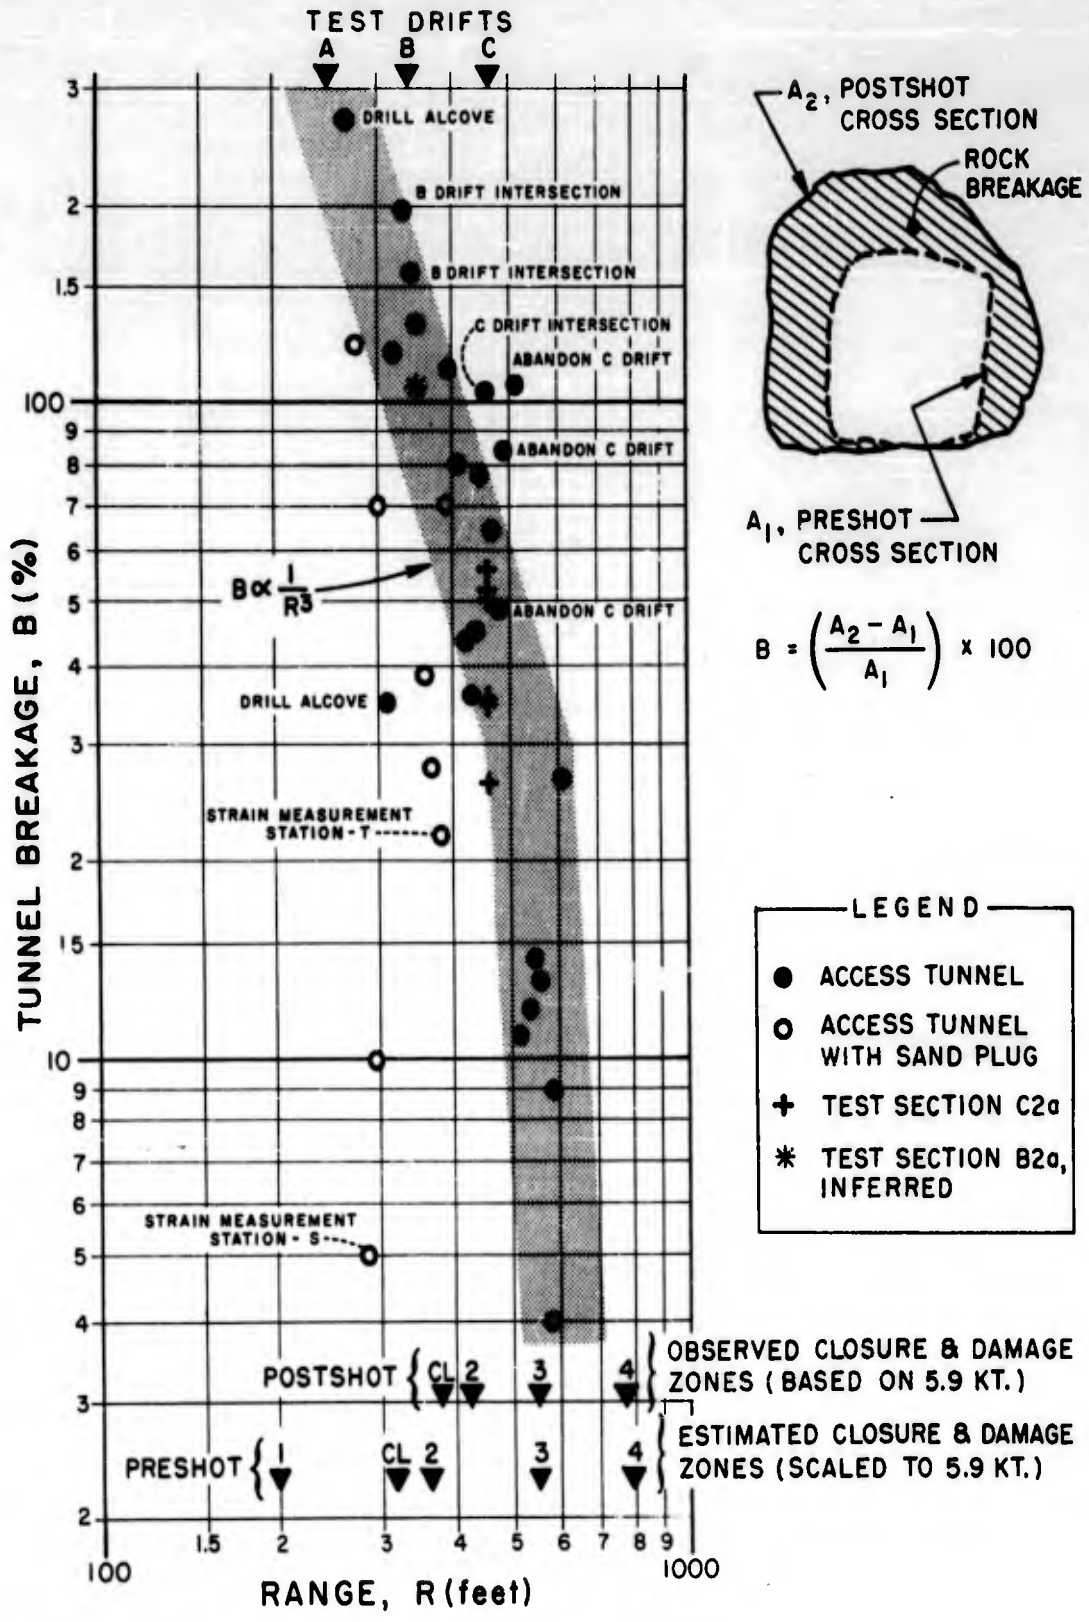
Figure 4.1 Rock breakage versus range, access tunnel and test drifts.
