OPERATION

# PLUMBBOB

Project 1.8b

EFFECTS of ROUGH TERRAIN on DRAG-SENSITIVE  
TARGETS (U)

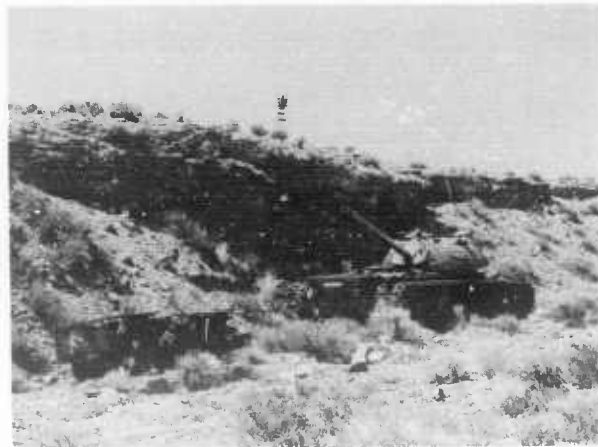
Figure 5 Station 7.02(b), Line 2.

At one location near Line 2 (Station 7.02b, c, and d) there was a steep bluff (the bank of a wash) behind which were placed three jeeps and an M48 tank, all side-on (Figure 5). This wash, or gully, was approximately 100 feet wide. One jeep and the tank were placed against the bluff, one jeep was placed midway in the wash, and the other jeep was placed against the far bank of the wash. This configuration was expected to ascertain the degree of protection which might be obtained at a given distance from a wall. The information would be of value in choosing a most advantageous position when the detonation point cannot be predicted.
