WT-1132

The primary purpose of Project 5.1 of Operation TEAPOT was to determine the structural responses and progression of failure in the post-buckling range of aircraft structures when subjected to destructive gust loads produced by a nuclear explosion. Three QF-80 drones, chosen as the test vehicles, participated in full-scale field tests conducted at the Nevada Test Site during Shot 12.

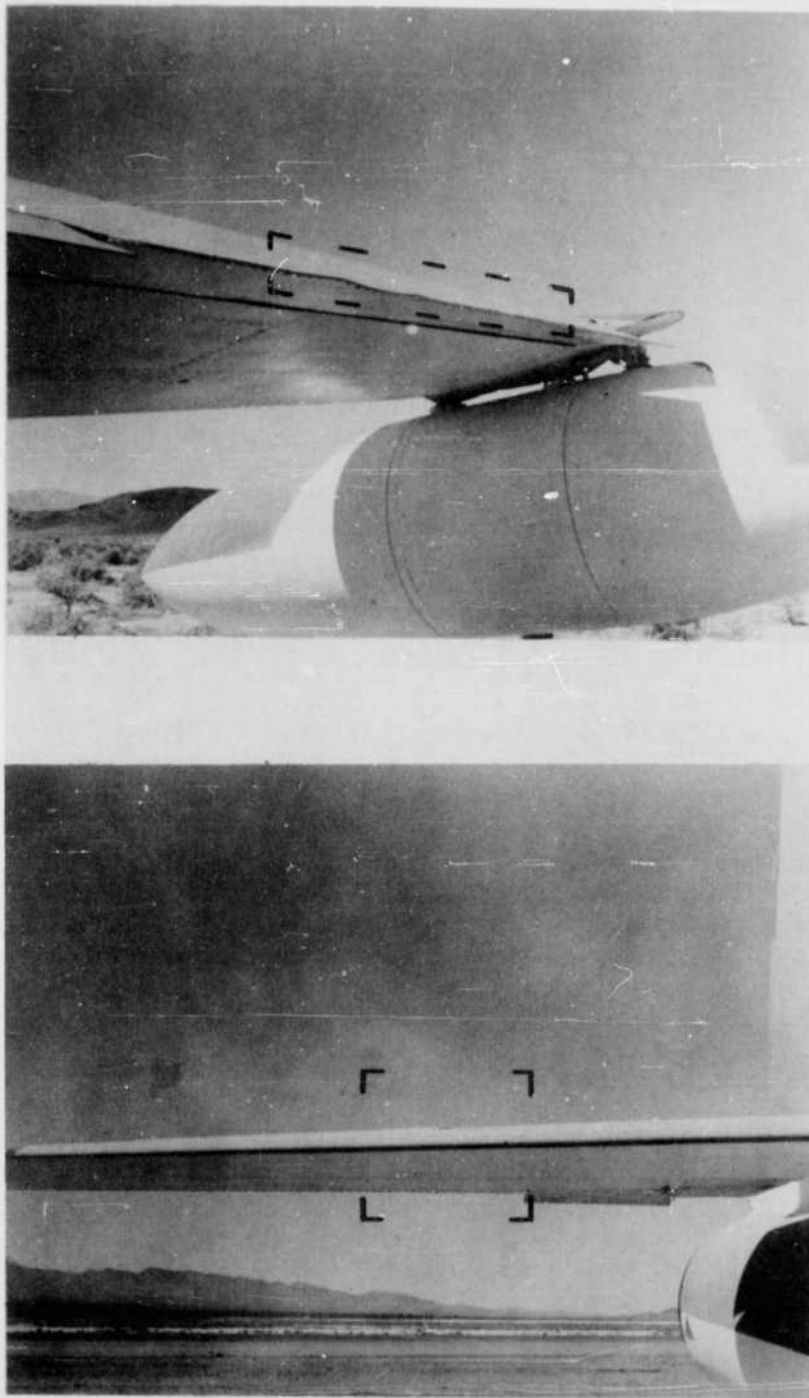
Figure 5.16 Visual Damage, Drone 1

Visual Damage. Close inspection of the recovered drone components in the field and in the laboratory revealed that the blast had very little permanent effect on Drone 1. The horizontal stabilizer was only slightly damaged by blast effects and to an even less degree by thermal effects. There were small permanent buckles, on the upper skin between Stations 40 and 50 on each side, which extended completely across the scab fix. There were also small permanent wrinkles in the elevator, particularly at the trailing edge. The ailerons and flaps had small wrinkles at the trailing edge, but the wing itself showed no indication of damage due to blast. Figure 5.16 shows the blast damage to the horizontal stabilizer and to the aileron. None of these effects would be likely to seriously affect the flight performance of the drone.

The thermal damage consisted only of slight scorching and blistering of dark or blackened areas. These areas consisted of the black deflection-

calibration markers and some areas around the elevator leading edge, where a dark protective coating had been applied to the elevator-position pots.

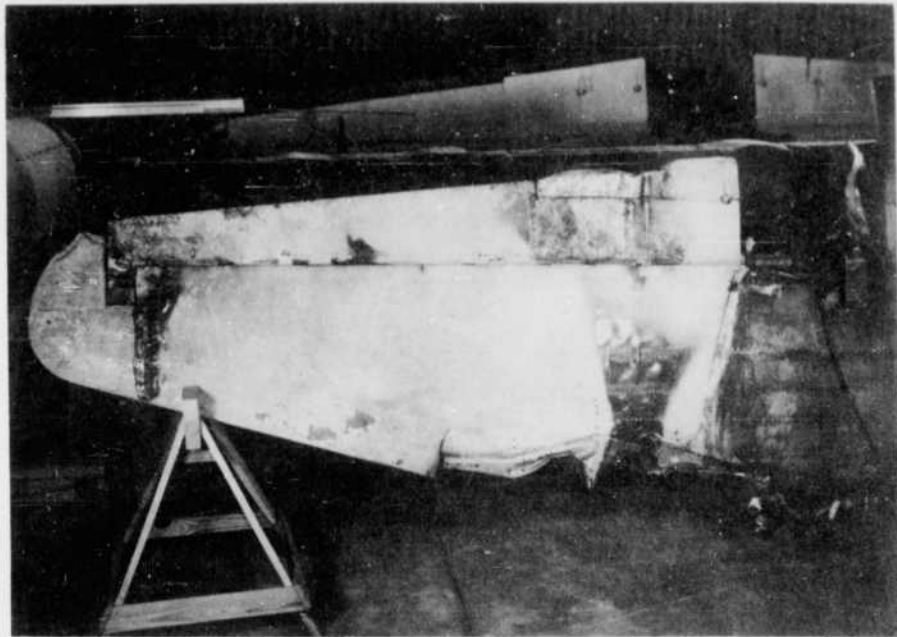
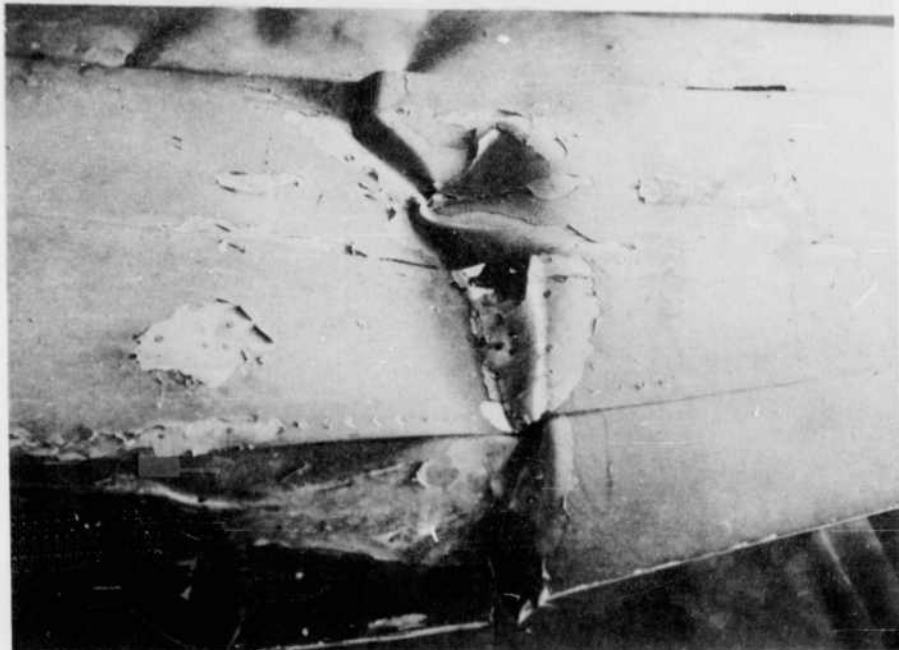
Figure 5.18 Visual Damage, Drone 3

Performance. Drone 3 also survived the blast but lost some altitude. When intercepted by the director, both tip tanks were gone, the elevators, stabilizers, and ailerons were damaged, and there was some heat damage

evident on the drone lower surface. The horizontal stabilizer was seriously damaged.
