BUREAU OF SHIPS GROUP TECHNICAL INSPECTION REPORT

U.S.S. SEARAVEN (SS196)

TEST ABLE [U] 8

6 OPERATION CROSSROADS

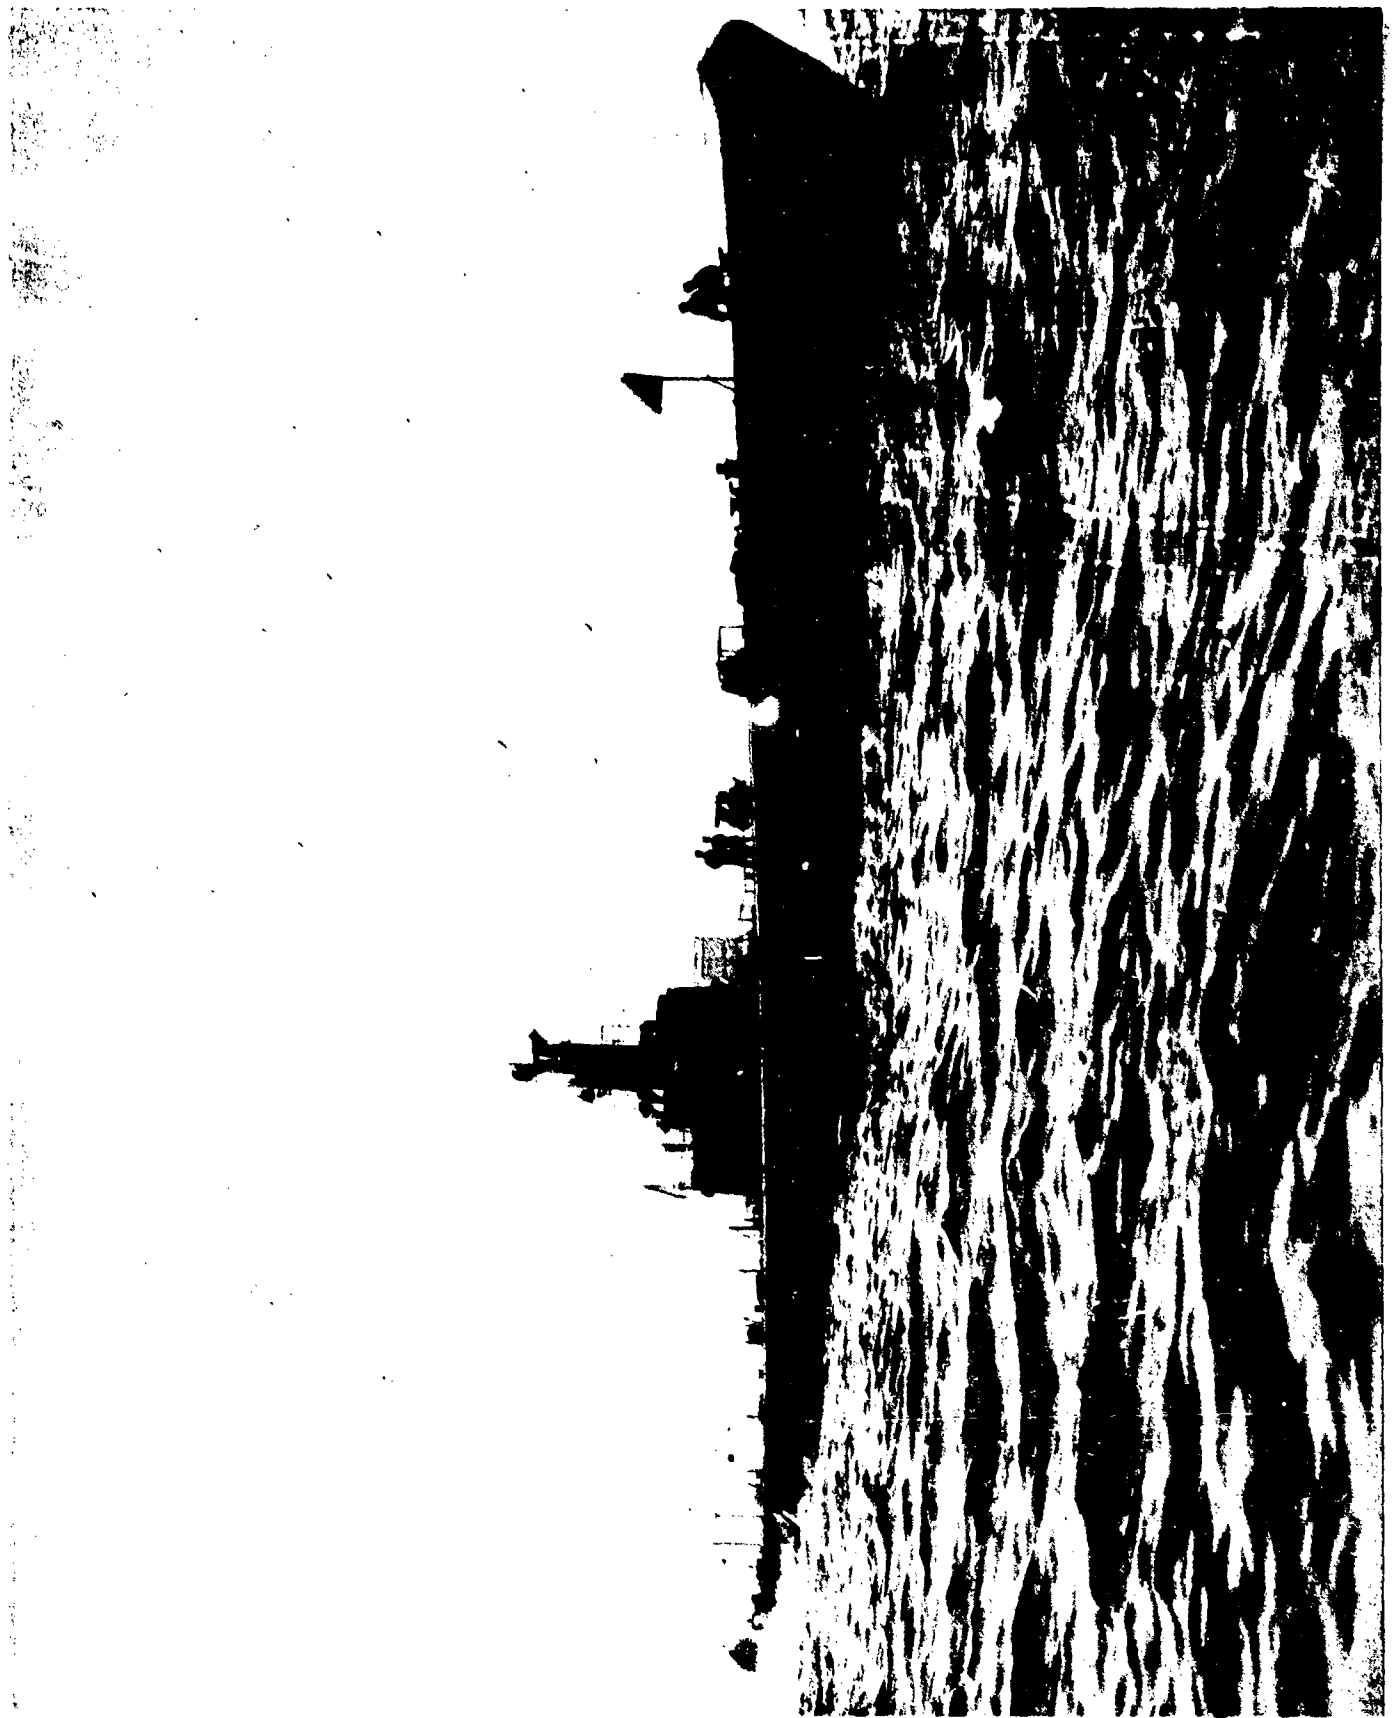
AA-CR-227-92-96. General view from starboard bow.

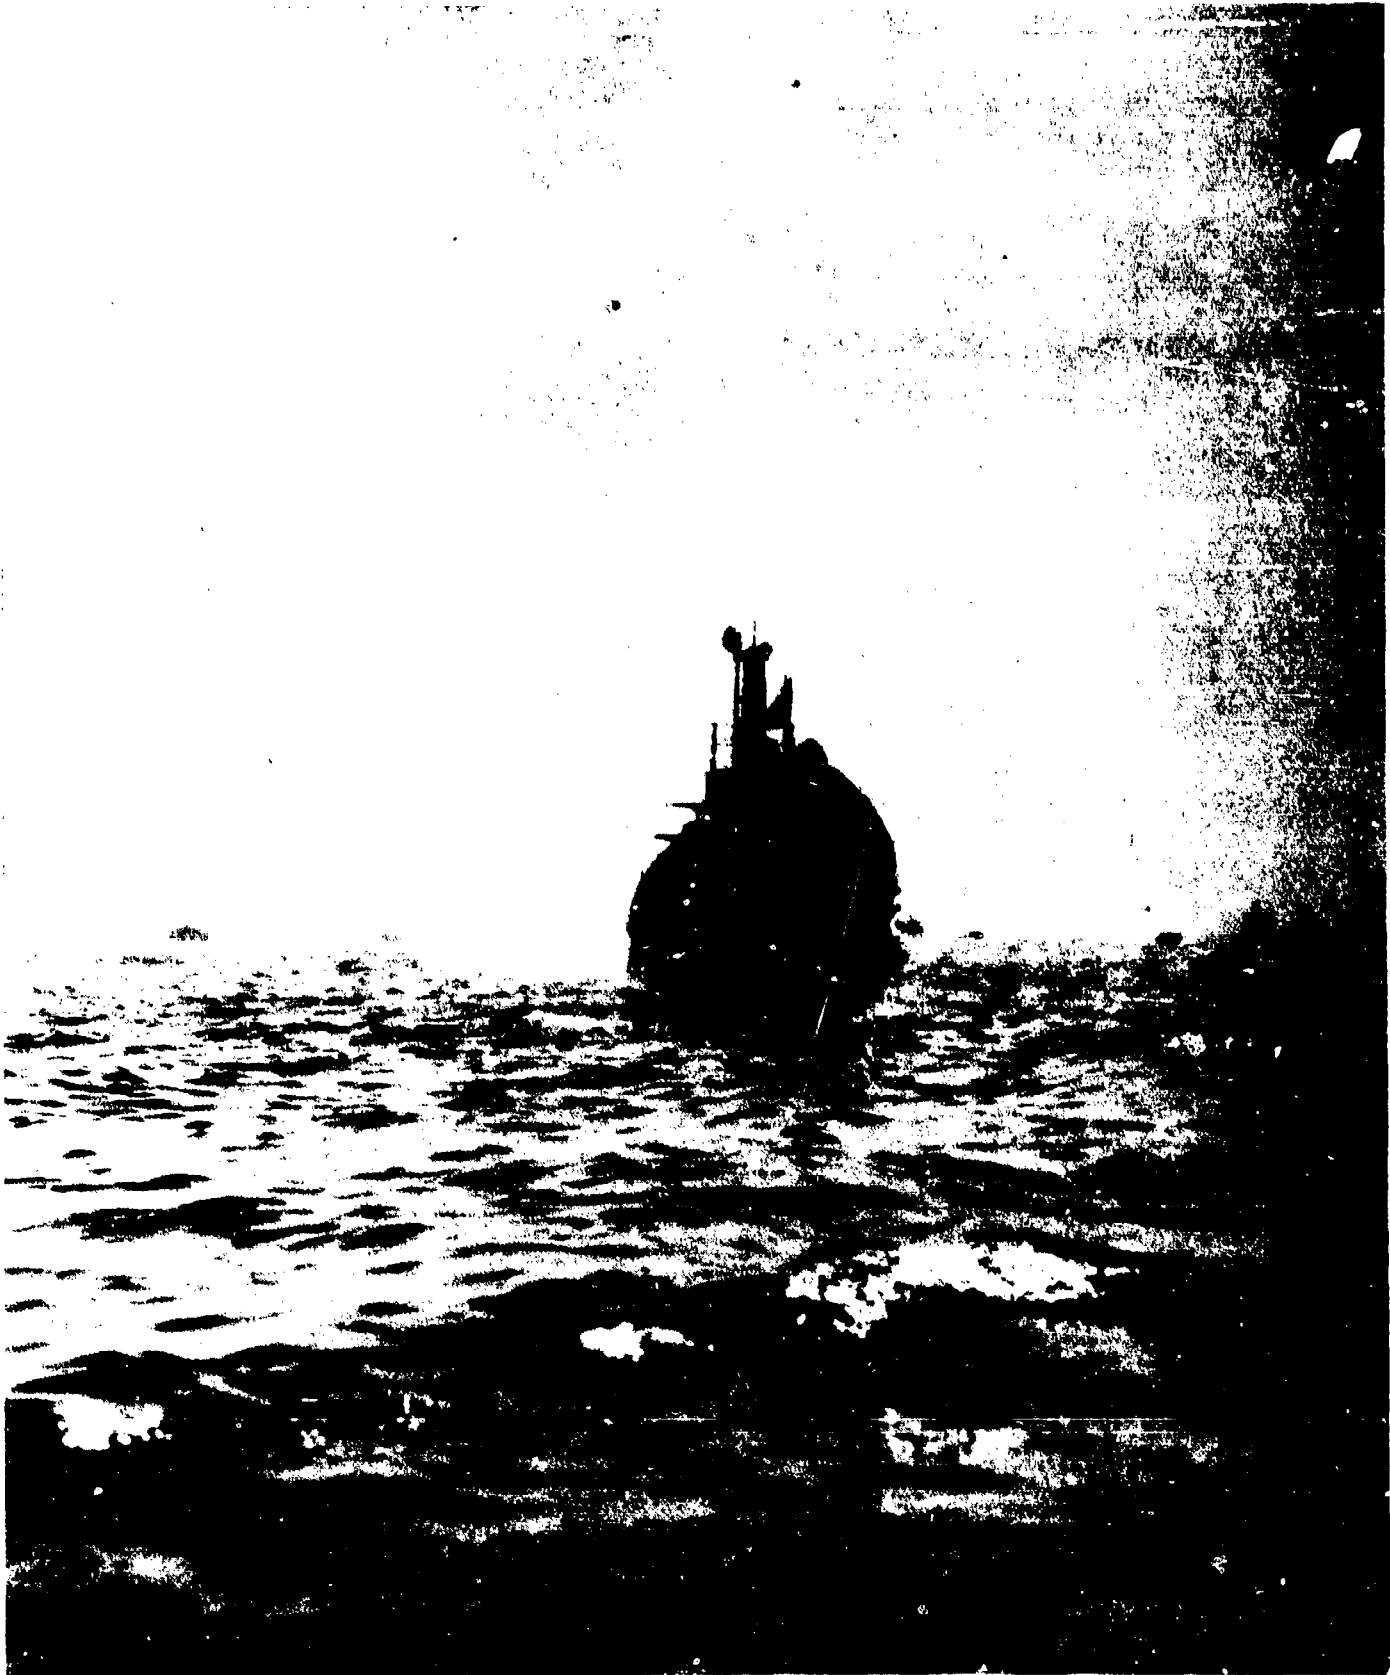
AA-CR-227-92-95. General view from ahead.

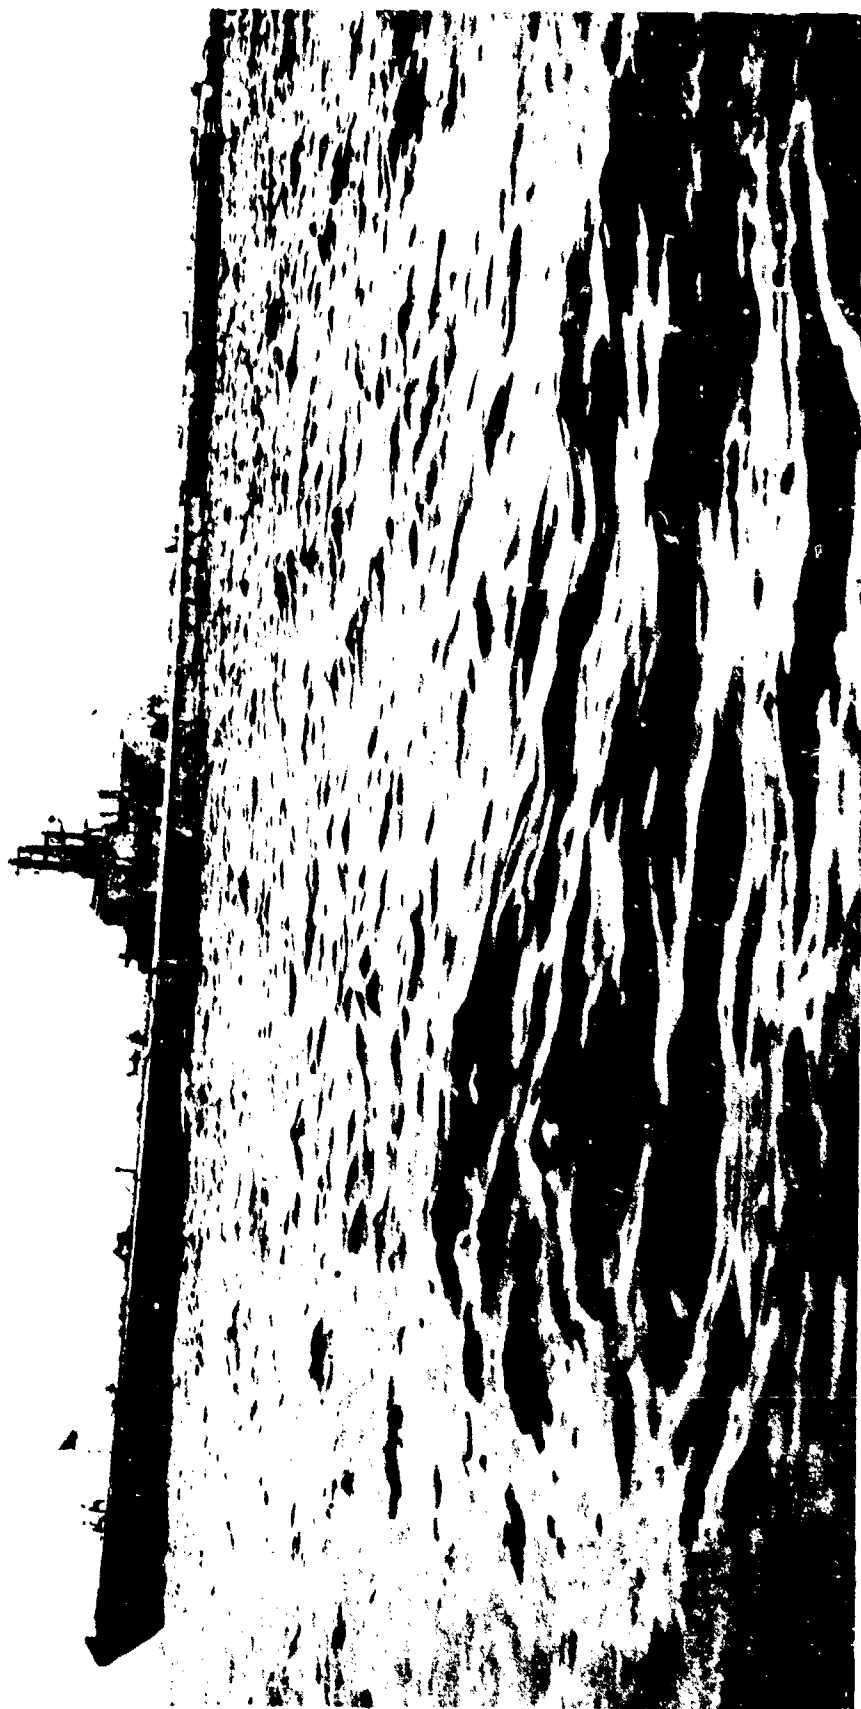
AA-CR-227-92-93. General view from port beam.

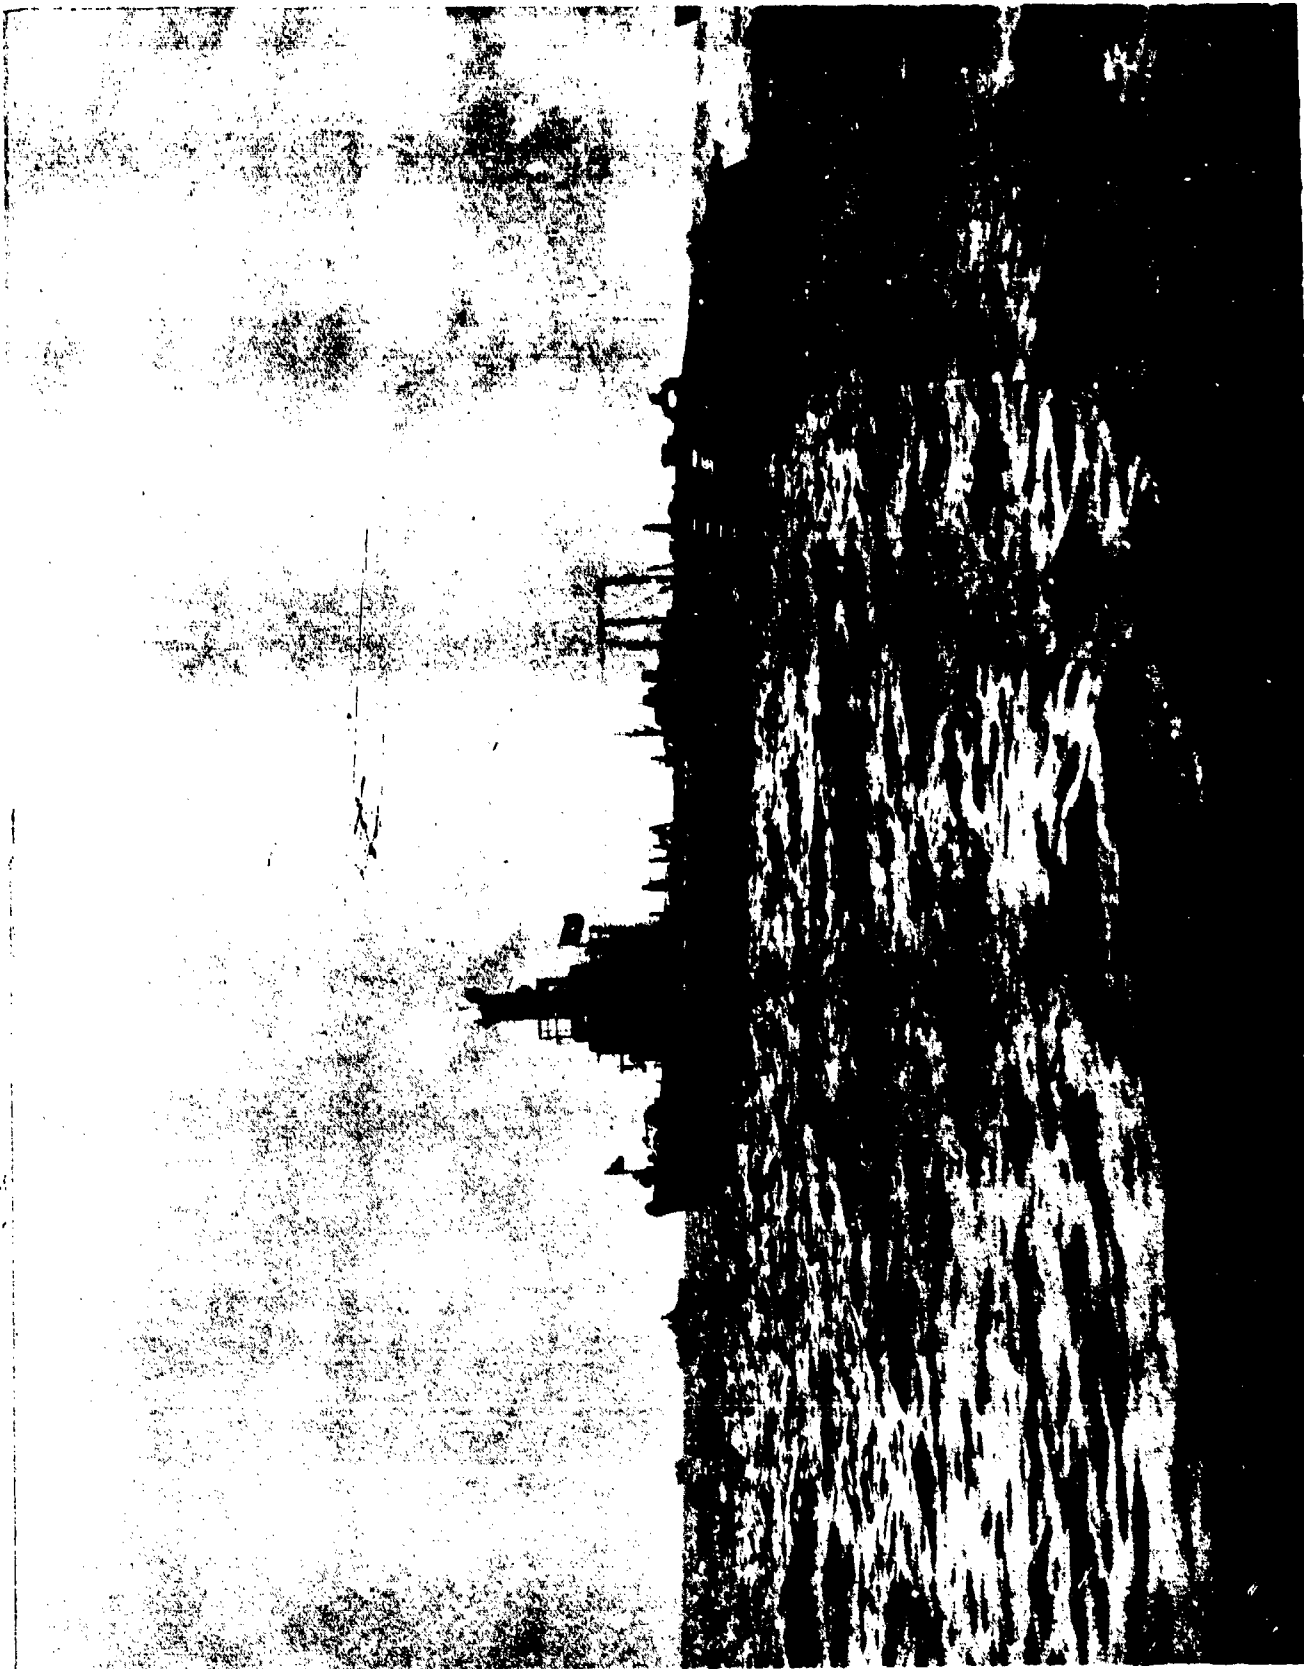
AA-CR-227-92-92. General view from port quarter.

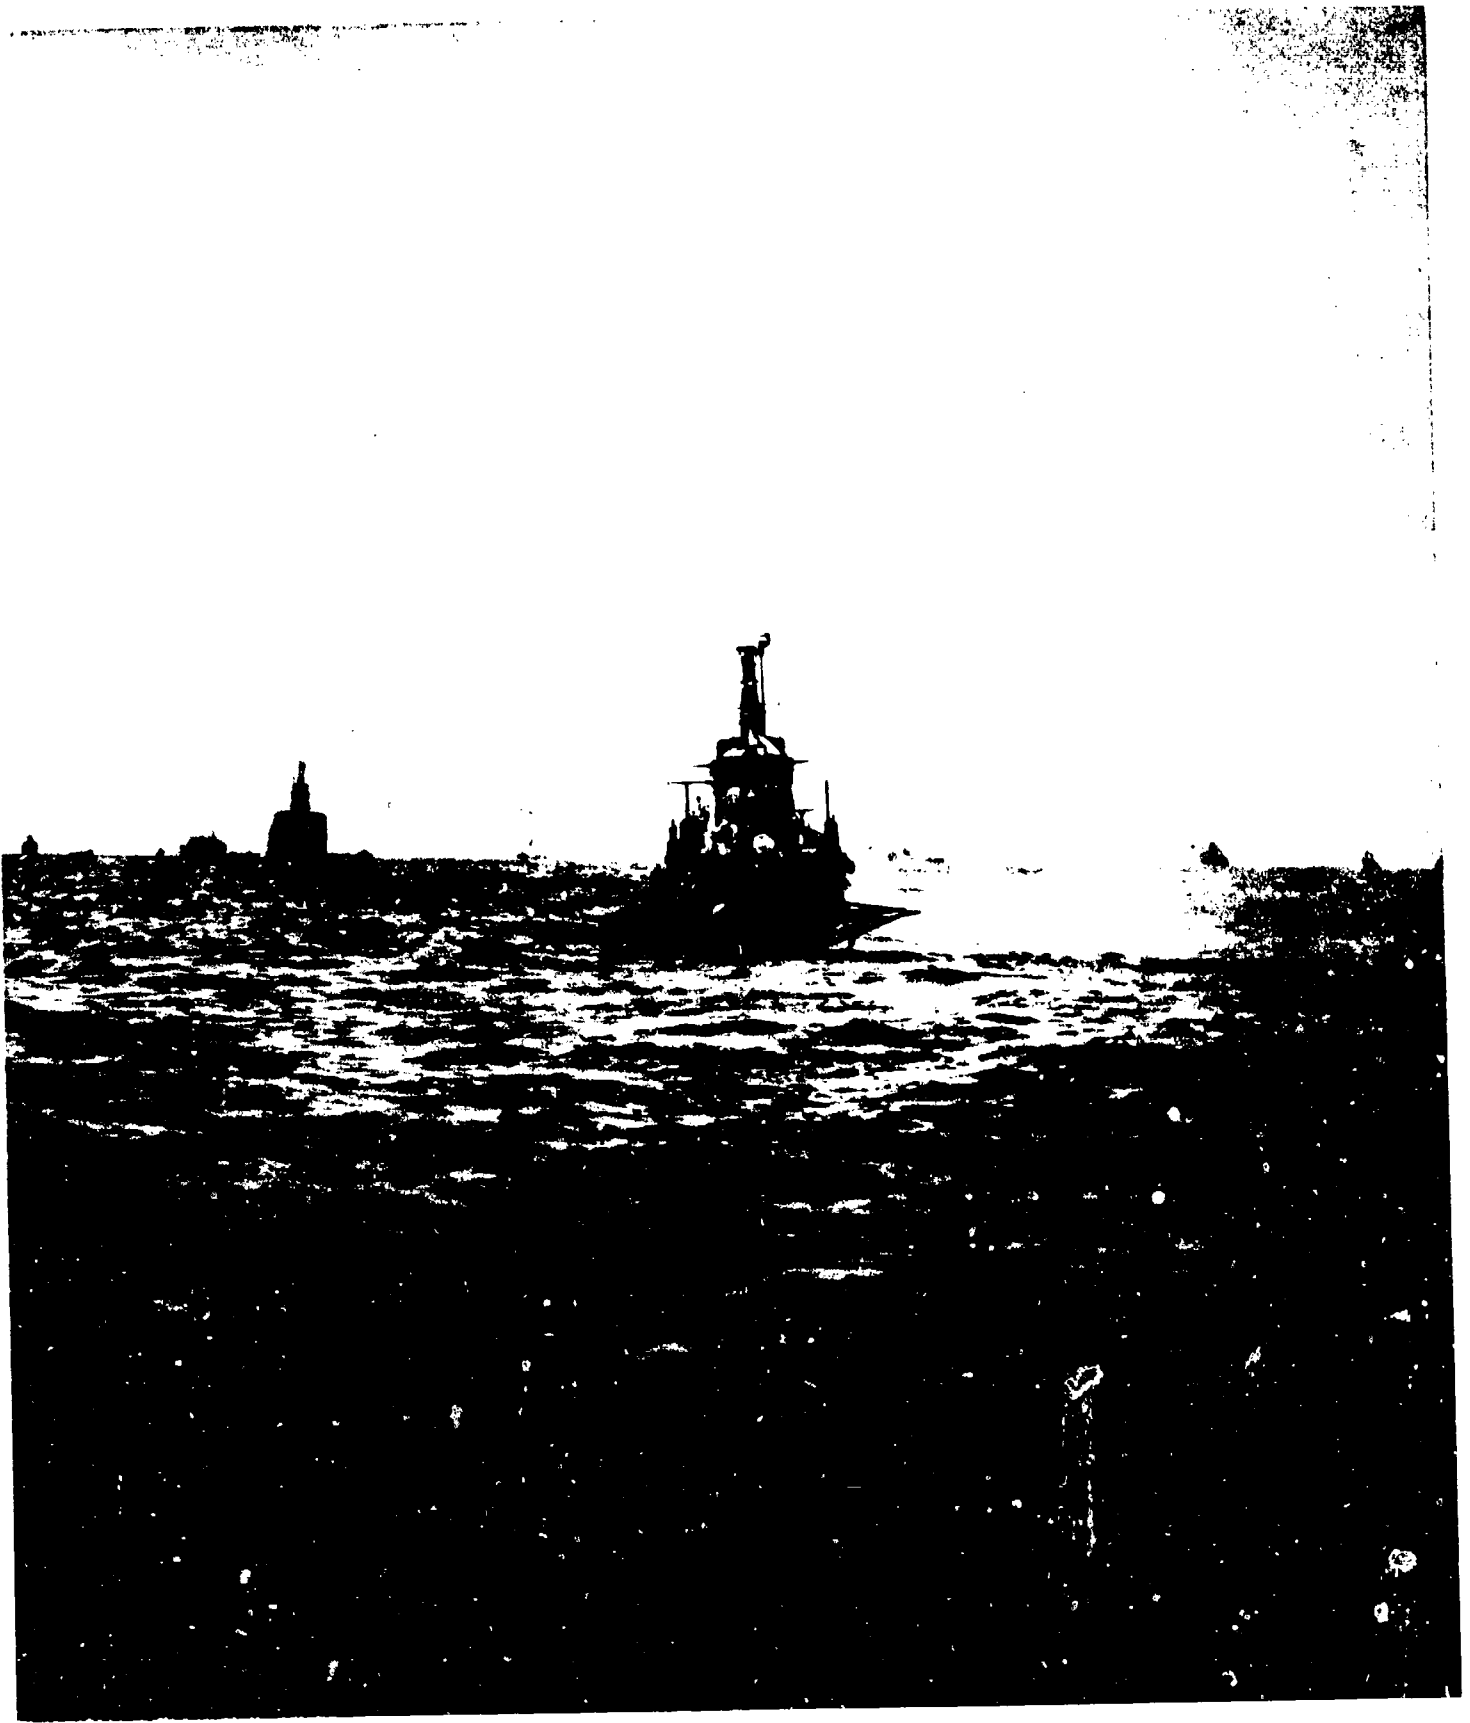
AA-CR-227-92-91. General view from astern.

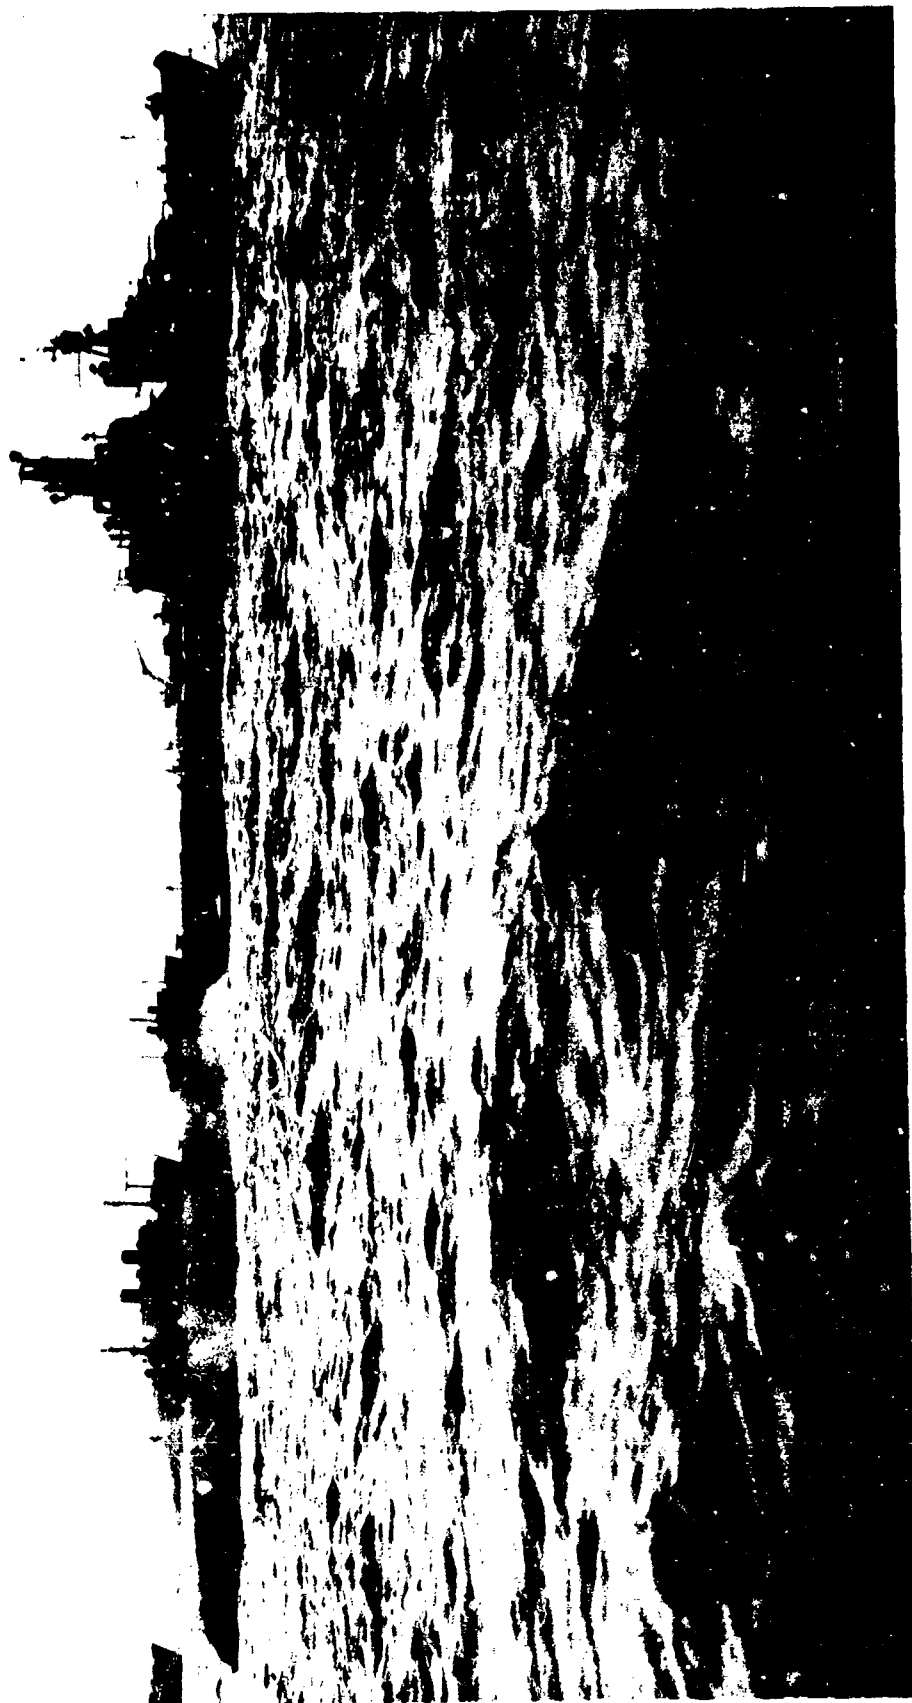
AA-CK-227-92-90. General view from starboard quarter.

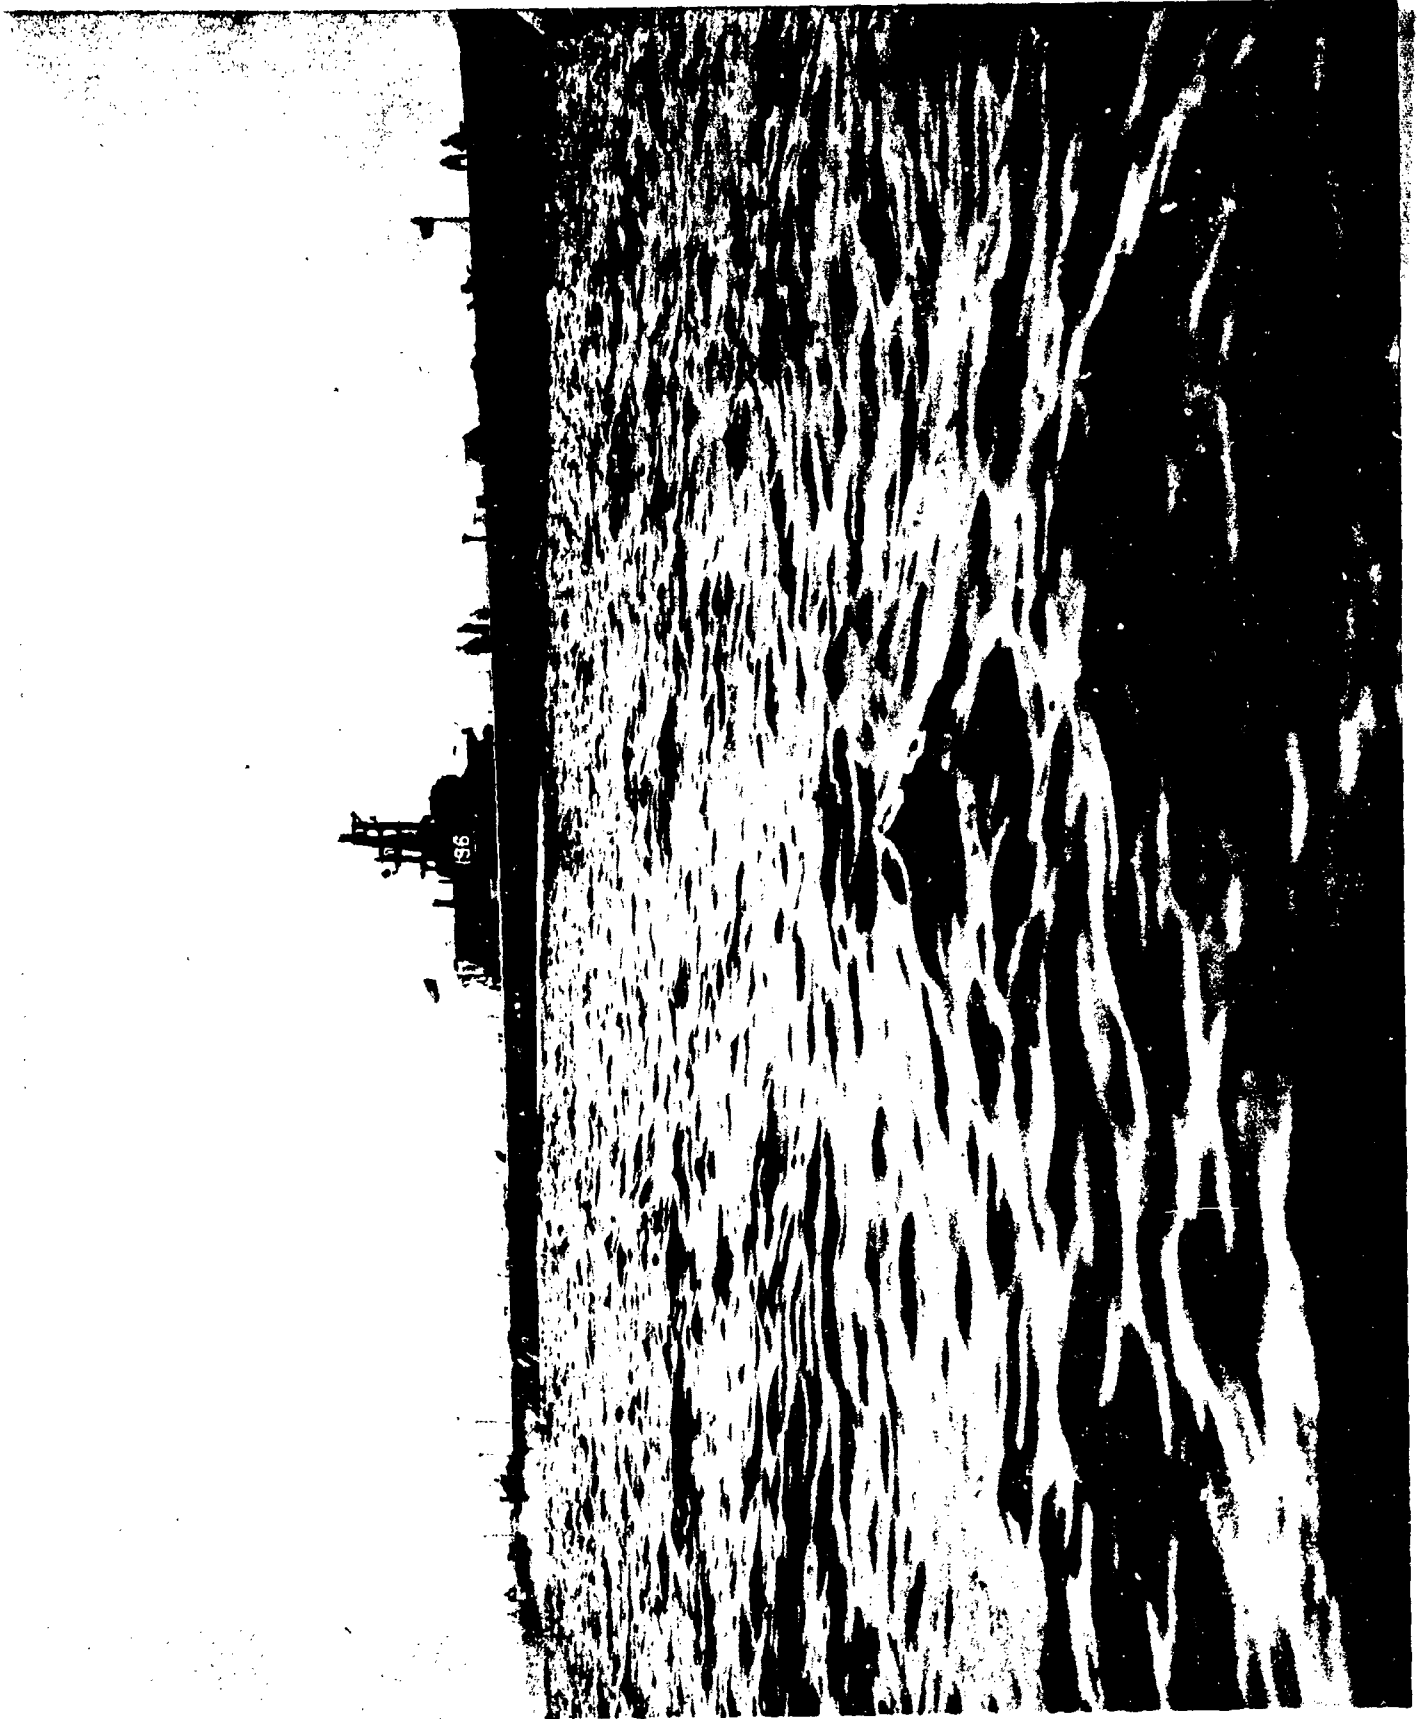
AA-CR-227-92-89. General view from starboard beam.
