## TECHNICAL INSPECTION REPORT

### U.S.S. TUNA (SS 203)

### TEST ABLE [✓]. ⑧

⑥ OPERATION CROSSROADS

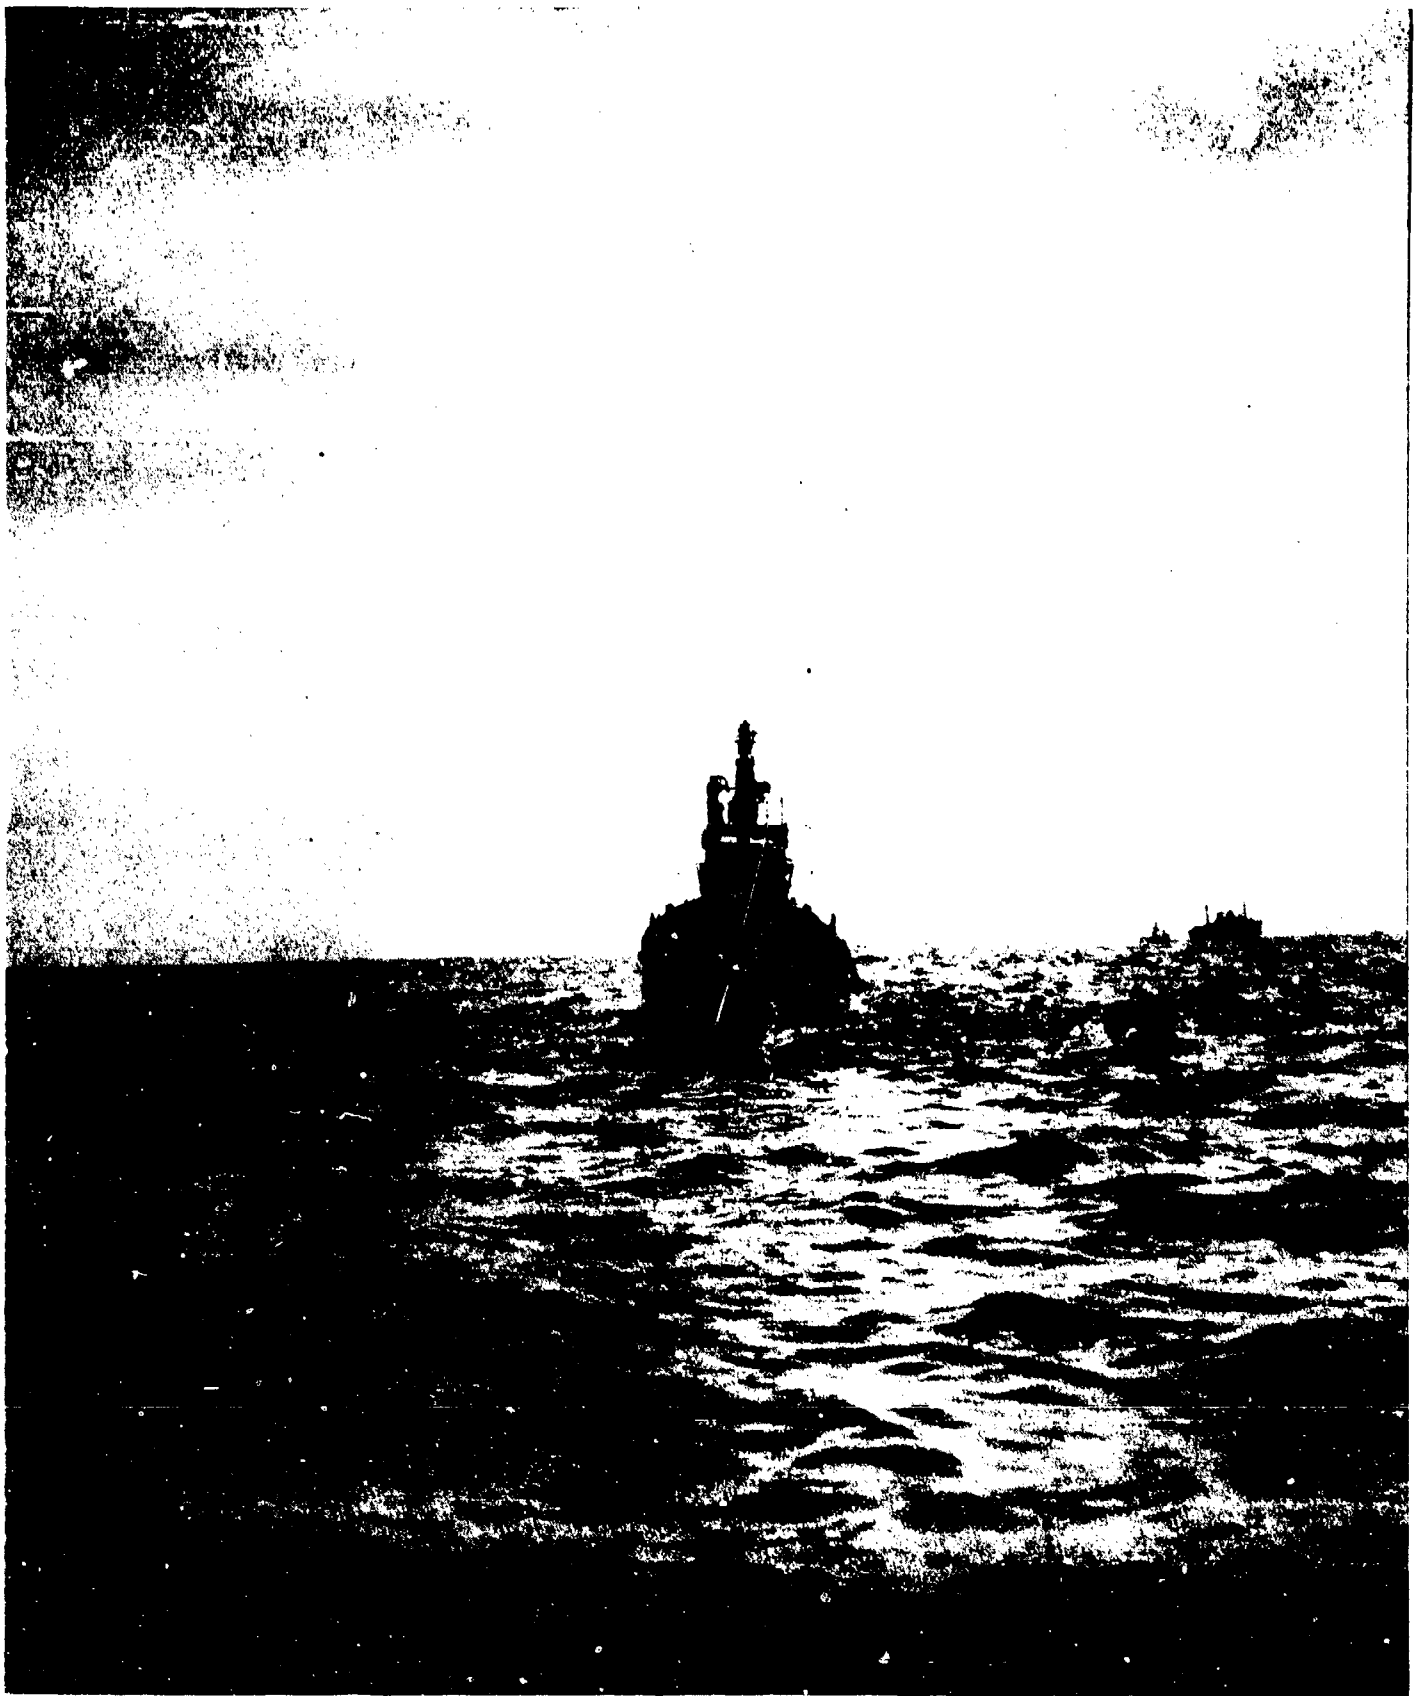
AA-CR-227-92-46. General view from ahead.

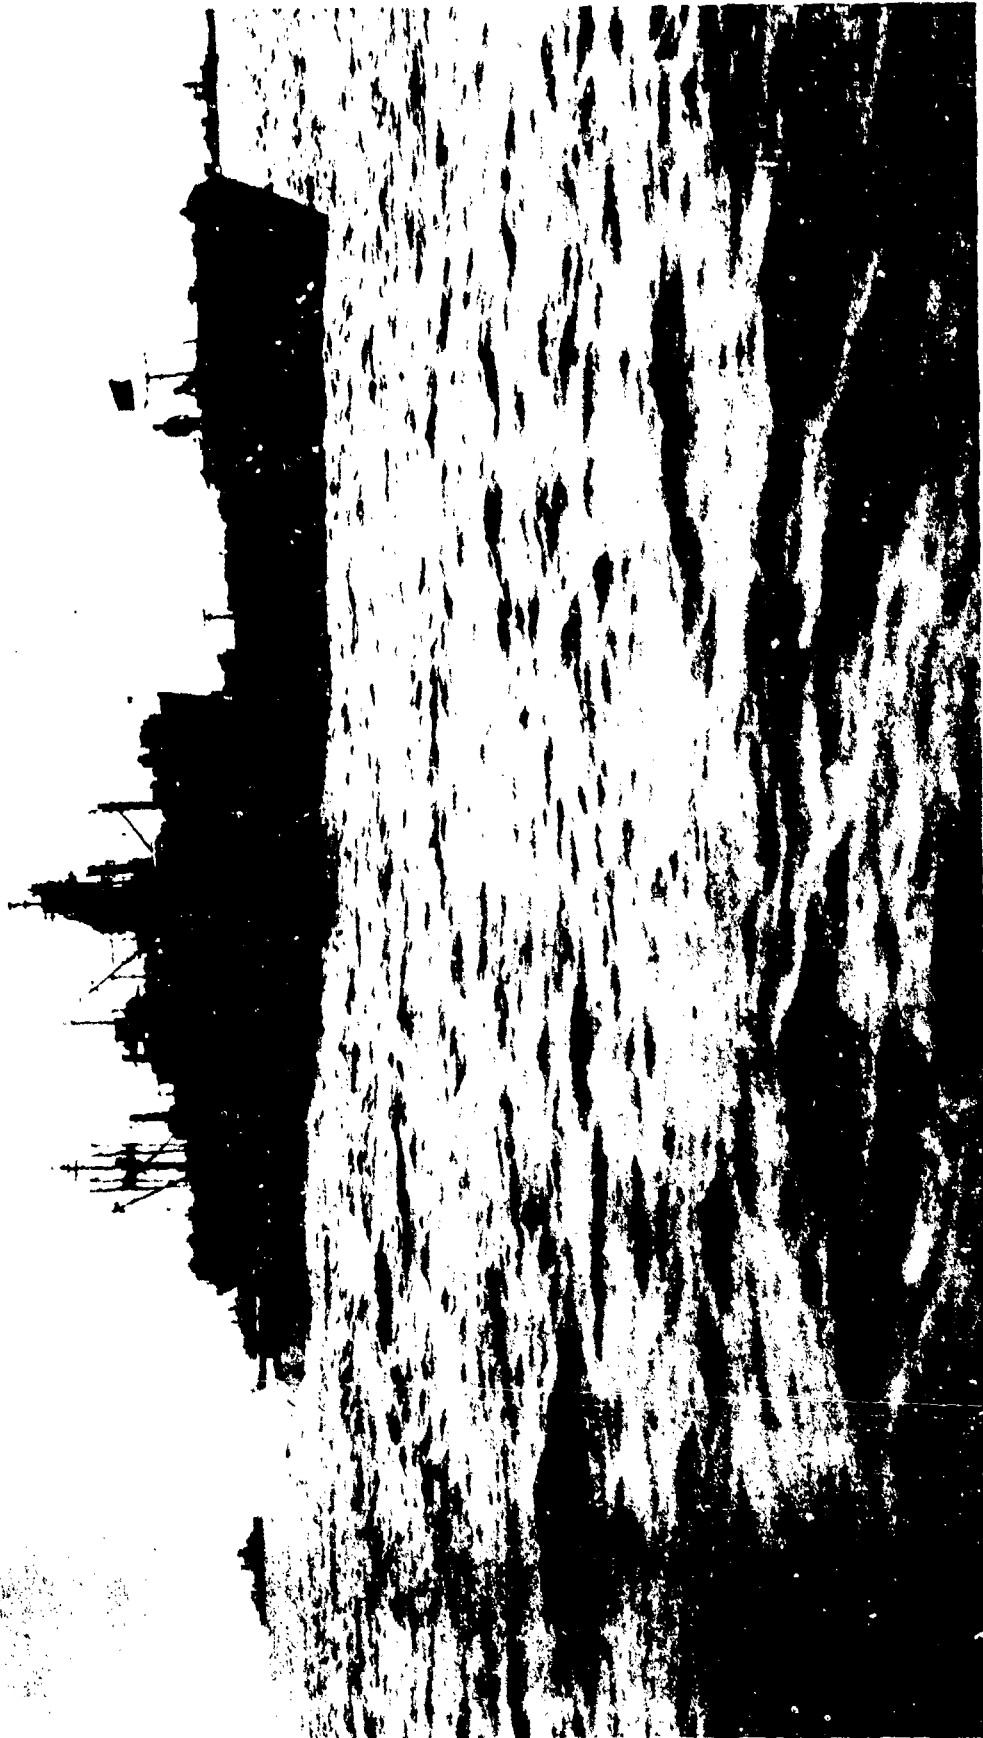
AACR-227-92-47 - General view from starboard bow.

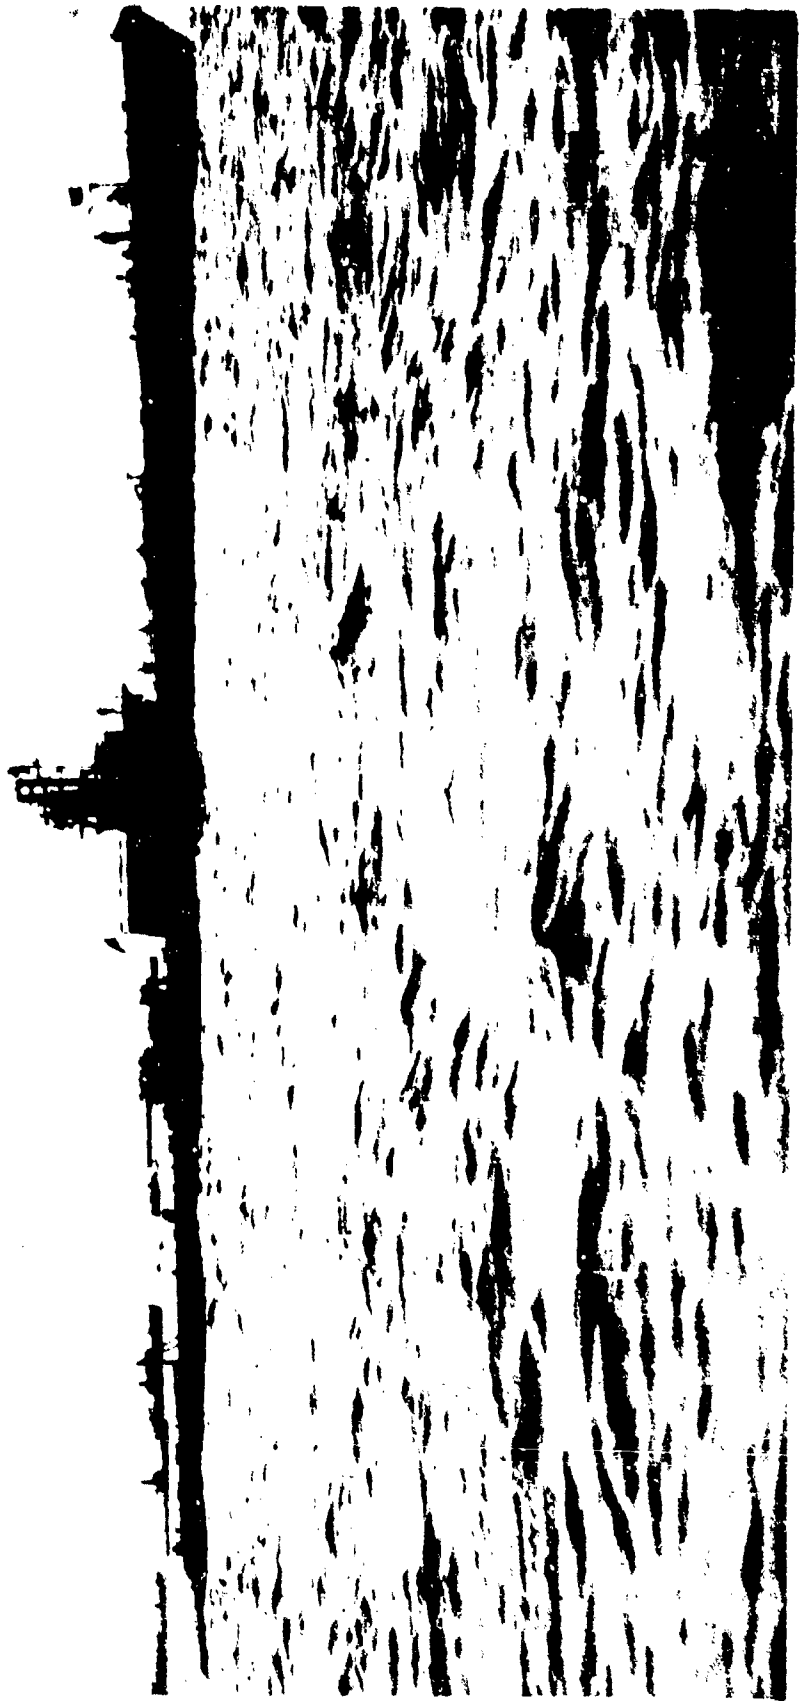
AA-CR-227-92-48. General view from starboard beam.

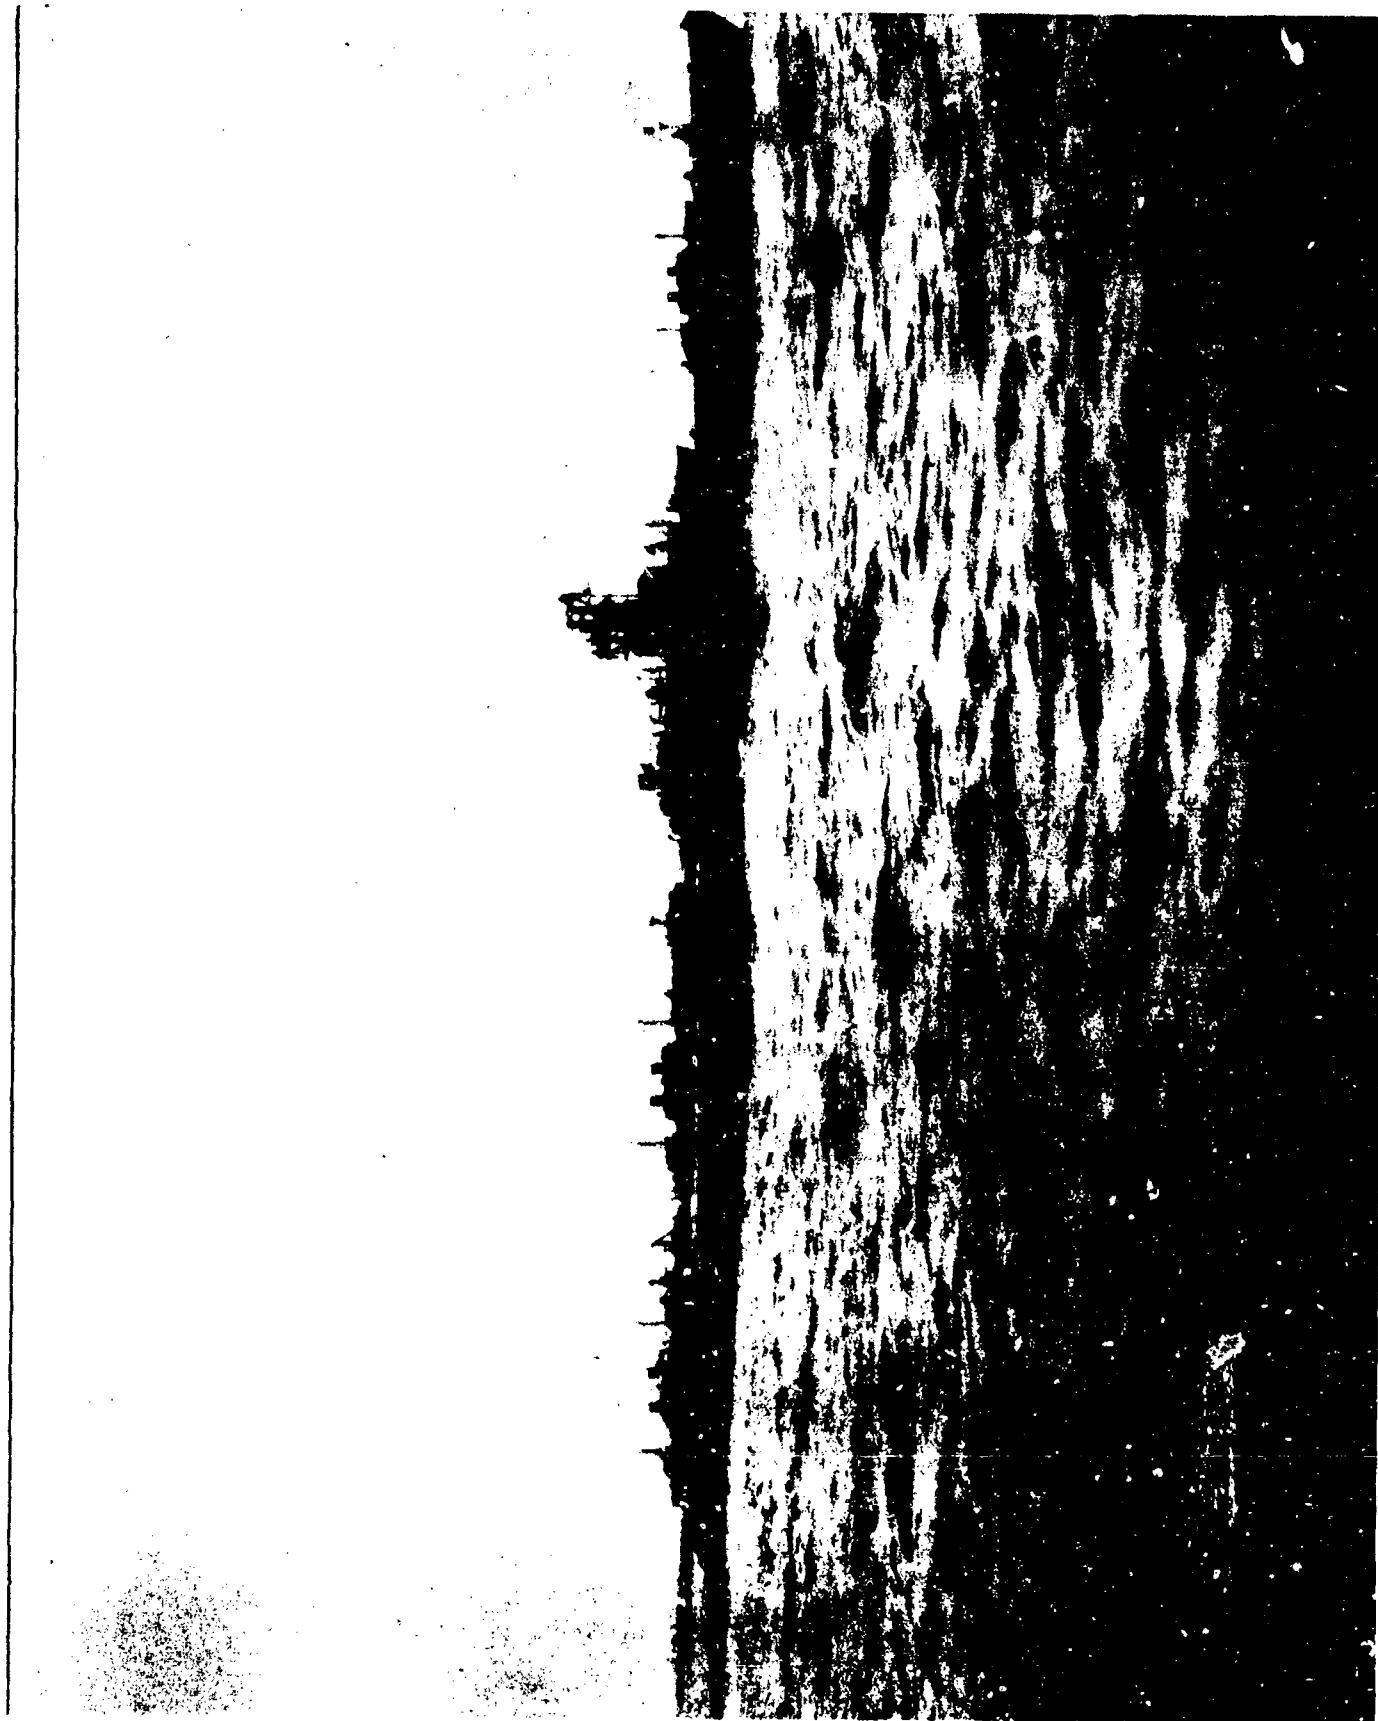
AA-CR-227-92-49. General view from starboard quarter.

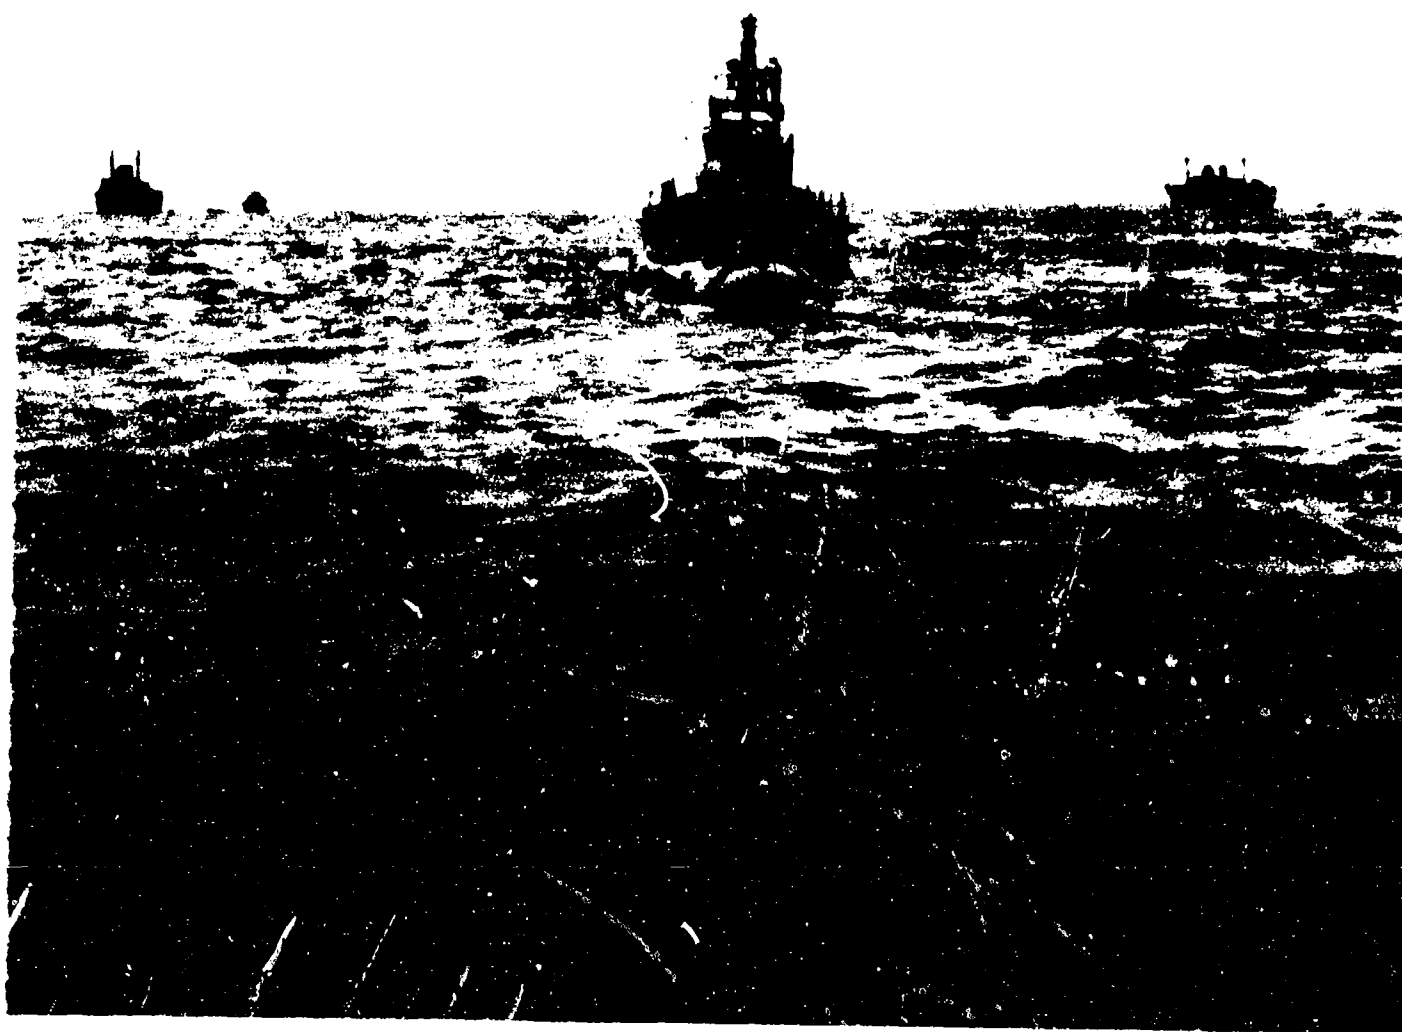
AACR-227-92-50 - General view from astern.

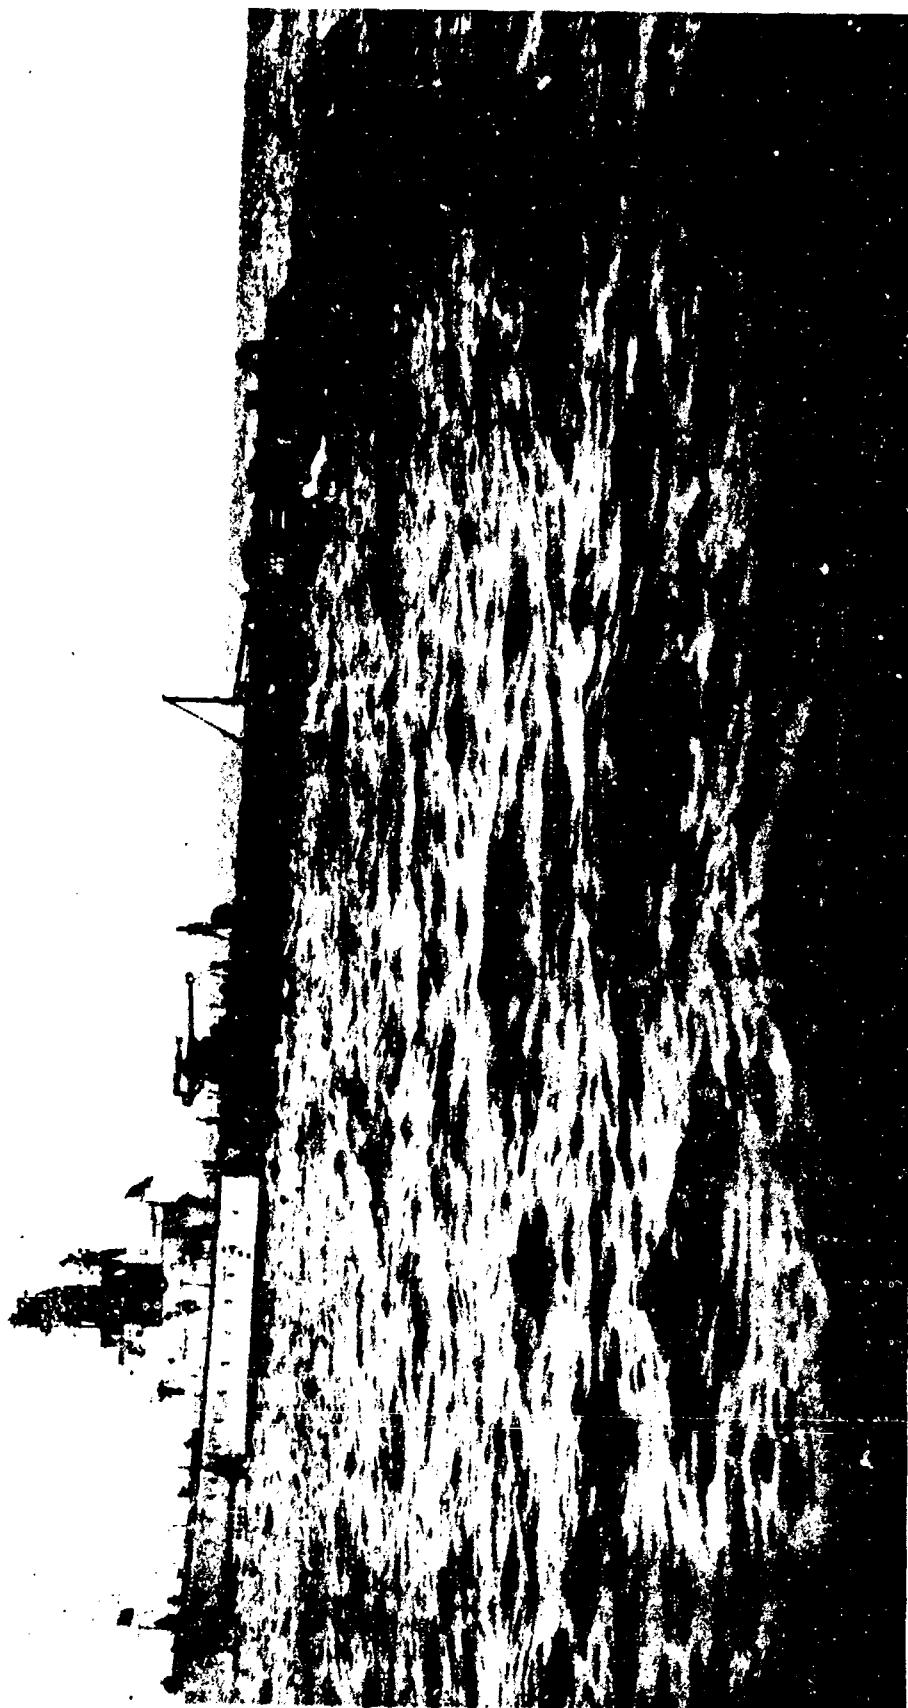
AACR-227-92-51 - General view from port quarter.

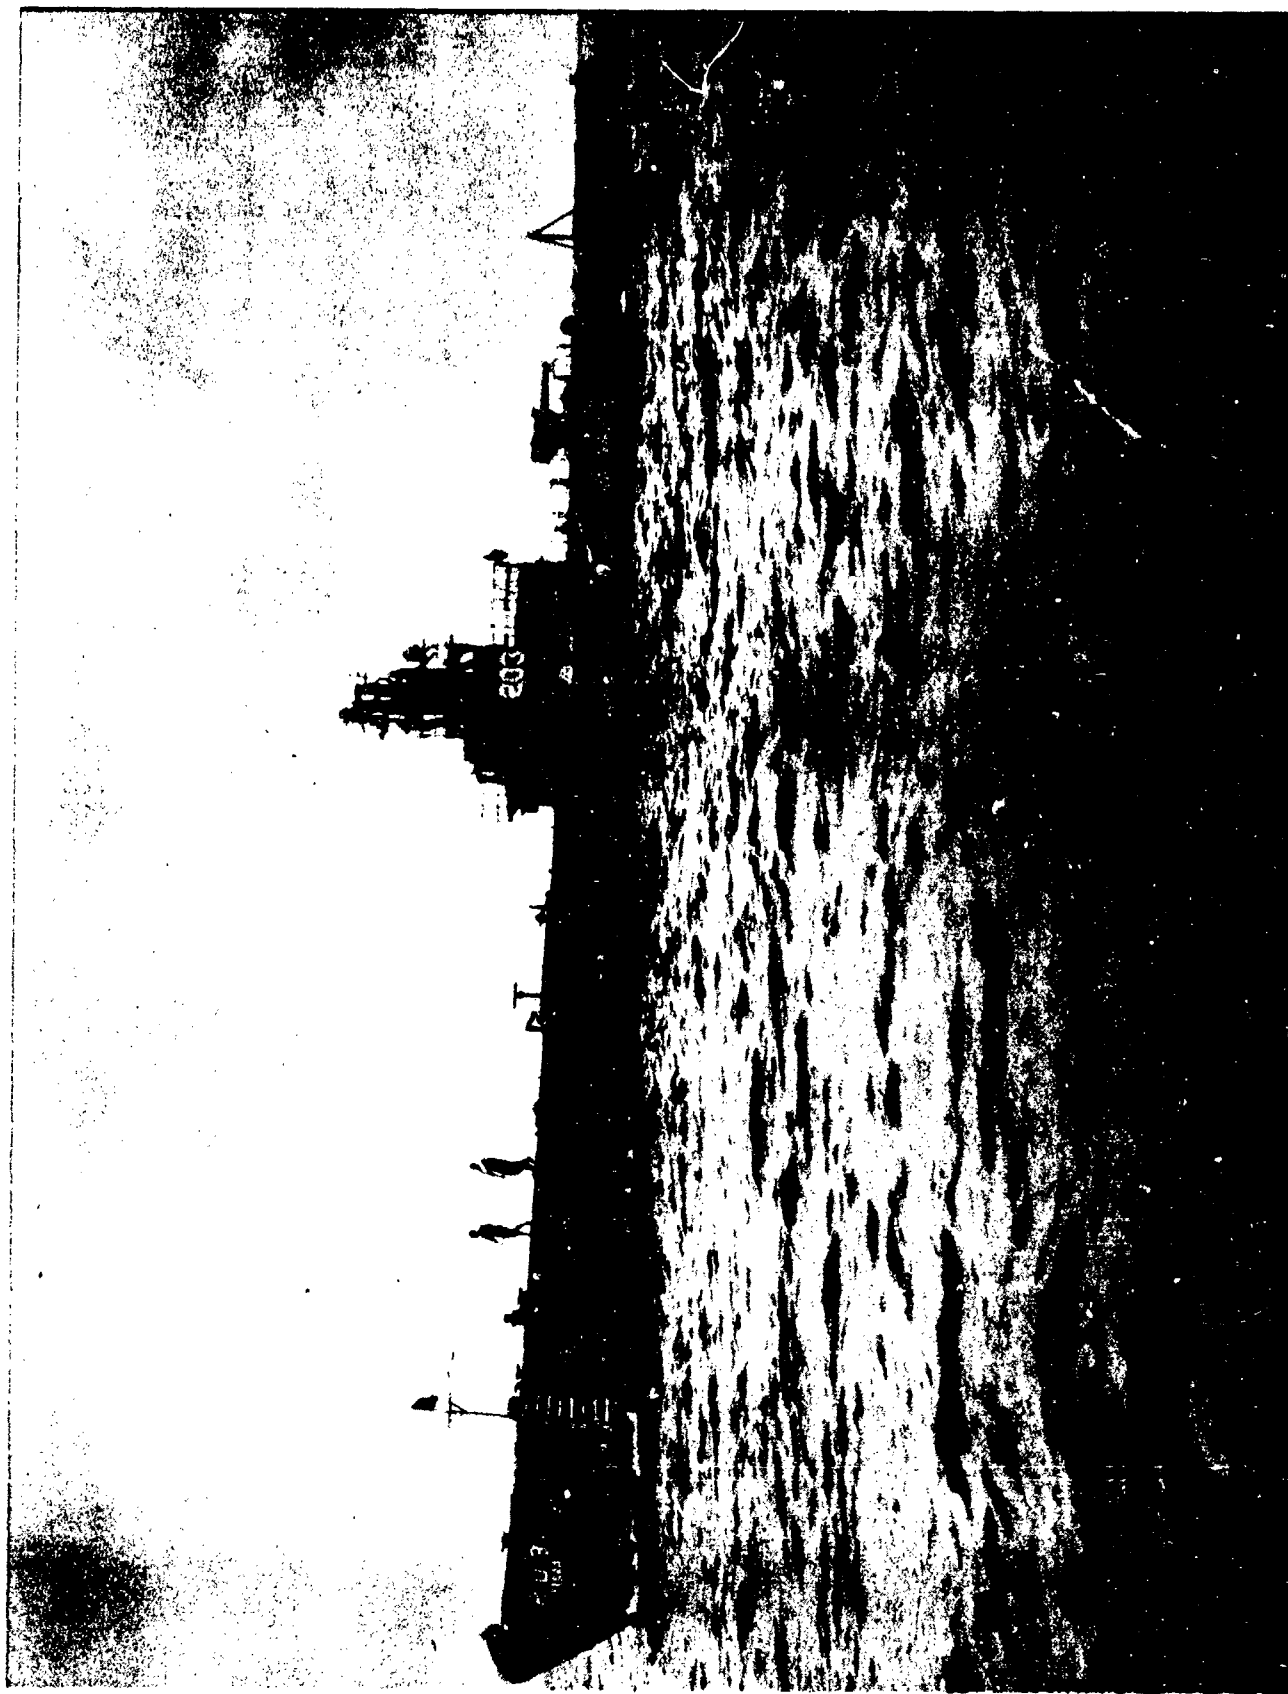
AACR-227-92-45 - General view from port bow.
