BUREAU OF SHIPS GROUP TECHNICAL INSPECTION REPORT

U.S.S. BUTTE (APA 68)

TEST ABLE

OPERATION CROSSROADS

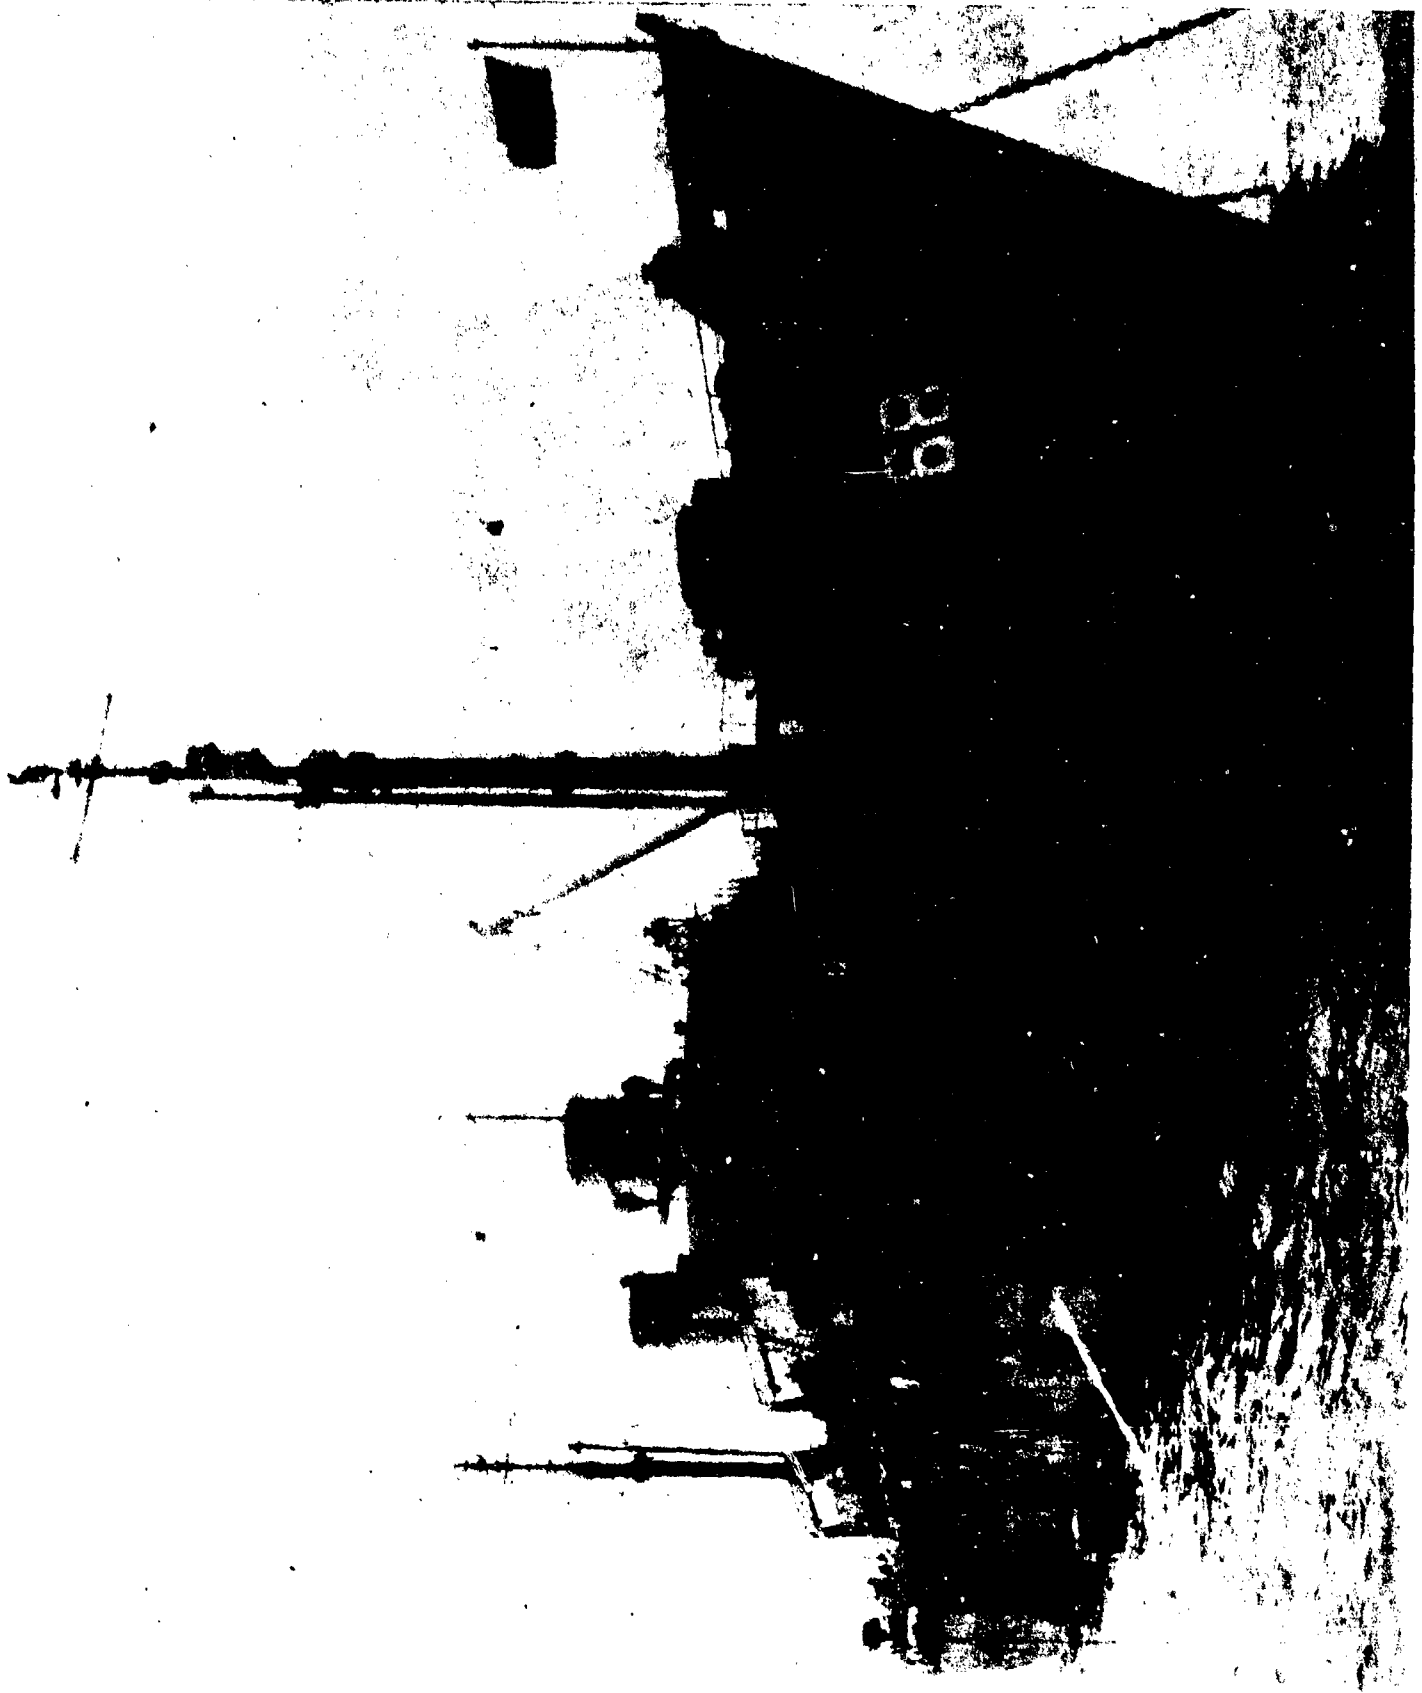
AA-CR-227-49-131. View from off starboard bow after Test A.

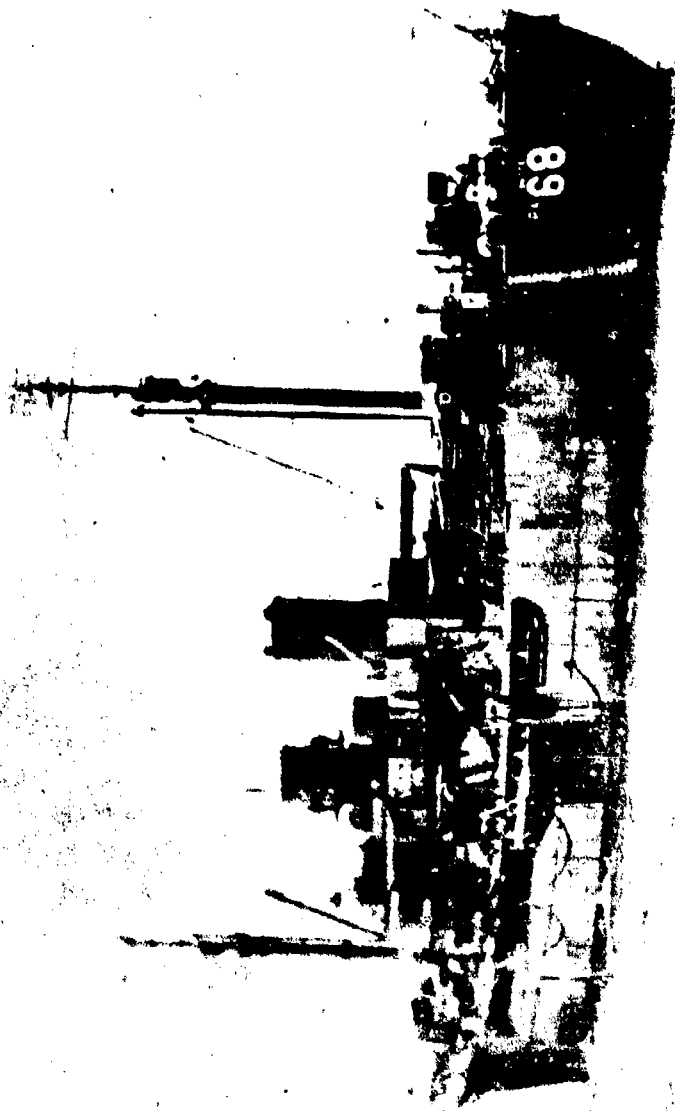
AA-CR-227-87-74. View from off port quarter after Test A.

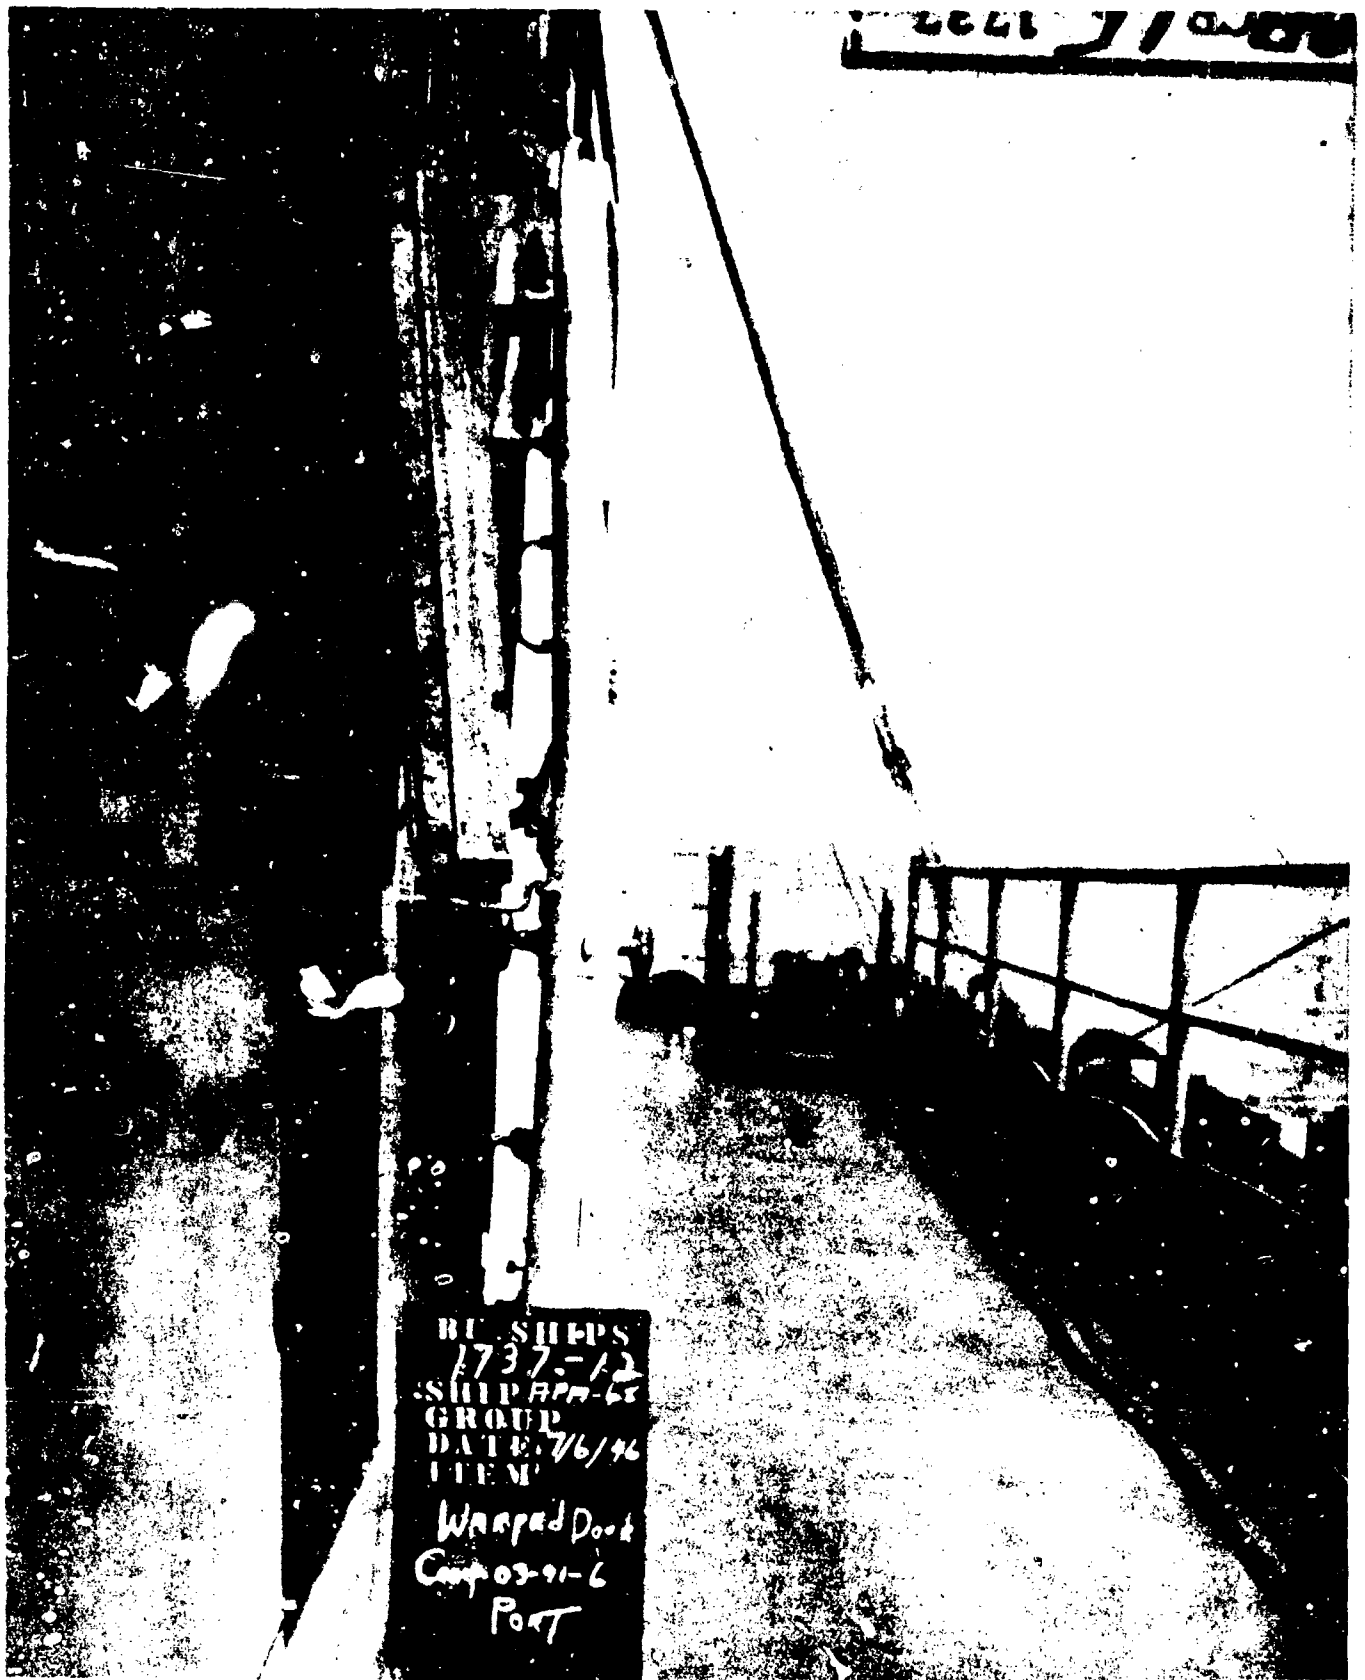
AA-CR-65-1737-12. Dished door 03-41-6.

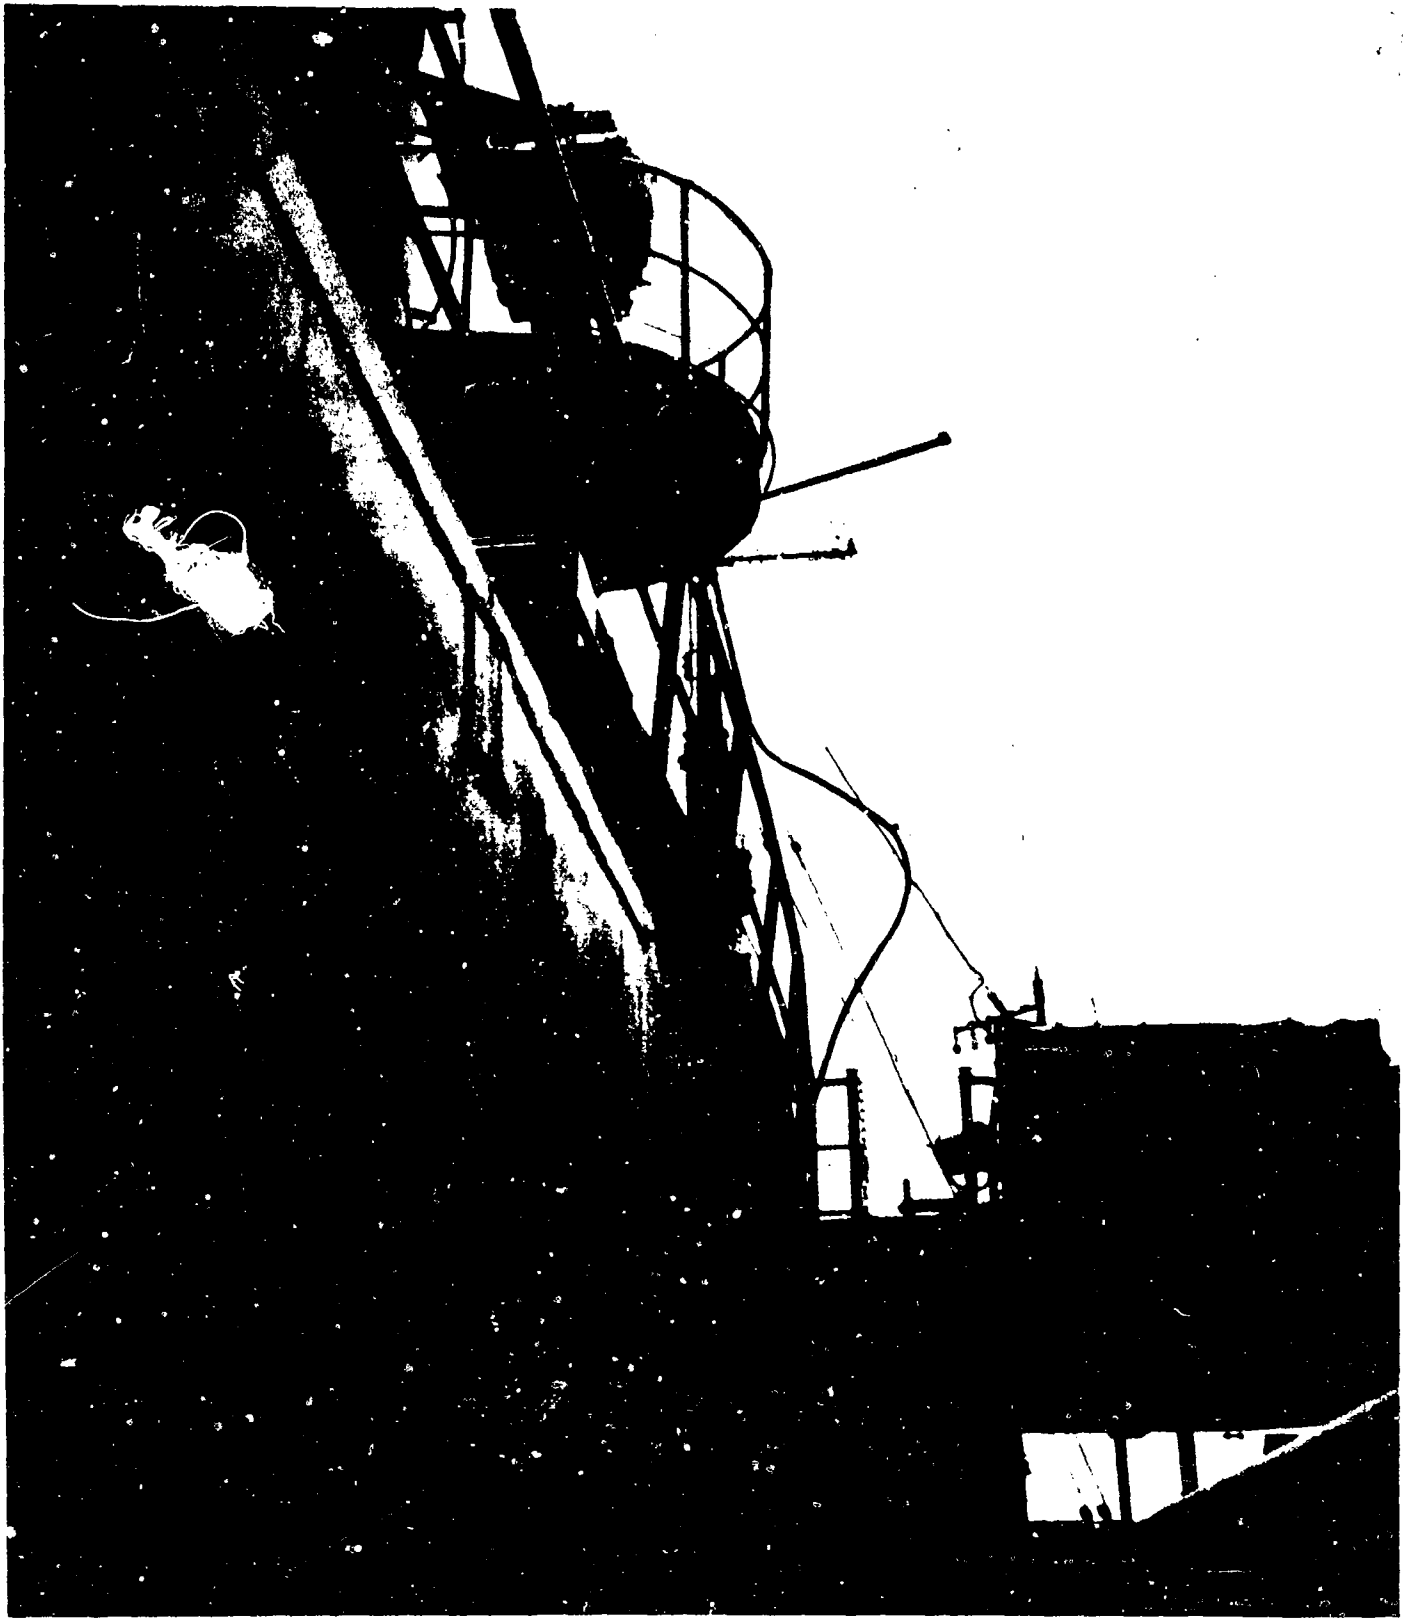
The port flag bag is dished on the outboard and after sides. The starboard flag bag is dished on the inboard side and the welded connection to the signal bridge is cracked. The adjacent railing is bent outboard and the canvas wind screen is torn off. The pipe to which the bottom of the screen was secured was torn loose at the connection to the bulkhead and was bent. (Photographs 1739-9, page 46 and 2103-5, page 47).

Damage mentioned under (a) was caused by blast.

AA-CR-88-2103-5. Twisted securing pipe for wind screen. Looking forward on navigating deck.

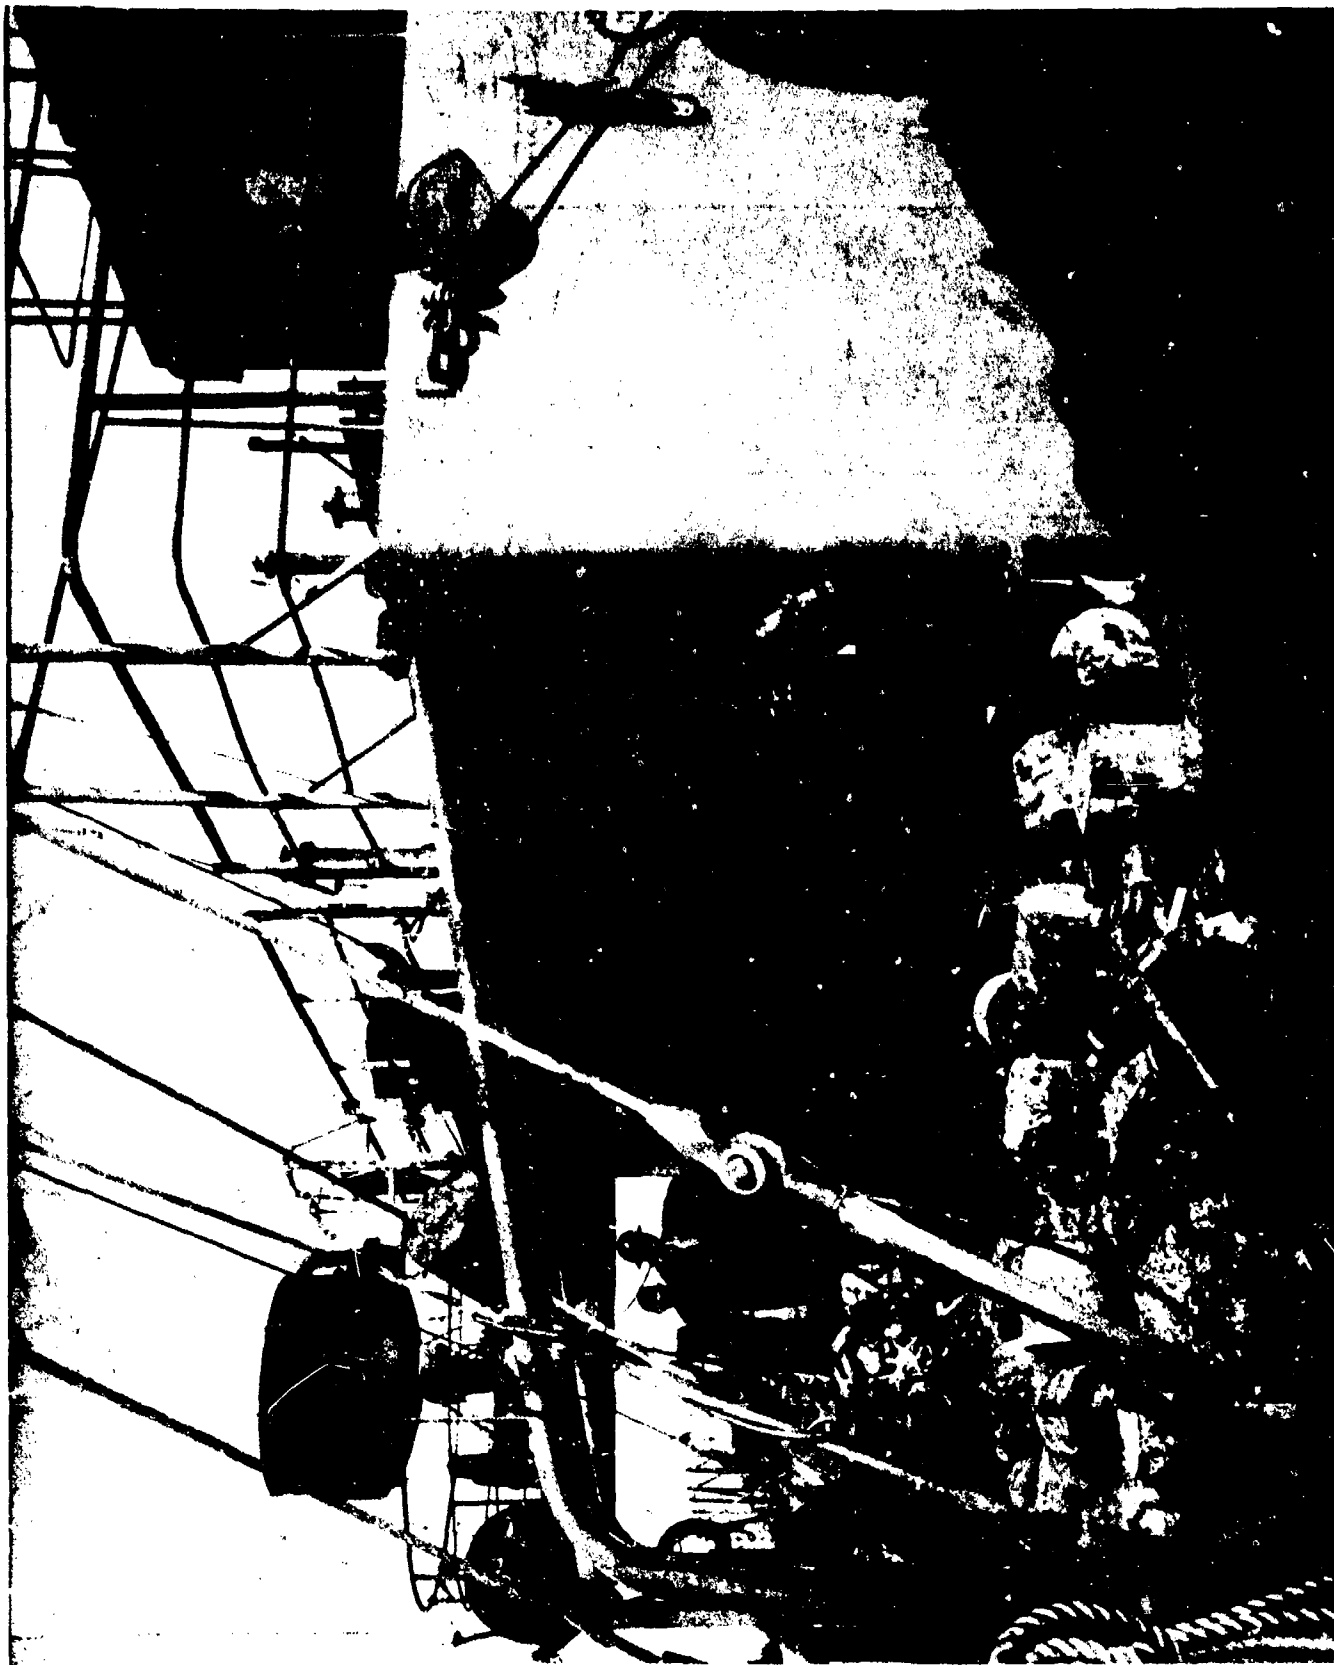
AA-CR-82-1823-6. Looking aft at fire debris on upper deck, frame 128, starboard.

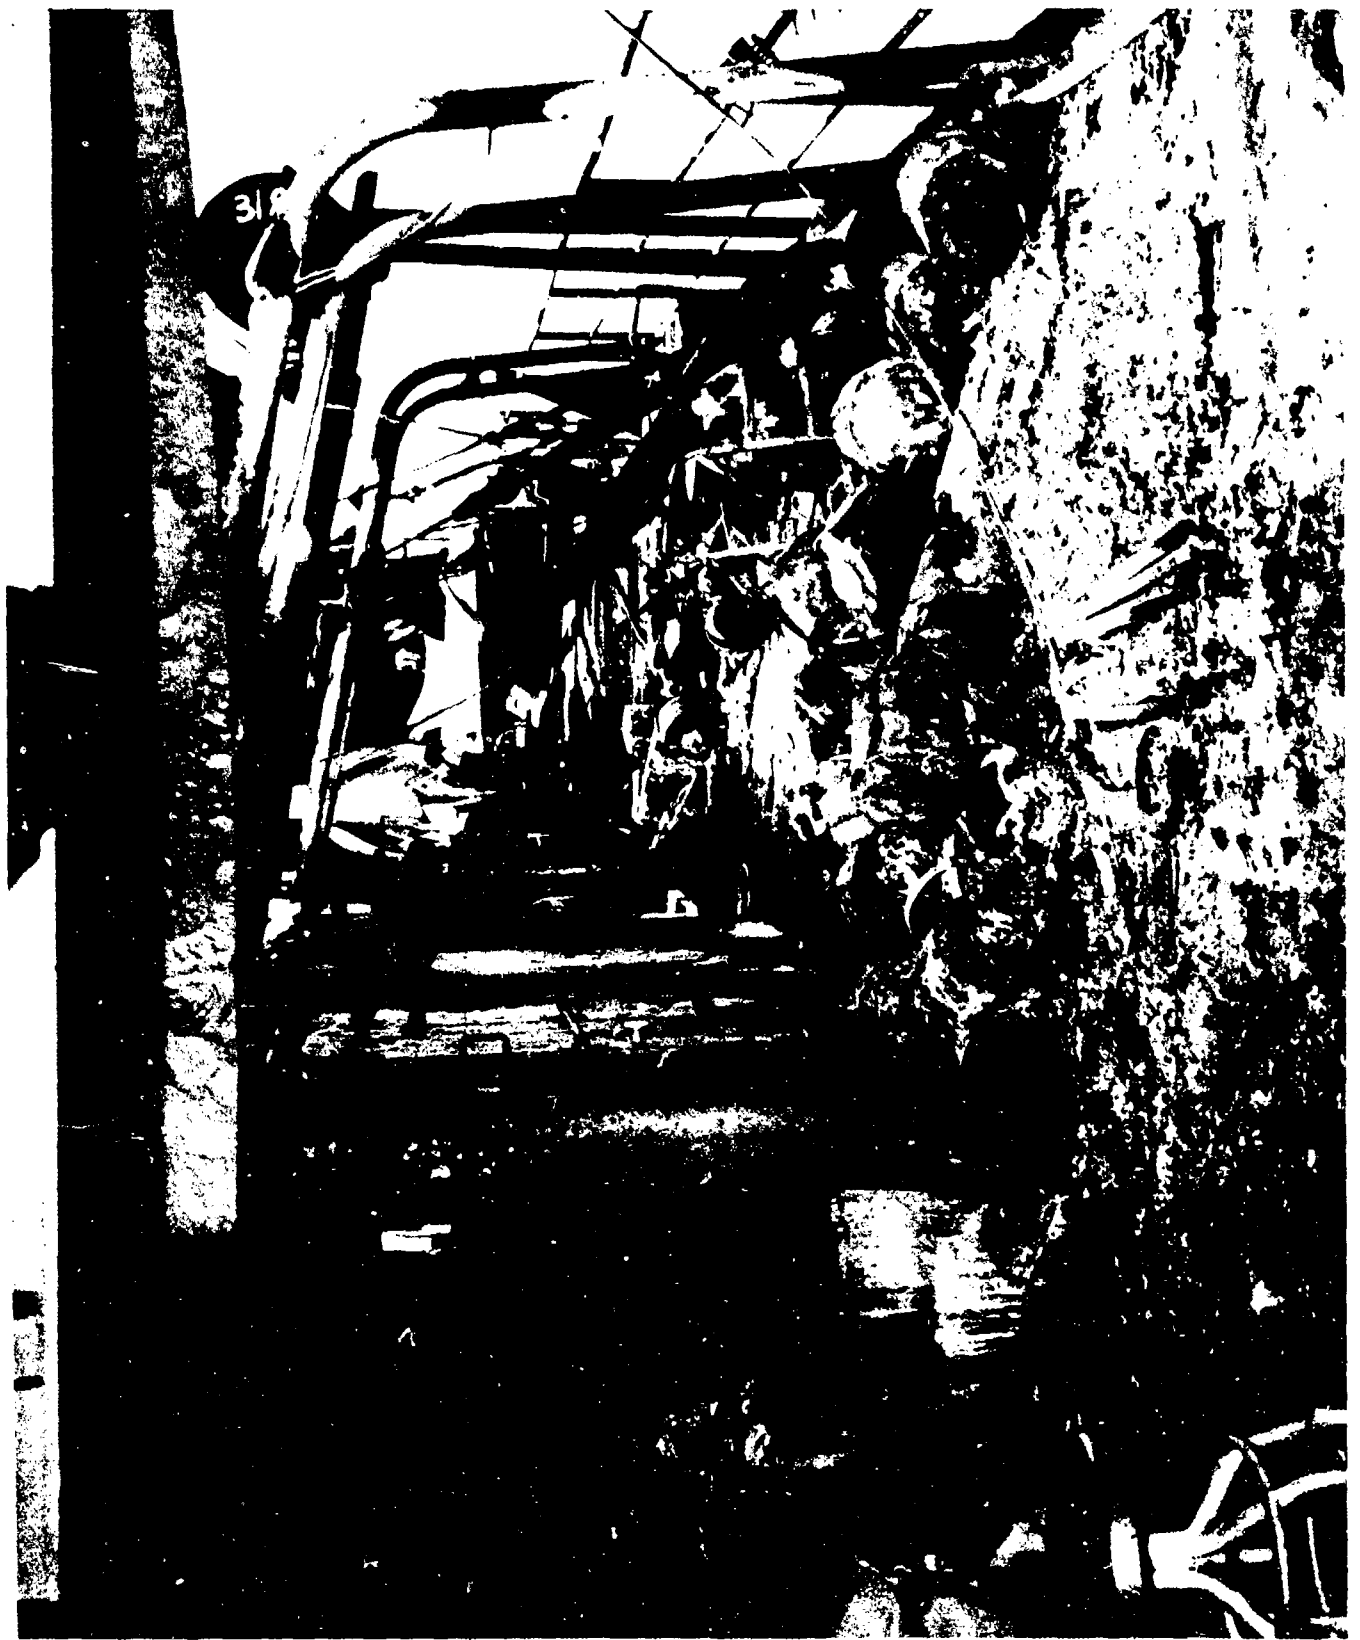
AA-CR-82-1823-5. Looking forward, fire debris on upper deck, frame 140, starboard.

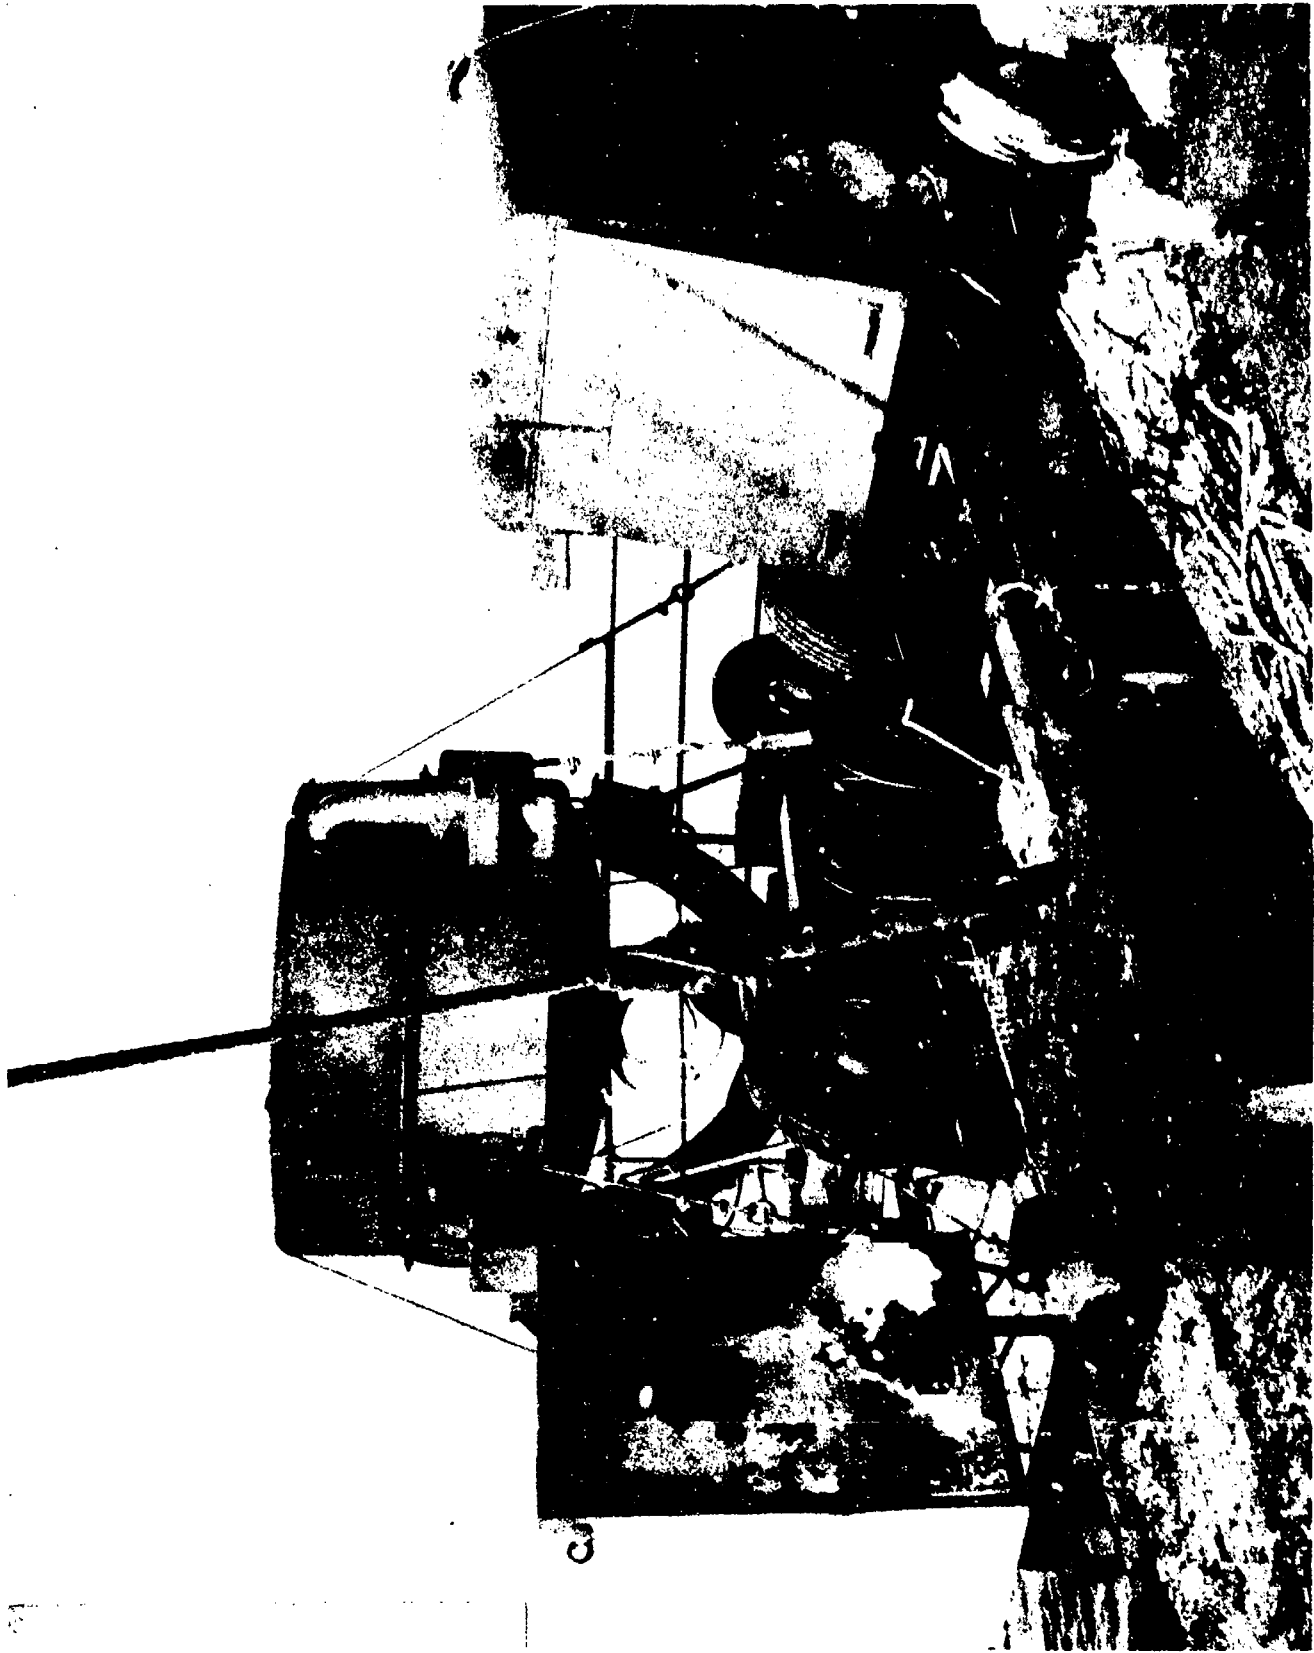
AA-CR-82-1823-3. Army gear on after deck house.

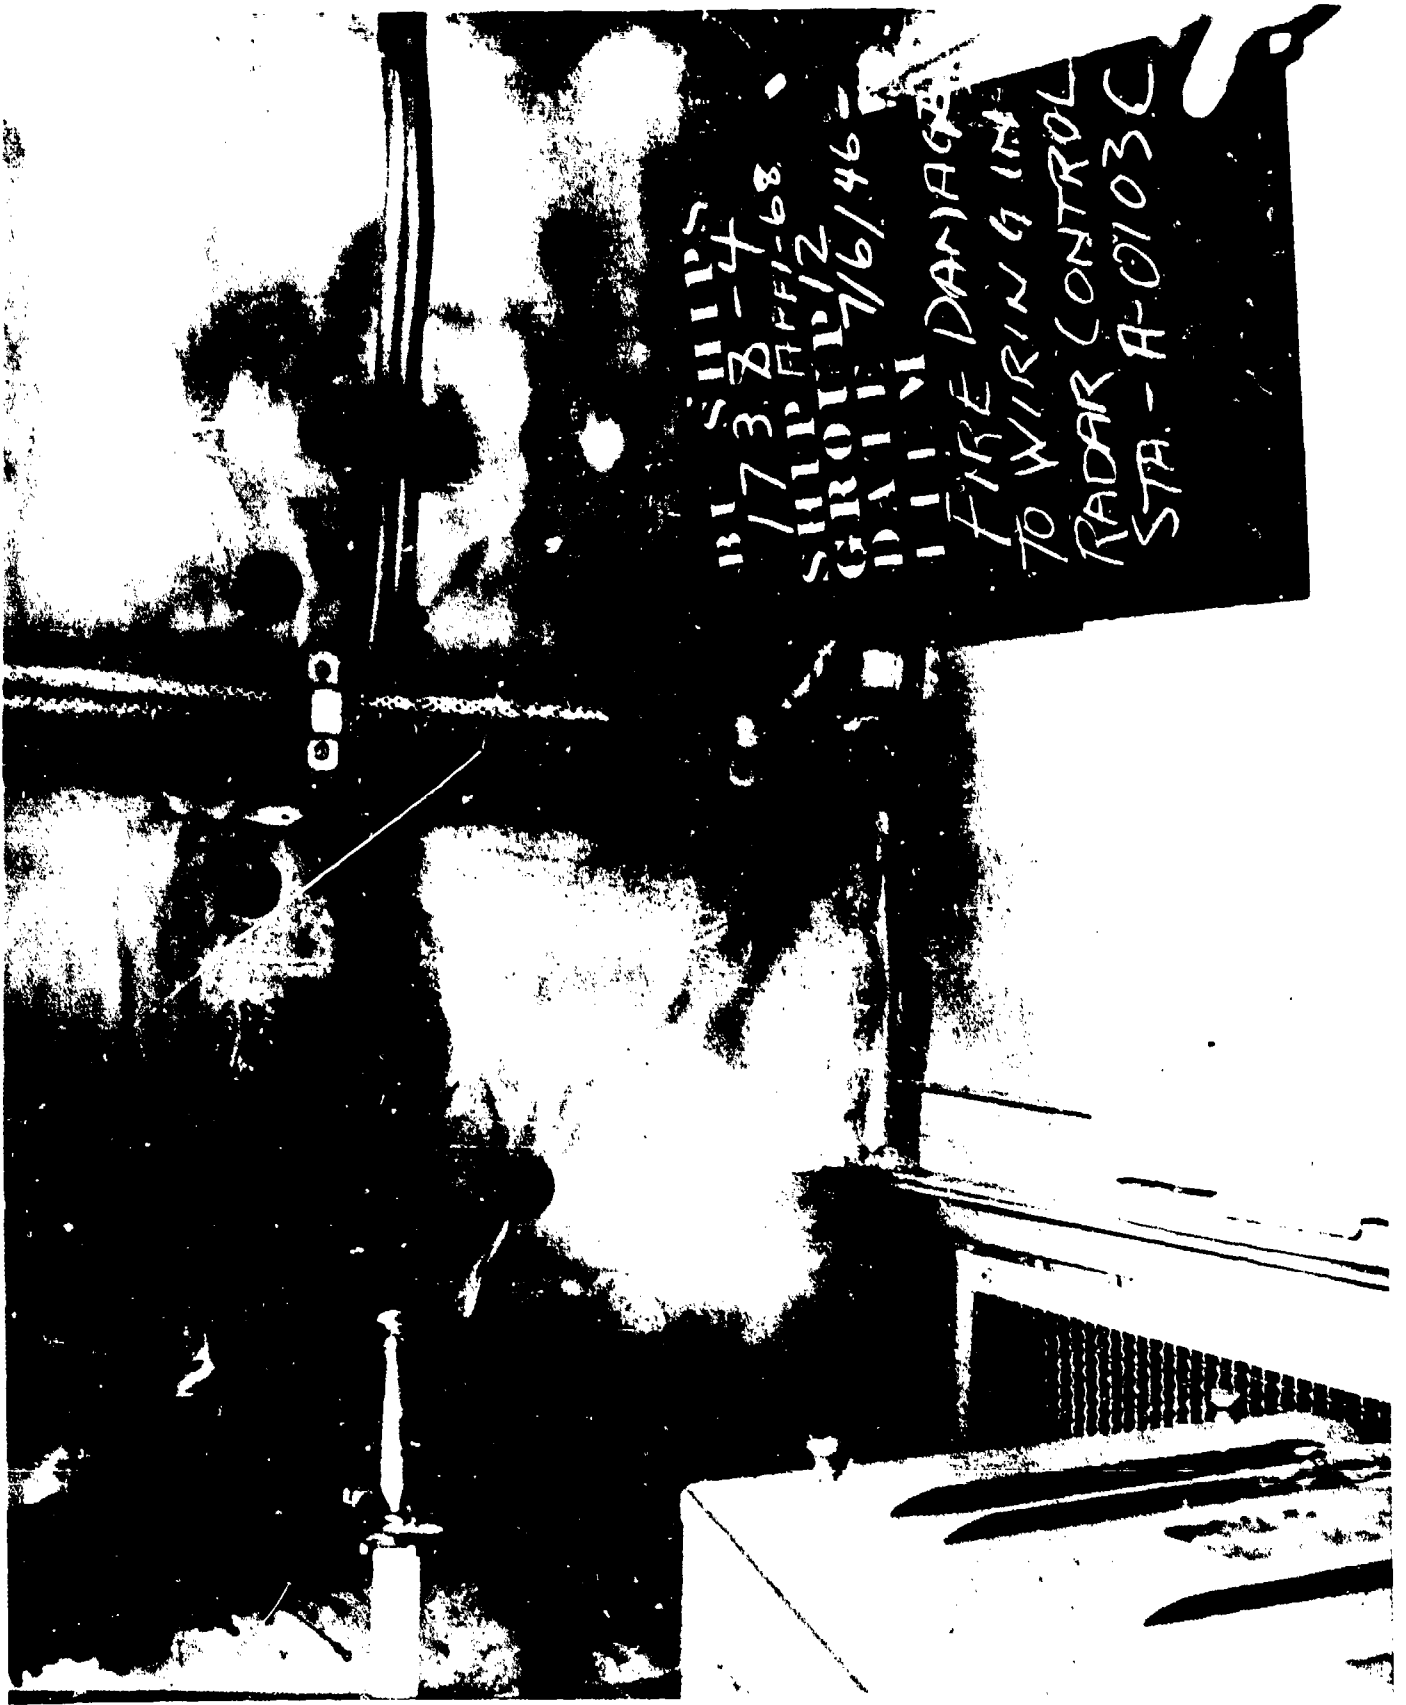
The second fire started in an 8' hawser faked out down on top of the forward deck house, frame 27-36. The fire ignited a cargo net and temperature within the 40MM R.S. Room A-101-M reached a maximum of 130 degrees F. (Photograph 1738-2, page 58). Heat was conducted through the insulation below the O2 deck and damaged the insulation on wiring in the Radar Control Station A-0103-C. (Photograph 1738-4, page 59).

AA-CR-65-1738-4. Fire damage to wiring in Radar Control Station. A-0103C.

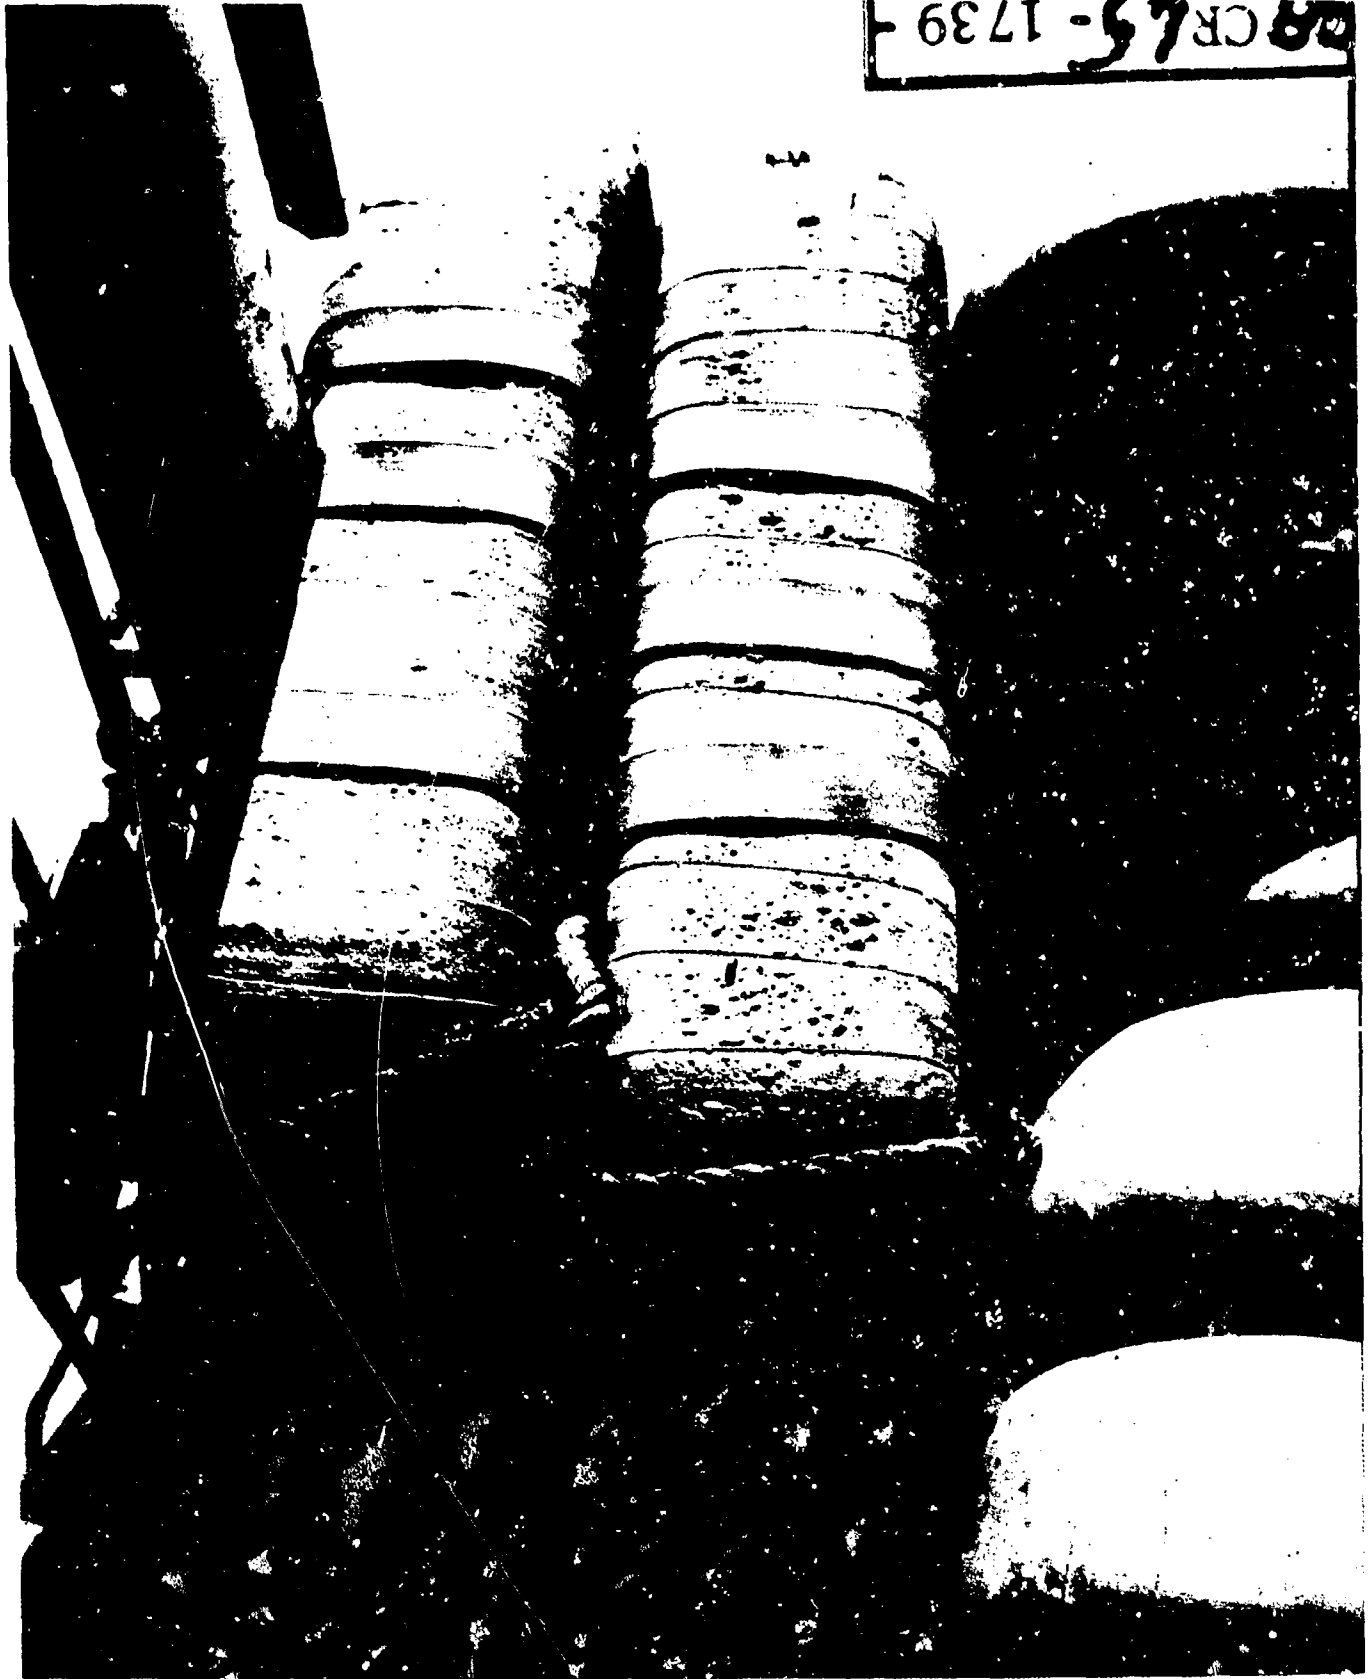
AA-CR-65-1739-8

Blistering and scorching of paint is peculiarly localized. A good deal of localization can be attributed to older paint or rust and/or waterstained paint. (Photographs 1739-1, page 67, 1739-2, page 68, and 1739-8, page 69). Relatively fresh paint seems to be fairly resistant to scorching and blistering. Baked alkyd paint as typified by the coating on U.S. Army test equipment has practically no or very slight scorching discernable. Painted wood or canvas showed far more blistering by radiation than did similarly placed steel surfaces. (Photograph 1739-8, page 69). Red striping paint (Toluidine-Toner) ground in Alkyd was practically vulnerable to radiation effect, having entirely burned off in three different places.

AA-CR-65-1739-8. Paint blisters on life raft covering.
