TECHNICAL INSPECTION REPORT

(6) OPERATION CROSSROADS,
U.S.S. NIAGARA (APA 87).

(8) TEST ABLE [U].

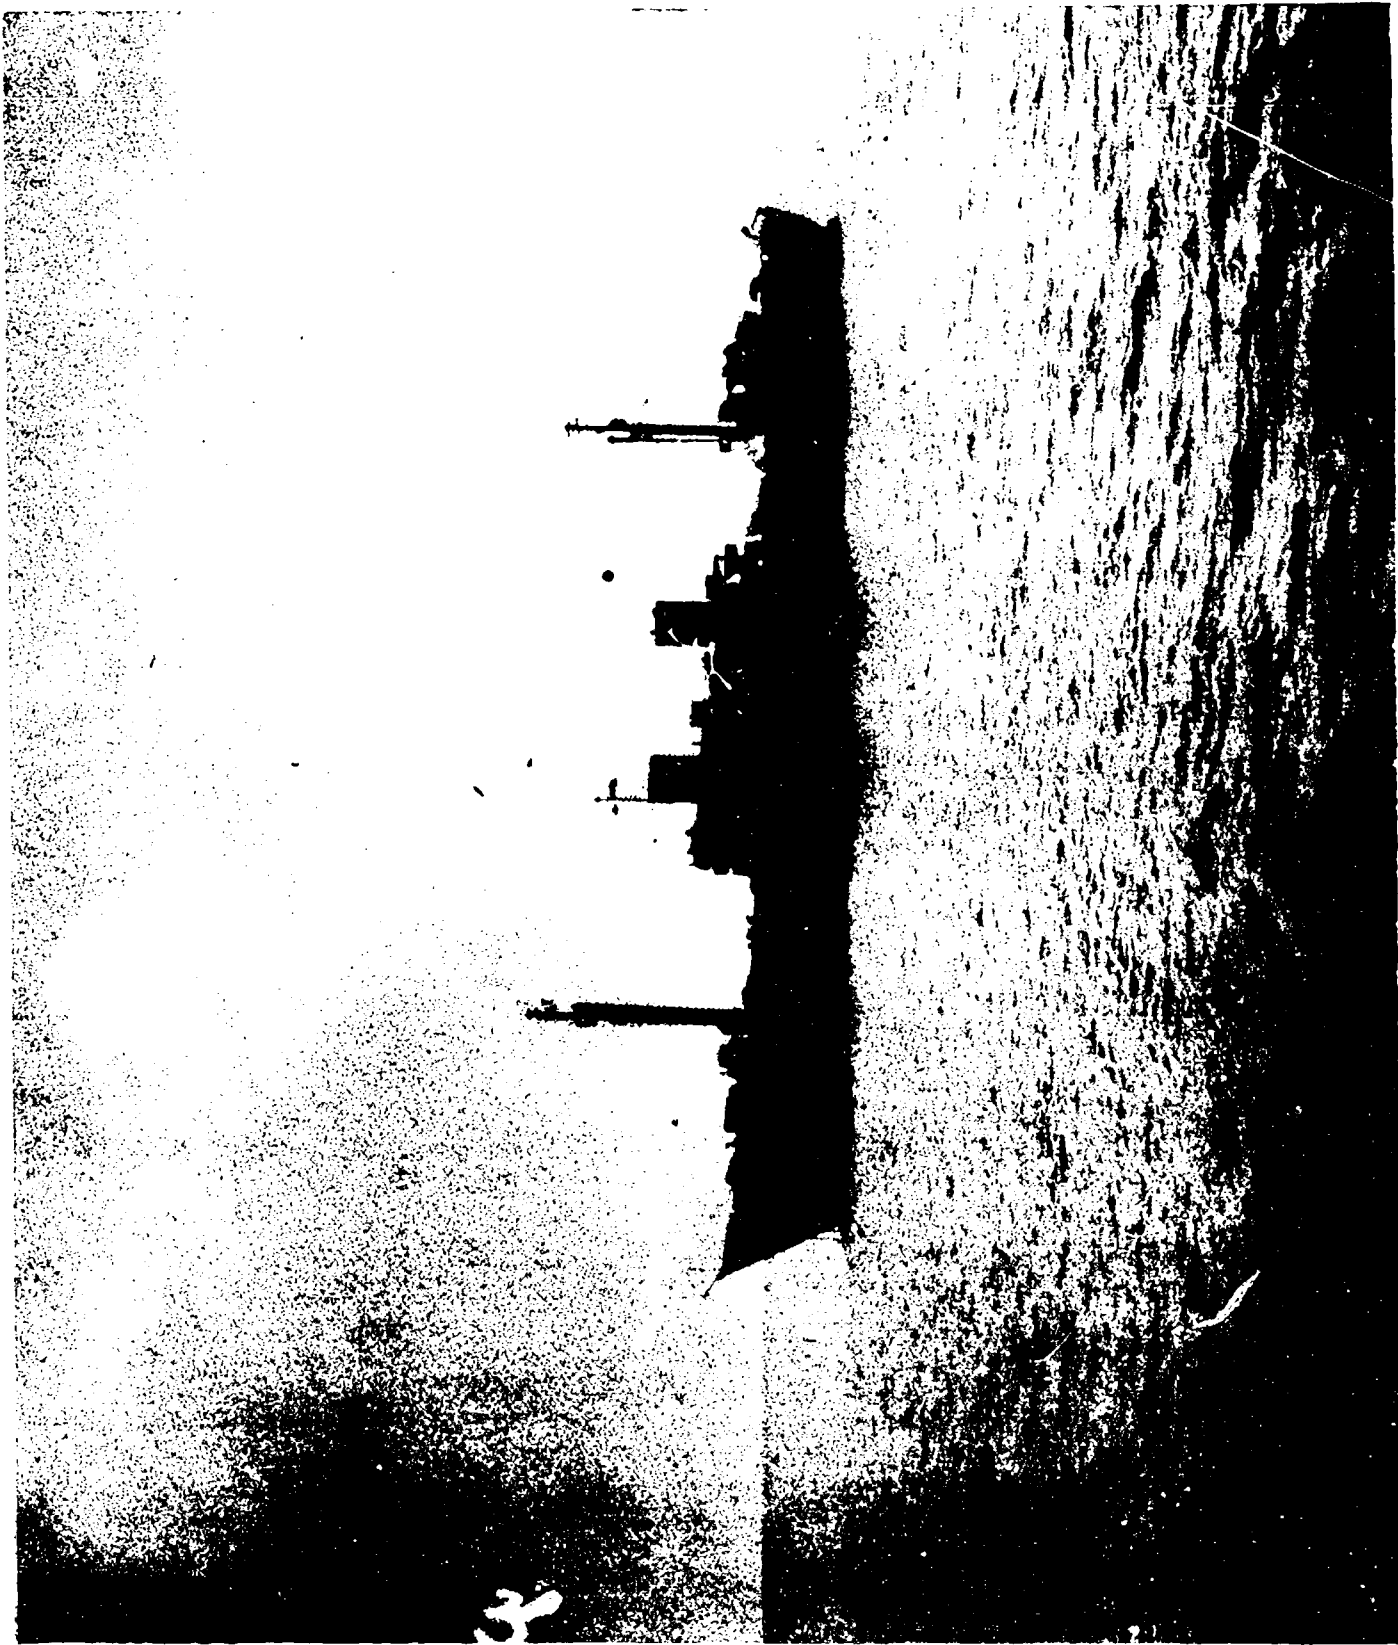
AA-CR-60-964-3. View from off port beam after Test A. Note smoke from fire at frame 113, port main deck weather passageway.
