# BUREAU OF SHIPS GROUP TECHNICAL INSPECTION REPORT

**OPERATION CROSSROADS.**  
U.S.S. LCT's 705, 816, 818, 874, 1013,  
1078, 1112, 1113

TEST ABLE

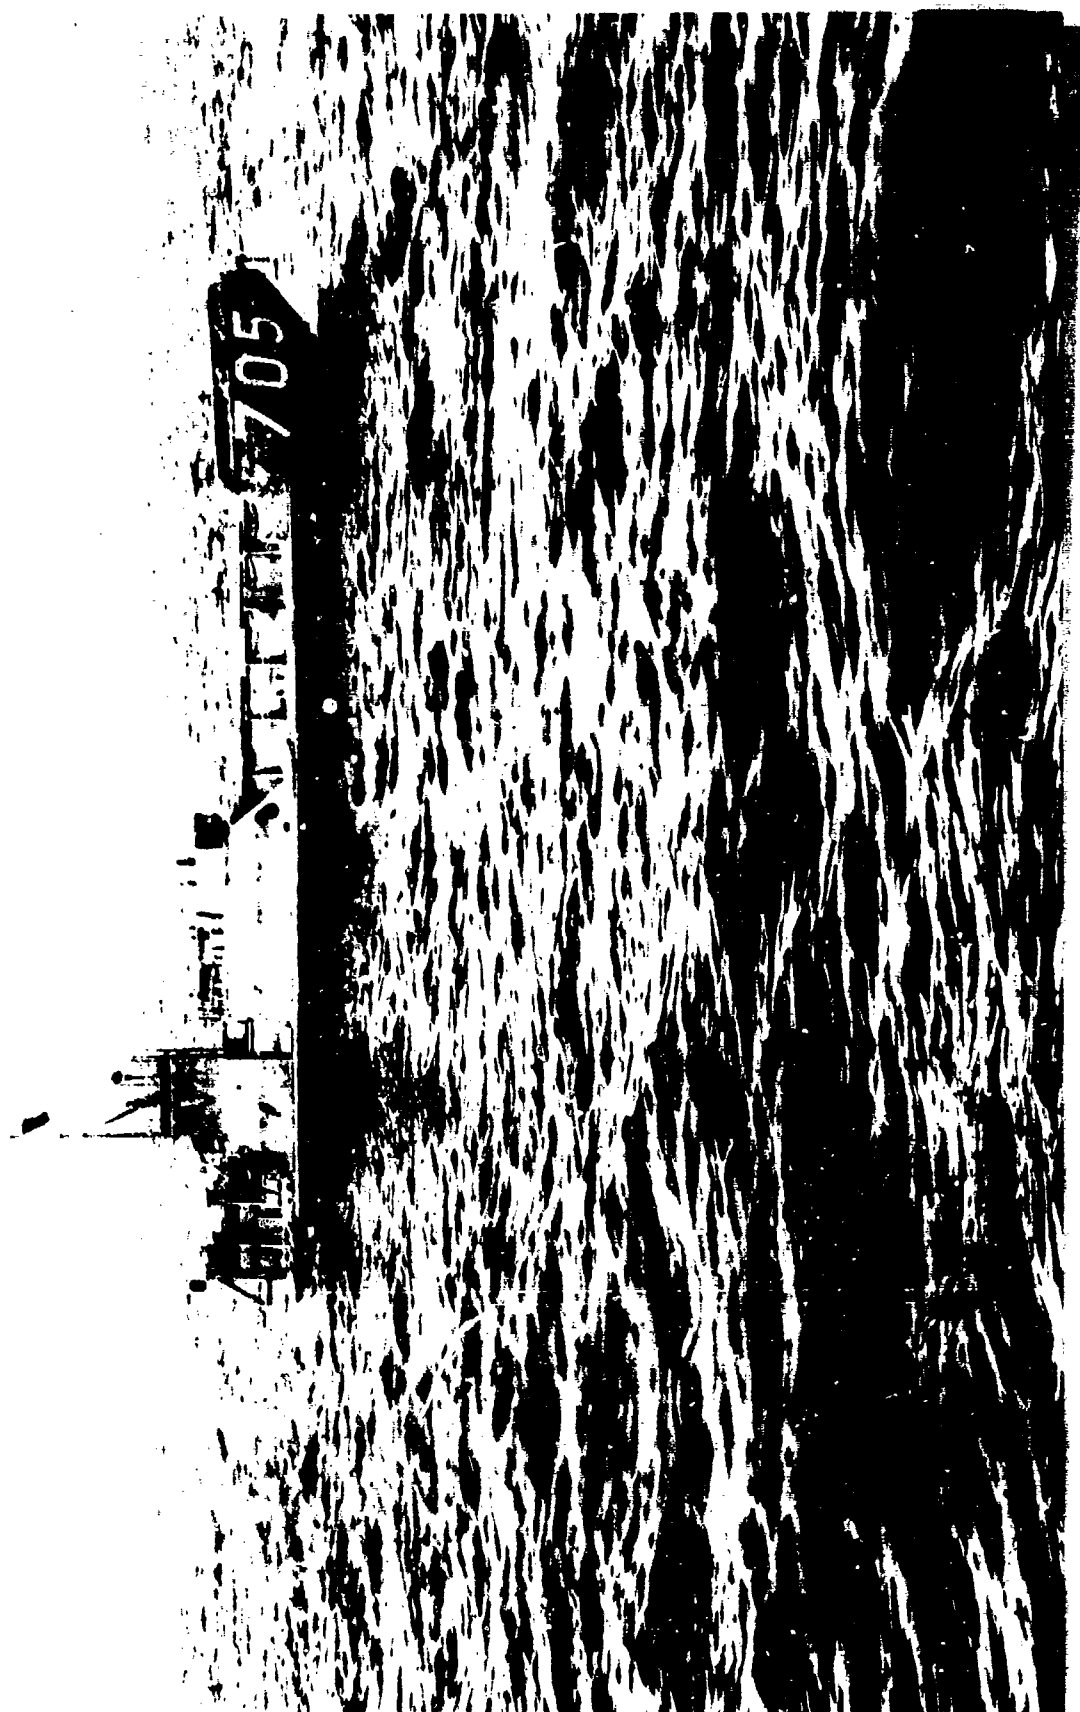
AA-CR-227-87-42. View from starboard beam after Test A.

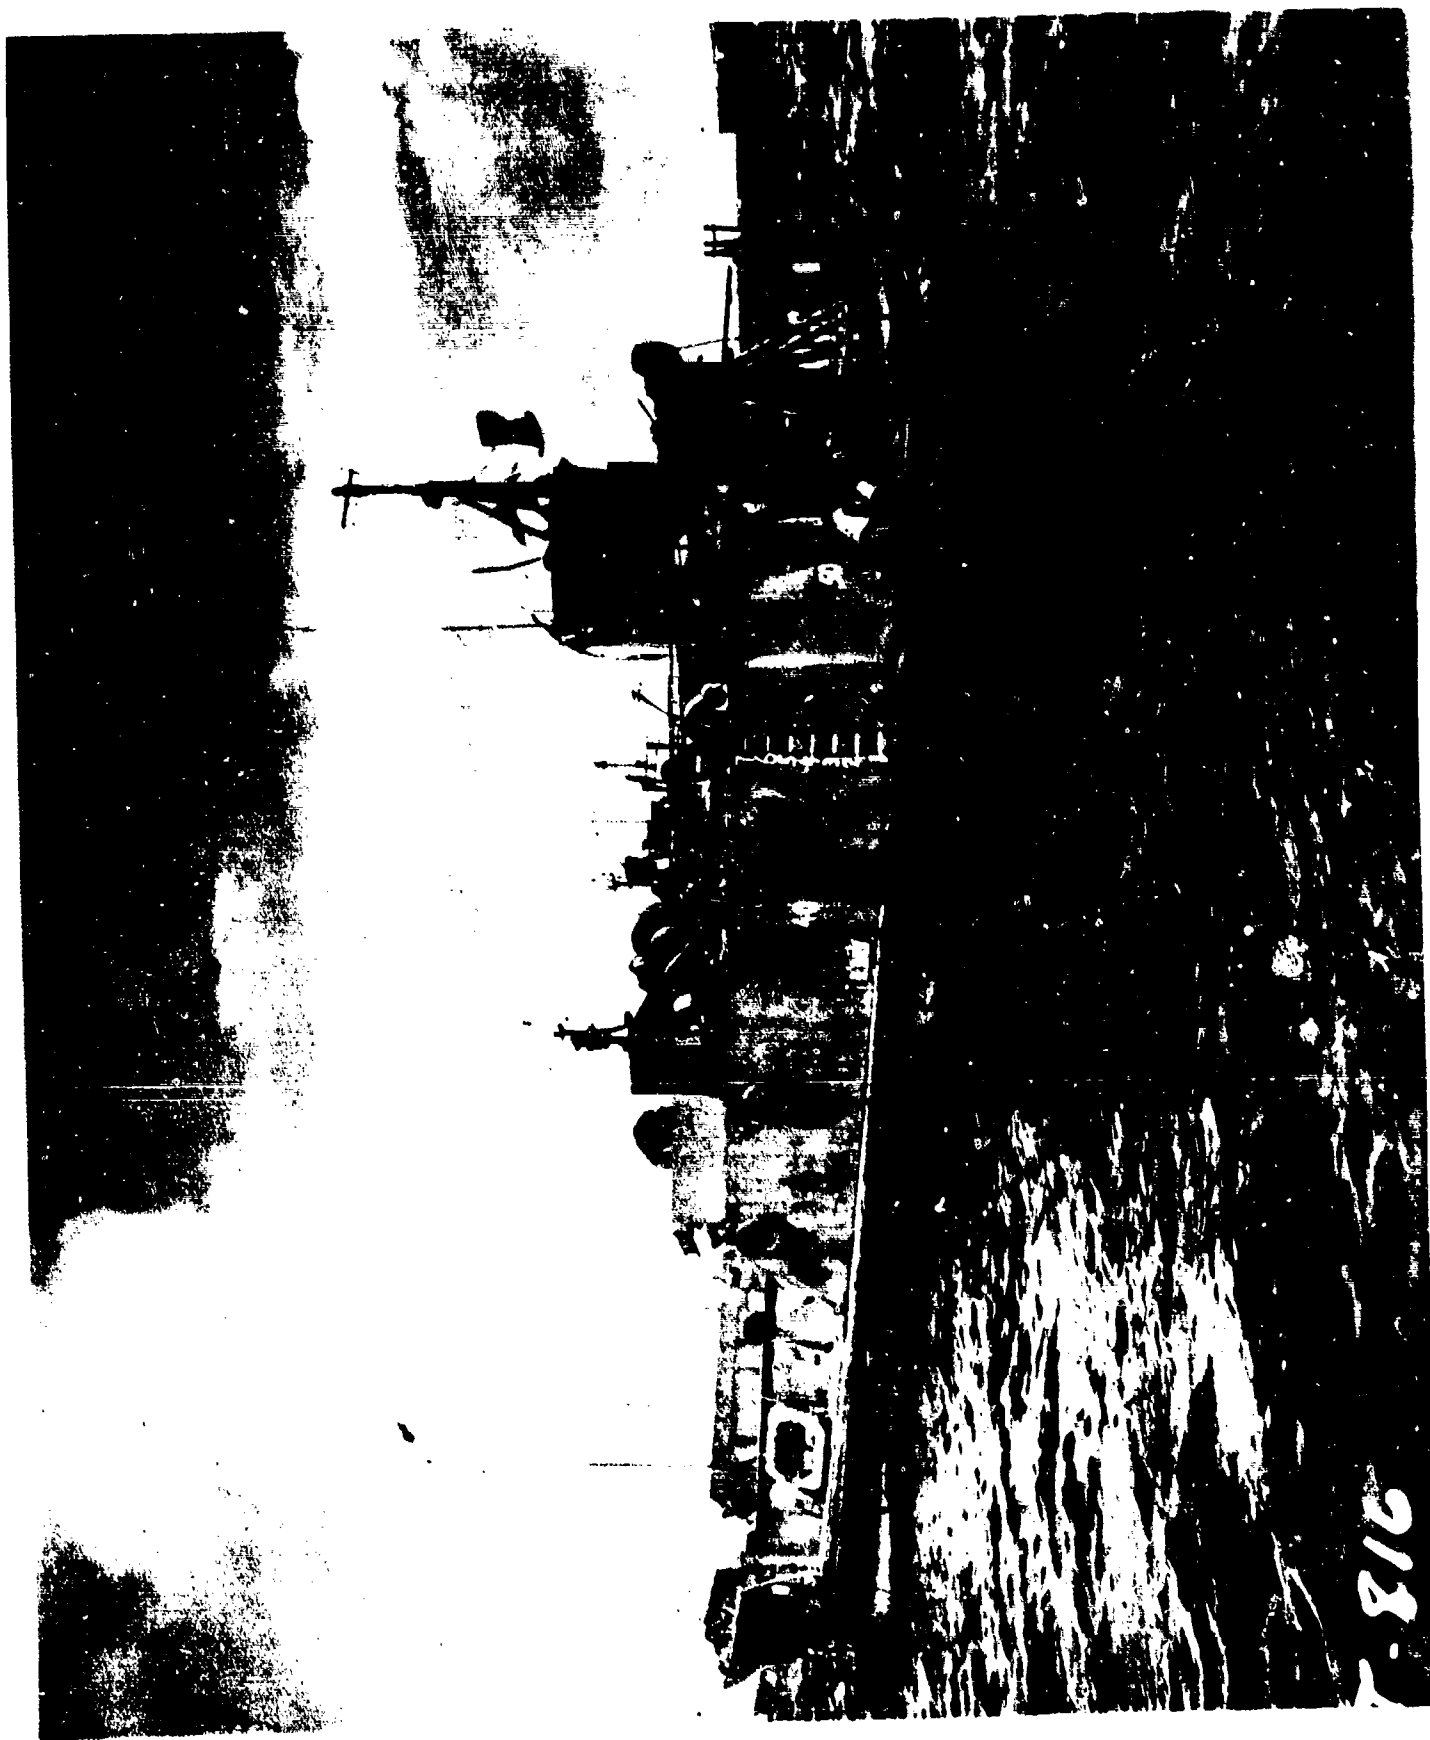
The wooden mast is nearly burned through just below the yardarm. (Photos 2889-6, 7, and 8, pages 46, 45, 44). On the after end of the house top port, a coil of rubber covered electric cable burned. The wheelhouse after bulkhead is slightly dished. The after bulkhead of the starboard deck house is dished slightly. The angle framework of the canvas covered flagbag is severely distorted. The bridge awning is collapsed. Canvas wind screens on the bridge are torn.

AA-CR-218-2889-8. View from off port quarter after Test A.

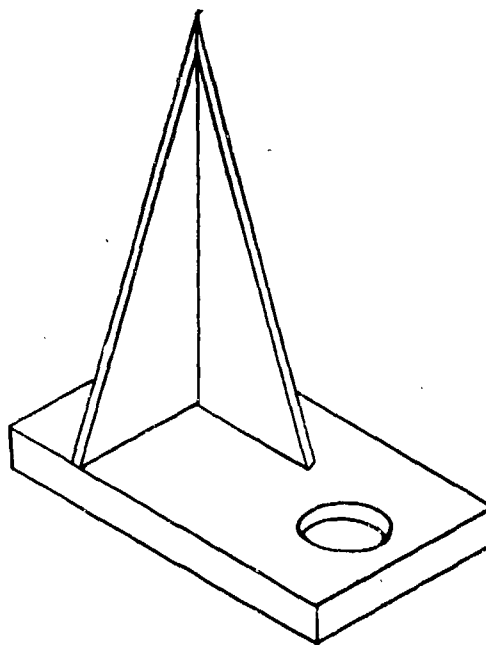
Figure 1 - "X" gage, or tapered lead angle maximum displacement gage.

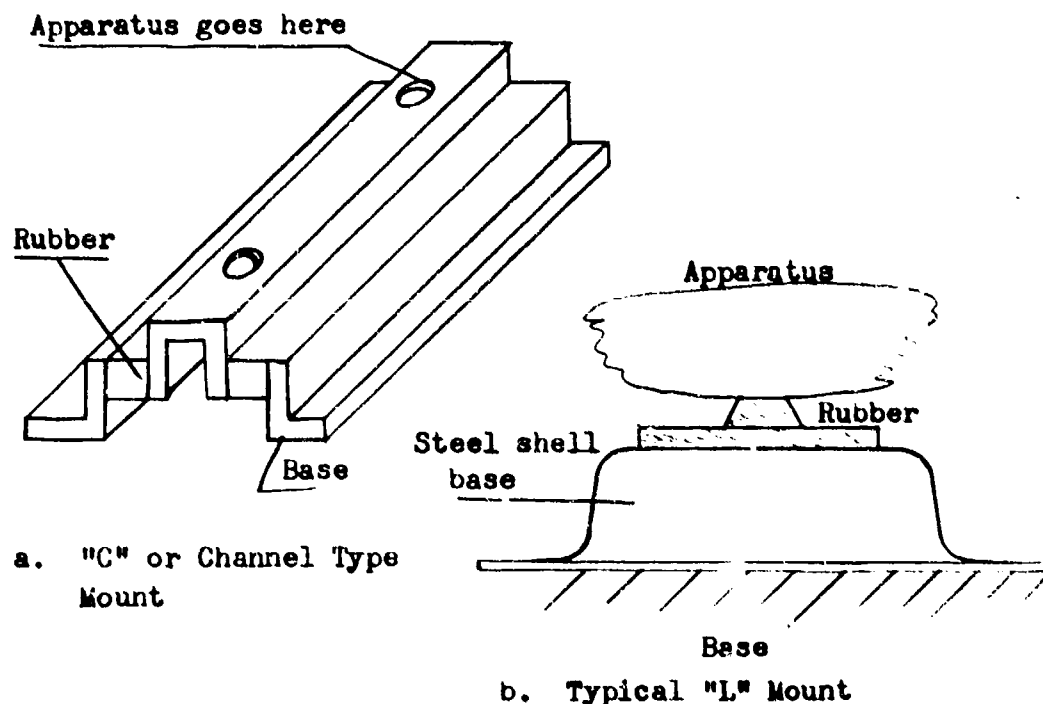
Figure 2 - Principal types of shock mounts.

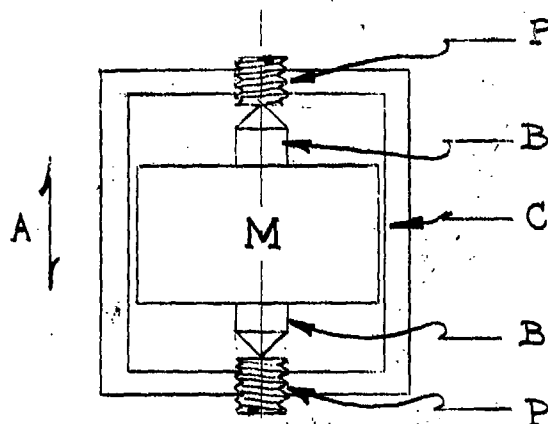
The indenter gage was designed as a peak-reading accelerometer. Figure 4 shows the essential details of such a gage. The mass  $M$  is guided by case  $C$  and rests against the hardened steel pins  $B$ . The end of  $B$  in contact with  $M$  is cut square, but the other end has a 90° conical point and just contacts the flat surface of a soft aluminum plug  $P$ .

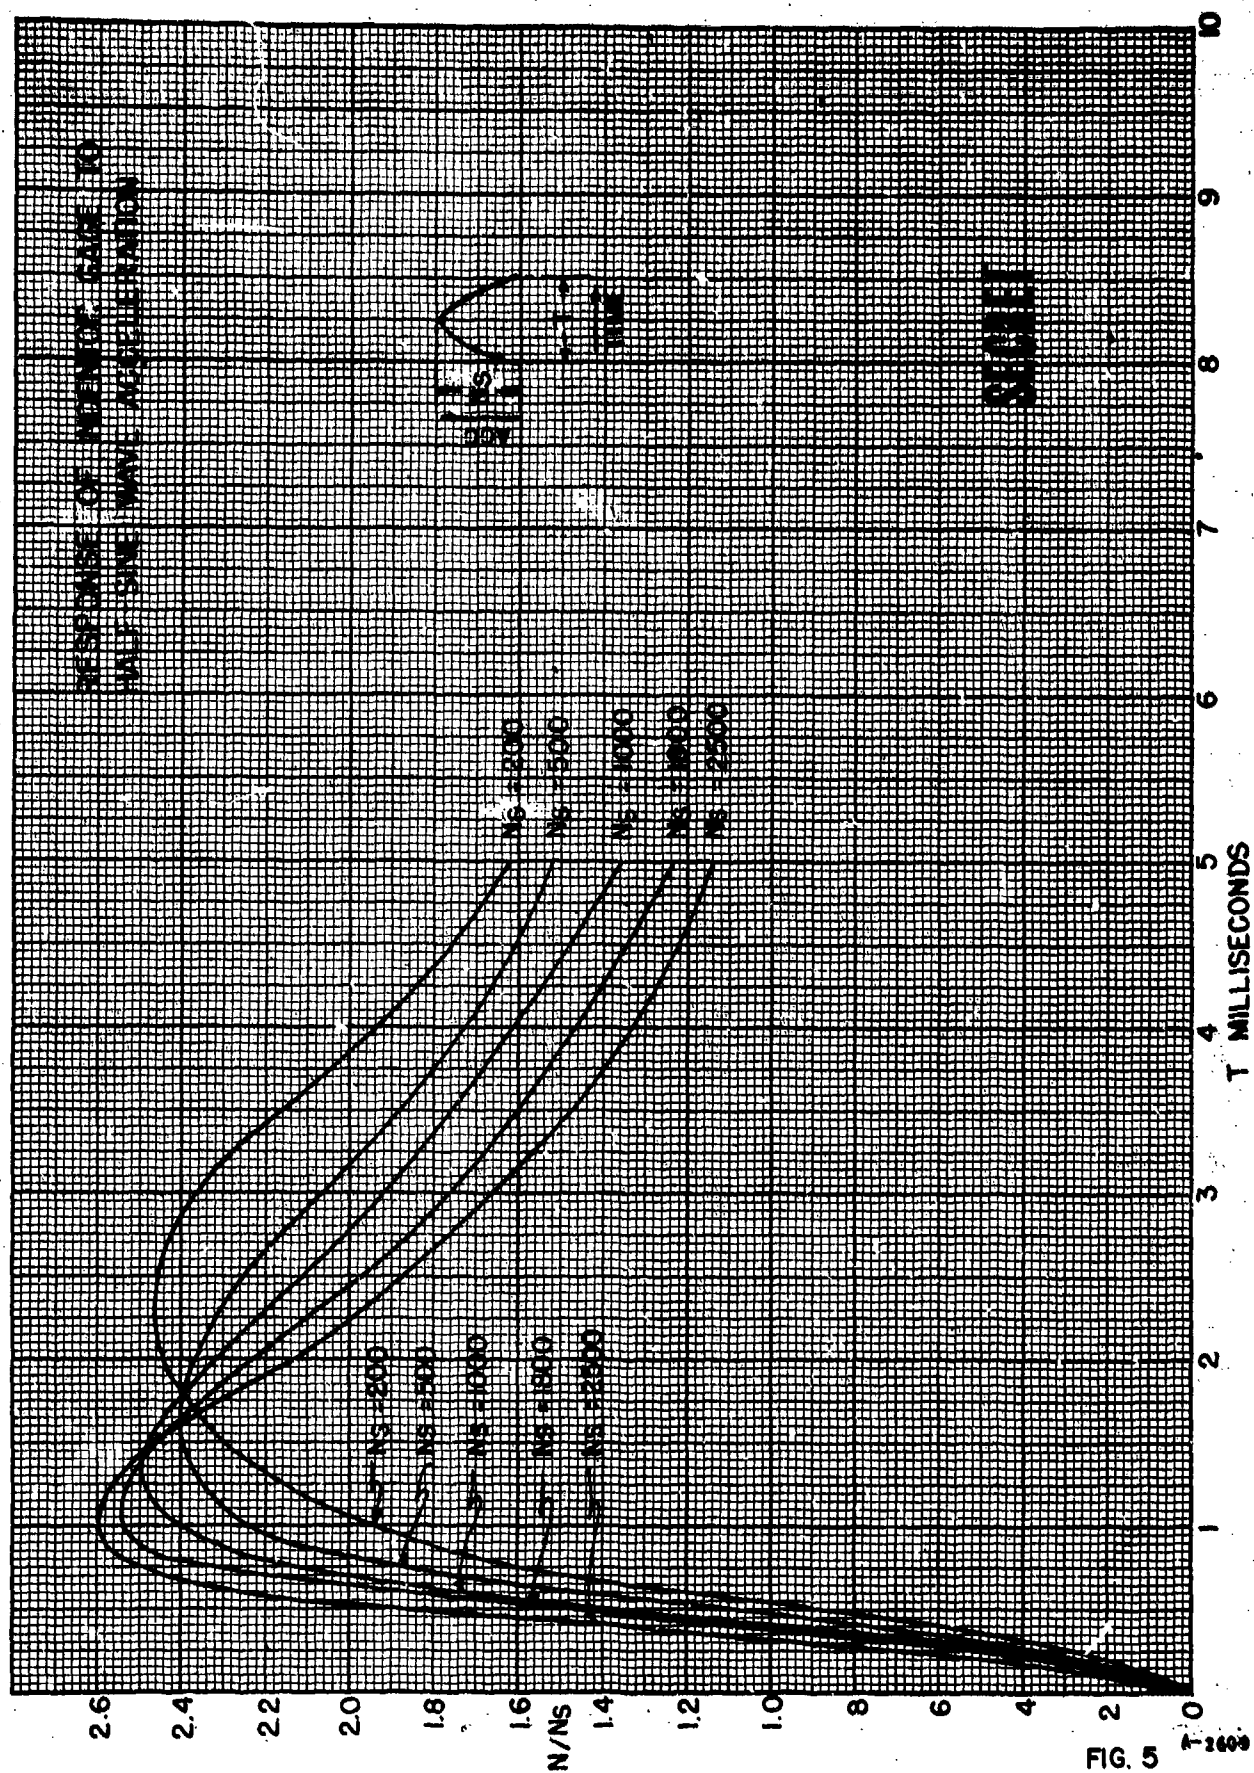
A theoretical analysis of an indenter gage with values of  $M$  and  $R$  the same as those for the gages used at Bikini has been made by Dr. Paul Symonds of NRL for the case when the gage base undergoes a half-sine wave pulse of acceleration with a peak value of  $A_p$  and a duration  $T$ . The curves resulting from this analysis are shown in Figure 5.

The gage reading is too low for  $T < 1/2$  millisecond and is about  $2-1/2$  times too high for  $T$  in the vicinity of 1-4 milliseconds. At larger values of  $T$ , the reading approaches the true value.
