BUREAU OF SHIPS GROUP  
TECHNICAL INSPECTION REPORT

(6) OPERATION CROSSROADS.  
U.S.S. PENNSYLVANIA (BB38).  
TEST BAKER [u]. (8)

OPERATION CROSSROADS

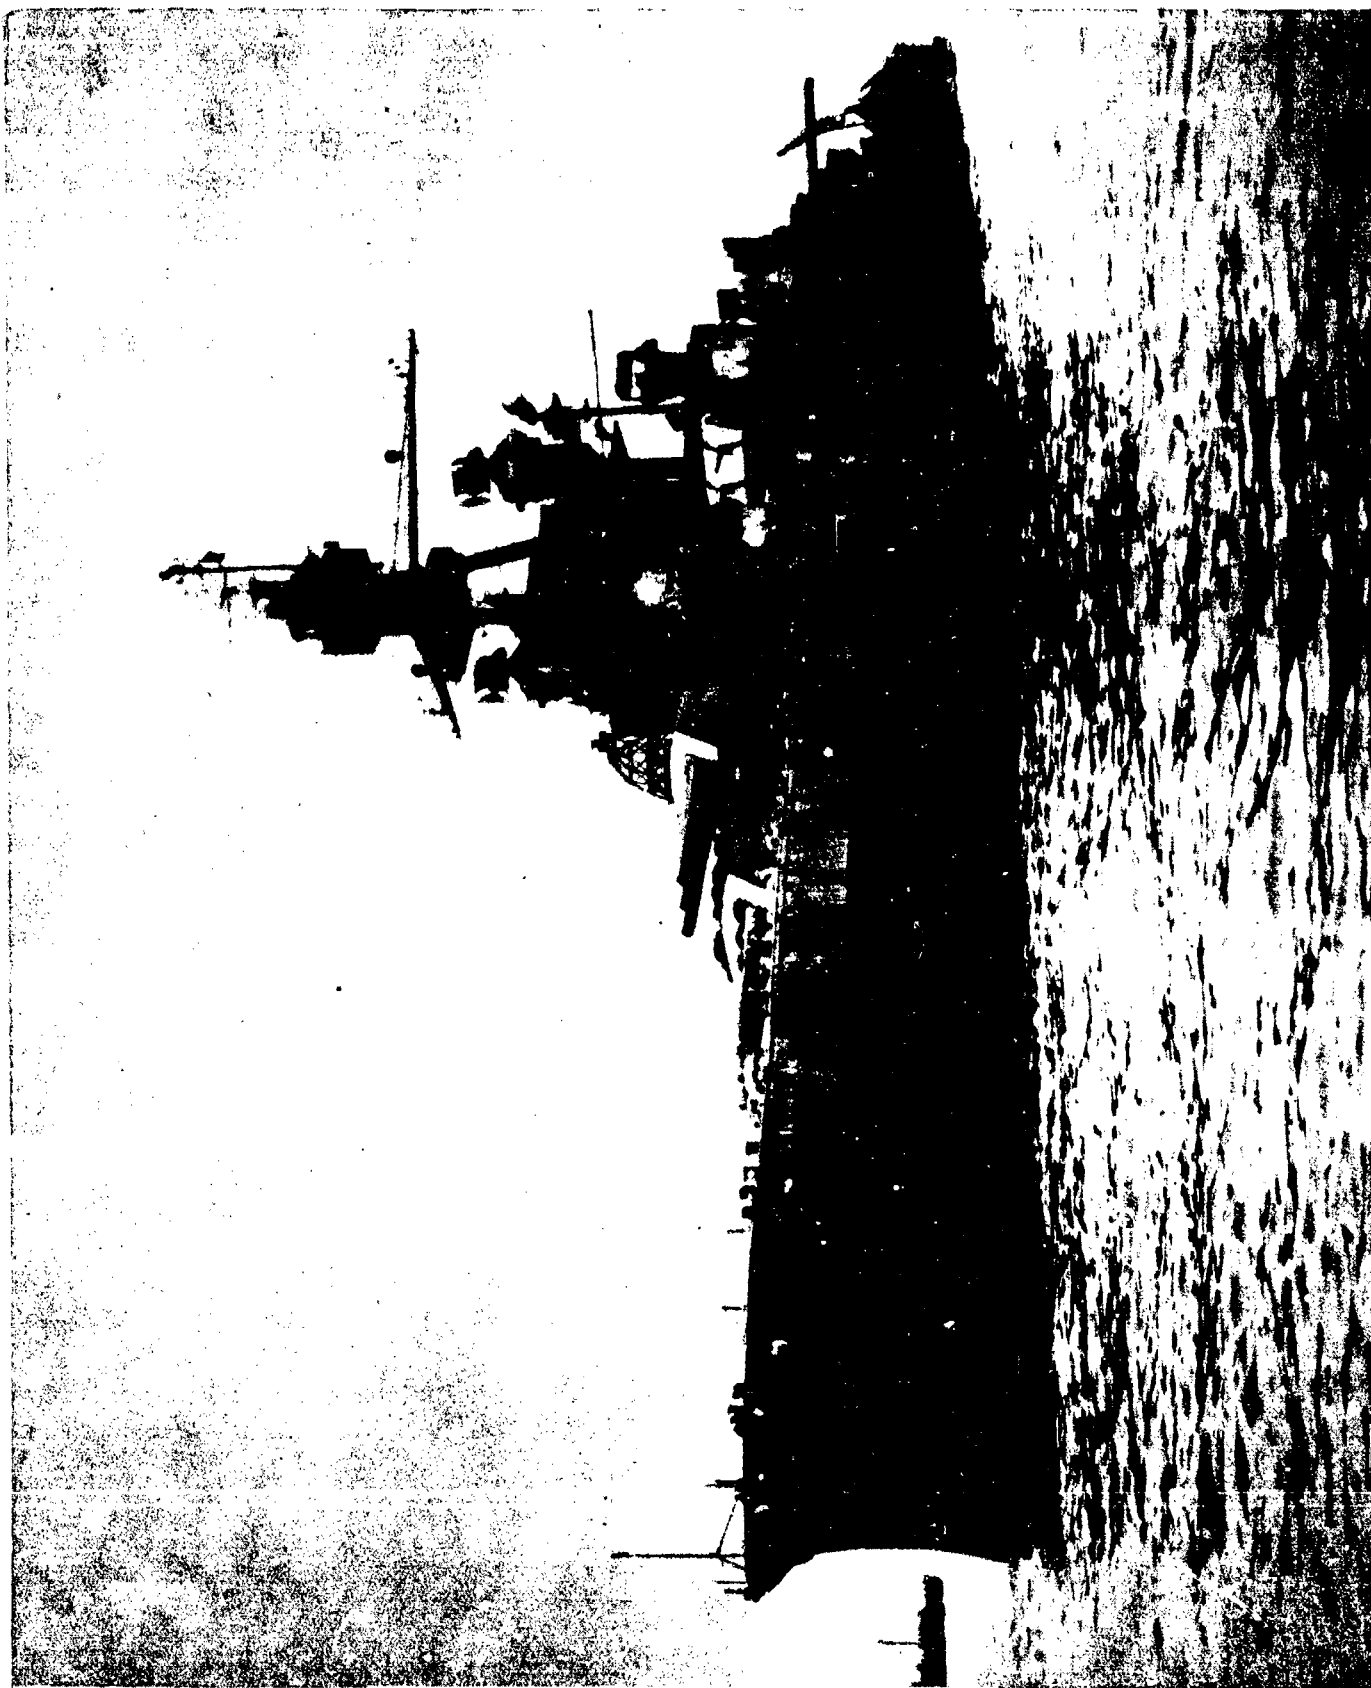
AB-CR-227-289-36. View from off port bow after Test B.

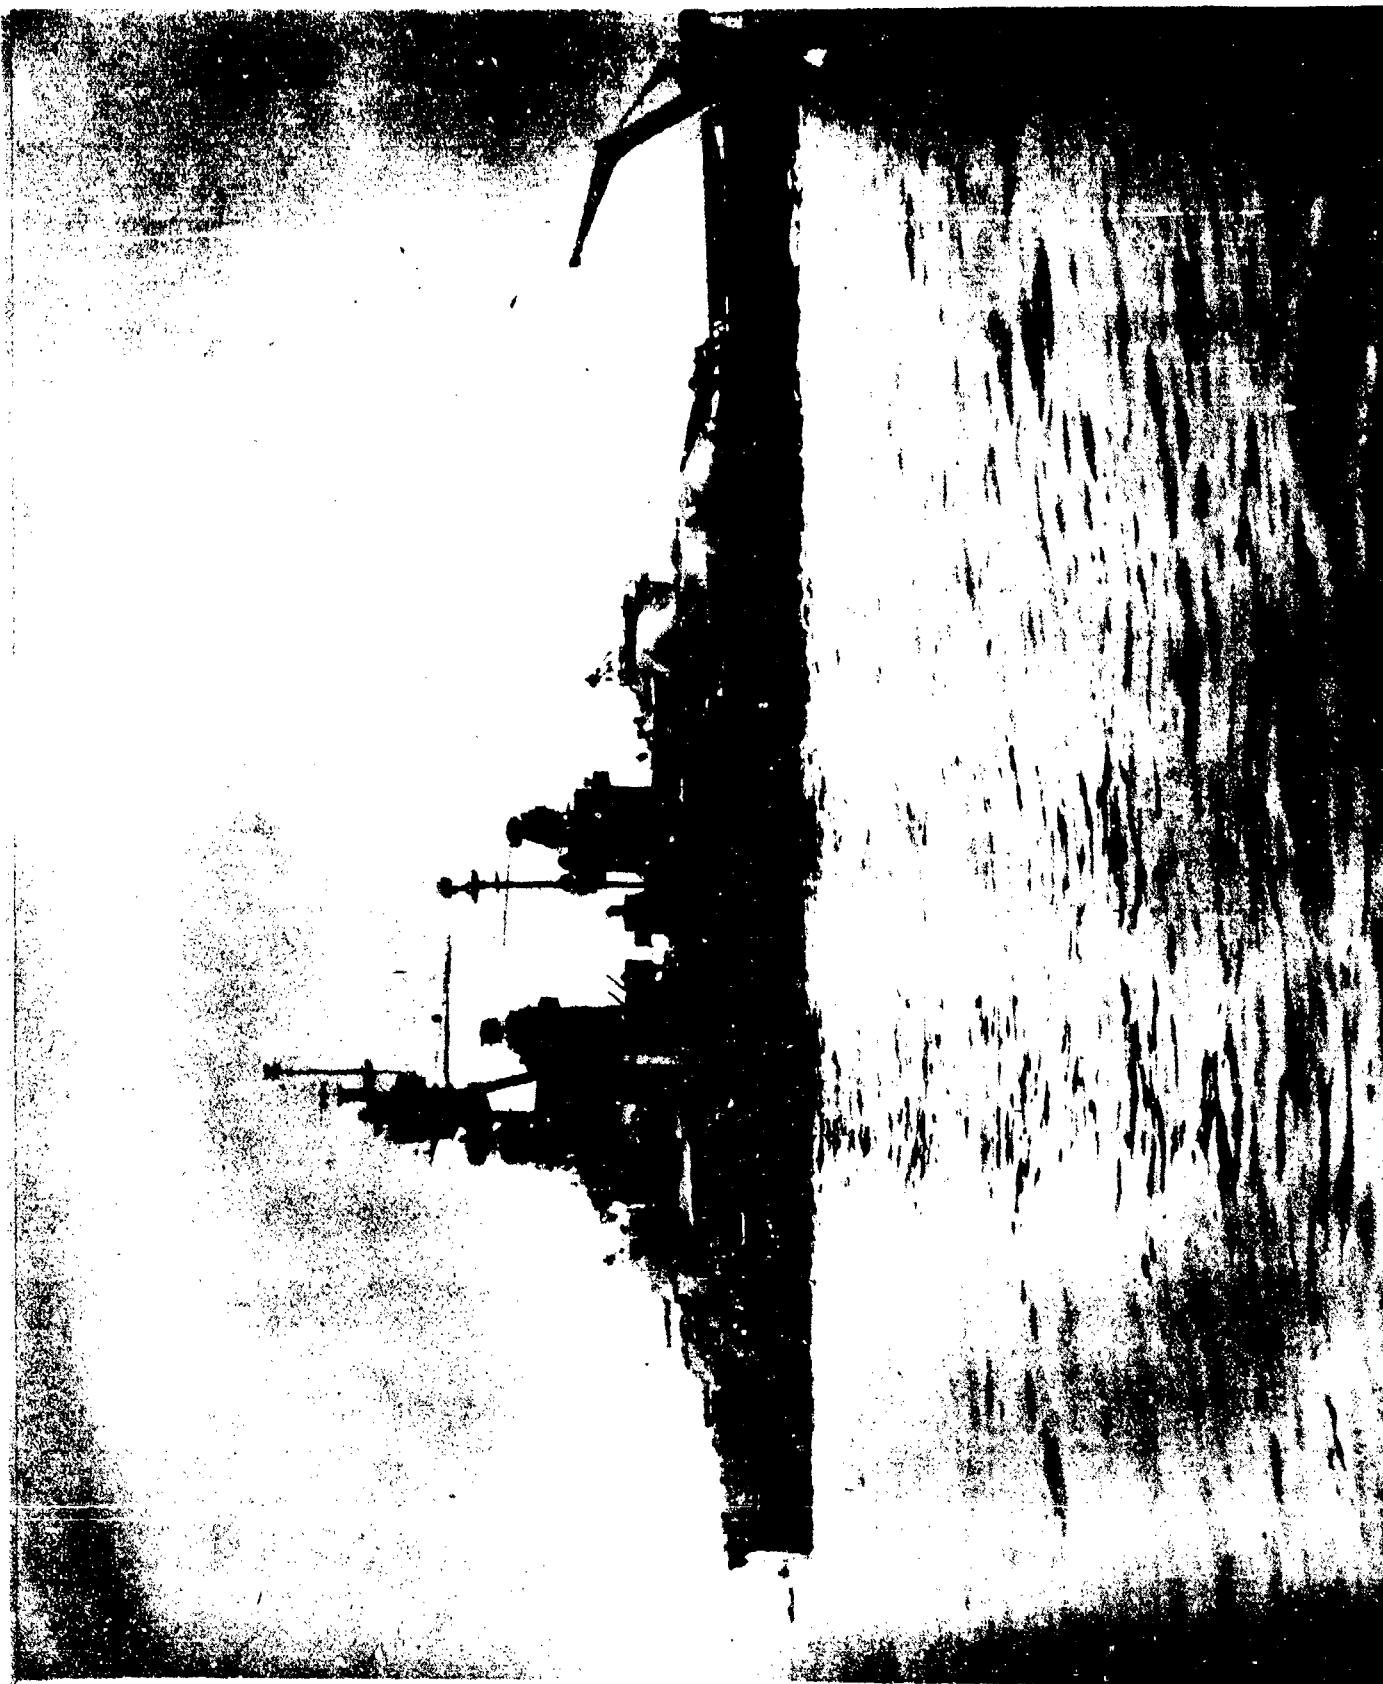
AB-CR-227-289-34. View from off port quarter after Test B.

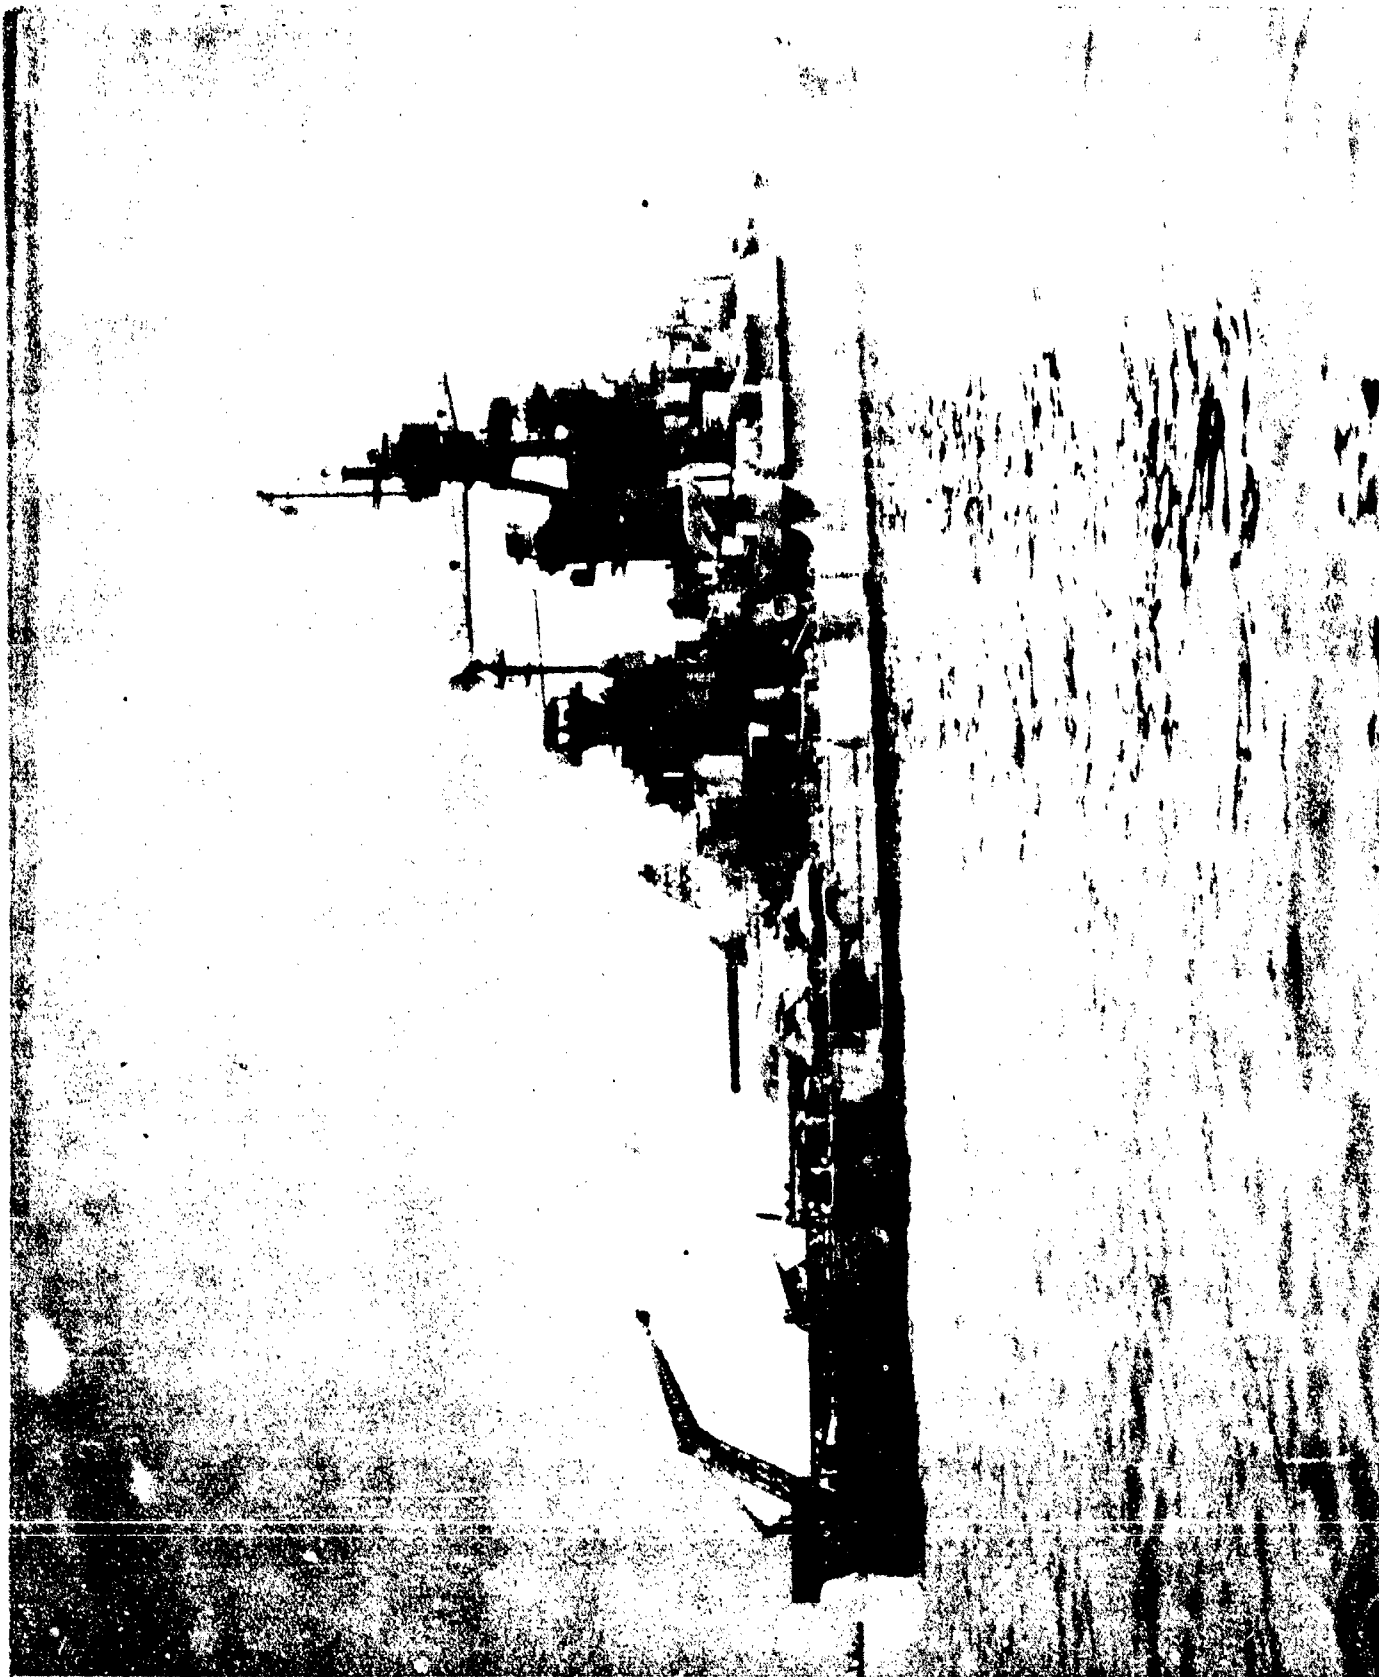
Hull damage occurs primarily on the starboard side aft in the area of previous torpedo damage and consists of opened seams.

AB-CR-227-289-40. View from off starboard quarter after Test B.

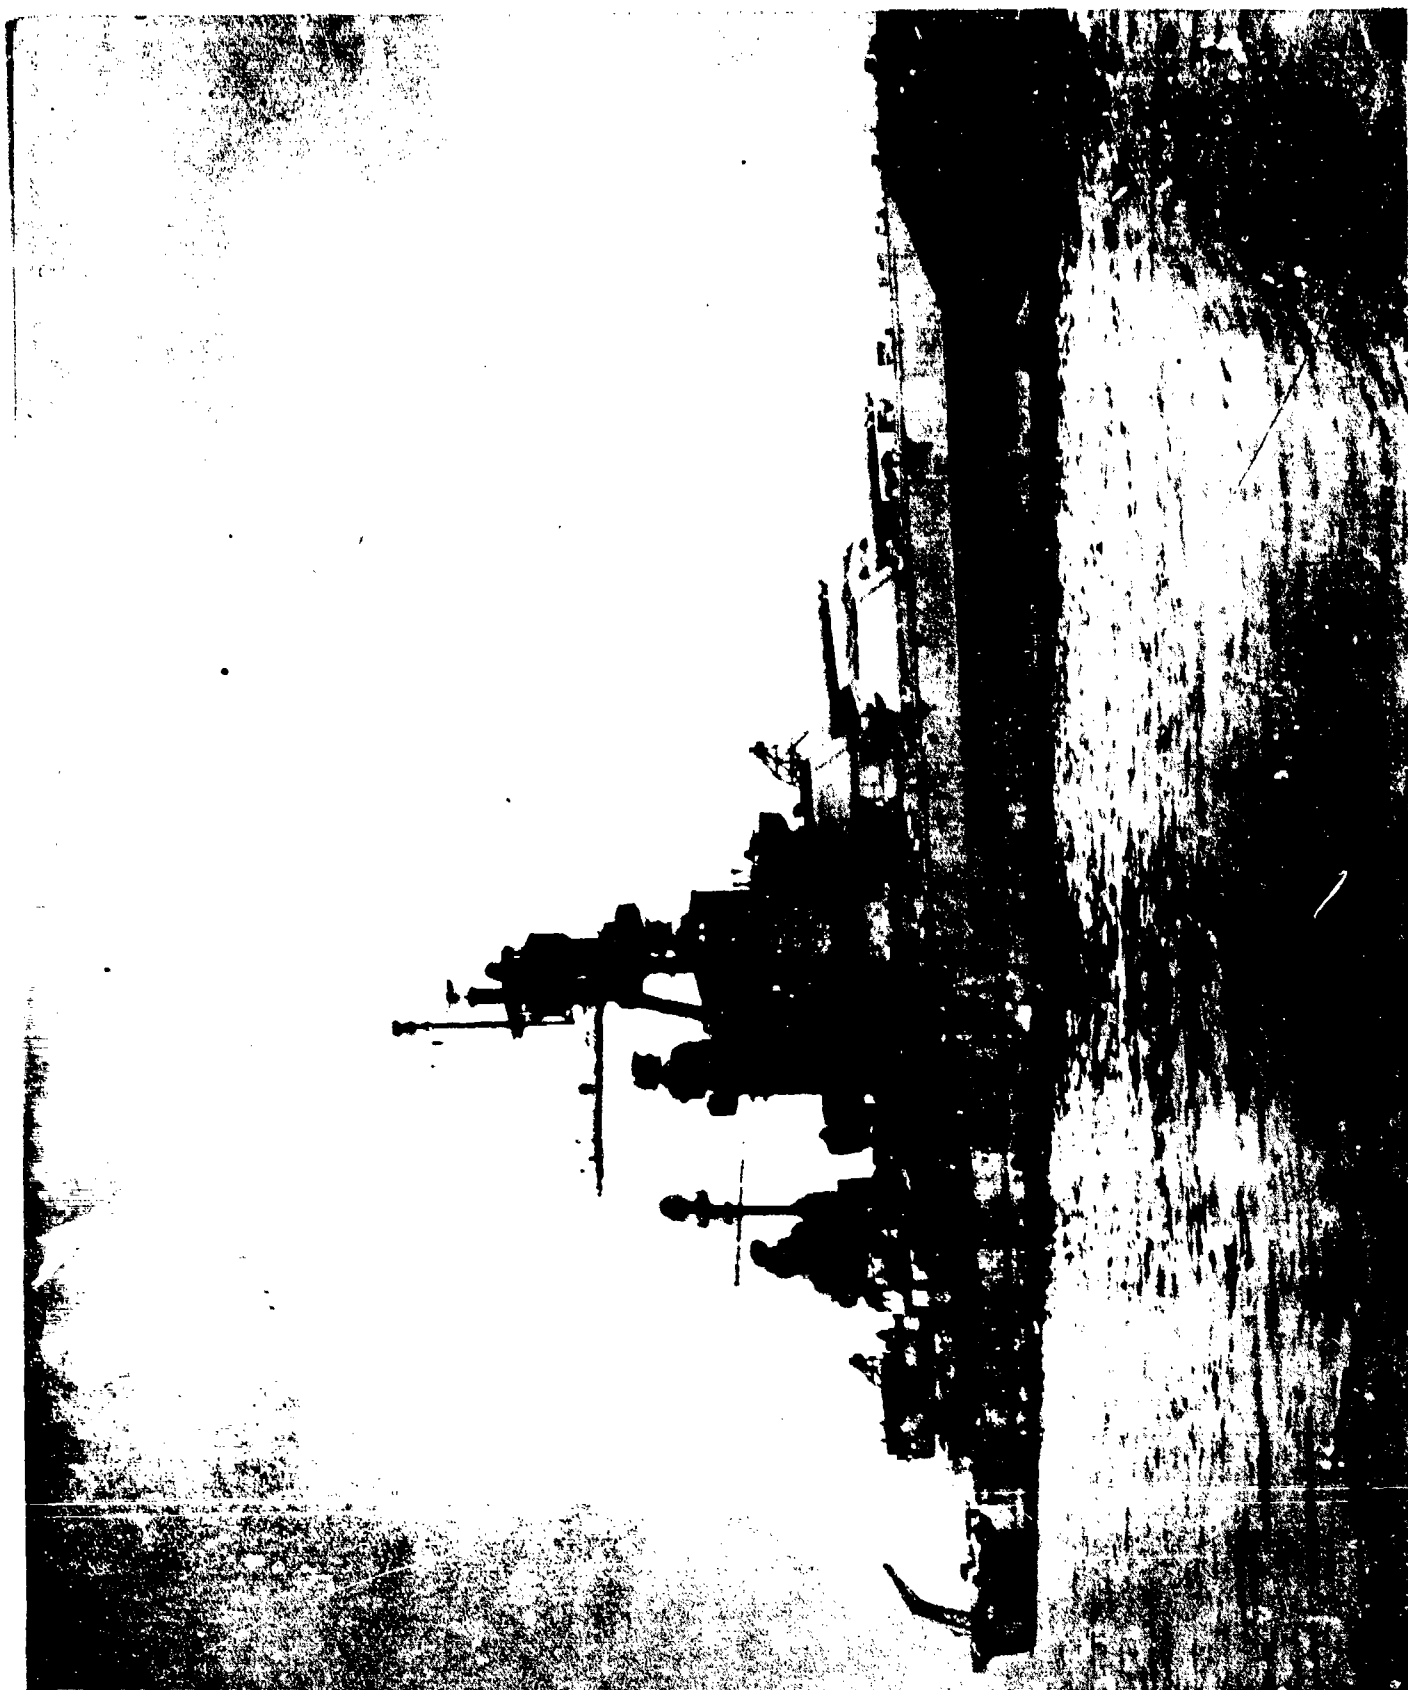
AB-CR-227-289-38. View from off starboard bow after Test B.
