BUREAU OF SHIPS

TECHNICAL INSPECTION REPORT

⑥ OPERATION CROSSROADS.  
U.S.S PENSACOLA (CA24).

TEST BAKER.

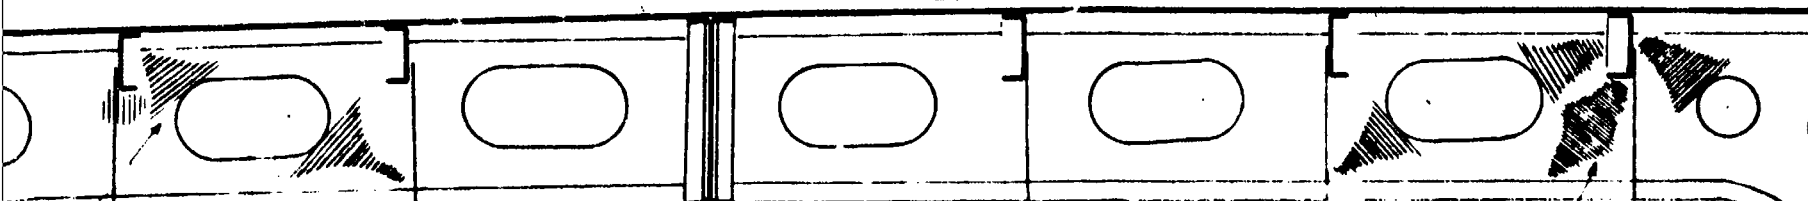
PHOTO 2982-9

FAILURE IN TRANSVERSE BEAM

FR. 64, LOOKING FWD., FWD. ENGINE RM.

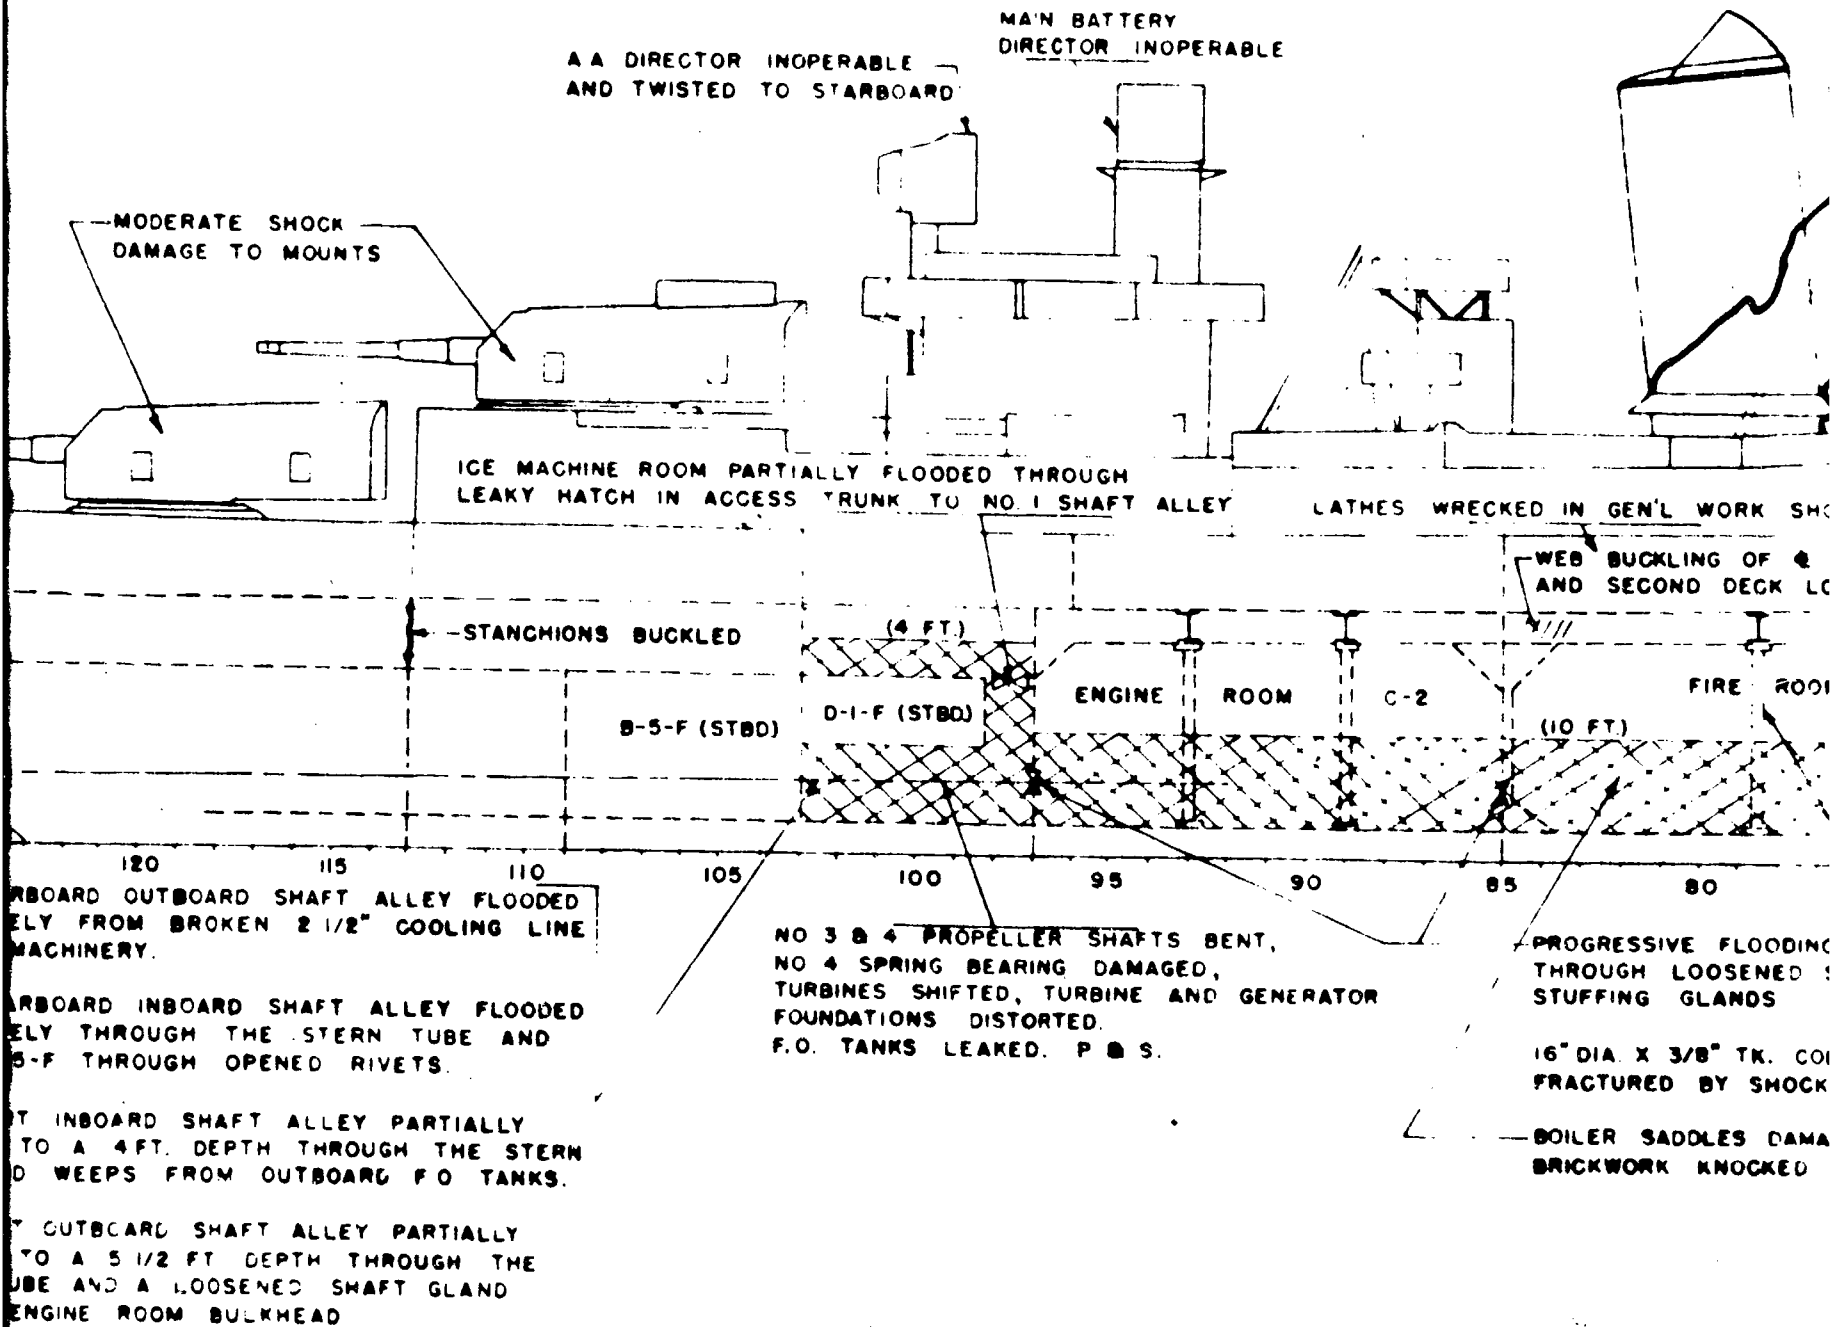
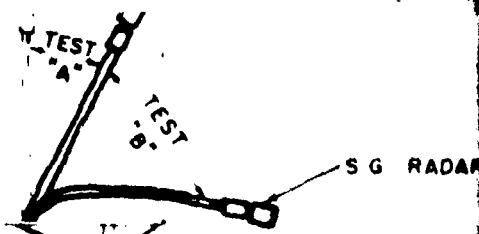
In the engineering spaces there is evidence of severe shock and vibration. Structural foundations under condensers are deformed and rivets are sheared, turbine casings are cracked, boiler saddles are slightly damaged, considerable brickwork is knocked down, gratings are displaced and moveable gear is severely disarranged. In both the forward and after firerooms, the 16" x 3/8" centerline column is fractured, having been severely wrinkled by compression and having then failed when placed in tension. Longitudinal and transverse girders supporting the armored deck in way of the engineering spaces are severely buckled in the webs, principally in way of lightening holes.

BOILER SADDLES DAMAGED AND  
BRICKWORK KNOCKED DOWN
