TECHNICAL INSPECTION REPORT

(6) OPERATION CROSSROADS.
U.S.S. BRACKEN (APA64).
TEST BAKER [U]. (8)

(9) Bureau of Ships group
technical inspection rpt.

OPERATION CROSSROADS

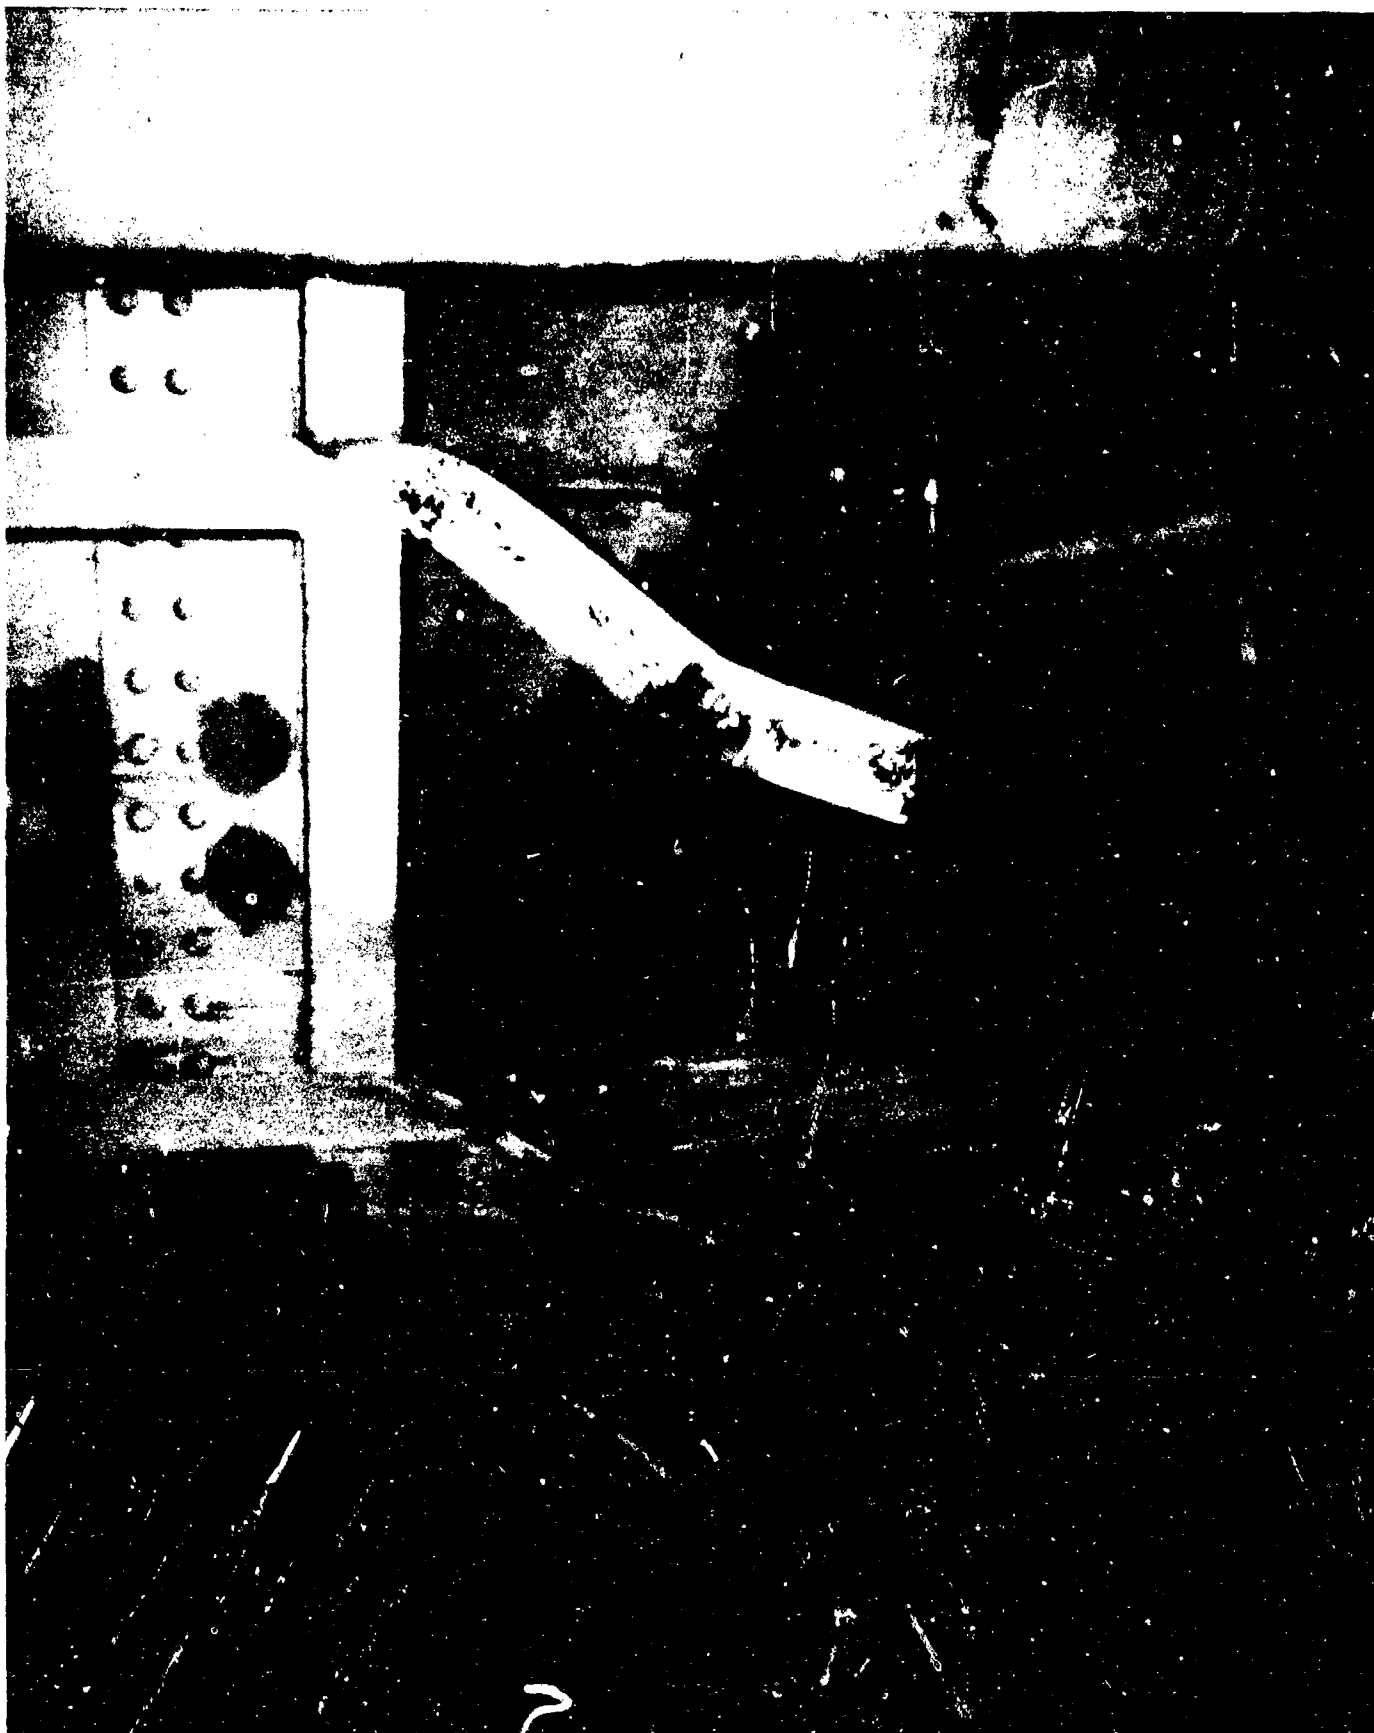
At frames 104-105, port, just below the sheer strake, a hole approximately three square feet in area was punched through the shell plating when a tug collided with the vessel (Photo 4063-2; page 34).

There was no structural damage as a direct result of the bomb. A hole about 6'' x 36'' was punched in port side at frame 105 by salvage tug coming alongside.

AB-CR-234-4063-2. Hole in port side at frames 104 and 105.

There is a hole about 6'' x 36'' at frame 105, port side, about 6 feet below the main deck. Rumor is that salvage tug made it. No missile was found inside the ship.
