BUREAU OF SHIPS GROUP

TECHNICAL INSPECTION REPORT

6 OPERATION CROSSROADS.
U.S.S. BRISCOE (APA 65)

TEST BAKER [U]

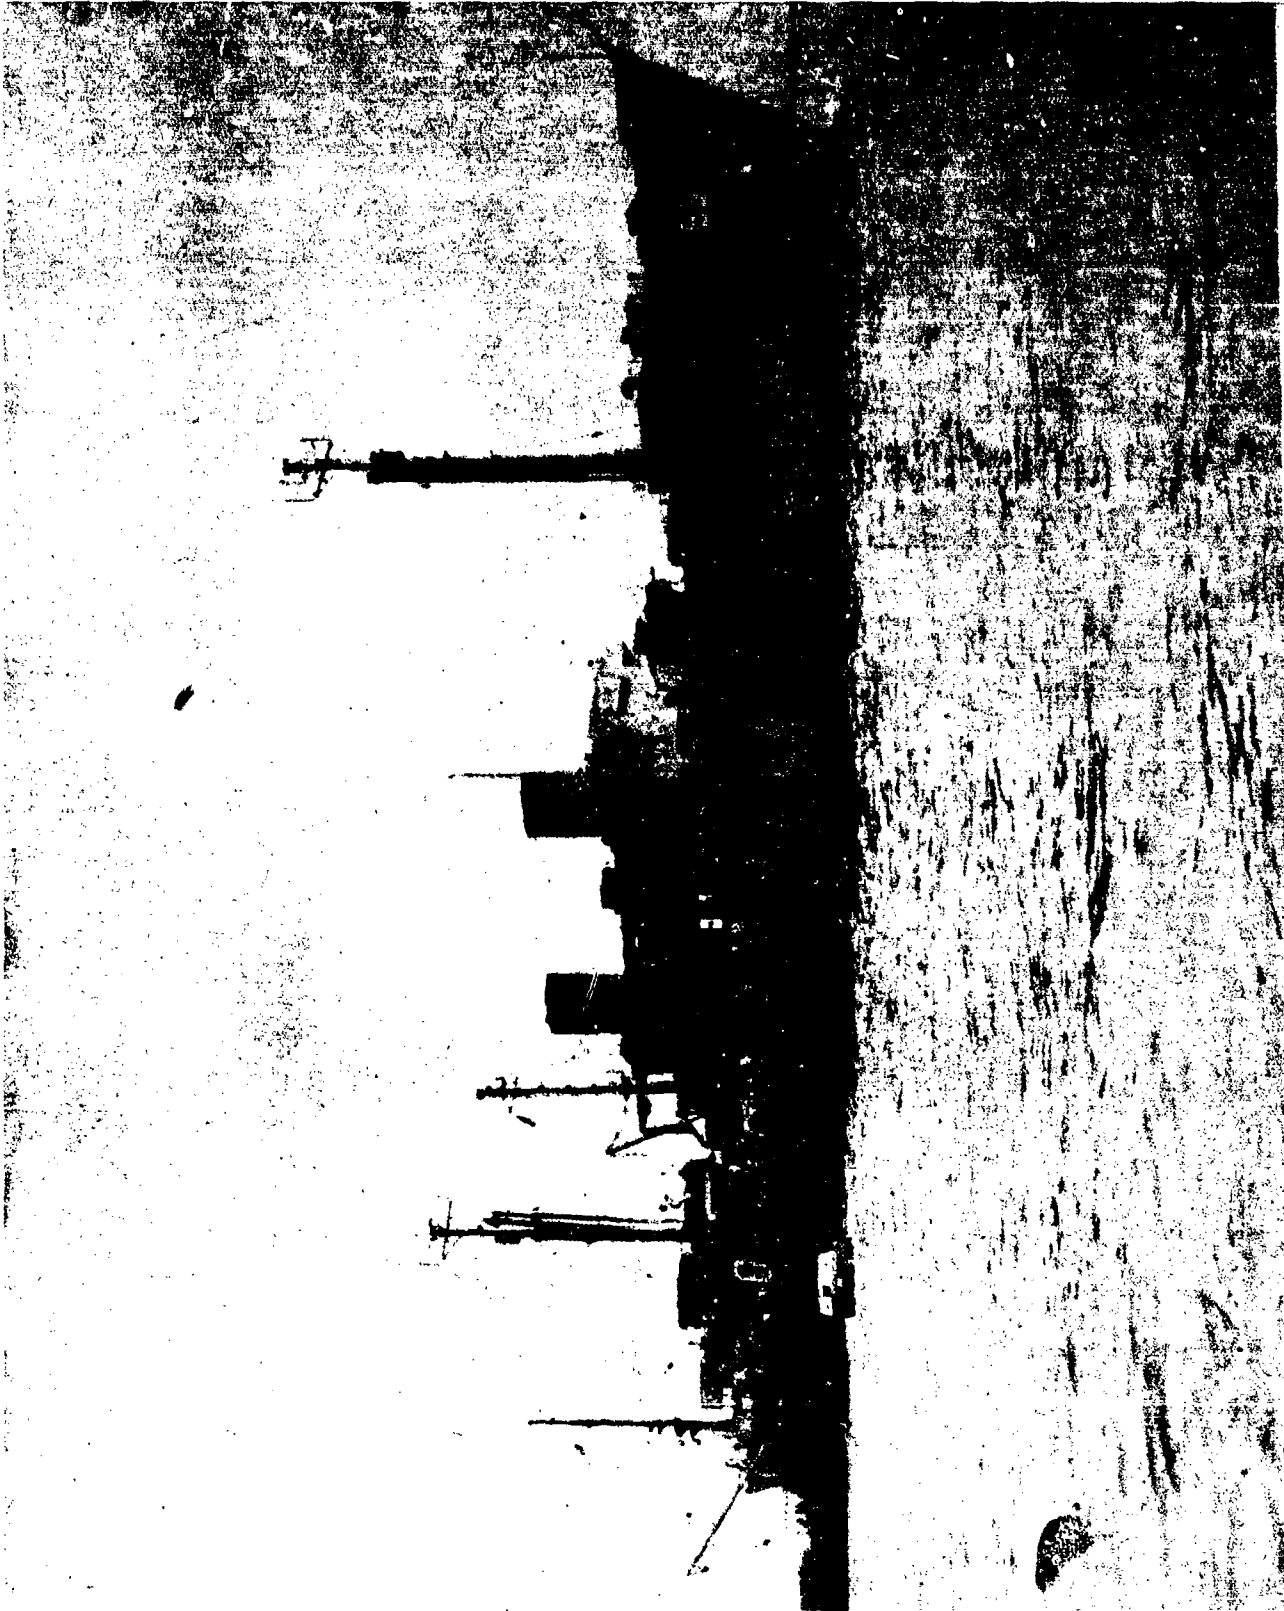
AB-CR-227-289-62. View from starboard bow after Test B.

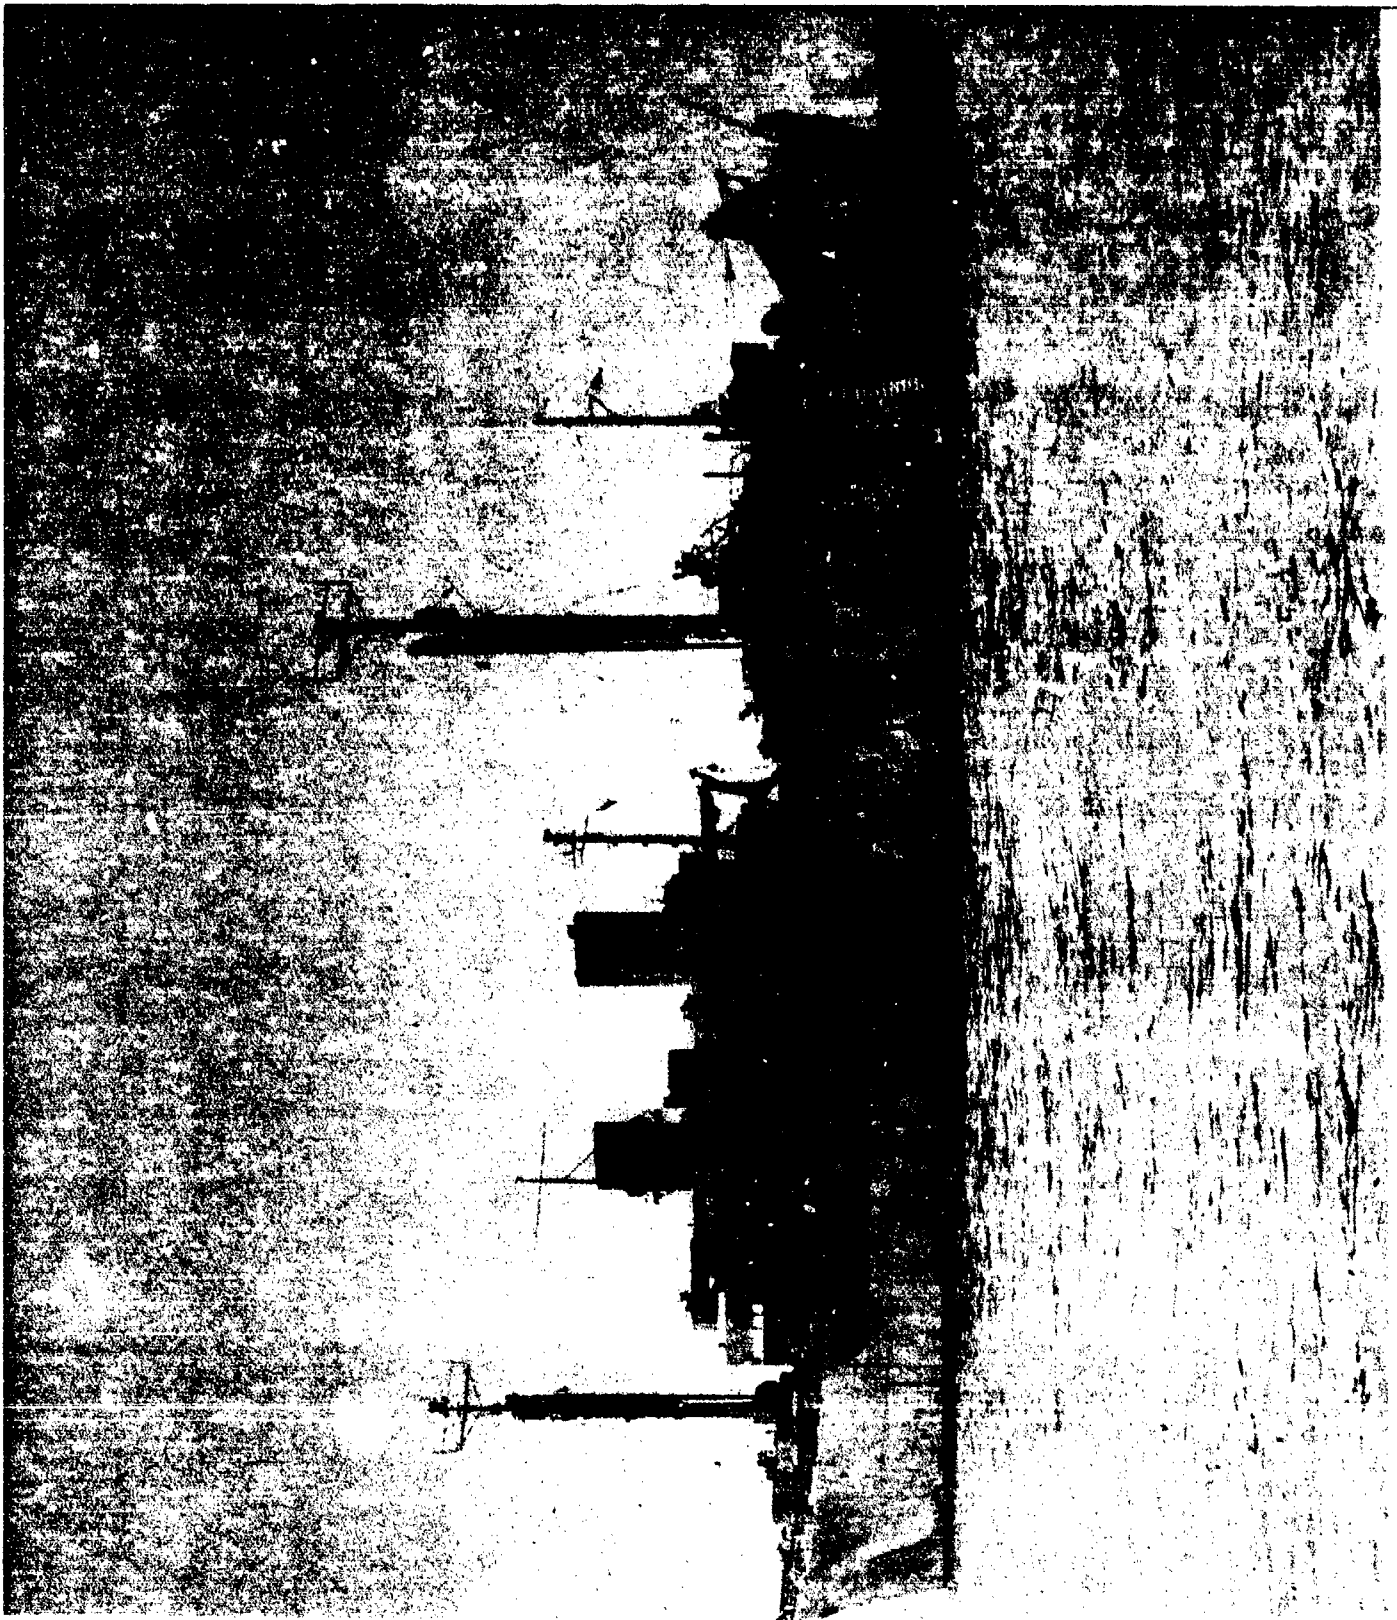
AB-CR-227-289-58. View from port quarter after Test B.

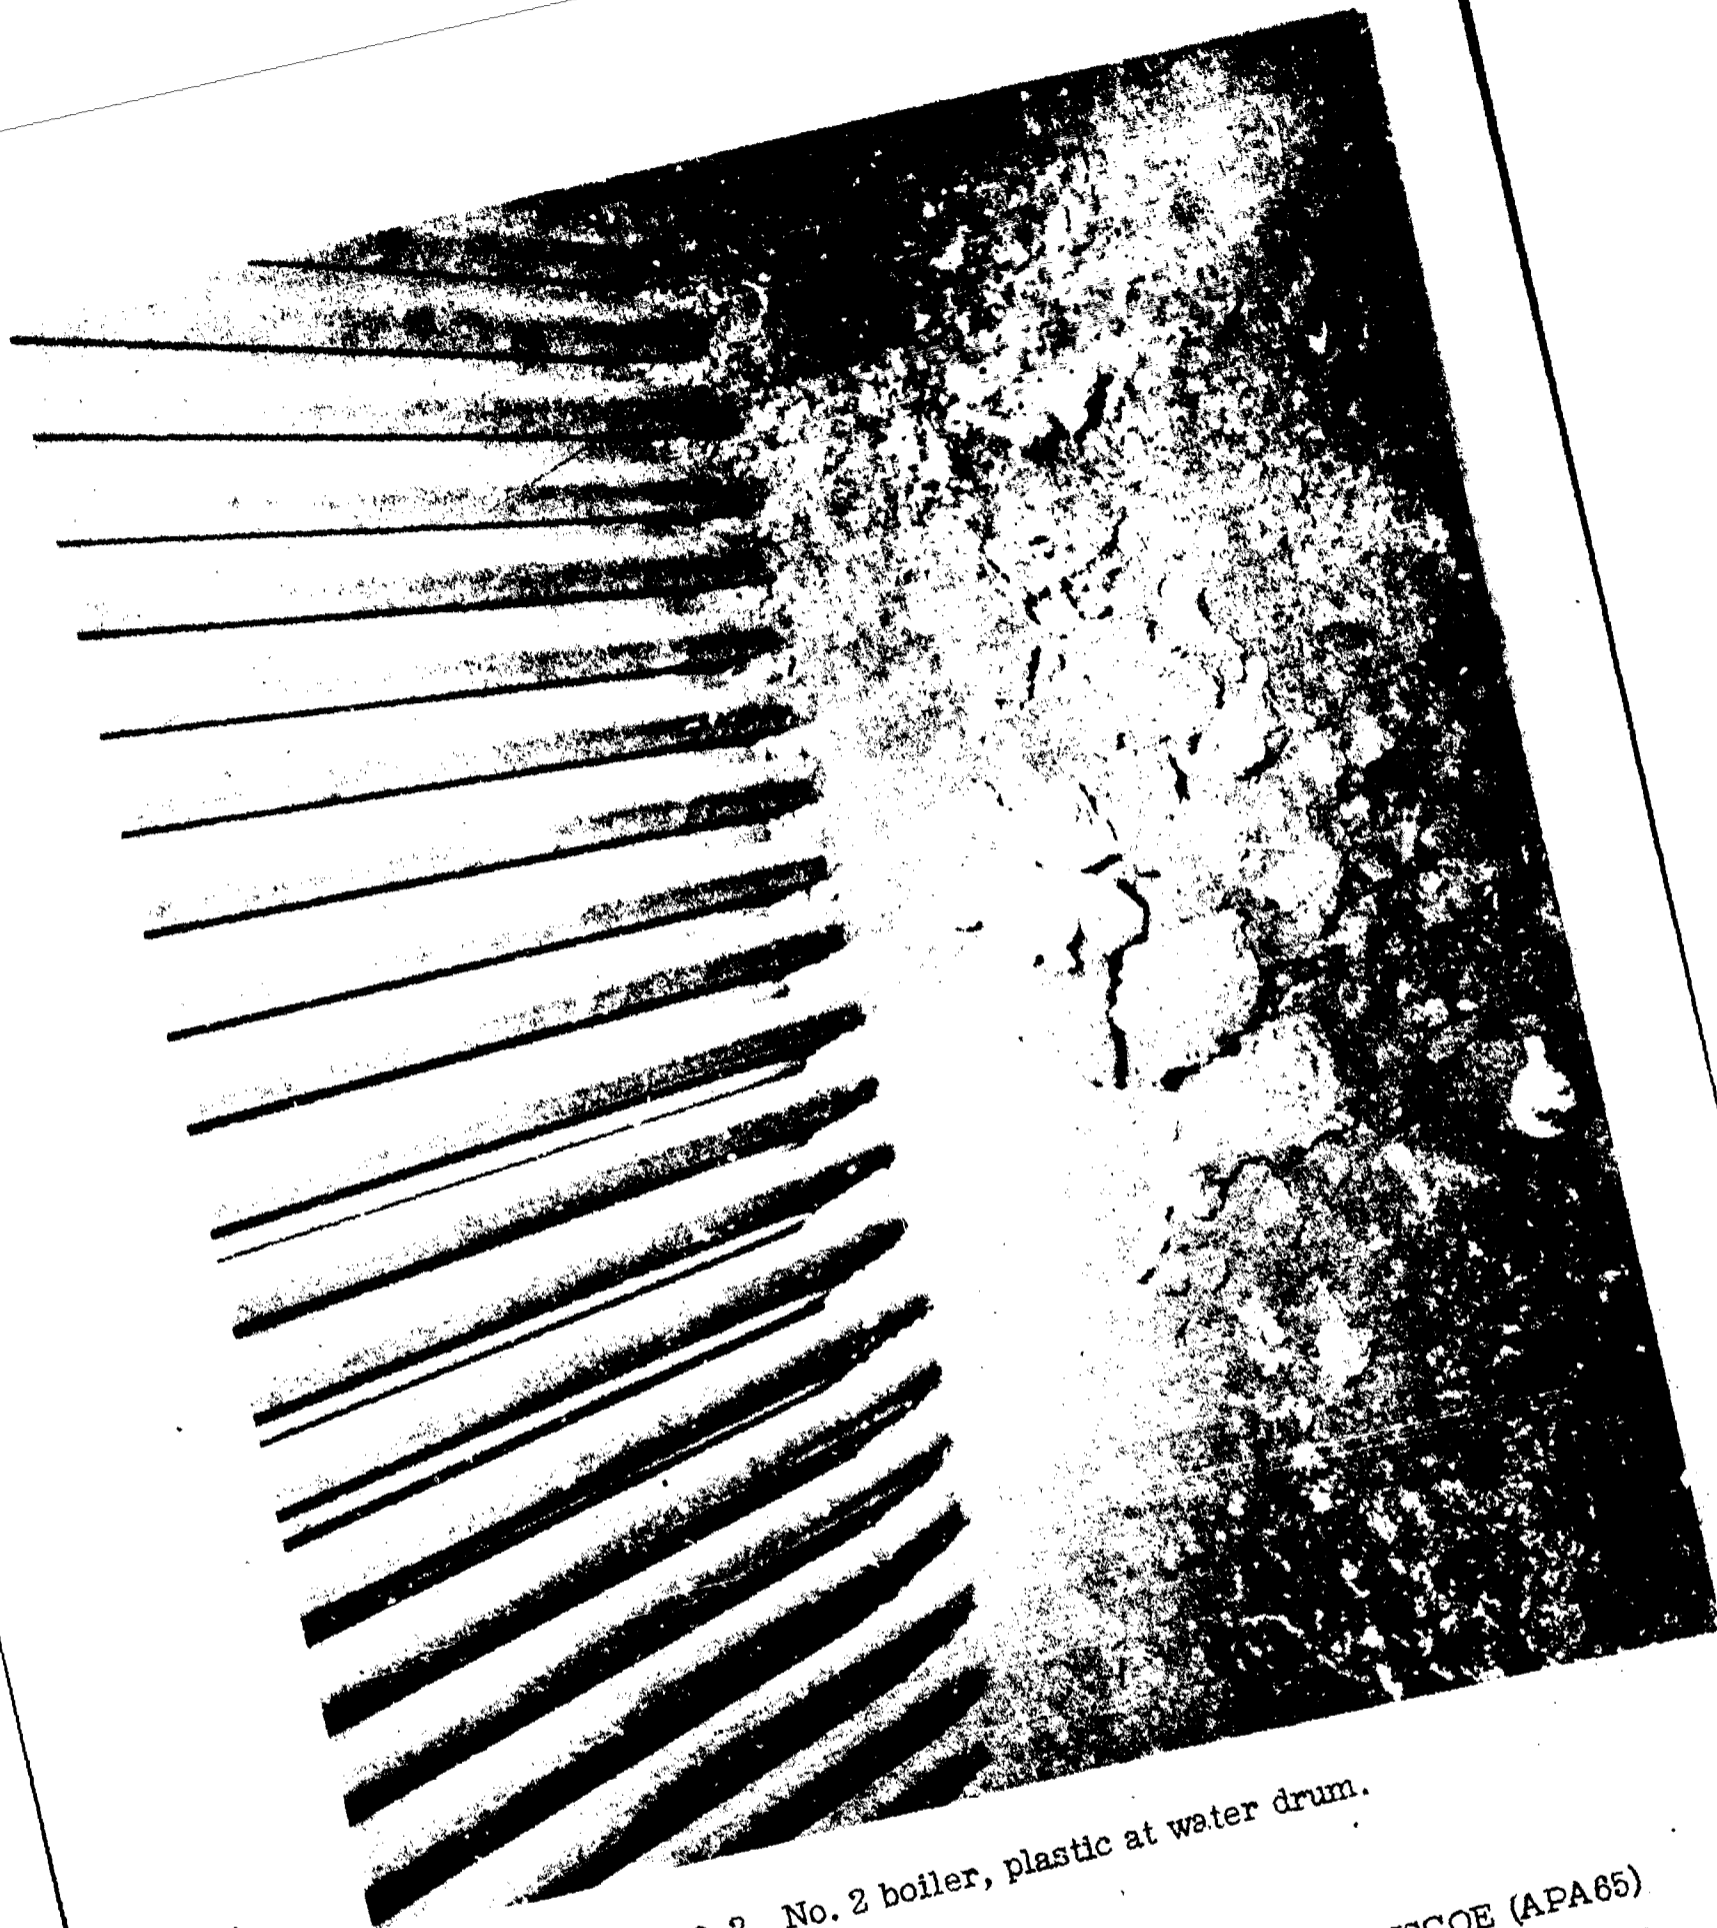
(d) Brickwork and furnaces - The plastic refractory at the water wall headers and around the generating tubes near the furnace floors had cracked off and fallen down. Slag on the walls had spalled, cracked off and fallen to the deck. It is considered that the amount of cracking and spalling of the brickwork was not sufficient to require any reduction in the steaming rate of the boilers and that they could have continued in operation for an extended period without repair. (Photos 4045-12, 1933-1, 2, pages 42 , 43 , and 44).

AB-CR-76-1933-2. No. 2 boiler, plastic at water drum.

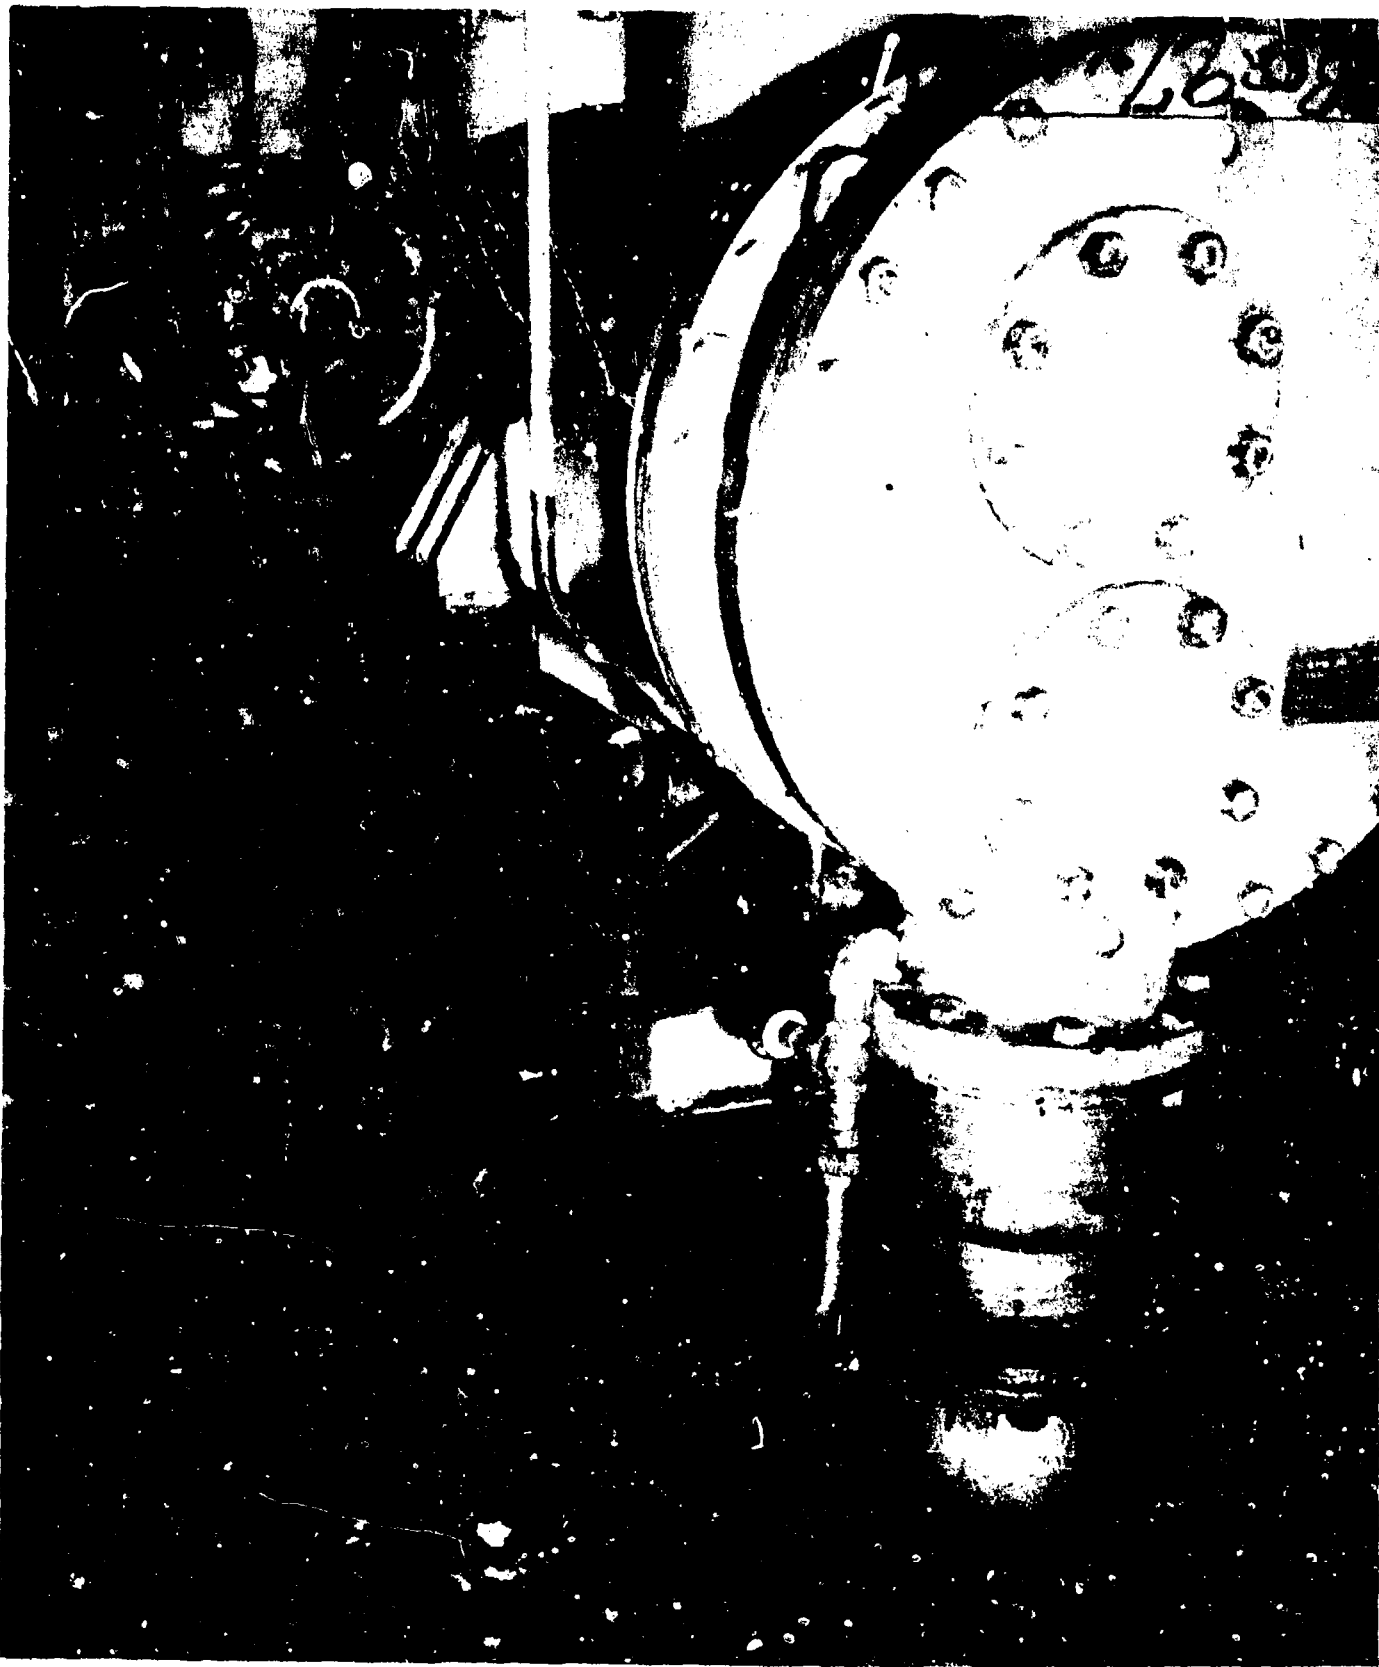
The auxiliary condenser in the forward engine room had shifted slightly on its foundation, and holding down bolts were stretched beyond their elastic limit and were loose, but not broken. See photo 4044-1, page 47 , for full view of condenser and photograph 4044-2, page 48 , for mounting foot.

AB-CR-97-4044-1. Ship's service auxiliary generator, No. 1 engine room.

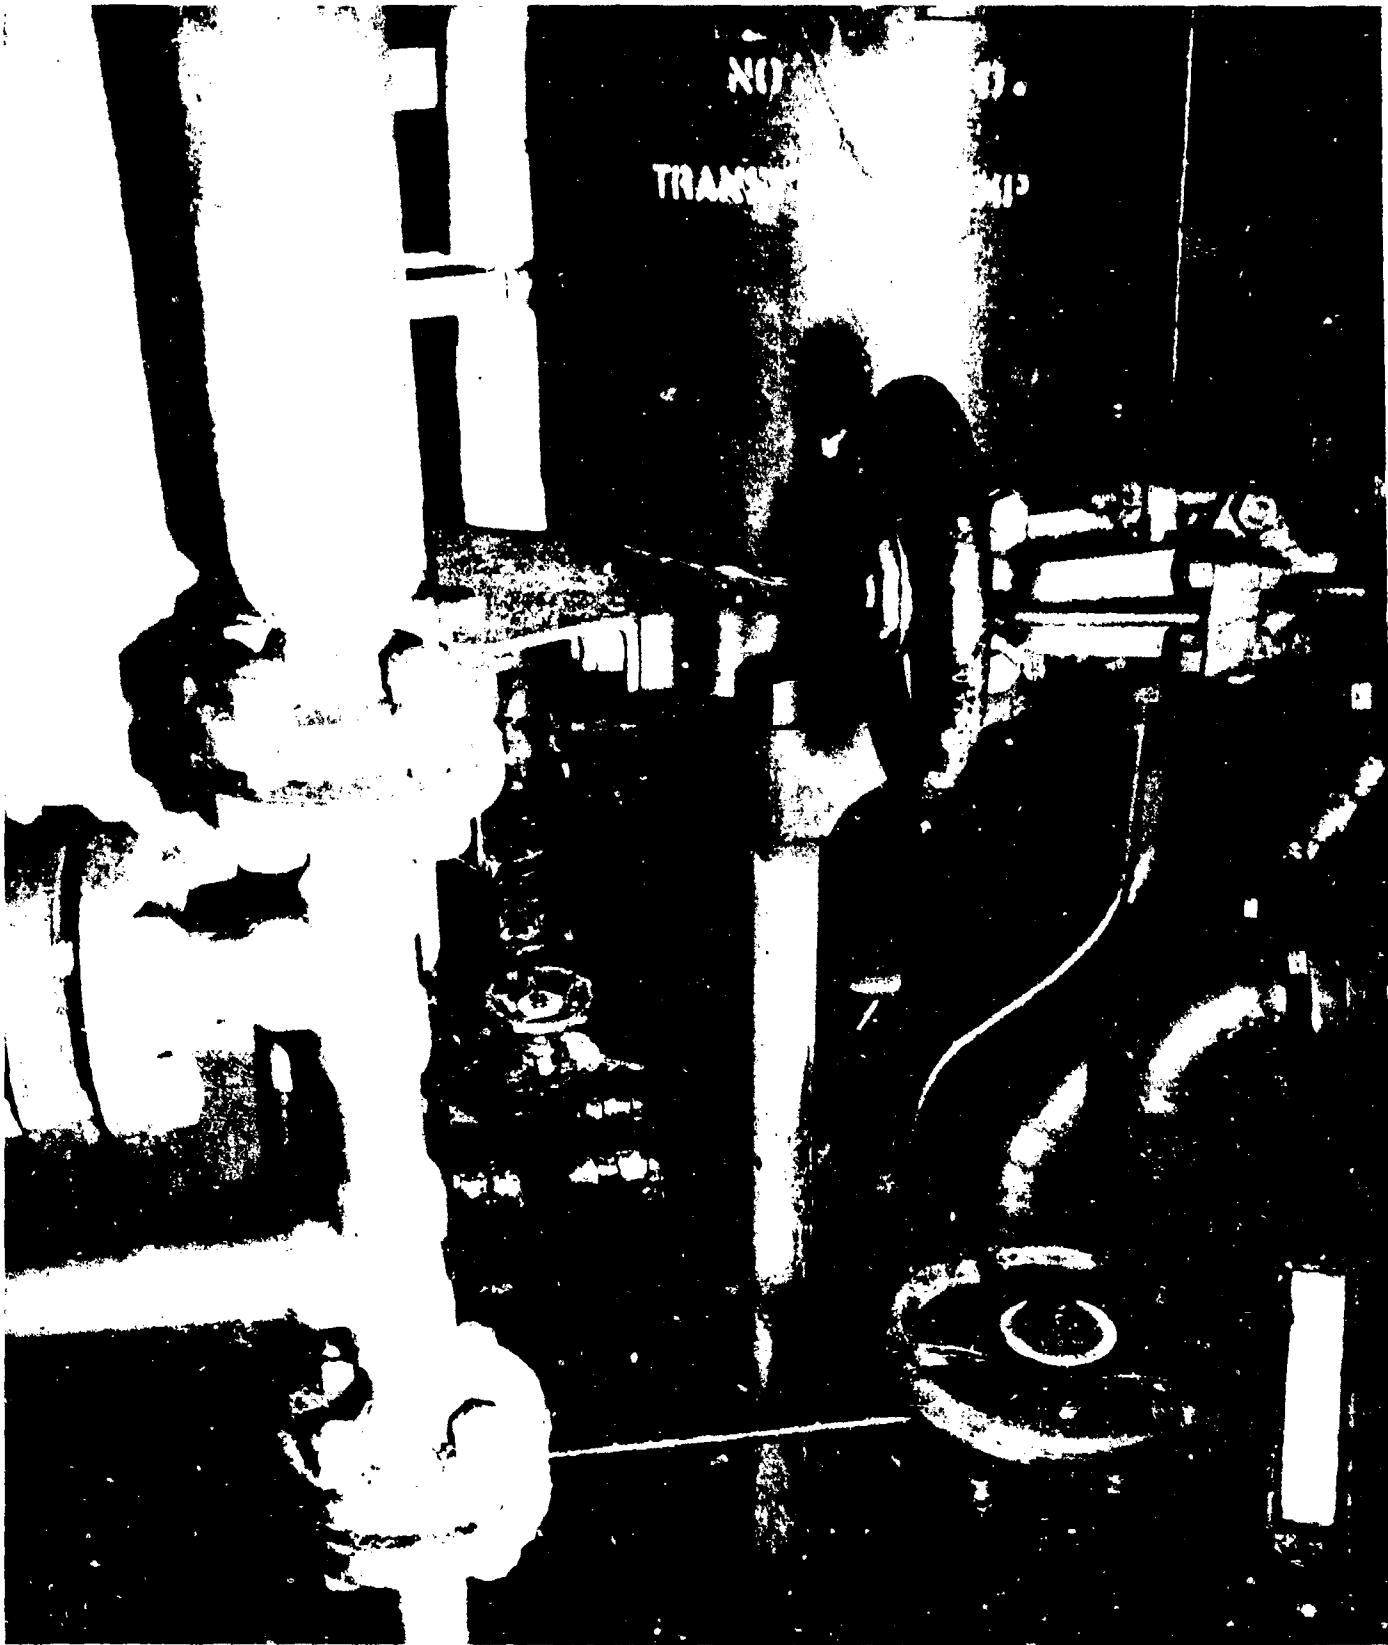
On practically all vertical reciprocating pumps, the bolts securing the steam end to the ship's structure had been stretched and were loose in the holes. In one case, (#1 fuel oil transfer pump) one bolt was missing. Photo 4044-4, page 49 , is of #1 fuel oil transfer pump but may be considered as typical of all vertical reciprocating pumps on this vessel. It is not believed that this would have impaired operability of the pumps.

AB-CR-97-4044-4. No. 1 fuel oil transfer pump foundation bolts.

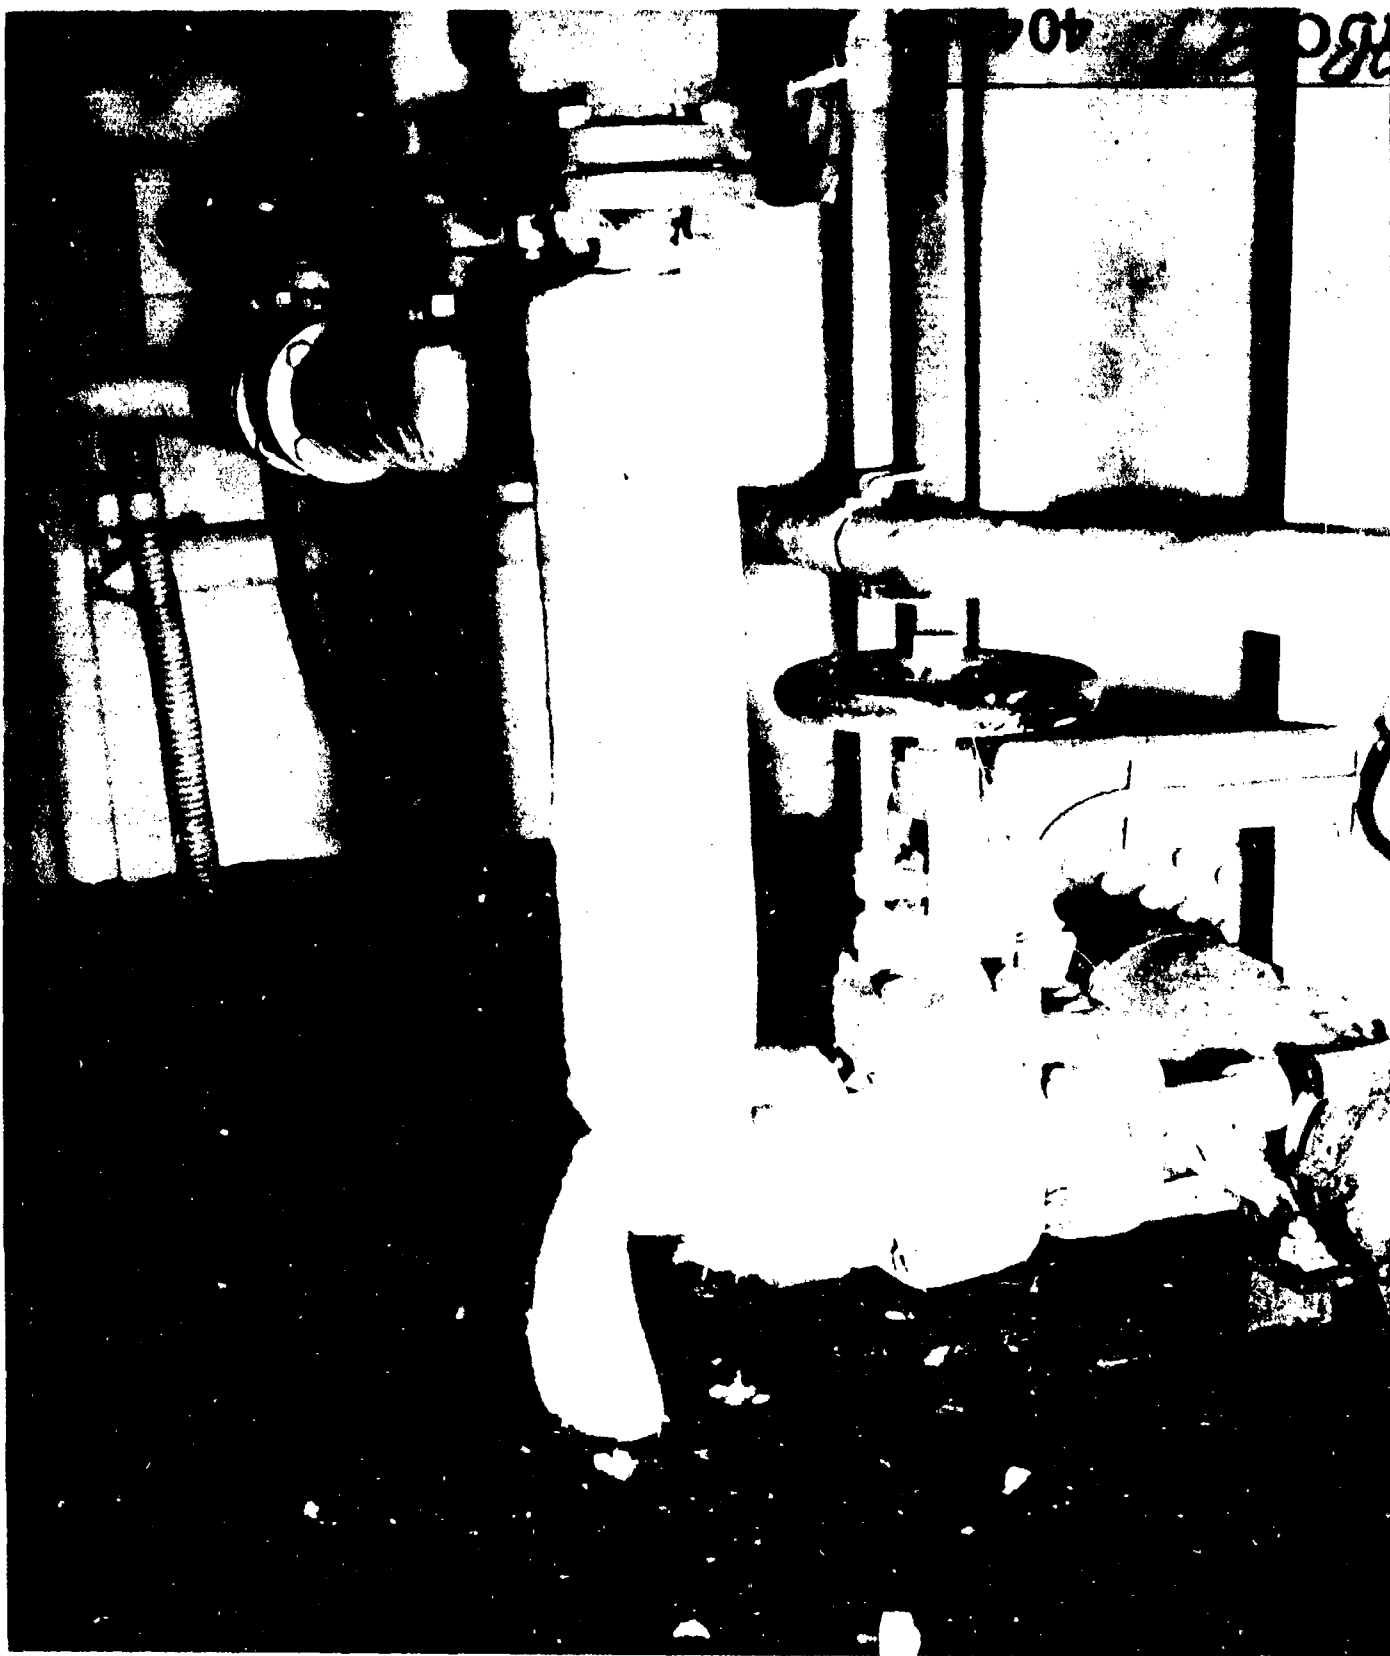
The hot water circulating pump mounted under the hot water heater in the forward engine room, had a broken discharge nozzle, caused by shock. (Photo 4044-5, page 50).

AB-CR-97-4044-5. No. 1 engine room, fresh water circulating pump.

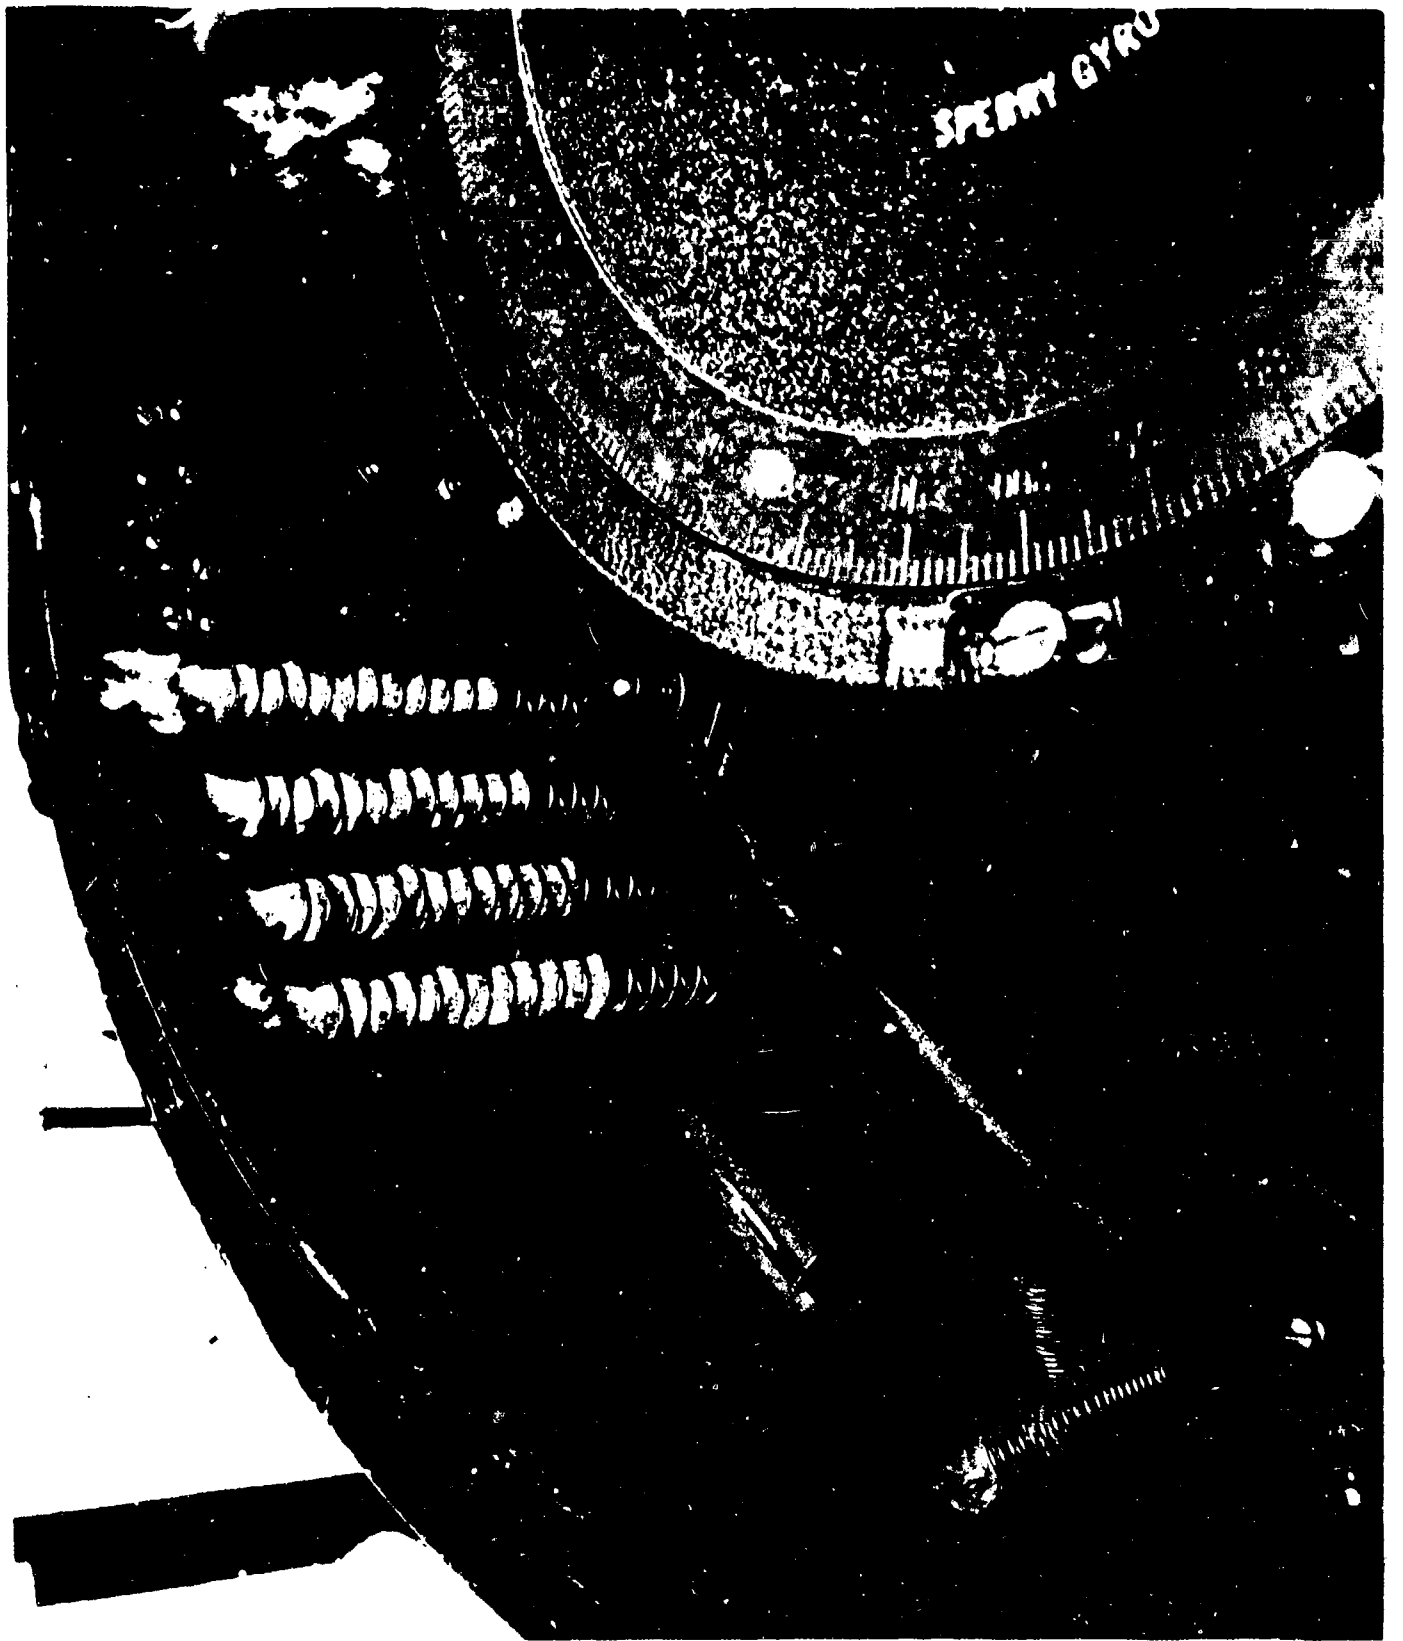
Some coil suspension springs were elongated, others pulled free from the compass. Traces of mercury were found on the phantom ring and in the binnacle case.

It is believed that the suspension cable is either broken or elongated enough to allow the rotor case to rest on the vertical ring bearing. No operational test was made. Ref. photographs No. 4065-6, page 58 ; No. 4065-7, page 57 .

AB-CR-234-4065-7. Side view of master gyro showing position of sensitive element with elongated suspension springs.

AB-CR-234-4065-6. View of master gyro showing elongated suspension springs, and springs disconnected.
