BUREAU OF SHIPS GROUP
TECHNICAL INSPECTION REPORT

OPERATION CROSSROADS.
U.S.S. CATRON (APA 71).

TEST BAKER [U]. (8)

OPERATION CROSSROADS

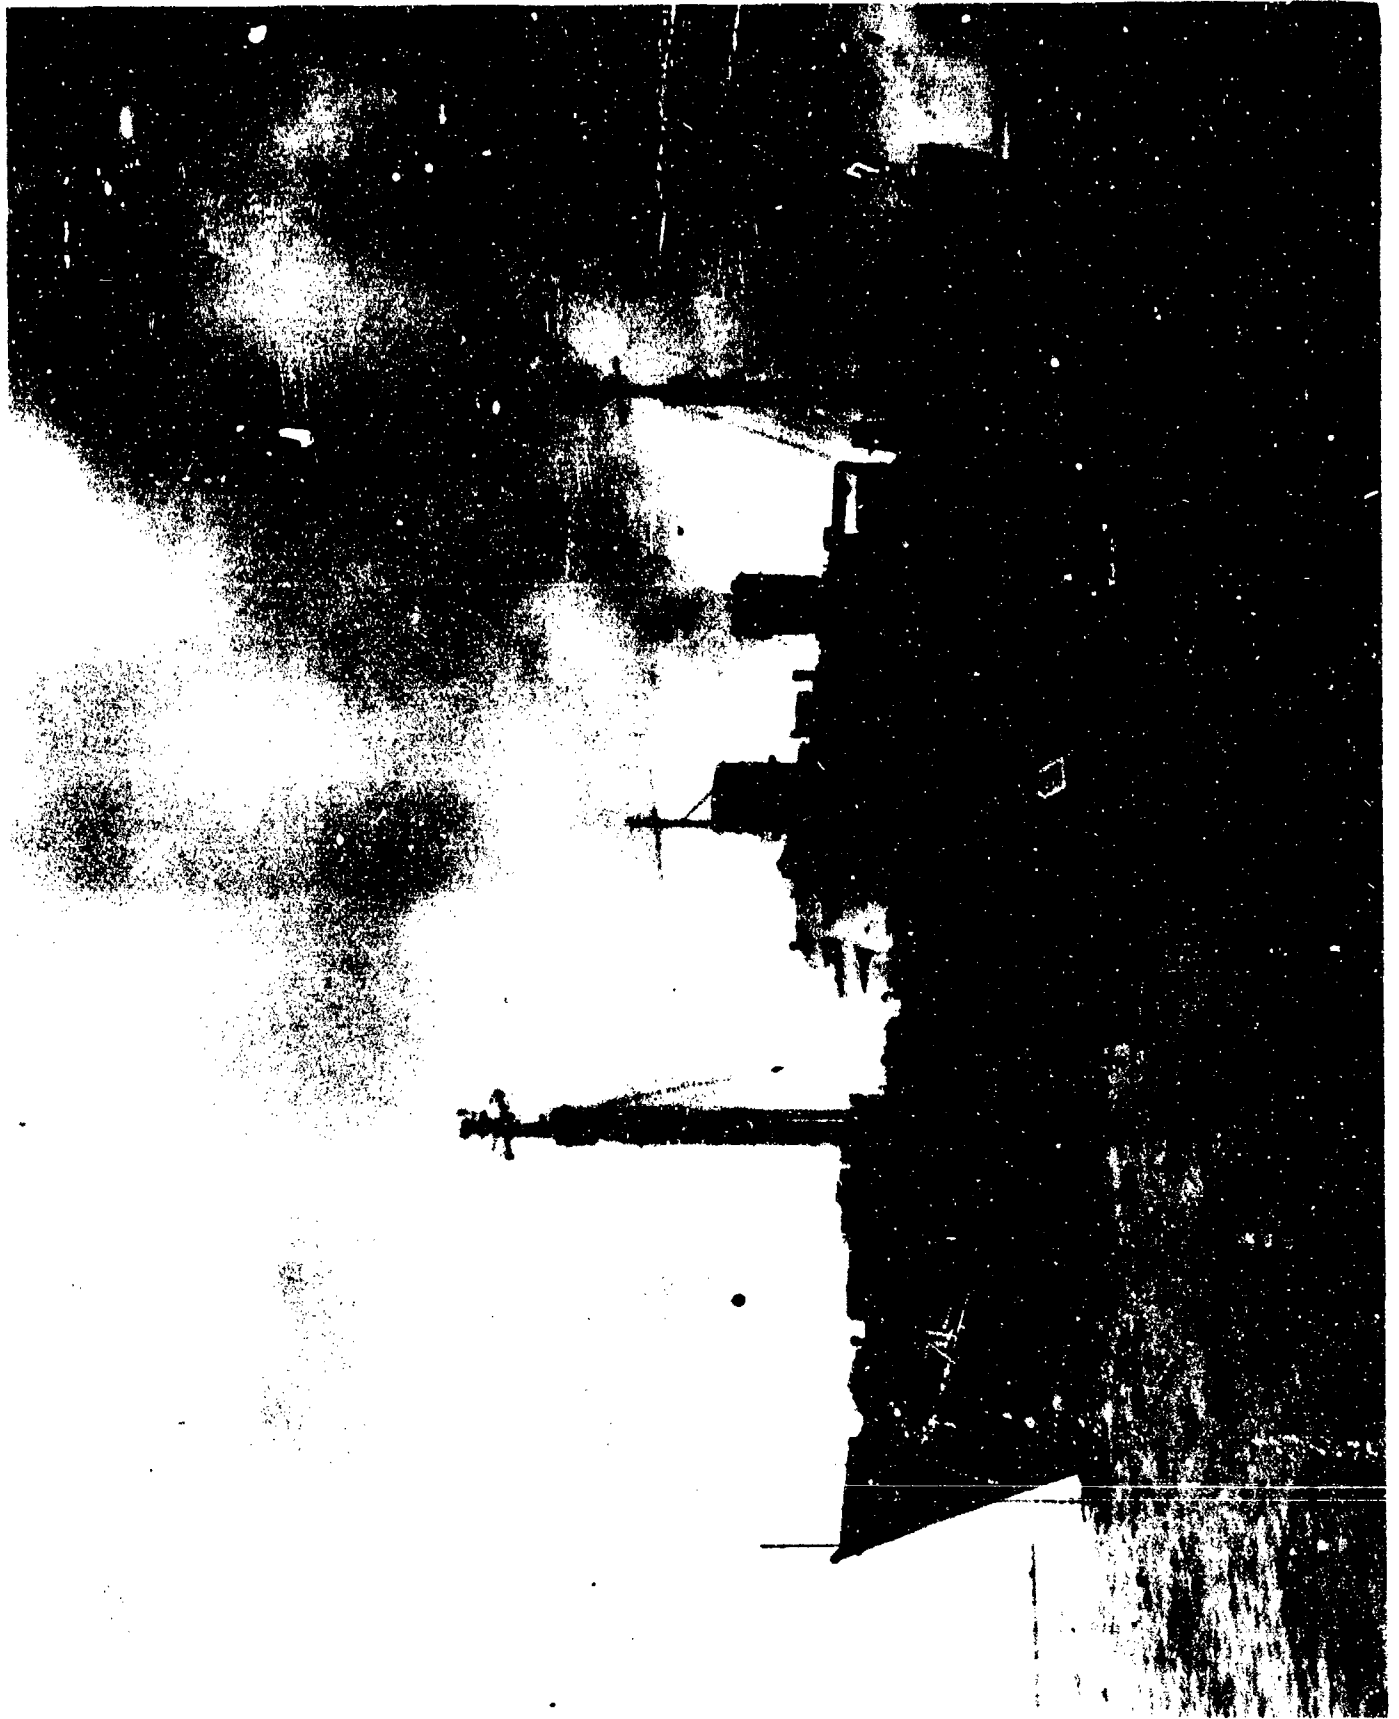
AA-CR-227-289-46. View from off port bow after Test B.

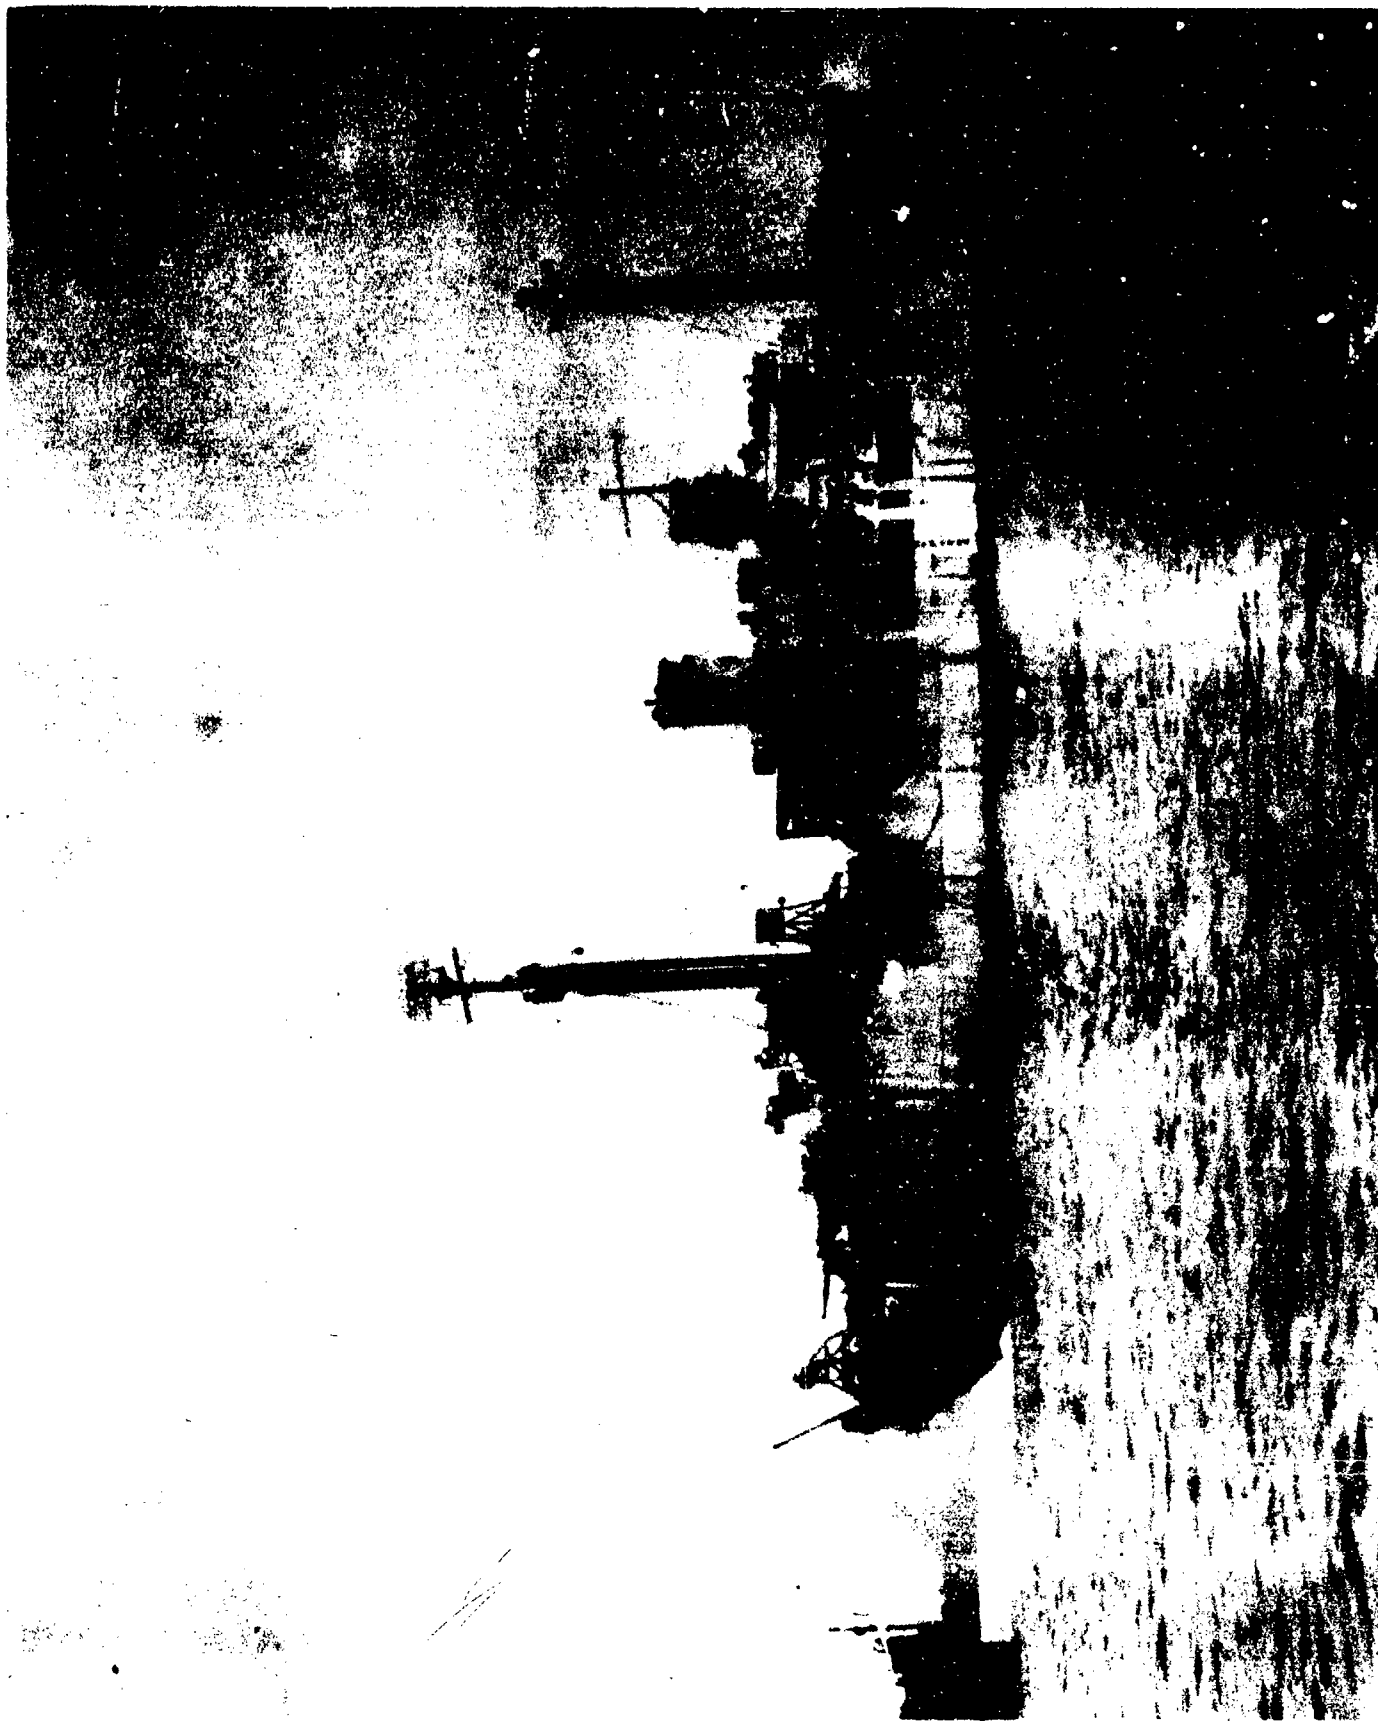
AB-CR-227-289-42. View from off starboard quarter after Test B.
