TECHNICAL INSPECTION REPORT

6 OPERATION CROSSROADS.
U.S.S. CRITTENDEN (APA 77)

TEST BAKER [U]

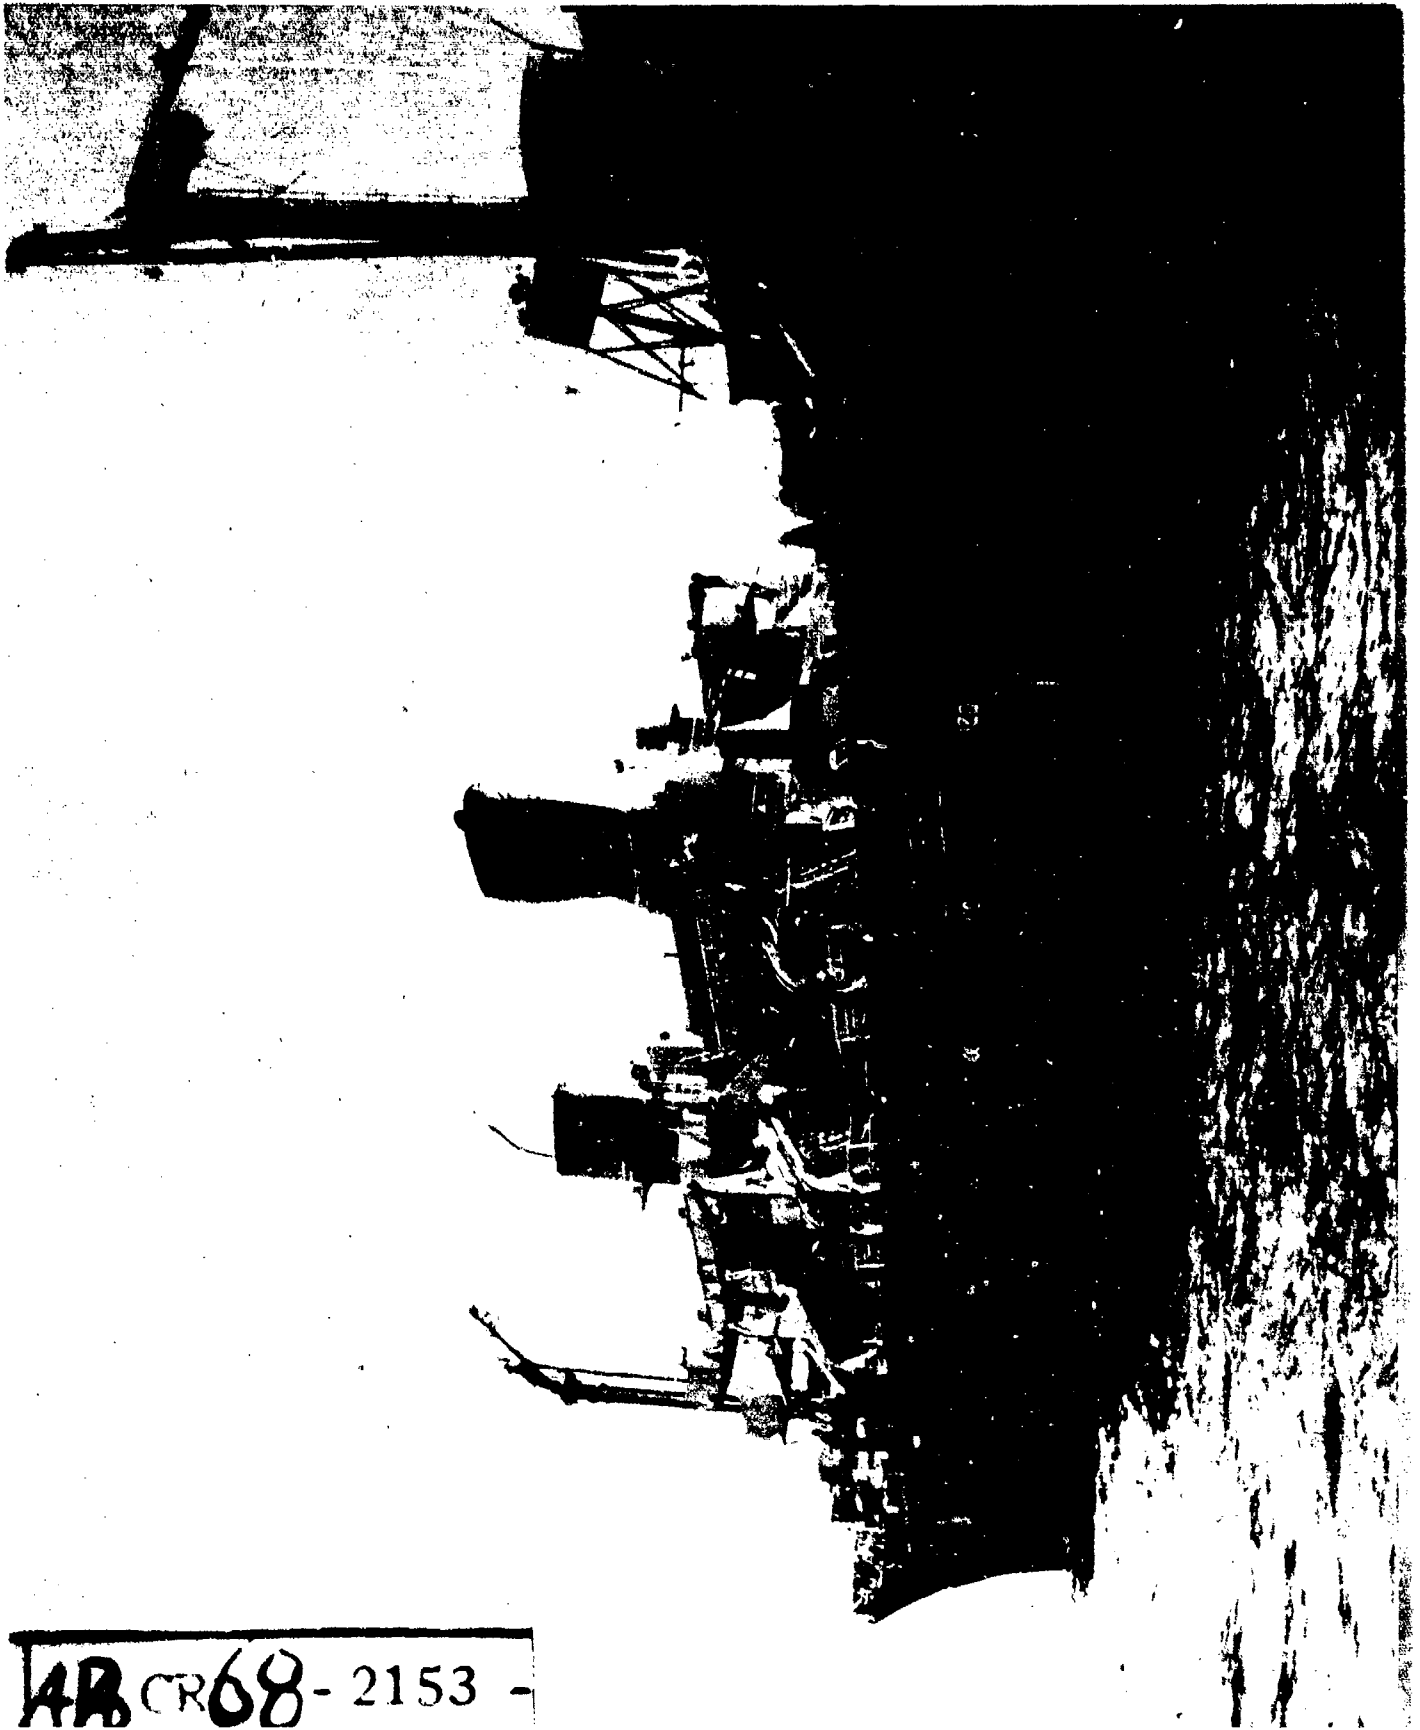
Guns and directors are not affected. The previously dislocated 40MM director foundation on the after deckhouse top, port, shows no additional displacement (photo 2153-10, page).

AB-CR-68-2153-10. View from off port quarter, bow to frame 142.
