# BUREAU OF SHIPS GROUP TECHNICAL INSPECTION REPORT

## OPERATION CROSSROADS. U.S.S. DAWSON (APA79). TEST BAKER [U].

U.S.S. DAWSON (APA 79)

TECHNICAL INSPECTION REPORT

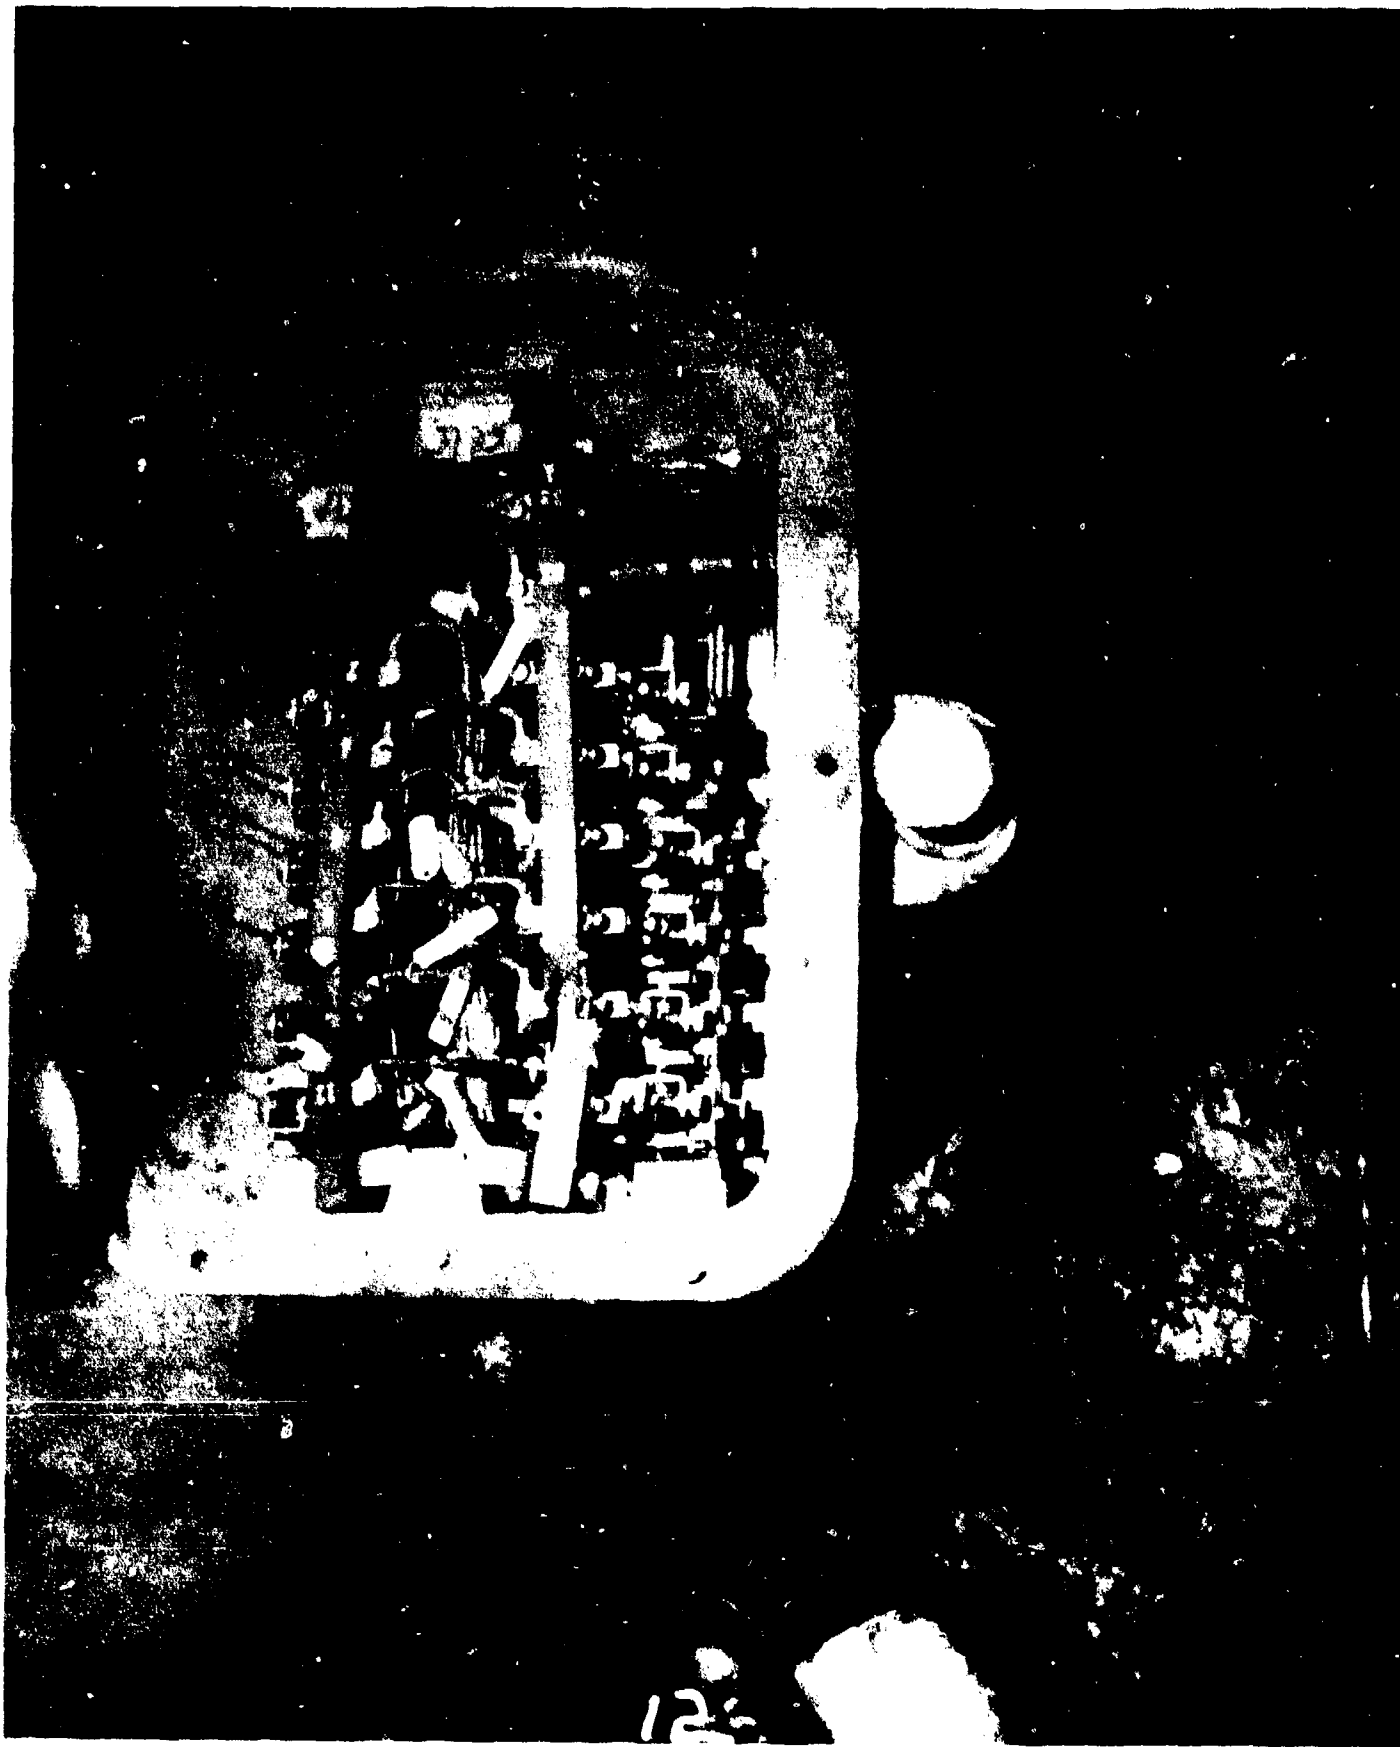
The anchor windlass controller located on the upper deck forward, was struck by a fragment, damaging the cover and rendering the windlass temporarily inoperable (photo 2176-12, page 42). Emergency electrical repairs to the equipment could have been made in a few minutes.

The watertight anchor windlass control switch located on the 01 deck forward was struck by a fragment. The enclosure cover was distorted and the internal phenolic strips were broken. See photograph 2176-12, page 42, showing a top view of the control switch with the cover open. The controller was rendered inoperable by this damage.

AB-CR-62-2176-12. Anchor windlass controller hit by missile, located on the forecastle.

however, it is considered that emergency repairs could be made by the ship's force to permit hoisting of the anchor. Replacement of the internal mechanism of the control switch required for proper operation of the anchor windlass.
